# National Transportation Safety Board

## Railroad Accident Brief

Accident Number:	DCA-01-MR-004
Location:	Baltimore, Maryland
Date and Time:	July 18, 2001, 3:08 p.m.
Accident Type:	Derailment and fire
Companies:	CSX Transportation
Injuries:	5 (minor)
Fatalities:	None
Cost:	\$12 million

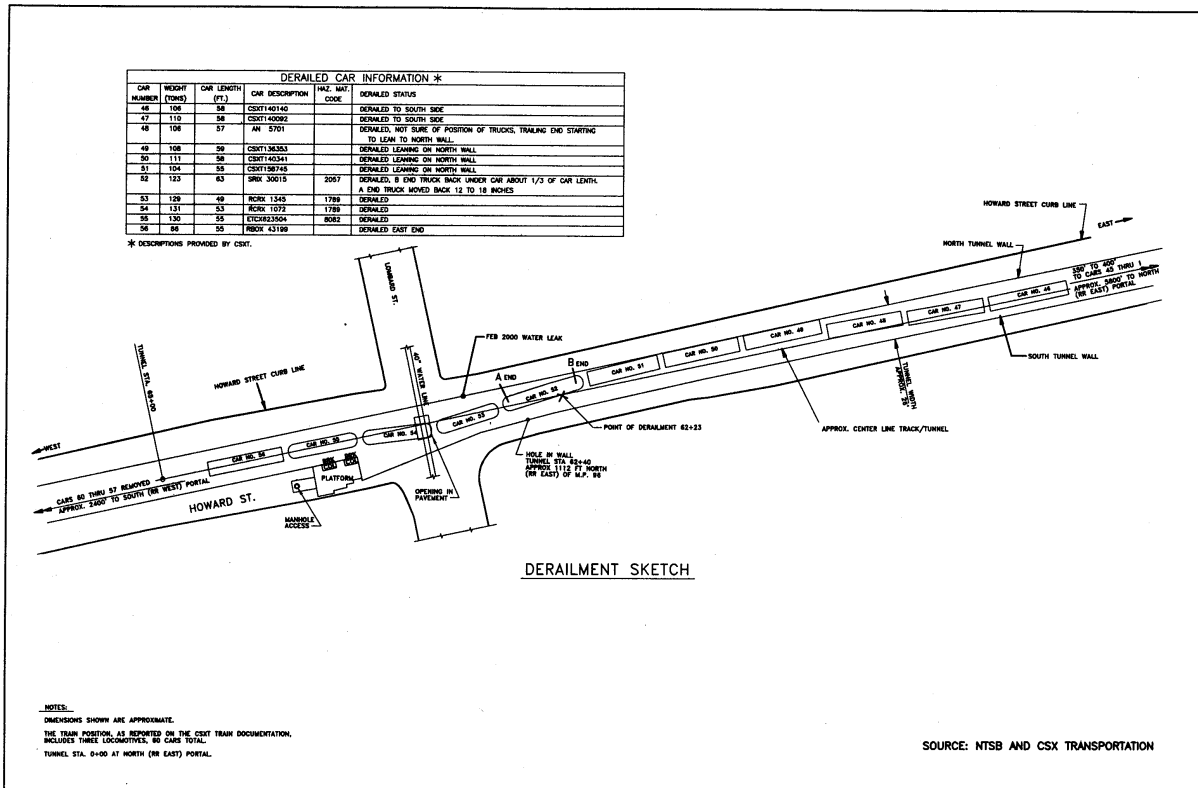
Figure 1. Positions of derailed cars.

The 47th car in the consist showed the most rib wear, indicating that this car had spent the most time derailed, so it was probably the first car to derail. The trucks of the 46th car had the next most rib wear. There was less wear to the B-end (leading end) spring seat ribs of the 48th car and only scrapes to the A-end (trailing end) ribs. Therefore, it appears that the 46th car was the second car to derail (pulled off the track by the 47th car) and that its derailment was followed by the derailment of the 48th and subsequent cars.

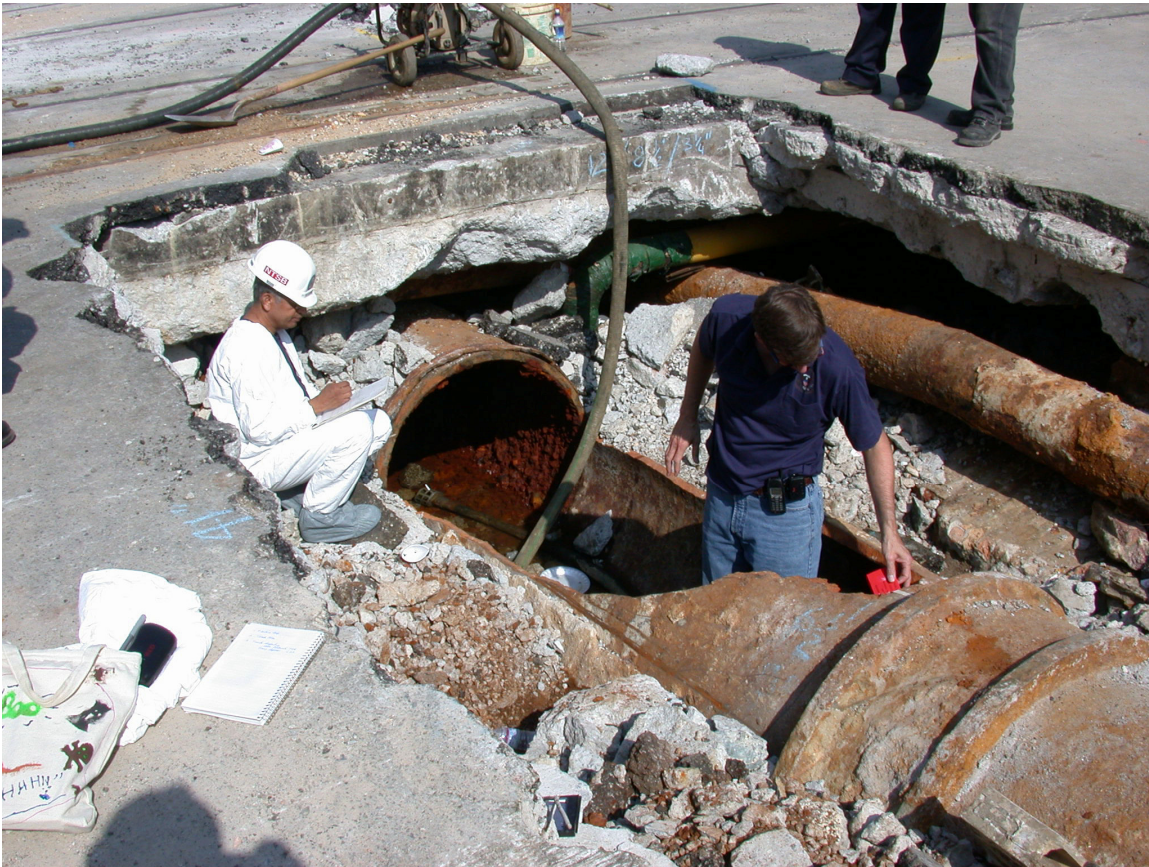
**Figure 2.** Broken 40-inch-diameter water main.

The 40-inch-diameter cast iron water main that ran directly above the Howard Street Tunnel, which ruptured and introduced a large volume of water into the tunnel, was considered as a possible causal factor in the accident. When postaccident examination was made of the ruptured pipe, no indication of third-party damage or significant corrosion damage was found at or near the point of rupture. Metallurgical examination of the fractured pieces of the water main showed that the fractures in the pipe section were brittle, with no evidence of crack arrest positions or slow growth regions, which indicates that a sudden overstress fracture of the cast iron pipe occurred.

A finite element analysis<sup>10</sup> of the tunnel and surrounding area in the vicinity of the water main was performed using the ABAQUS<sup>11</sup> code to determine whether the fire within the tunnel could have caused the water main to fracture. The analysis concluded that the postaccident fire was responsible for thermal expansion of the tunnel and that the expansion caused the tunnel walls to heave upwards, displacing the surrounding materials and imparting significant loads upon the water pipe. Further, the unique construction

details of the tunnel, the pipe, and the light rail foundation<sup>12</sup> combined to generate discontinuities in resistance to the thermal heaving, generating significant concentrations of stress within the water pipe. The location of the high stress concentrations predicted by the analysis was consistent with the location of the initiation of the fracture in the pipe, as determined through metallurgical examination. Therefore, the 40-inch water main that ran directly above the Howard Street Tunnel broke after the train had derailed, as a result of the thermal expansion of the tunnel caused by the postaccident fire within the tunnel.
