# Cultural Landscape Report

## Jacob Riis Park

Gateway National Recreation Area

1992

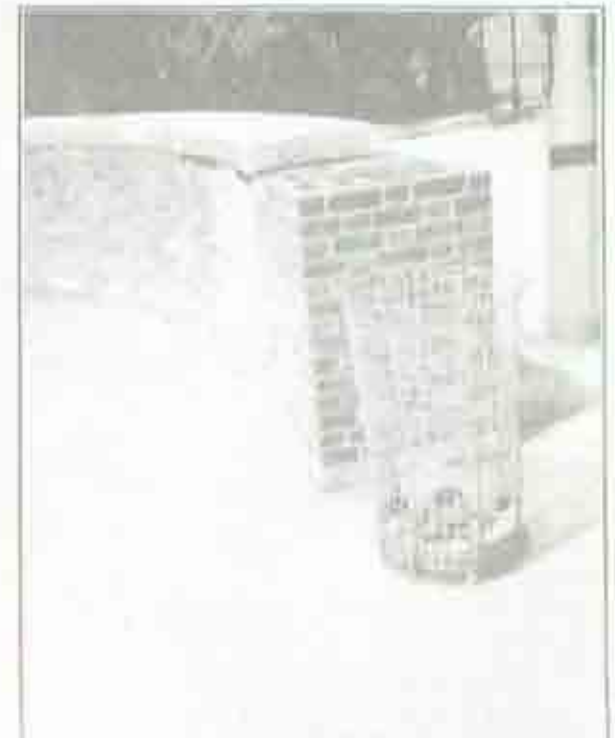
The Trash Receptacles currently in use at Riis Park are a basket design manufactured out of galvanized wire mesh with no additional paint or finish and are used without a liner (see Figure 19). These baskets are used throughout the Park. Historic photographs (see Figures A-2, A-10, A-28, and A-43, for example) show that these were the same type of trash receptacles which have been used throughout the park since its inception, although there is no way to determine if these items are the originals, or more contemporary replacements with the same design.

Figure 19: Existing Trash Receptacle

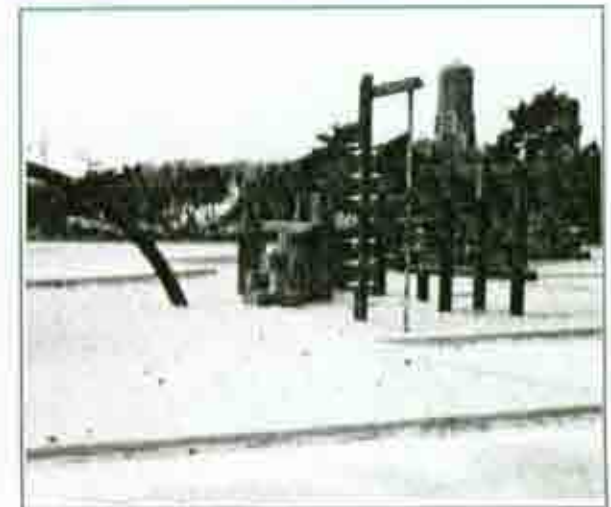
The existing Play Equipment at Riis Park includes several metal swing sets, basketball backboards, and a wooden play structure (see Figure 23). The swing sets are rusted and in a deteriorated condition with some broken or missing seats, but still function. Some of the swings may be original. The basketball backboards are also in a deteriorated condition, paint is peeling, the basketball nets are missing, the supports are rusted and some are bent. The wooden play structure, added at a later time when the playground was reconfigured, is usable but suffers from splintering and peeling varnish.

Figure 23: Existing Playground Area

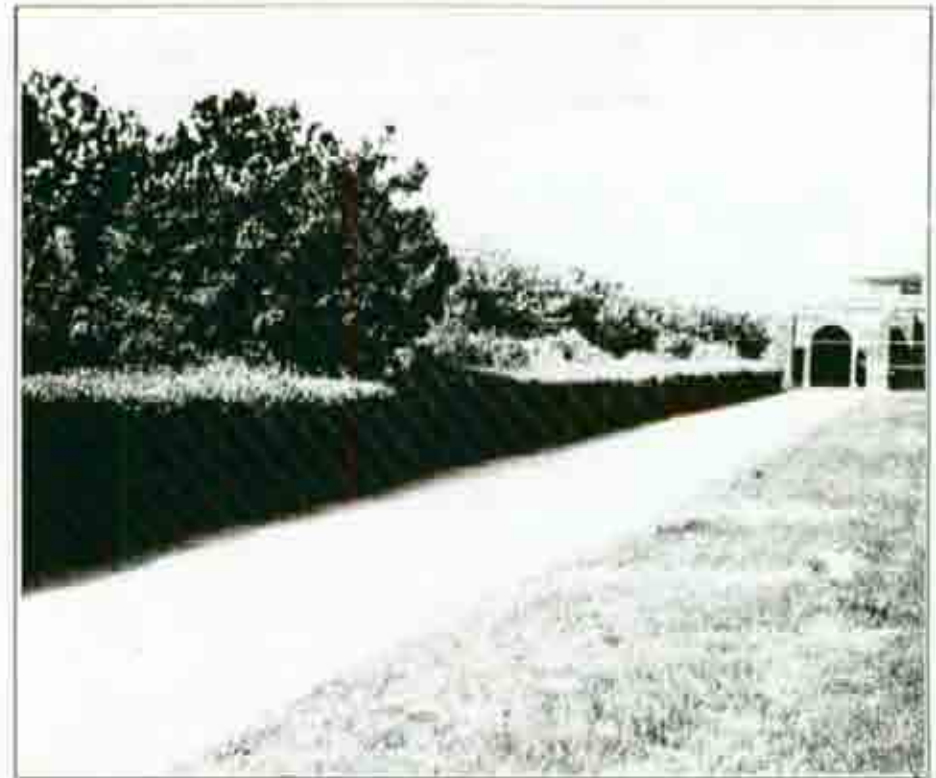
- o Planting beds along the building edges -- beds against the northern walls of the Bathhouse contain Washington Hawthorn (*Crataegus phaenopyrum*), Ligustrum (*Ligustrum sp.*) and Rugosa Rose (*Rosa rugosa*). They appear in a 1937 photo and because of their size, they may have been planted in 1932 when the first phase of the Bathhouse was constructed (see Figure 31). This cannot be verified since as-built plans from the 1932 construction have not been found. The Japanese Black Pines (*Pinus thunbergi*) bordering the east and west sidewalks are not shown on the 1937 planting plans but, based on the size of these plant materials, must have been added soon afterward. This planting is part of the original historic fabric of the park. The Eleagnus (*Eleagnus umbellata*) shrubs in this area were also shown on the 1937 plans but only a few of them exist compared to the planting plan. The Privet (*Ligustrum sp.*) that exists in this area was not part of the 1937 planting and the installation date for this work is unknown. The beds along the east and west sides of the Bathhouse also have plantings of Eleagnus and

Figure 31: Foundation plantings of the Bathhouse

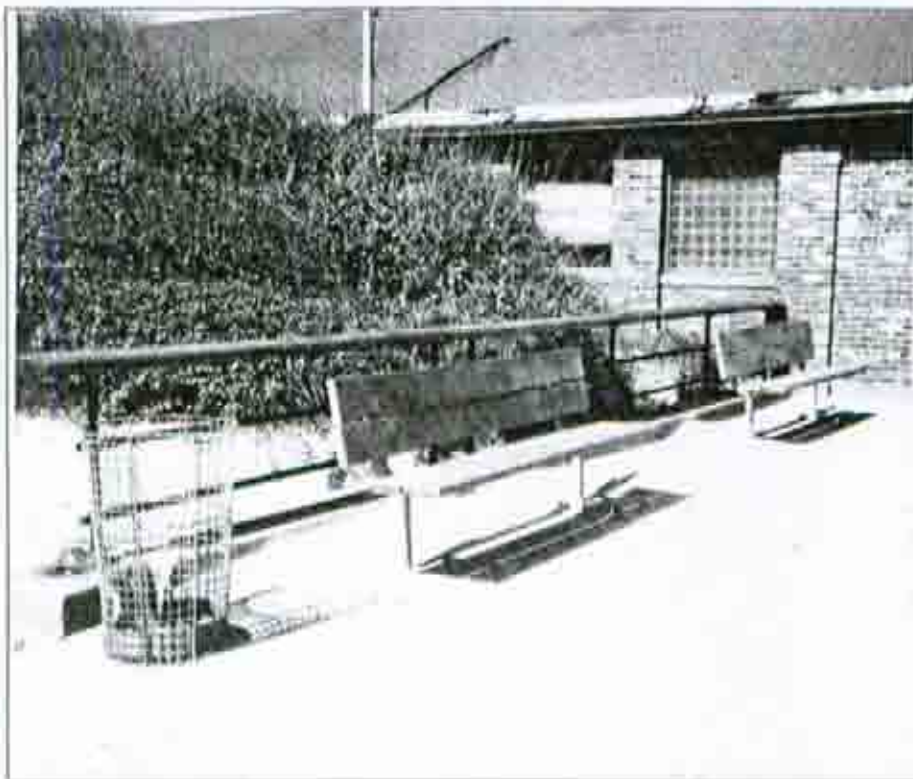
Subsequent to 1937, few changes have been made to the Bathhouse or surrounding grounds. A steady deterioration has occurred due to a variety of reasons including heavy use, the seaside climate, vandalism, and limited maintenance budgets. Large areas of the Bathhouse are not in use and recently a chain link fence was erected to prevent further building damage and to prevent park users from entering a hazardous area. Figure C-1 (Appendix C) shows major existing site features and the condition and location of site furniture and other landscape elements.

Figure 32: Bench and trash receptacle

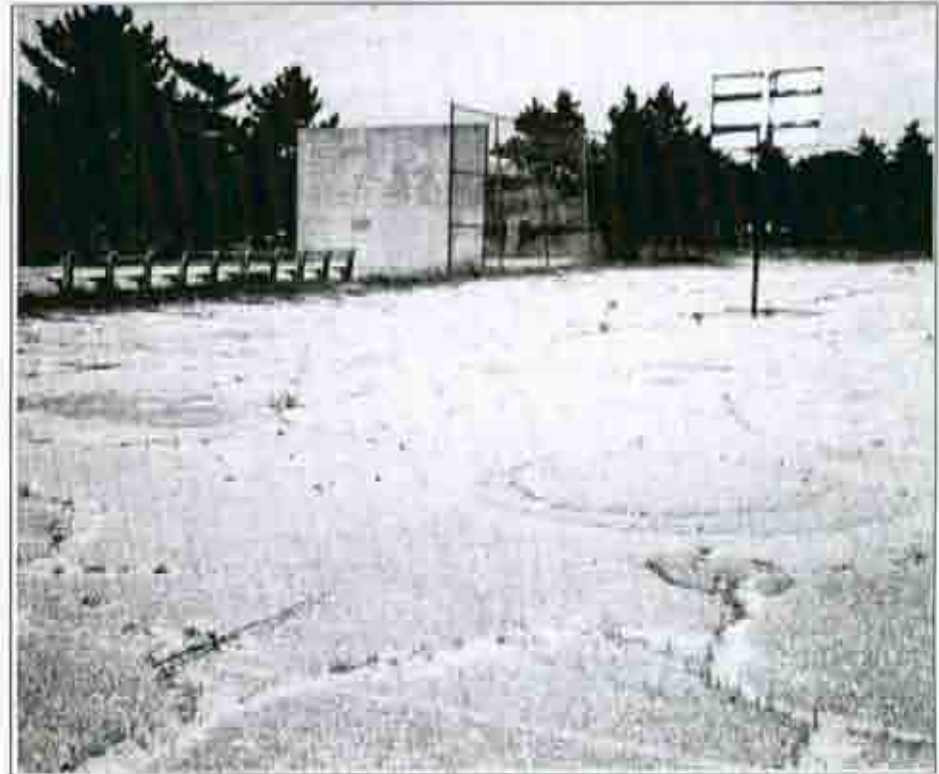
Figure 56: Deteriorating game court surfaces

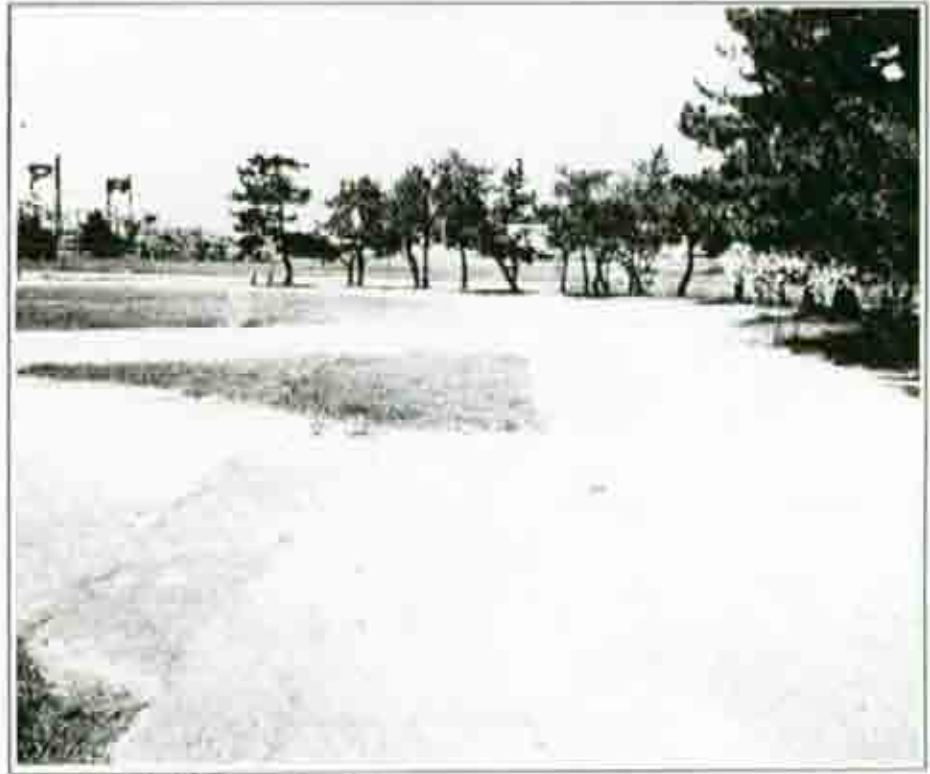
Figure 44: Typical Mall pavement condition

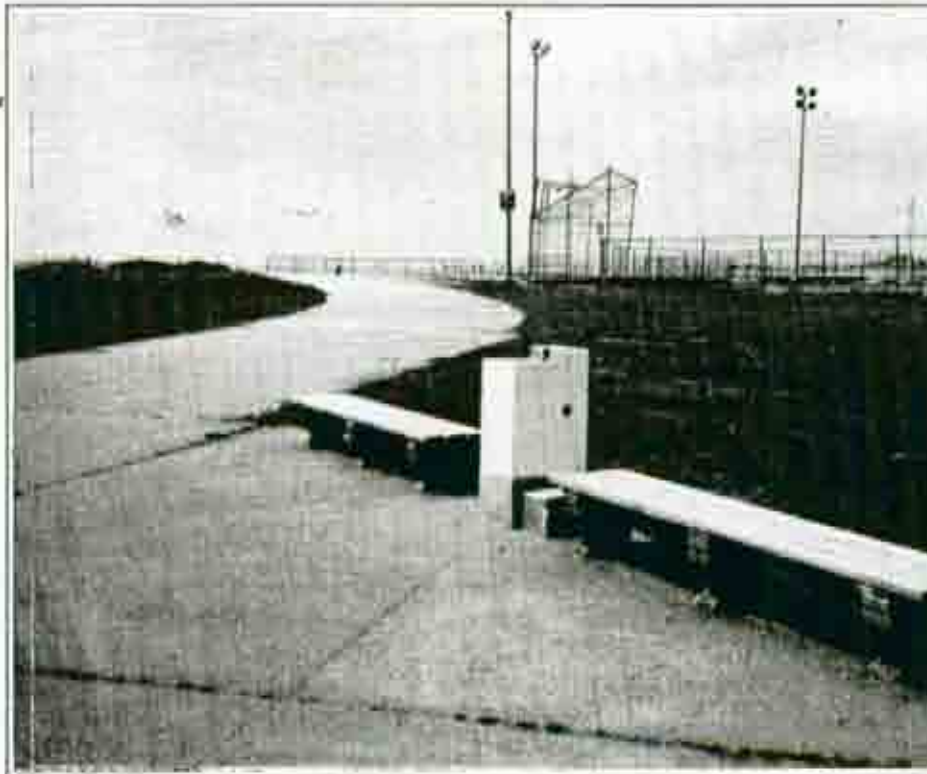
Figure 62: Deteriorating Benches
