# Service Bulletin

Bulletin No.: 01-08-42-001L

**Subject:** Exterior Lamp Condensation and Replacement Guidelines

**Models:** 2019 and Prior GM Passenger Cars and Trucks

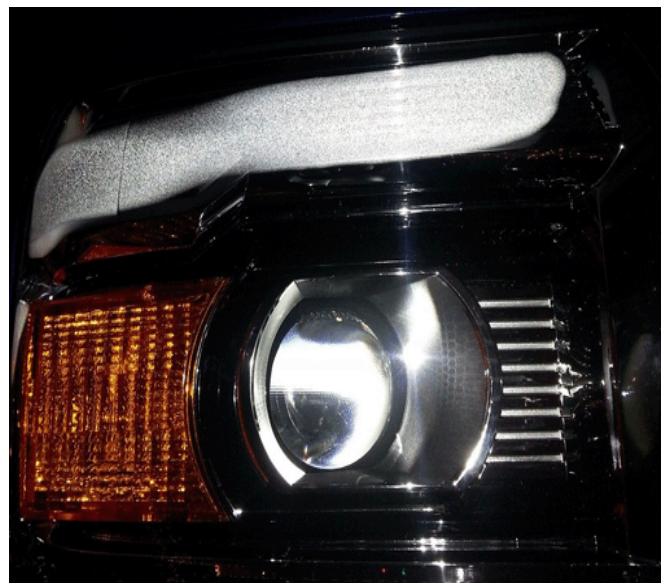
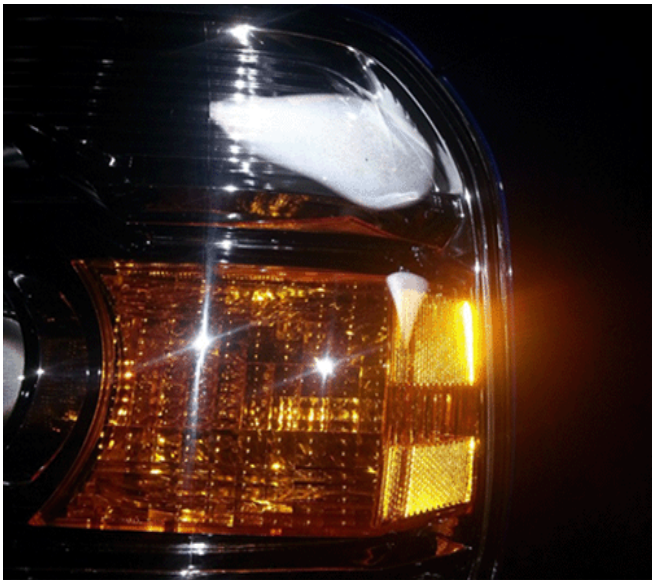
#### 2014 Sierra Headlamp, Full and Partial Examples

### A Fine Mist or White Fog on the Inside Surface of the Lamp Lens Occurring After a Period of High Humidity

- May be located primarily in the lens corners (near the vents) and SHOULD NOT cover more than half the lens surface.
- The condition should clear of moisture when the vehicle is parked in a dry environment, or when the vehicle is driven with the lights ON.
- A comparison of the equivalent lamp on the opposing side of the vehicle indicates a SIMILAR performance.

If the above conditions are noted, the customer should be advised that replacement of a lamp assembly may not correct this condition.

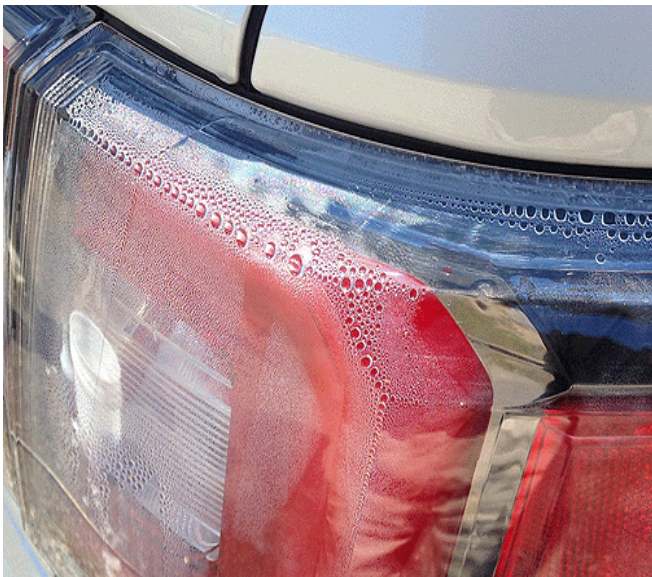
#### 2014 Acadia Tail Lamp Example

### Numerous & Various Size Drops of Water Collecting on the Inside Surface of the Lamp Lens After the Vehicle Has Been Exposed to Rain or a Car Washing Environment

- A condition that covers more than half the surface of the lamp lens.
- An accumulation of water in the bottom of the lamp assembly.
- A condition that WON'T clear when the vehicle is parked in a dry environment, or when the vehicle is driven with the lights ON.
- A comparison of the equivalent lamp on the opposing side of the vehicle indicates a different performance.

**Note:** Any of the conditions listed below would indicate the need to service the lens or lamp assembly.

**If a lamp is found to be exhibiting a leak, review the most recent version of Service Bulletin 02-08-42-001 for information regarding impact damage and modification inspection.**

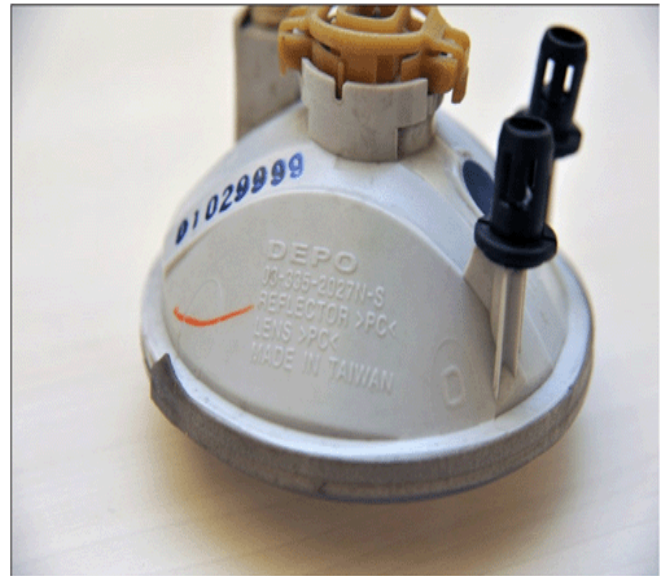
This fog lamp was returned for retaining moisture. As you can see it is marked with the Depo brand (it is also called out on the front lens).
