13.1 Ground-based damage survey and radar analysis of the El Reno, Oklahoma Tornado

Timothy P. Marshall¹, D. Burgess², G. Garfield², R. Smith³, D. Speheger³, J. Snyder⁴, H. Bluestein⁴

¹Haag Engineering Company, Irving Texas

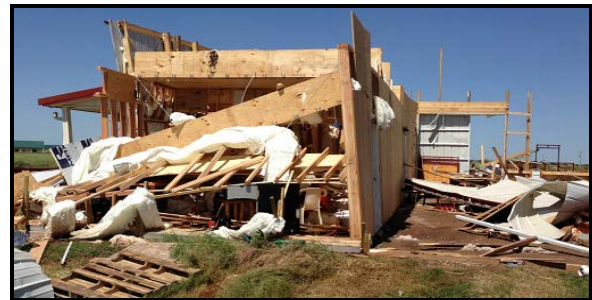
A total of 135 outbuildings were assigned EF ratings in the El Reno tornado damage path. There were 85 outbuildings rated EF0, 41 EF1, and 9 rated EF2. Most outbuildings were associated with rural residential properties. Generally, these were small, wood-framed structures with metal clad walls and roofs, utilized as barns to store farm equipment or hay (Fig. 11). Total destruction of these buildings (DoD 12) yielded a maximum EF2 rating. In several instances, destroyed outbuildings were adjacent to residences that sustained less severe damage. This indicated to us that failure wind speeds in the EF scale need to be adjusted between outbuildings and residences.

Figure 11. EF1 damage to a metal-clad, wood-framed outbuilding (DoD 6).

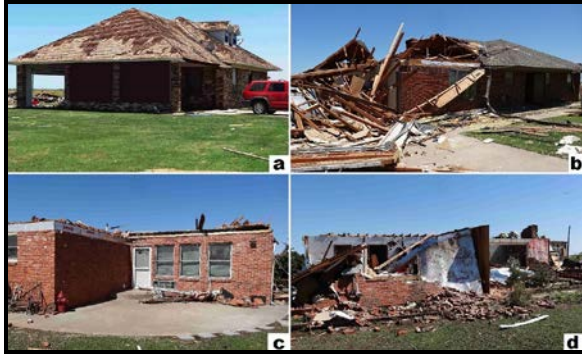
A total of 147 residences were assigned EF ratings in the El Reno tornado damage path. There were 103 residences rated EF0, 24 EF1, 17 EF2, and only 3 rated EF3 (Fig. 12). Residences were rated EF0 if they lost some of their roof covering (DoD 2). An EF1 rating was given to residences that lost a portion of their roof deck (DoD 4). Residences were rated EF2 if they lost most of their roof (DoD 6). Homes with perimeter walls down but interior walls remaining upright were rated EF3 (DoD 8). One residence had all walls down and a pile of debris remaining on its concrete slab foundation. This damage severity was a candidate for an EF4 rating. However, close examination revealed anchor bolts around the foundation perimeter did not have nuts or washers to secure the wall bottom plates (Fig. 13). Since the walls were not anchored to the foundation, damage to this residence was rated EF3 instead of EF4.

Figure 12. Increasing damage ratings to wood-framed houses: a) EF0, b) EF1, c) EF2, and d) EF3.

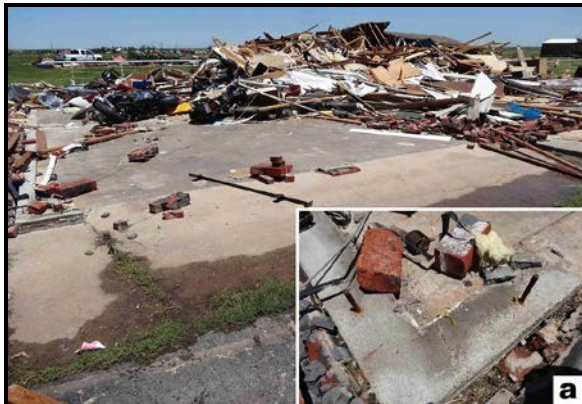
Figure 13. All walls on this home had collapsed in the center of the tornado path. Close examination revealed no nuts or washers on the anchor bolts (inset a). Therefore, a rating of EF3 was assigned instead of EF4.

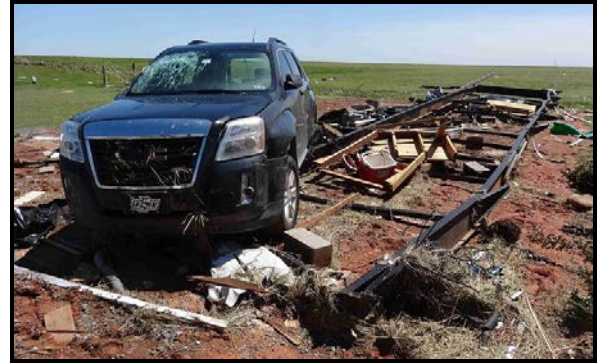
Generally, these homes sustained more severe damage than adjacent homes constructed on permanent concrete foundations. This indicated to us that failure wind speeds in the EF scale need to be adjusted between manufactured homes and permanent homes. In one instance, the steel frame of a single-wide home was all that remained except for an SUV that came to rest on top of the frame (Fig. 14).

Figure 14. An SUV that came to rest on the steel frame of a destroyed single-wide mobile home.

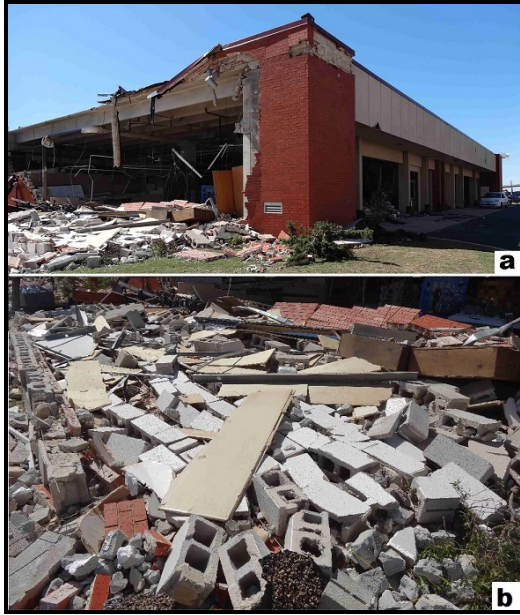
There were three, one-story institutional buildings at the Canadian Valley Technology Center near the north end of the tornado damage path. The northernmost building sustained only roof damage and was rated EF1. The west (main) building was a one-story, steel-reinforced concrete framed structure with concrete masonry unit (CMU) in-fill walls covered with brick veneer. A portion of the masonry wall collapsed at the southeast corner of the building (DoD 7), resulting in this building being rated EF2 (Fig. 15).

Figure 15. Damage to a concrete framed building at the Canadian Valley Technology Center: a) collapse of concrete masonry walls, b) closer view showing the absence of vertical steel reinforcement in the wall. Damage to this building was rated EF2.

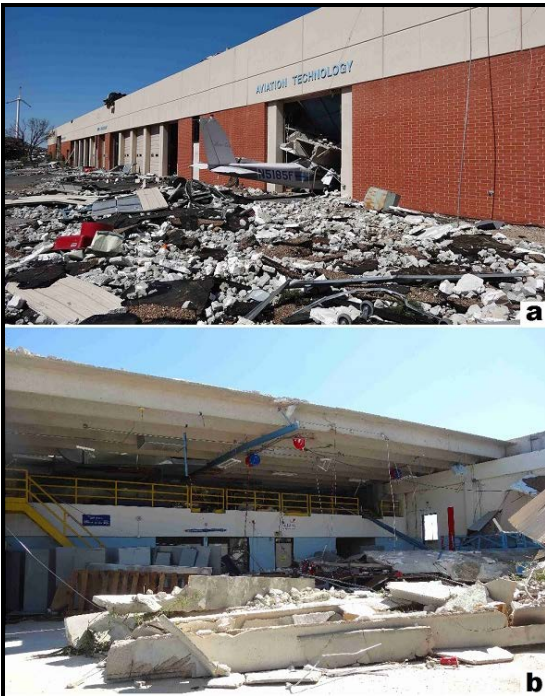
A large rectangular building east of the main building contained the Aviation Technology Department. This building experienced partial roof collapse when overhead doors failed allowing internal pressure to lift and fracture several double-tee roof beams. The double tees fractured at midspan and collapsed into the building (Fig. 16). Perimeter walls remained standing. Damage to this building (DoD 8) was rated EF3.

Figure 16. Damage to the Aviation Technology Department at the Canadian Valley Technology Center: a) an airplane in the doorway and b) collapsed large span, steel-reinforced concrete double tee roof beams. The beams fractured at midspan due to wind uplift forces. Damage to this building was rated EF3.

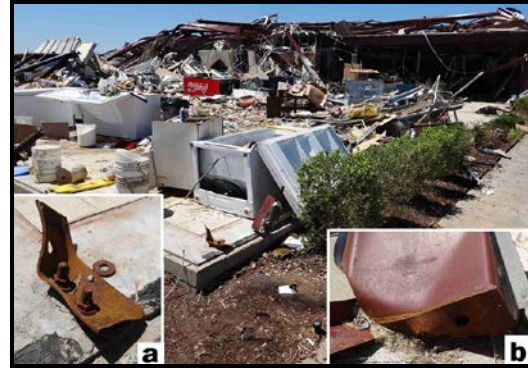
The tornado destroyed all three metal buildings at the Oklahoma West Livestock Market. These buildings were constructed on concrete slab foundations. Steel columns failed where they were attached with anchor bolts to their foundations. Base plates were either torn from the columns when the welds failed or the anchor bolts were pulled through the base plates when deformed (Fig. 17). Damage to these buildings was rated EF3.

Figure 17. Destruction of a metal building at the Oklahoma West Livestock Market. Steel column base plates were: a) torn along welded connections, or b) pulled through their anchor bolts. Damage to this building was rated EF3.

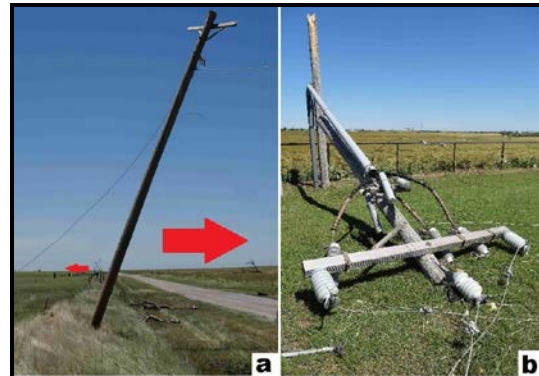
There were numerous wooden power poles damaged by the tornado. Such poles had stood alongside rural roads. The poles were tilted or broken (Fig. 18). A series of 15 double-wood poles were broken along Interstate 40. Tall, galvanized steel, single-pole towers were bent to the east along the west side of Radio Road where residences sustained EFO damage.

Figure 18. Wind damage to wood power poles: a) leaning poles in opposite directions, and b) a broken pole.

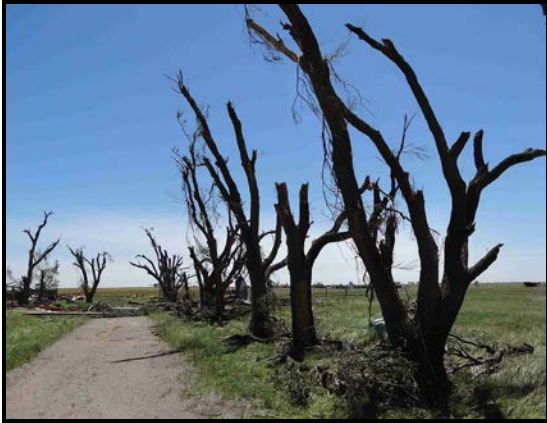
The tornado traversed mostly open country with few trees. Those trees present in the damage path were concentrated around houses and along creeks. Some of the most intense tree damage occurred along Choctaw Road where trees were defoliated, debarked, and had large branches removed (Fig. 19). Such tree damage was rated EF3, the maximum in the EF scale. Many trees had been uprooted in softer soil along creeks and were rated EF1 or EF2.

Figure 19. EF3 damage to trees along Choctaw Road (DoD 5).

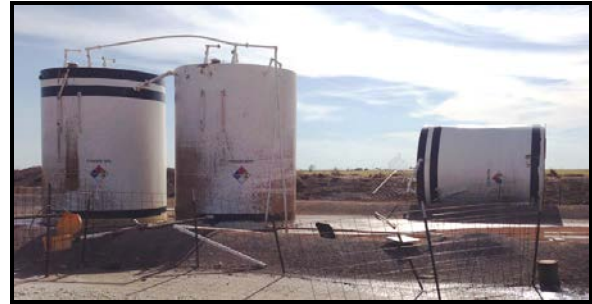
Our survey of oil tank batteries revealed toppled gas separator or heater treater tanks in 30 of the 112 sites. Barrel tanks fell over or were removed from 12 of the 112 locations (Fig. 20). Not surprisingly, the greatest damage to oil tank batteries occurred near the tornado center and to the south where the strongest winds occurred.

We compared the extent of damage to oil tank batteries with nearby DIs and determined that toppling of the gas separator and/or heater treater tanks was consistent with EF1 damage. Toppling of the barrel-shaped steel tank occurred in regions of

EF2 damage, and removal of tanks from a site occurred in regions of EF3 damage. Of course, a primary factor in whether the tanks moved was their weight and how full they were. Team members did not have that information. Still, oil tank equipment was a valuable damage indicator that should be studied further for possible inclusion in the EF scale.

Figure 20. Damage to an oil tank battery near South Country Club Road and 15th Street Southwest.

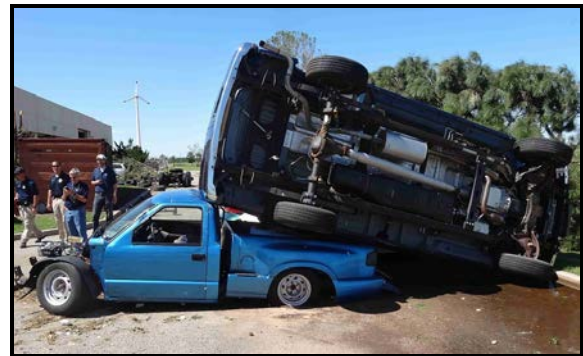
Several vehicles were rolled or tossed by the tornado, especially along and east of Highway 81 (Fig. 21). Such vehicle damage typically is associated with violent tornadoes. However, as noted with past studies by Marshall et al. (2008) and Marshall (2010), many factors determine whether vehicles are moved or transported by tornadic winds. Some factors include size, weight, and profile of the vehicle as well as horizontal and vertical components of the wind and acceleration effects. Because of these variables, vehicles are not currently a DI. As noted earlier, all eight fatalities in the El Reno tornado occurred in vehicles (NWS, 2013).

Figure 21. A vehicle flipped onto a pickup truck at the Canadian Valley Technology Center. The building adjacent to these vehicles was rated EF3 damage.

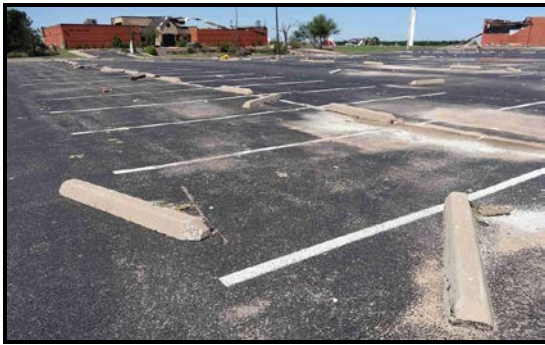
Several concrete stops had shifted westward in the parking lot at the Canadian Valley Technology Center. These parking stops were between two buildings rated EF1 and EF2, respectively (Fig. 22). The parking stops were secured to the pavement with pairs of steel rebar. The rebar had bent westward when the parking stops moved. Each concrete stop weighed approximately 111 kg. Movement of the parking stops indicated that high wind speeds extended to the ground. Similar observations have been made by Marshall (2012a, 2014) with lofted parking stops in the Joplin, Missouri tornado and shifted parking stops in the Vilonia, Arkansas tornado, respectively.

Figure 22. Westward movement of parking stops at the Vo-Tech Center. Such movement occurred in between buildings rated EF1 and EF2.

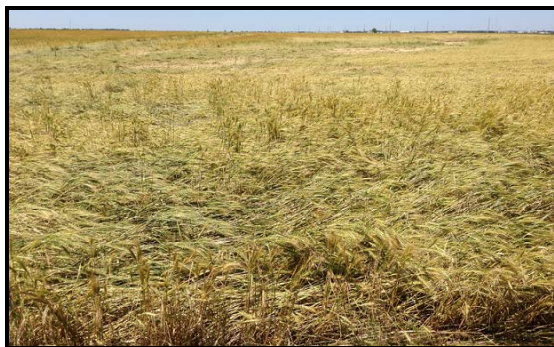
There were isolated areas and swaths in the tornado path where wheat crops were flattened (Fig. 23). Such evidence indicated that high speed winds reached the ground. However, there was uncertainty in determining the wind speeds necessary to cause such damage, especially since there were no DIs nearby. No ground scouring was found anywhere in the damage path.

Figure 23. A wind-damaged wheat field along Reuter Road where the tornado was most intense.

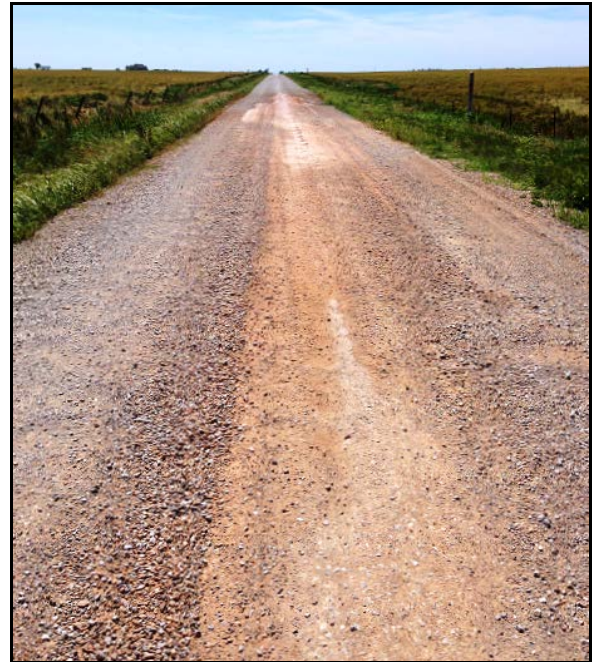
Intense tornadoes have been known to scour road surfacing as noted by Marshall et al. (2012b) in their survey of the violent Oklahoma tornadoes that occurred on May 24, 2011. Such was the case in the El Reno tornado along Reuter Road where we found two areas of substantial gravel loss (Fig. 24).

Figure 24. Scouring of the gravel road surface along Reuter Road was evidence strong winds reached the ground. This was near where three storm researchers were killed.

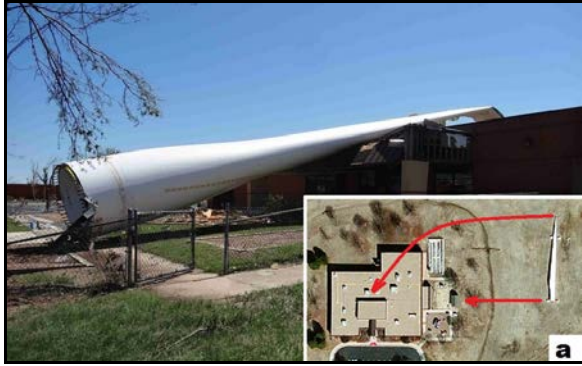
There was an unusual non-standard DI found in the El Reno tornado damage path. A 60 m long wind turbine blade was on display at the Canadian Valley Technology Center (Fig. 25). The blade sat in a concrete cradle east of a school building. The blade was lifted from its cradle and transported westward where it came to rest on a school building roof. Damage to the school building, outside the region of the blade impact, was rated EF0.

Figure 25. 60m long wind turbine blade that was on display was lifted from its mooring and deposited on a school building to the west. The inset a) image shows the location of the turbine blade before the tornado. Red arrows indicate how the blade pivoted counterclockwise to the west.
