# **Collision Reconstruction Report**

**Fatal Collision 23 / 2009**

**Bloor Street West near Avenue Road  
City of Toronto, Ontario**

**Monday, August 31, 2009**

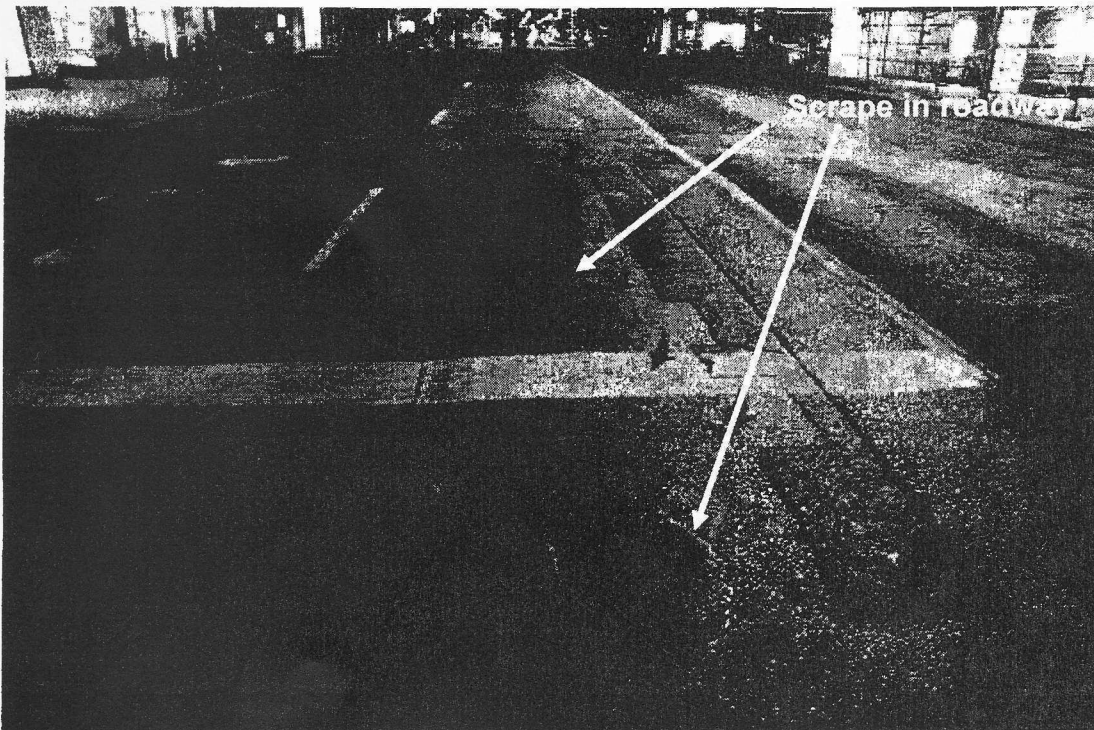
Fig 1.5 Bloor Street West facing east near #102 (TSV 00373.09 097)

Collision #2 was also captured on a video recording from a video camera located at 102 Bloor Street West (camera DVR #4 Cam 9 102). A scrape mark was located on the asphalt and it measured 6.7 meters (m) in length in the passing lane of westbound Bloor Street West.

The scrape began approximately 5.2 m east of the westbound stop line for the signalized pedestrian crosswalk near #102 Bloor Street West near the center of the passing lane.

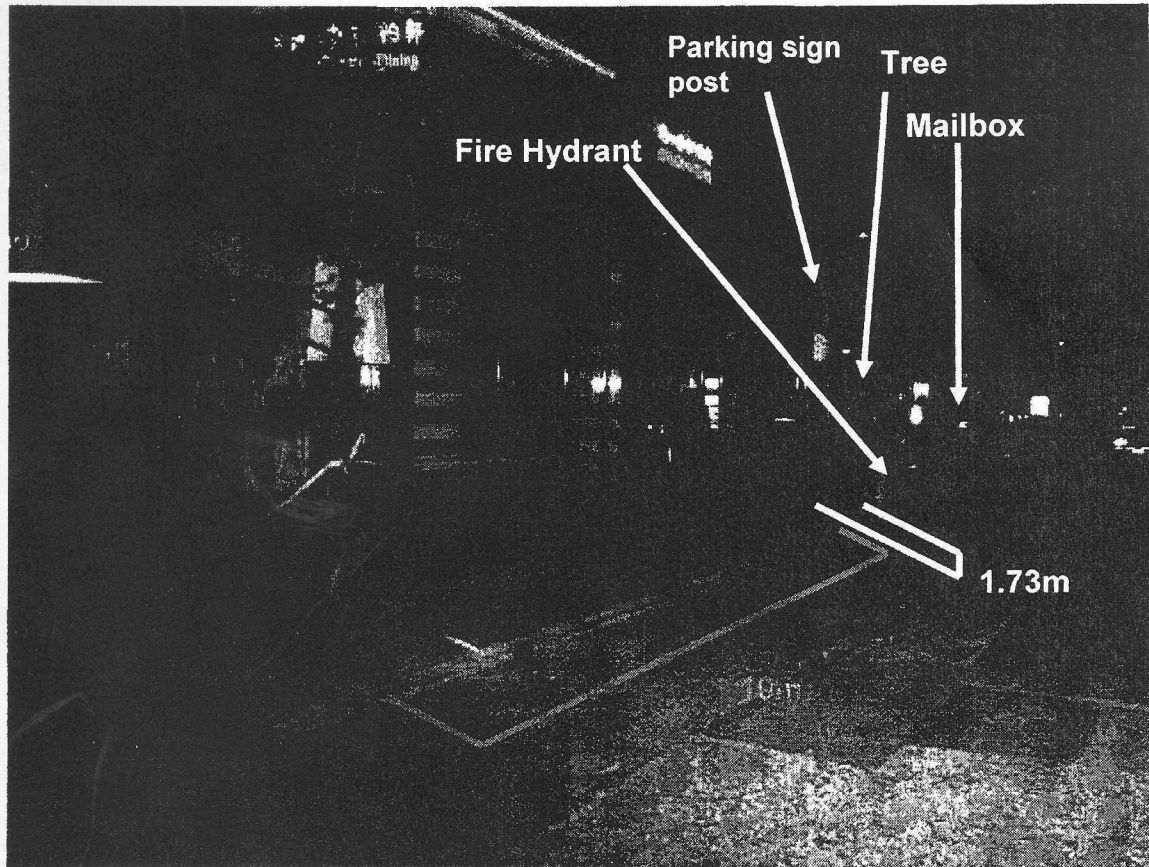
Fig 1.6 Bloor Street West facing westbound in eastbound curb lane (FIS 207309 5643)

Collision Scene #3 occurred near # 131 Bloor Street West on the south side of the roadway in the eastbound lanes. A tree near #131 Bloor Street West was observed to have a smear mark on it between 0.5 m and 0.43 m above the ground. A piece of bark was located on the sidewalk to the west of the tree. A fresh clean break in the tree bark was observed.

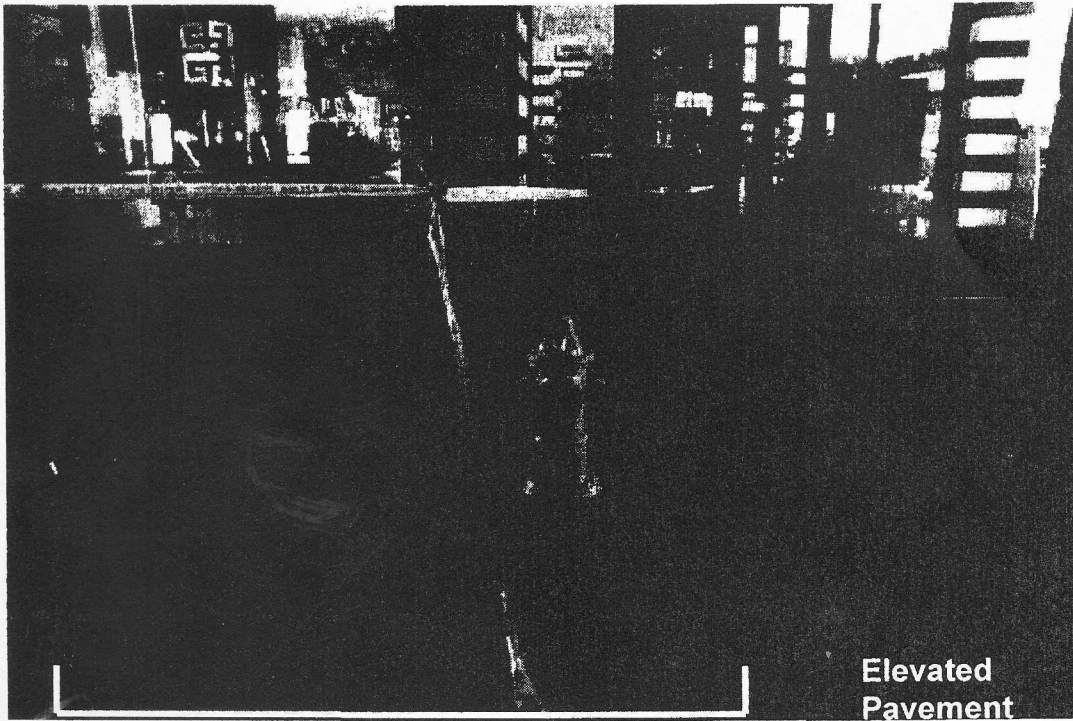
Fig 1.7 Fire hydrant near #131 Bloor Street West with elevated asphalt on roadway (TSV00373.09 087)

A raised patch of asphalt was observed on Bloor Street West in the vicinity of the fire hydrant. Fabric was located on the cap closest to the roadway of the hydrant which had a height of 0.5 m.

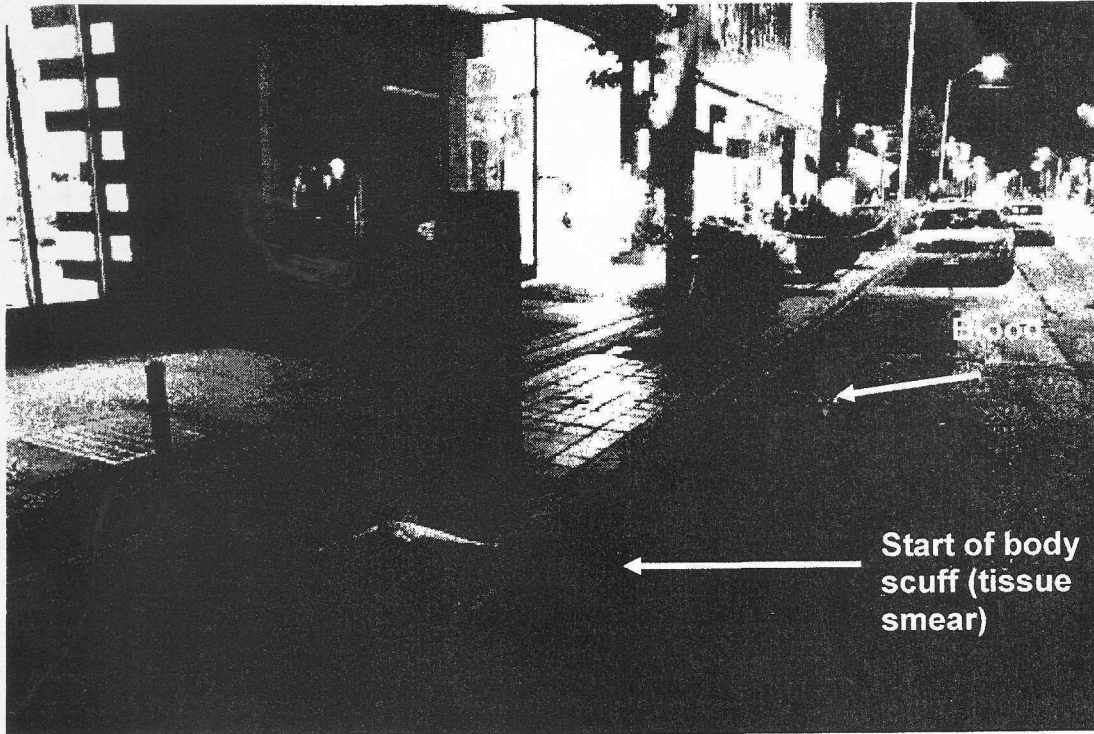
Fig 1.9 Bloor Street West facing westbound in eastbound curb lane (TSV 373.09 067)

No definitive curb strikes were located on the south curb of Bloor Street West in the vicinity of #131. The curb was 8 centimetres (cm) in height. The road surface in the vicinity of the hydrant was rough. The asphalt in the area of the tissue smear had numerous ridges some measuring up to 4 centimetres (cm).

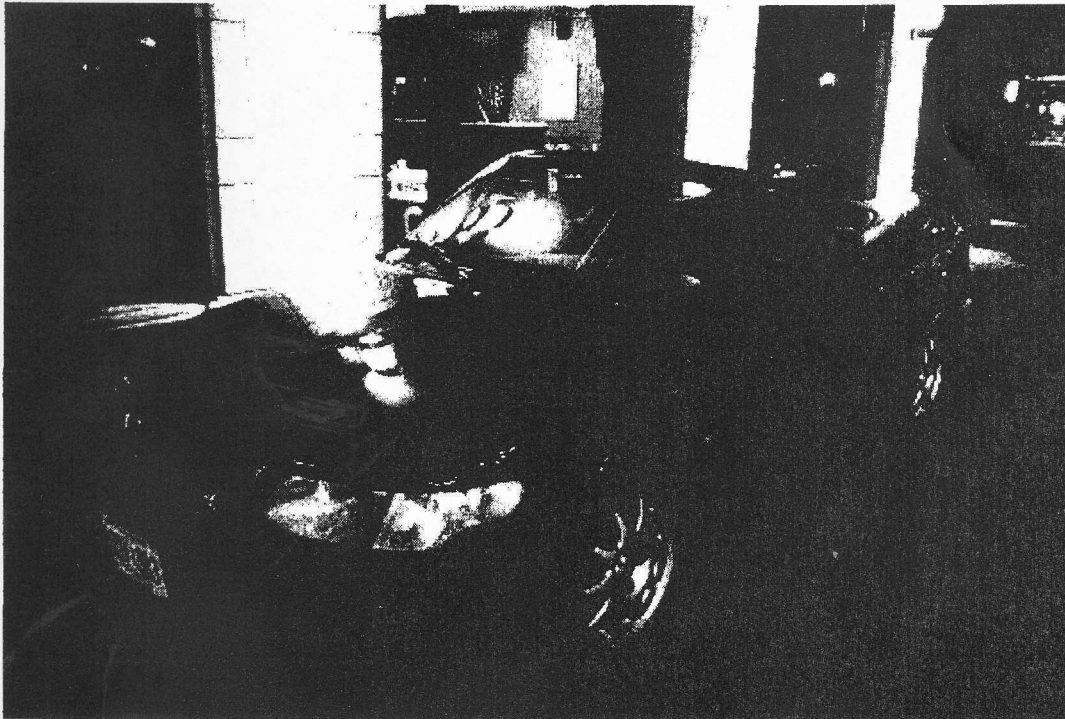
Fig 1.10 Involved Saab motor vehicle. (TSV 00373.09 009)

- Cleaning to the front bumper, hood and drivers' side of the vehicle
- Scrapes and cleaning to the undercarriage
- Dents to both the drivers' and passenger side of the vehicle, with numerous scratches and cracked paint all over the vehicle

A mechanical examination was completed after it's forensic examination. The Saab was found to have a damaged brake line that occurred at the Center for Forensic Science. No other defects were observed.

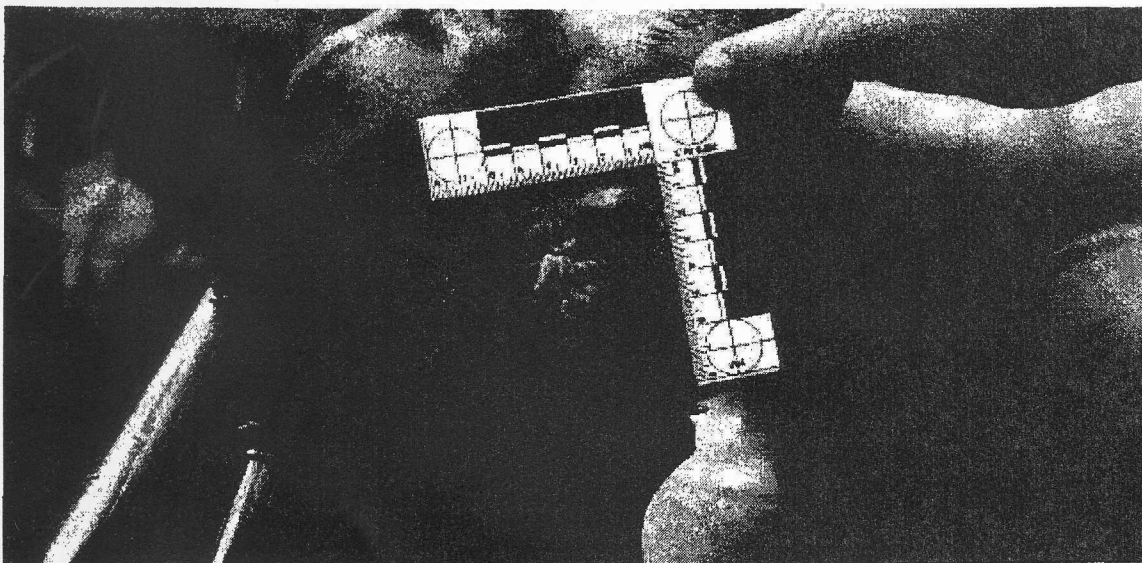
Mr. SHEPPARD sustained a large cut to the right side of his head and his right ear was torn.

Fig 1.12 Injury to right side of Mr. Sheppard's head (TSV 375.09 083)

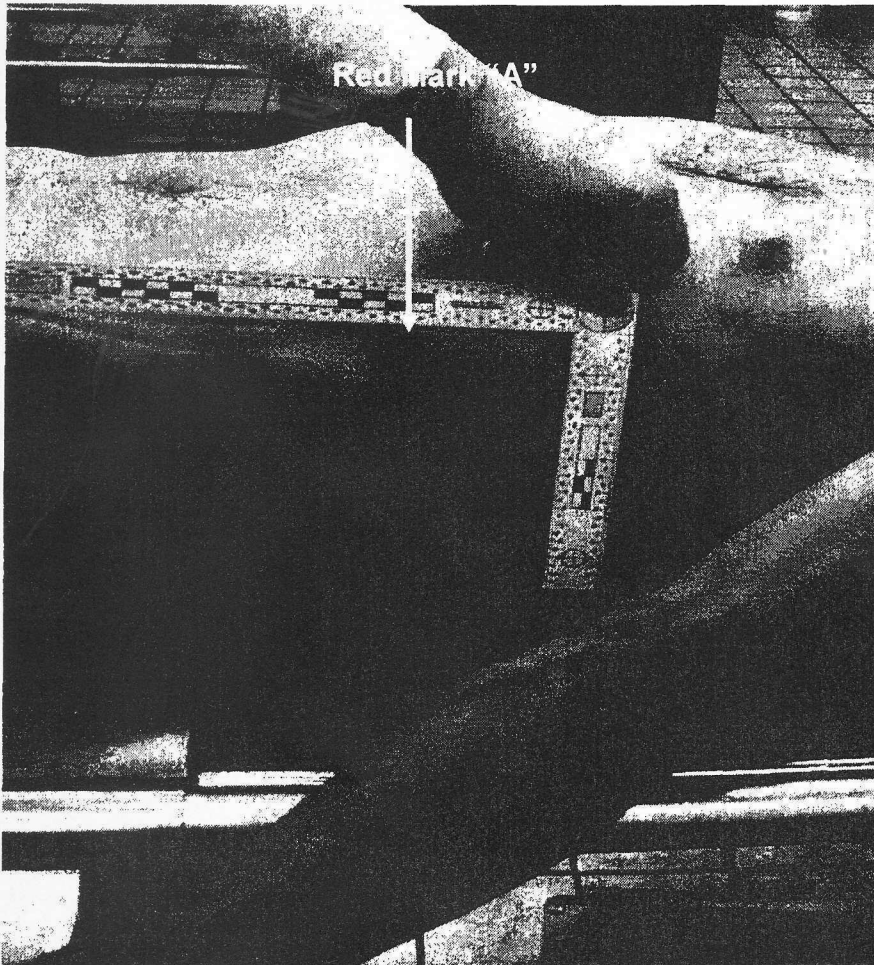
Mr. SHEPPARD's left chest was torn open. Redness to the chest was noted towards the center and front of his torso with the tear towards the back of the body. A number of scrapes were also noted on the cyclist's arms.

From the tear in the torso of the cyclist there were two red marks visible towards the center of the body. This redness fanned out to the opening in the cyclist's torso.

Fig 1.13 Tear to the cyclist's torso. (TSV 0375.09 056)

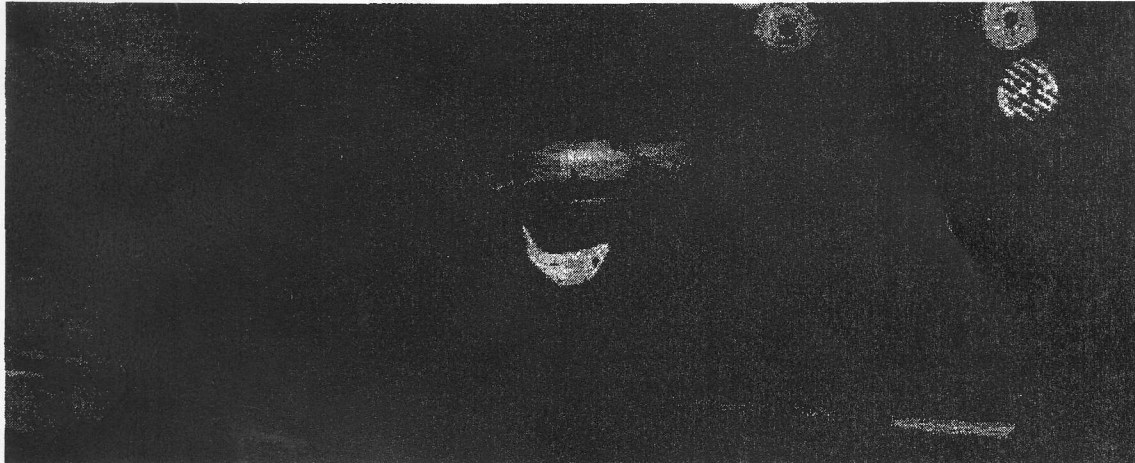
Fig 1.14 Picture of soiled left hand to the cyclist. (TSV 035.09 011)

Mr. SHEPPARD's hands were soiled at the time of the examination. A number of cuts were noted on both of his hands.

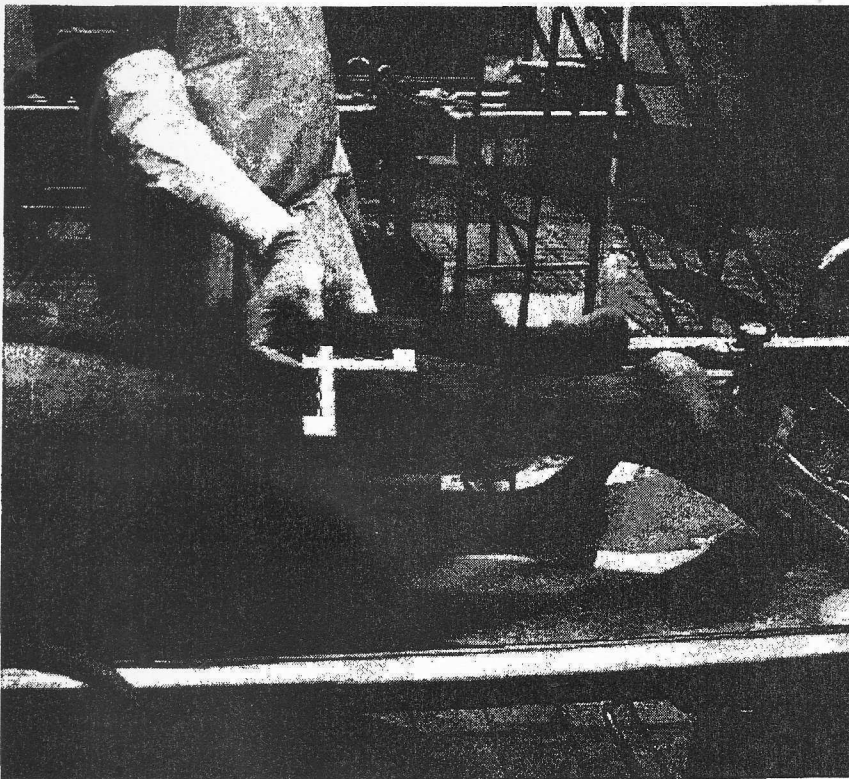
Fig1.15 Cut to left ankle with scraping on the left calf. (TSV 0375.09 043)

The cyclist had a cut to this left ankle and scraping to his left calf.

The cyclist had an abrasion wound to his left ankle which was consistent with glancing off the tree dislodging the bark.

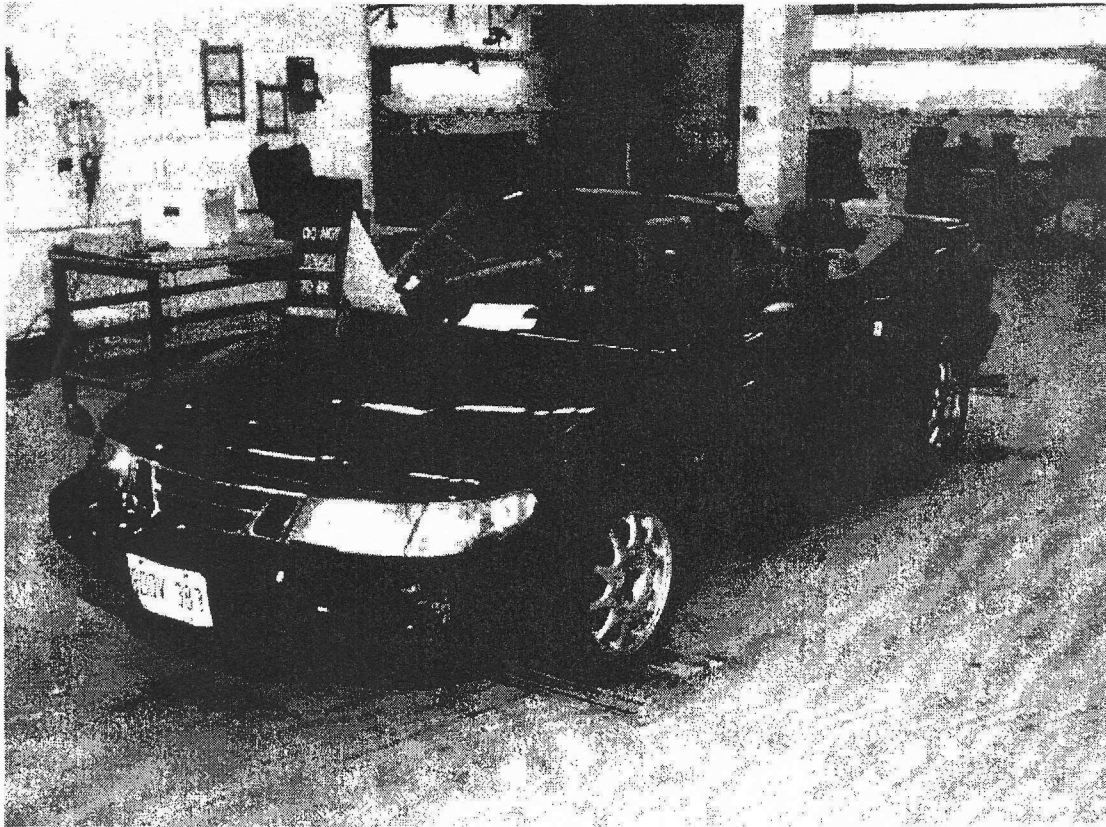
Fig 1.23 Photo of Saab at CFS with the front of the vehicle on Second lift. (FIS2072309\_6464)

During the mechanical examination of the Saab, the Qualified Automobile Service Technician, noted the drivers' side rear brake line was broken and there was a fluid leak.

Information from CFS was that the Saab had been put on the lift system in reverse with the front axle on the second lift and the rear axle on the first lift as in Fig 1.23.

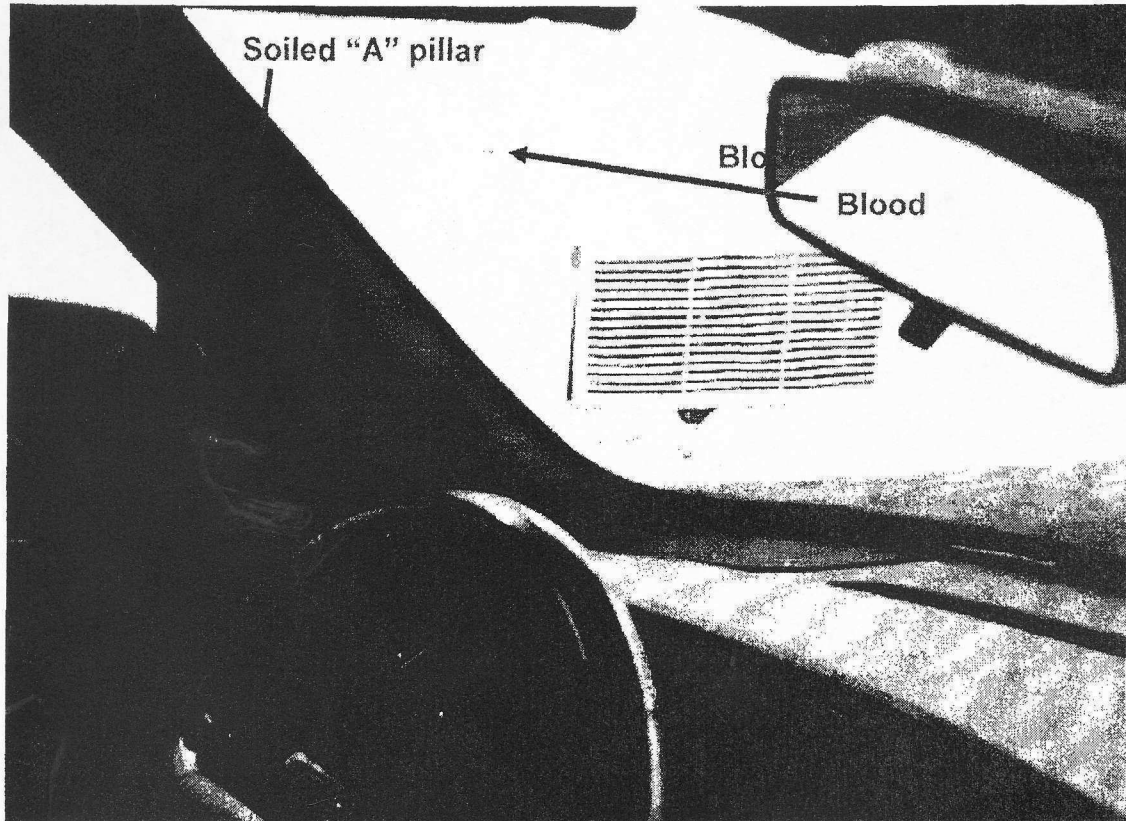
Fig1.25 Photo of interior of windshield of Saab with blood and soiled "A" pillar (TSV 043.09 055)

Mr. SHEPPARD'S hands according to witnesses were on the side of the vehicle. Soiled marks were located on the interior of the "A" pillar. Blood was located on the interior of the windshield parallel to the soiled markings, and was consistent with fingers sliding across the glass. Mr. SHEPPARD had cuts to his hands.

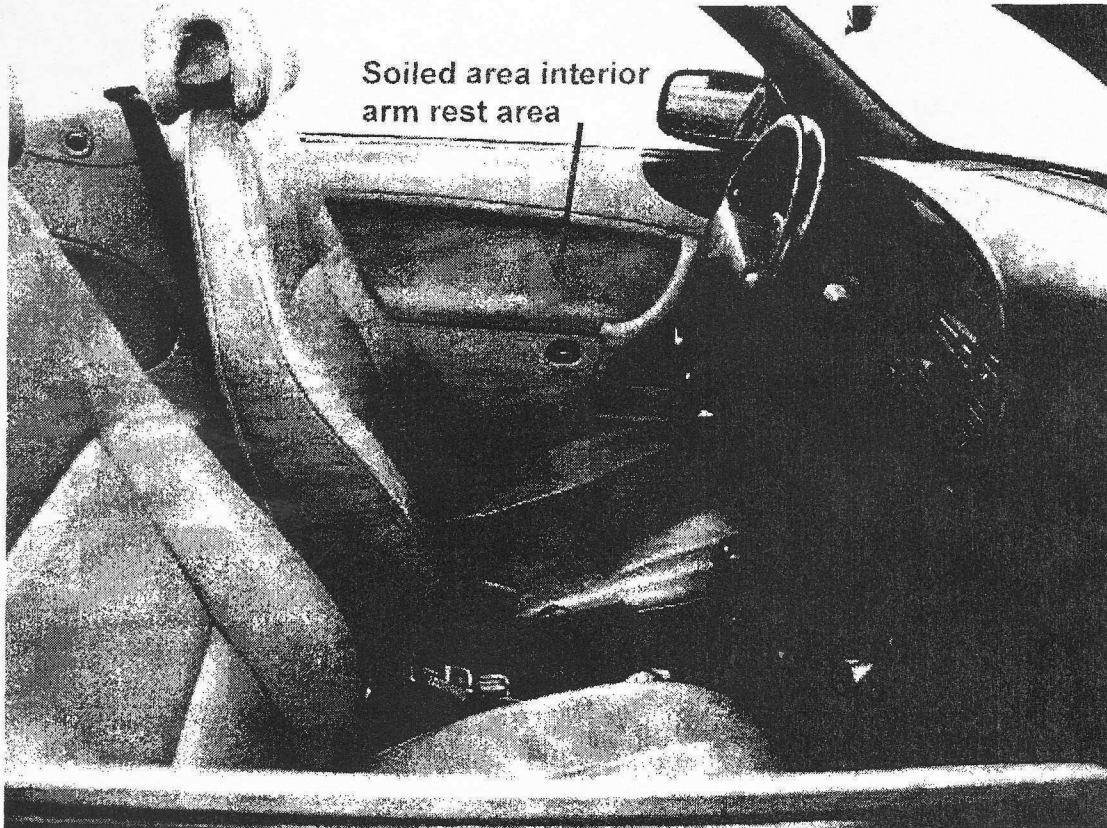
Another soiled mark was located on the interior drivers' door of the Saab.

Fig 1.26 Interior of Saab showing soiled area drivers' side. (TSV 04303.09 052)

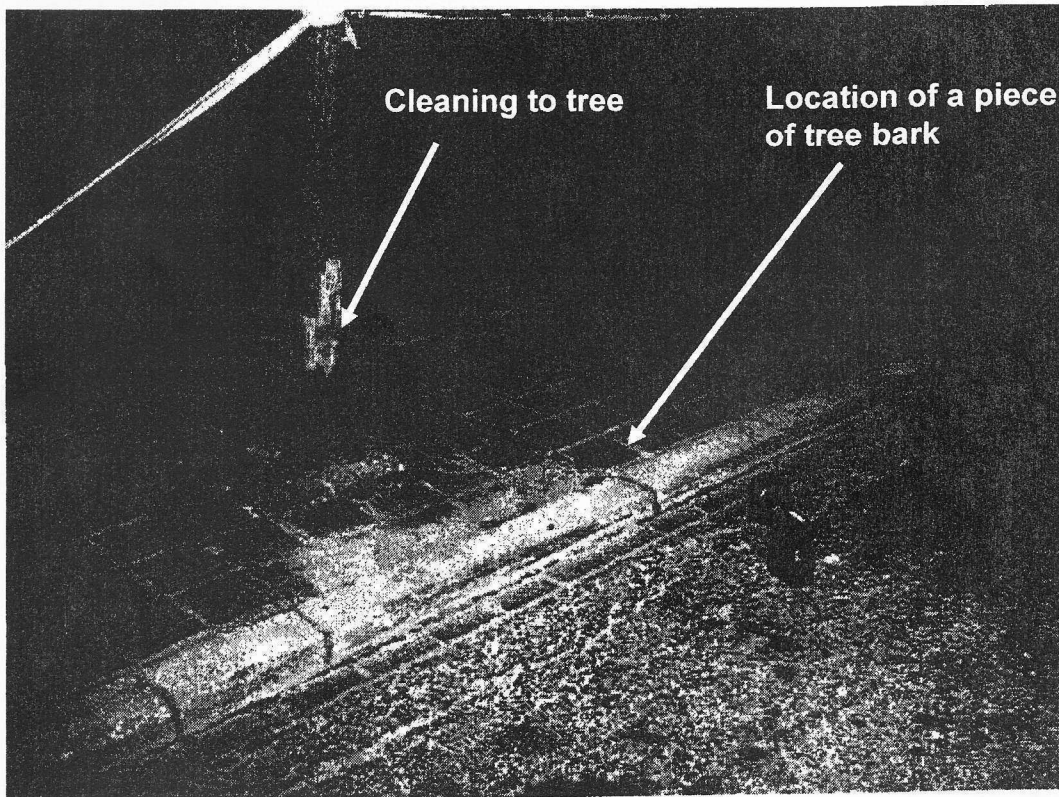
Fig 1.28 View of Bloor street near #131. Cleaning on tree, bark on boulevard. (FIS2072307 5646)

There was cleaning noted on a tree near #131 Bloor Street West with a small piece of bark located west of the tree. The tree was 0.8m south of the south curb of Bloor Street West 12.27m east of the fire hydrant near Sephora at #131.

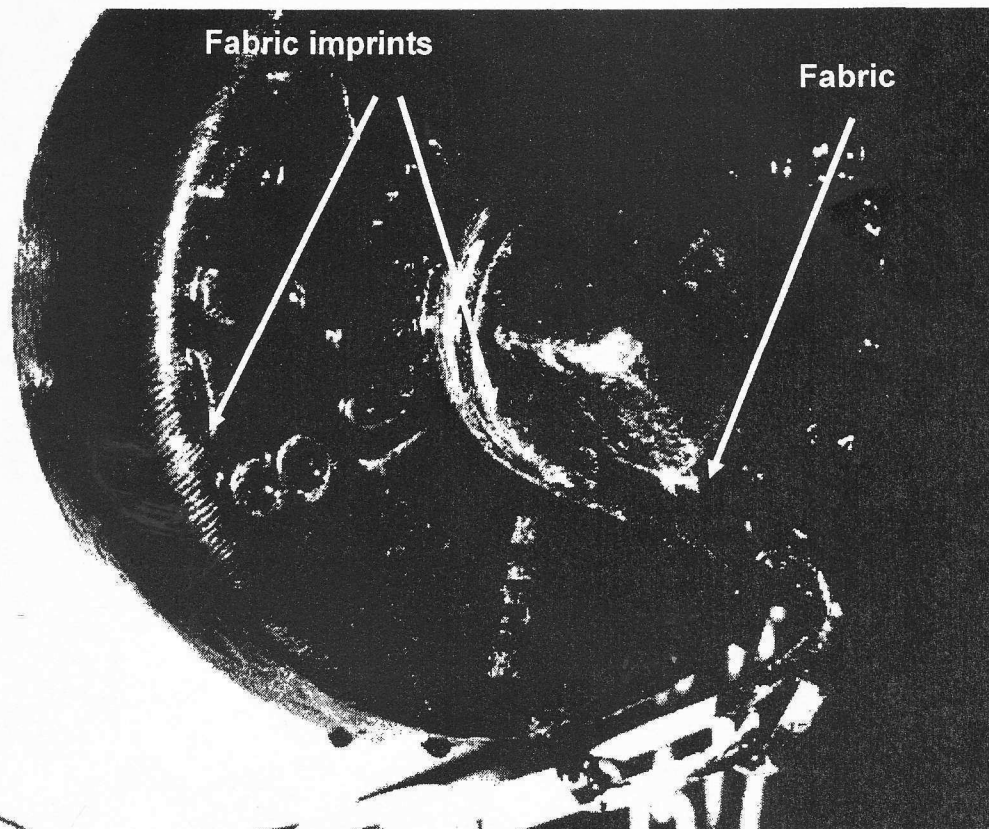
Mr. SHEPPARD struck the fire hydrant near #131 Bloor Street West. The hydrant tore open the torso of Mr. SHEPPARD, rotating him counter clockwise. Fabric was located on the hydrant cap. The redness leading up to the tear in the cyclist's torso was approximately the same size as the protruding cap on the hydrant.

Figure 1.30 Fabric on end of fire hydrant. (FIS 2072309 5646)

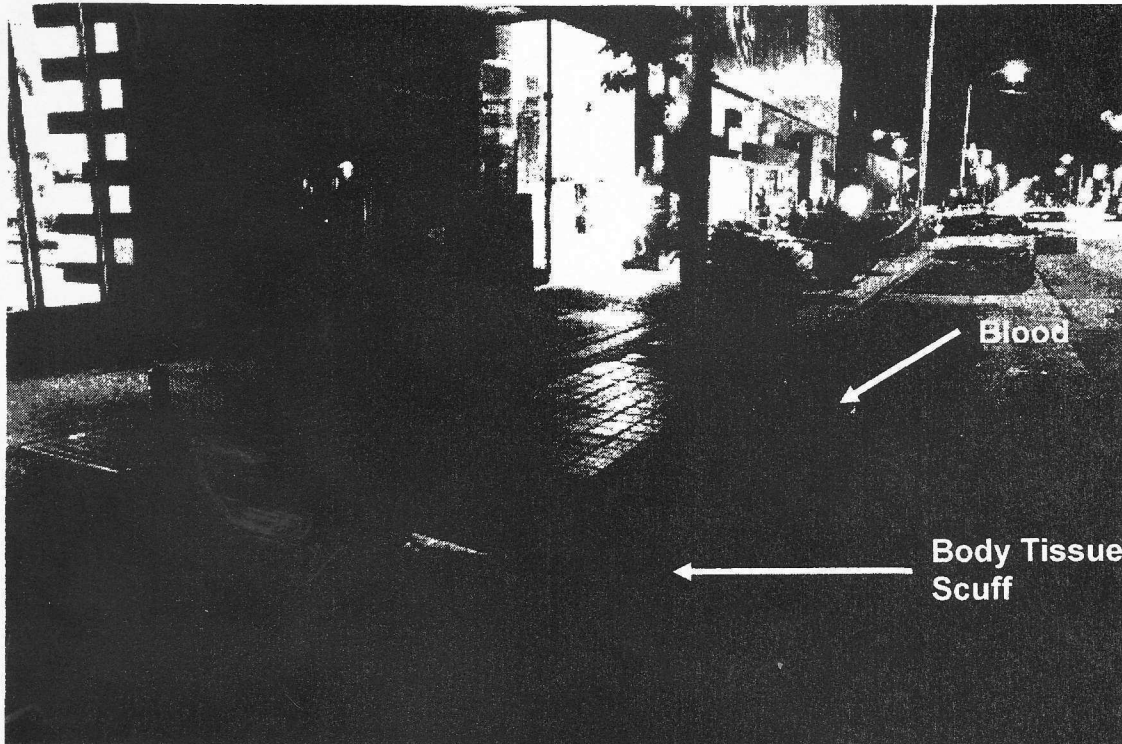
Fig 1.31 Body scuff on Bloor Street near #131. (TSV 00373.09 071)

The cyclist injuries were not consistent with him being run over by the Saab. The pavement to the north of the fire hydrant was very uneven and the asphalt patch was slightly raised in relation to the surrounding roadway.
