# **The Tornadoes of Oklahoma City of May 3, 1999**

a report prepared by

Wind Science and Engineering Research Center  
Texas Tech University  
Lubbock, Texas

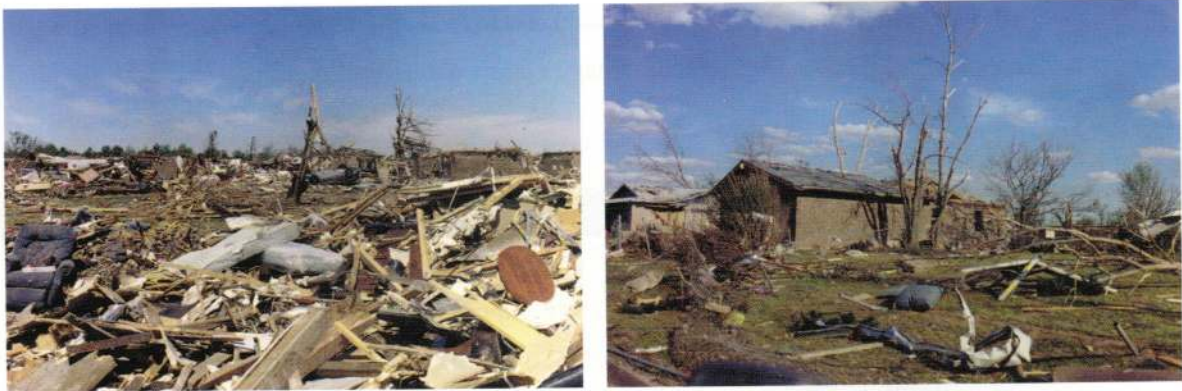
### **FIGURE 2. DEBRIS COMPARISON**

Higher wind speeds and/or longer durations increase the ability of a storm to generate debris and higher velocity projectiles. Homes located in the middle of the tornado path, where higher wind speeds and a longer duration occur, generate more debris than homes located along the perimeter of the tornado path (Figure 2). The amount of debris also depends on the built-up environment. Sparsely populated rural communities typically do not have the structures which generate the massive amounts of debris seen in more densely populated areas (Figure 3).

*Debris comparison between locations at the middle of the tornado path (left) and locations at the perimeter of the damage path (right).*

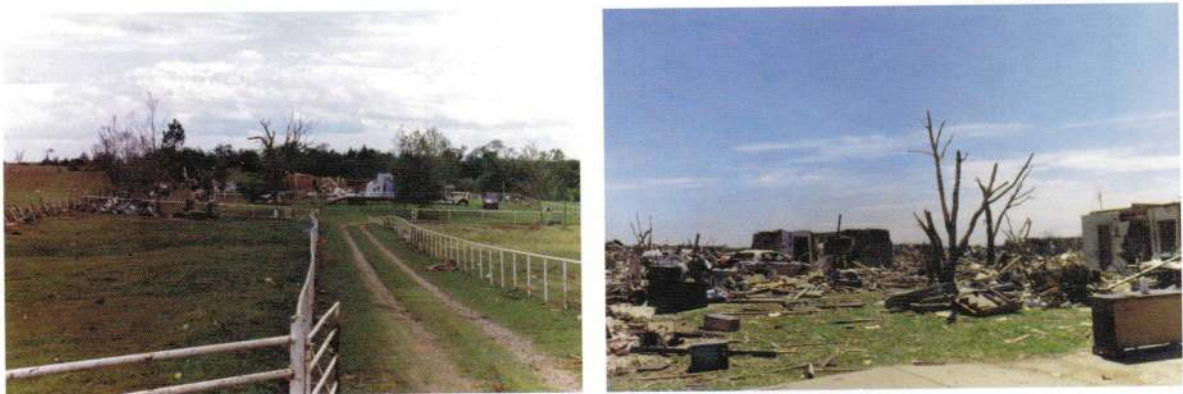
### **FIGURE 3. DEBRIS COMPARISON**

*Debris comparison between rural (left) and suburban (right) areas.*

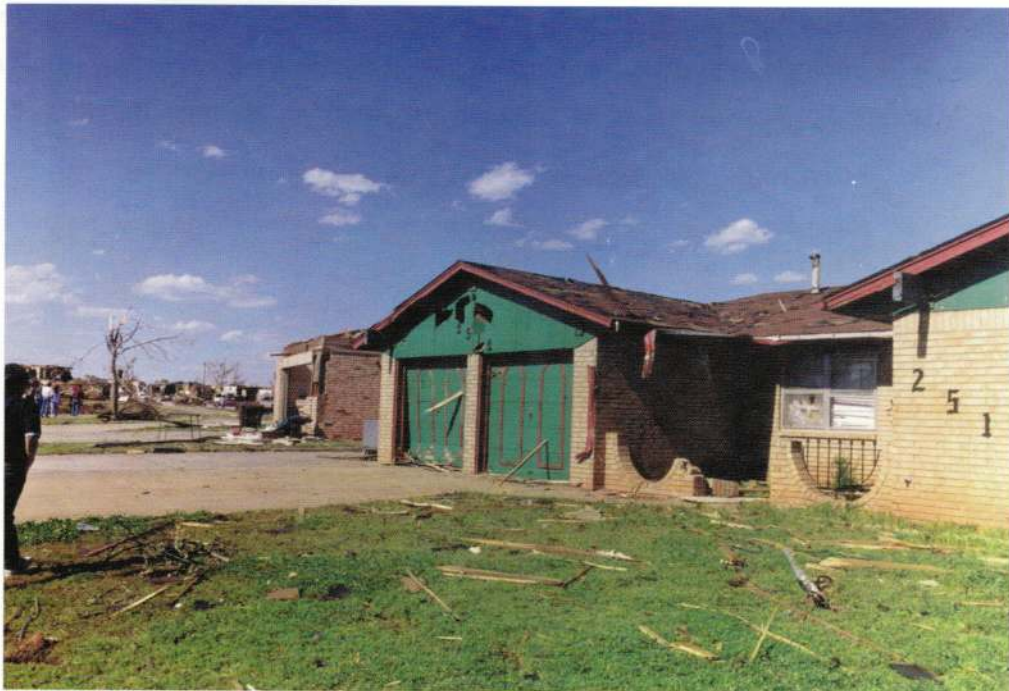
**FIGURE 4. GARAGE DOOR DAMAGE**

Orientation of a building, relative to the direction of the approaching winds, can affect the extent of damage a building experiences. One of the most vulnerable areas of single-family residences (relative to orientation) is the attached garage. Garage doors are notorious for blowing inward during extreme wind events, allowing the wind to enter the building and increase internal pressures. The resulting uplift on the roof compromises the roof and eventually other parts of the building. Therefore, homes with garage doors oriented in the direction of the approaching winds typically fare worse than homes without the garage door oriented into the wind (Minor et. al 1983; FEMA 1992; FEMA 1999). Figure 4 shows two homes with two-car garages. Notice that the home with two single garage doors (foreground) has an intact roof structure, whereas the home (background) with one double garage door is missing its garage door and roof structure. Both garages were oriented towards the approaching winds (wind direction is established from the debris penetrating the single garage doors on the house in the foreground). The double garage door was breached due to its larger area and flexibility, which ultimately led to the loss of the roof structure.

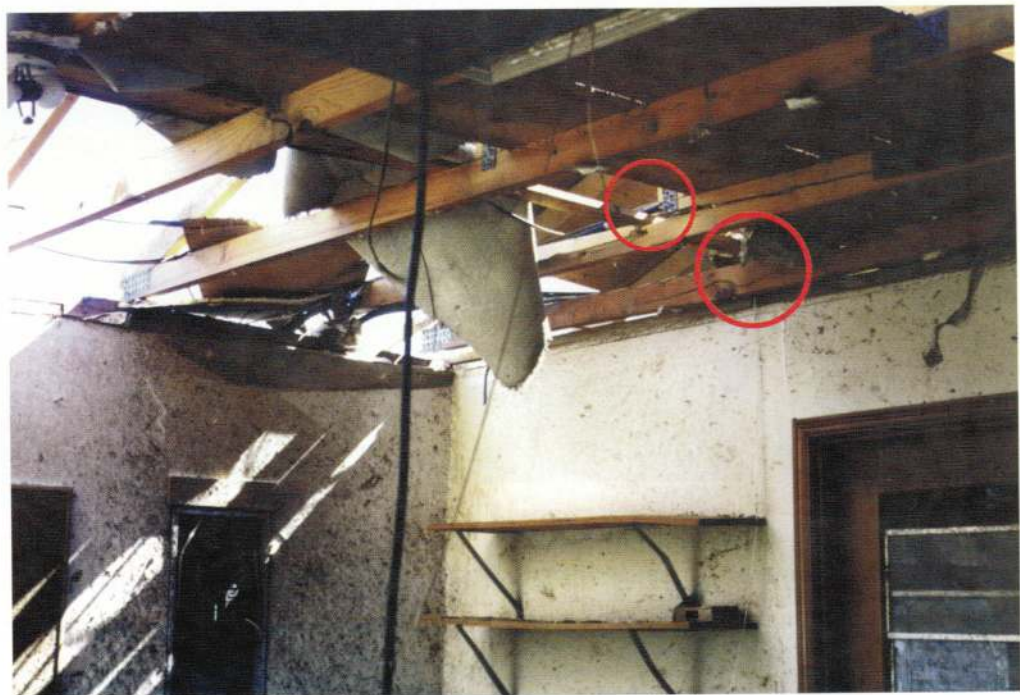
**FIGURE 5. FAILURE AT KNOTS IN WOOD MEMBERS**

The extensive use of wood in residential construction also makes material quality integral to the structural integrity. Wood structural members tend to fail at locations where there are knots, wane, or other imperfections (Figure 5).

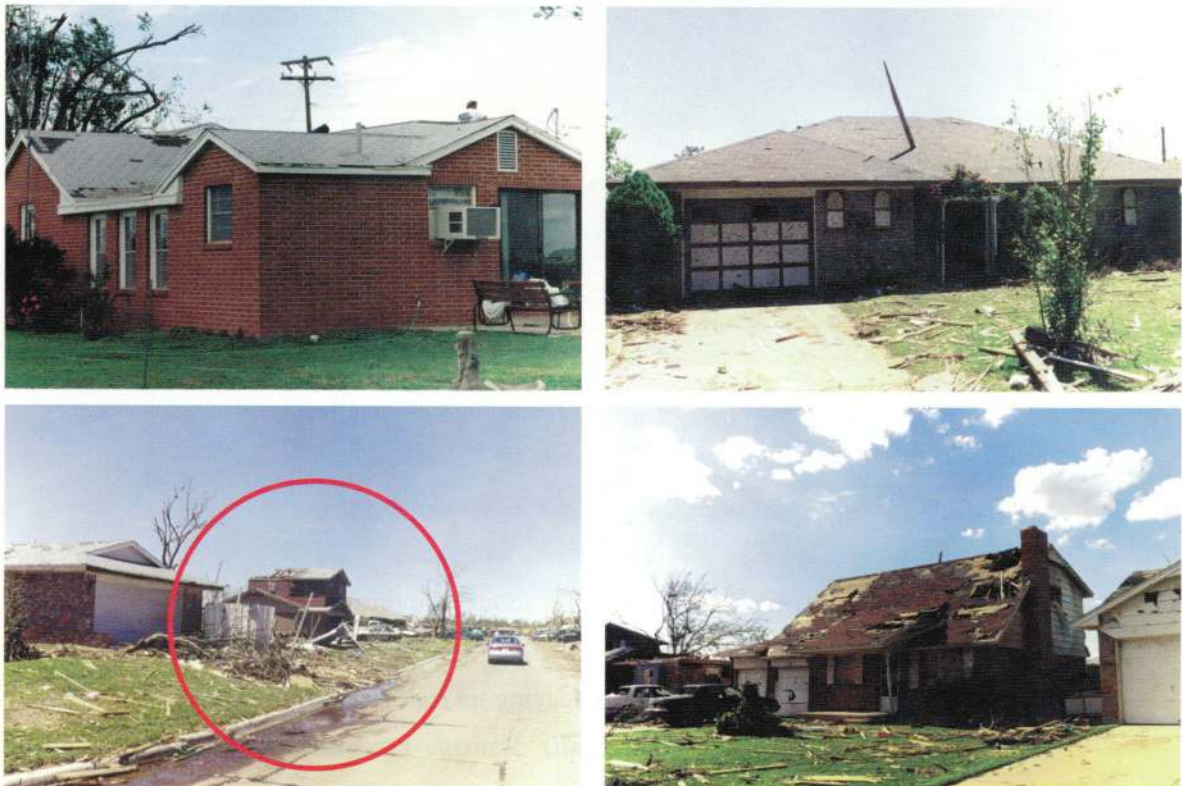
**FIGURE 6. MINOR/MODERATE DAMAGE (F0-F1 DAMAGE LEVEL)**

Residential damage in the Oklahoma City tornado is classified into four categories: minor/moderate, extensive, severe, and destroyed. Minor/moderate damage includes structures where exterior and interior walls are standing, and the envelope may be scarred from impact of debris; windows may be broken and 20% or less of the roof may be structurally damaged (Figure 6). Typical failure modes observed in this category were shingle damage along roof eaves, corners, and ridges (Figure 6, top left), projectile impacts (Figure 6, top right), windward gable roof truss failure (Figure 6, bottom left), and debris pitting of roof cover and cladding (Figure 6, bottom right). Minor/Moderate damage is repairable and the home can be lived in. This type of damage is believed to occur at gust wind speeds of 38-49 m/s (85-110 mph); this is comparable to 20-53 m/s (45-118 mph) wind speeds associated with F0-F1 Fujita damage scale.

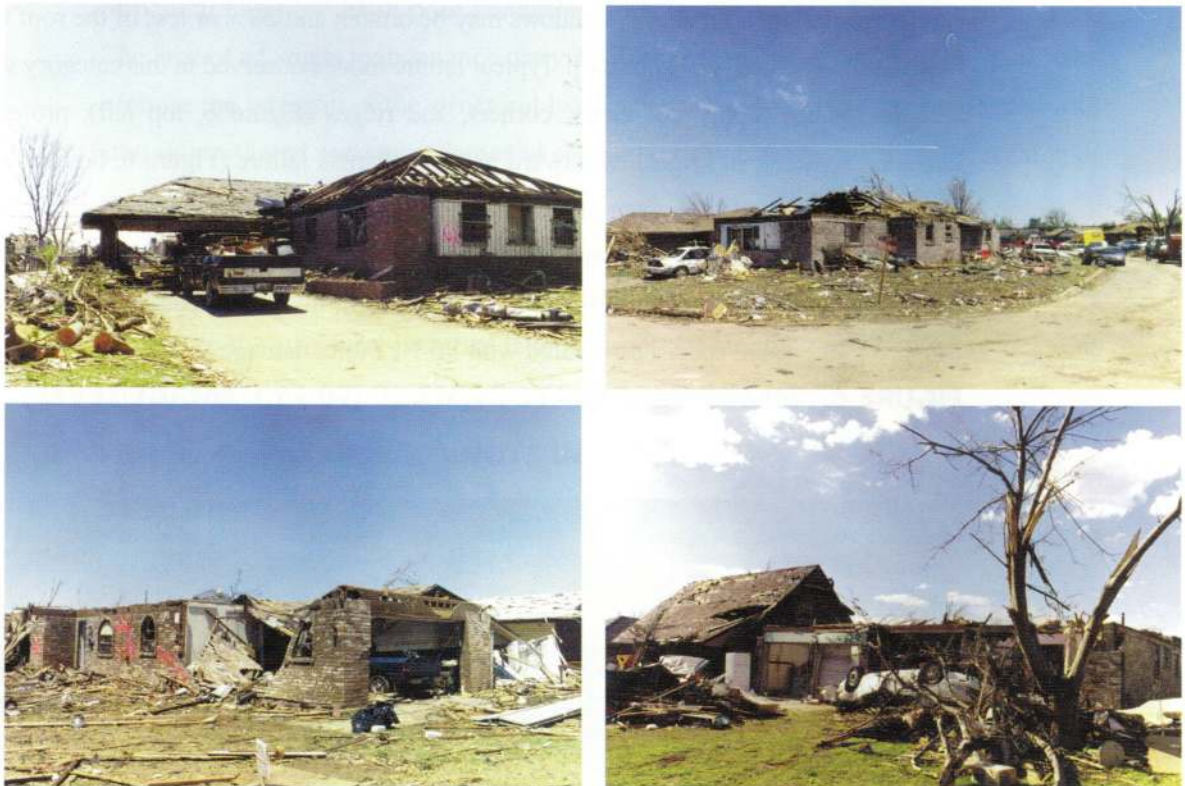
**FIGURE 7. EXTENSIVE DAMAGE (F2 DAMAGE LEVEL)**

Extensive damage includes structures with more than 20% of the roof structure damaged, most exterior walls remain standing, and 80% or more of the floor plan intact (Figure 7). The main failure modes associated with extensive damage are the inadequate connections of the roof cover to roof structure (Figure 7, top left and right) and the roof structure to the walls (Figure 7, bottom left and right). This type of damage is not considered a total structural loss, but uninhabitable until repaired. Extensive damage is estimated to occur with gust wind speeds in the range of 50-58 m/s (110-130 mph), as opposed to 54-73 m/s (121-163 mph) gust wind speeds associated with the F2 Fujita damage scale.

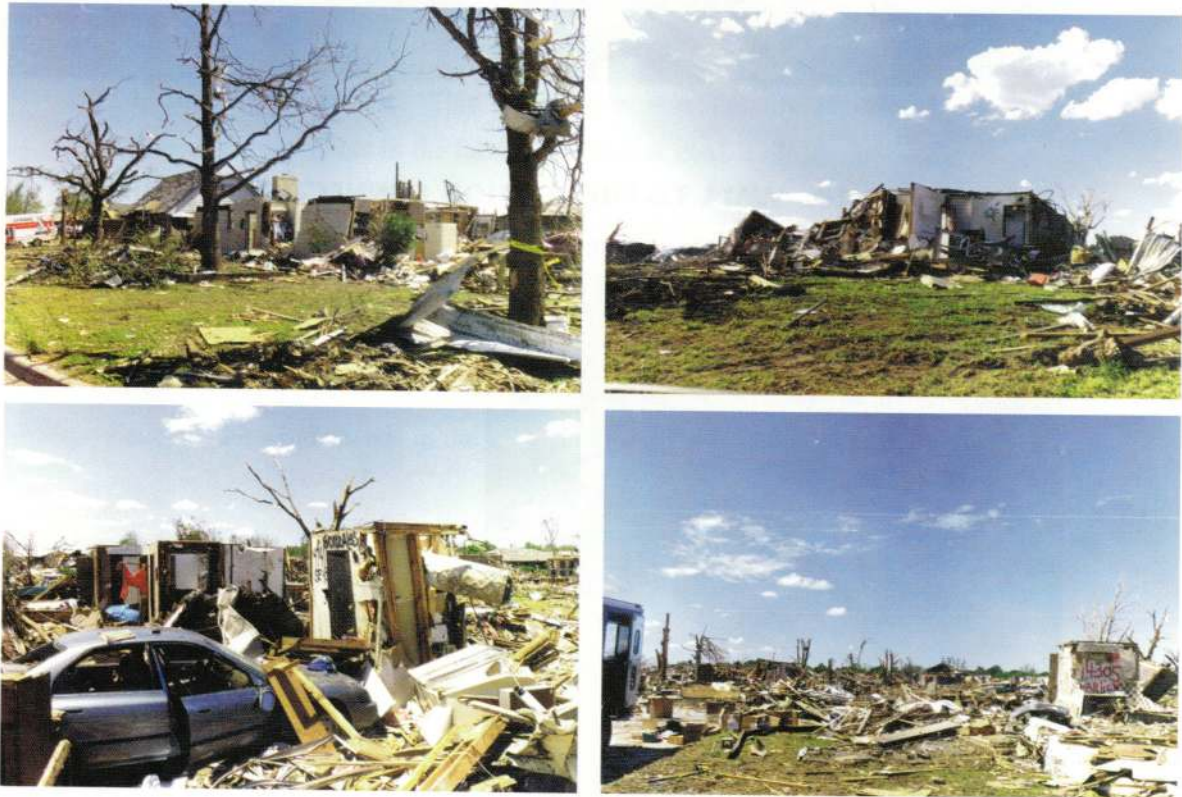
**FIGURE 8. SEVERE DAMAGE (F3 DAMAGE LEVEL)**

Structures with no roof or exterior walls remaining, and only interior walls or rooms standing are classified as severe damage. Severe damage ranges from the majority of interior rooms surviving (Figure 8, top left and right) to only one small interior room surviving (Figure 8, bottom left and right). Severe damage is considered survivable by occupants because small interior rooms can provide refuge.

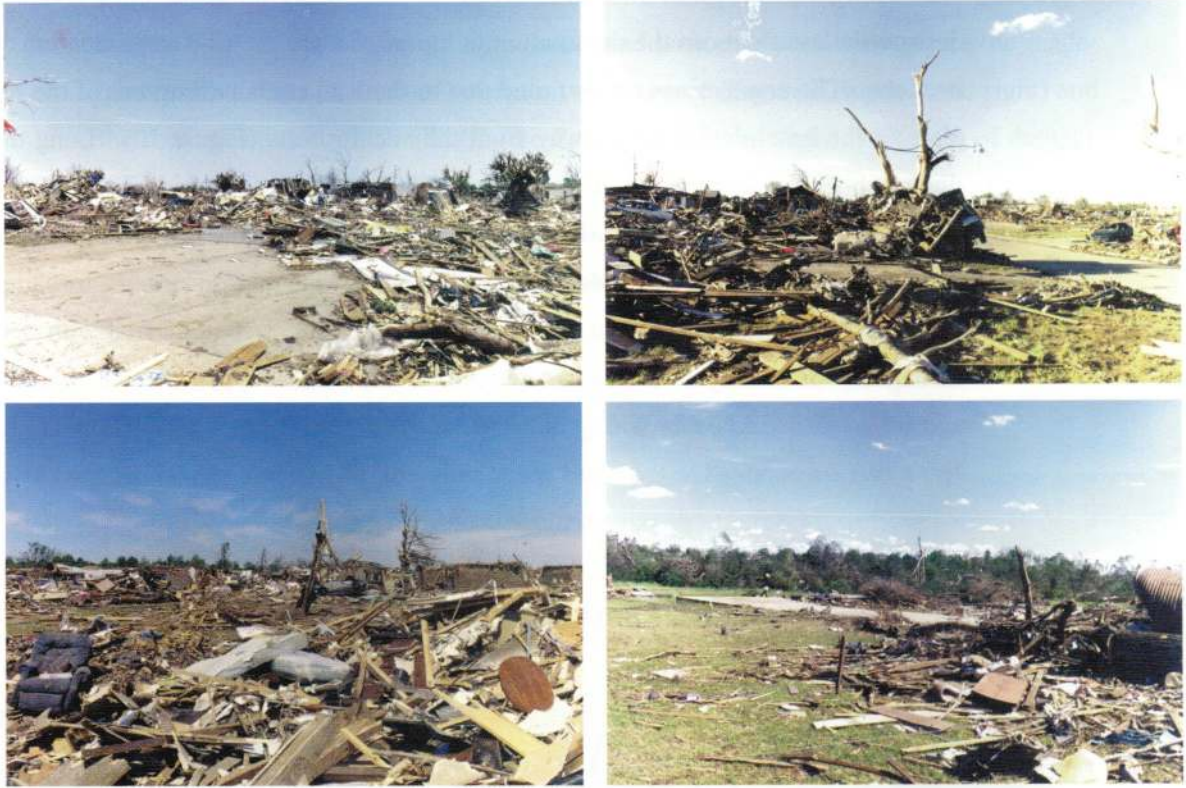
**FIGURE 9. DESTROYED (F4-F5 DAMAGE LEVEL)**

Structures wiped from the slab, leaving no roof or exterior or interior walls are classified as destroyed (Figure 9, all). Damage classified as destroyed is considered

unsurvivable. Although essentially all of the homes in the storm path had the better performing slab-on-grade foundations and all slabs were intact, in both severe and destroyed classifications the dominating failure mode was the wall to foundation connections. The connections either failed due to the wall studs pulling out of the base-plate or the base-plate ripping away from the anchor bolts (Figure 10). Long durations of high winds are believed to be a significant factor in resulting in severe damage and complete destruction of residences, and was also considered the culprit for the devastating damage and loss of life experienced in the Jarrell, Texas, tornado on May 27, 1997 (Phan and Simiu, 1998). Residential structures classified with severe damages or as destroyed are considered a total loss. These types of residential damage are estimated to occur with gust wind speeds in the range of 54 to 72 m/s (120 to 160 mph), as opposed to the wind speed range of 74-143 m/s (164-320 mph) associated with F3-F5 Fujita damage scale.

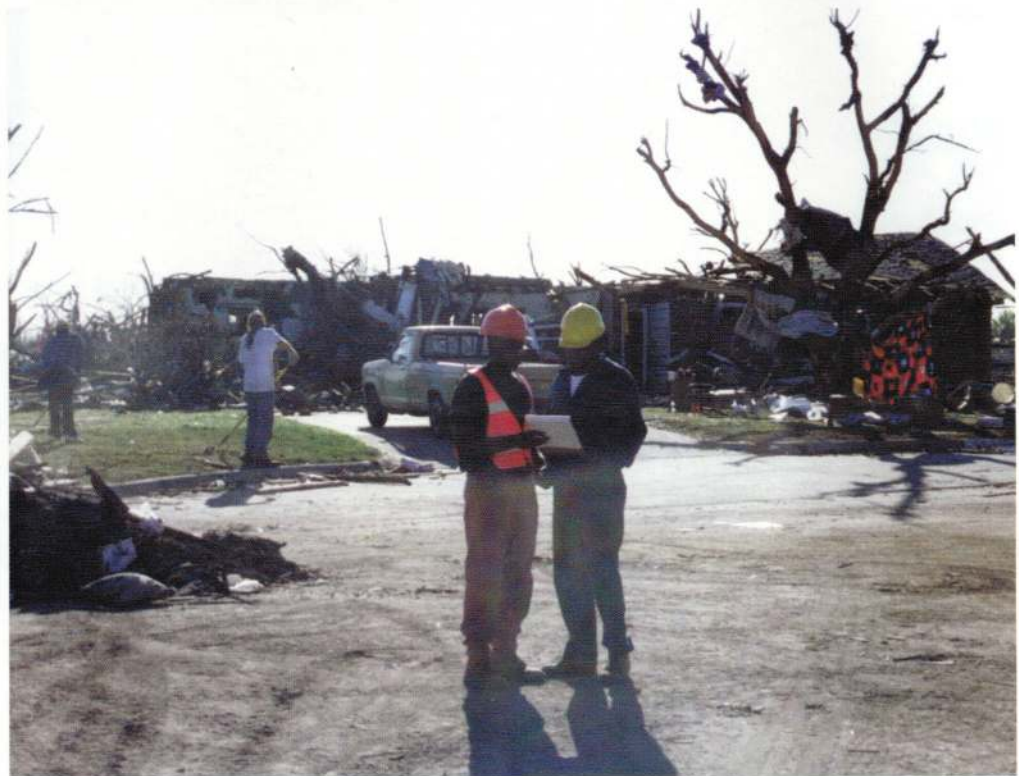
**FIGURE 16. BARTLETT HOME**

The Bartlett Shelter was located in Del City, Oklahoma. The Bartlett neighborhood experienced extensive to severe damage (Figure 15). The Lewis shelter was located in the Bridge Creek Estates in Bridge Creek, Oklahoma, an area which experienced minor/moderate damage. Both shelters survived without any damage, even though the Bartlett home was classified as having severe damage (Figure 16).

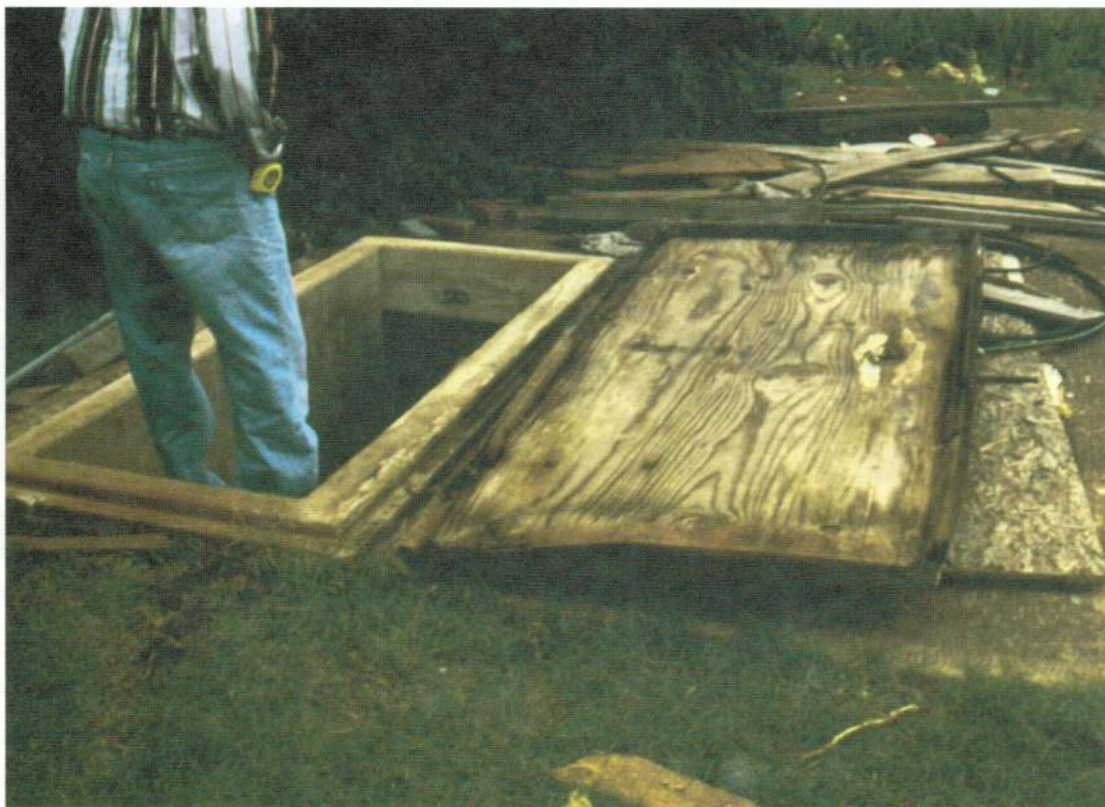
**FIGURE 18. BRIDGE CREEK CELLAR DOOR**

cellars suffered from maintenance problems, such as waterproofing of walls and roofs, which resulted in a musty and damp environment. Poor selection of materials and maintenance of painted items such as hinges and latches led to rusting, which

resulted in failures or poor performance. Cellar doors normally consisted of a single sheet of plywood covered with thin gage sheet metal, which exhibited deterioration of the zinc galvanization resulting in rust (Figure 18). The plywood backing was often found to be highly deteriorated from moisture (Figure 19). The older cellars were vented with substantial heavy steel pipe vents that performed well in the storm event (Figure 20).

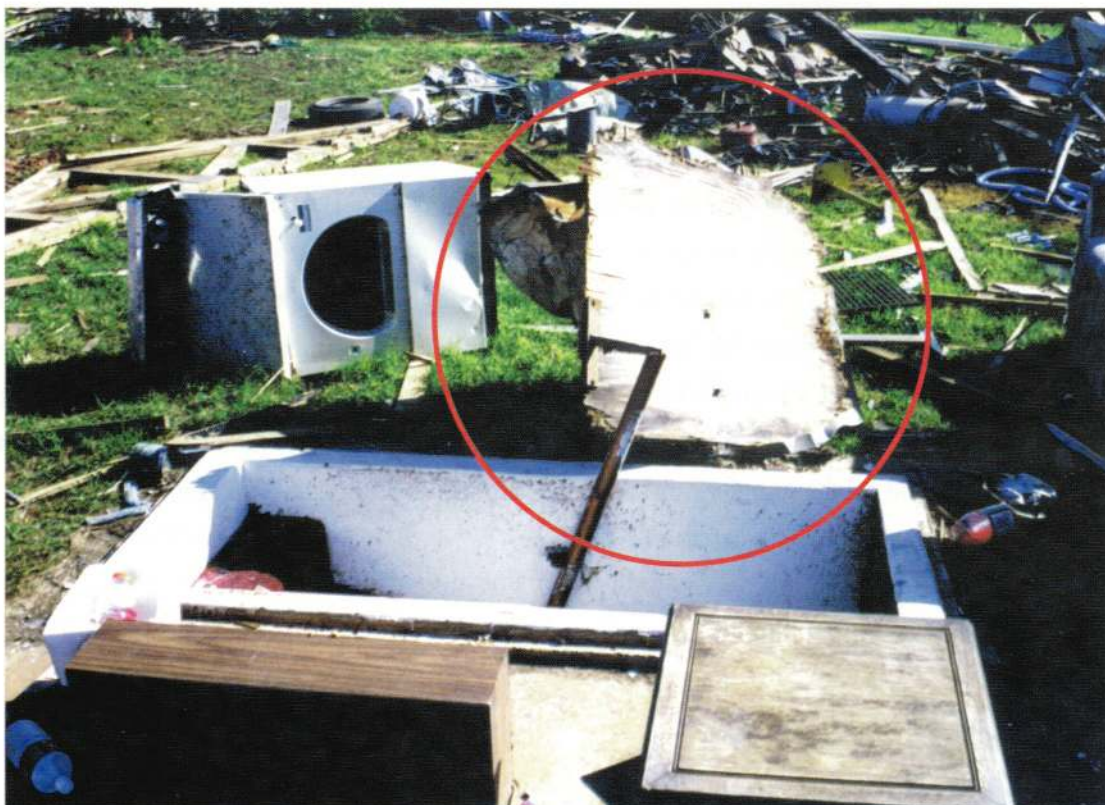
**FIGURE 19. MOORE CELLAR**

Countless families found safety in outdoor underground cellars. To our knowledge, people seeking shelter were not injured, though the occupants of the shelter pictured in Figure 18 could have been injured when the door was removed by the storm. Many of the observed

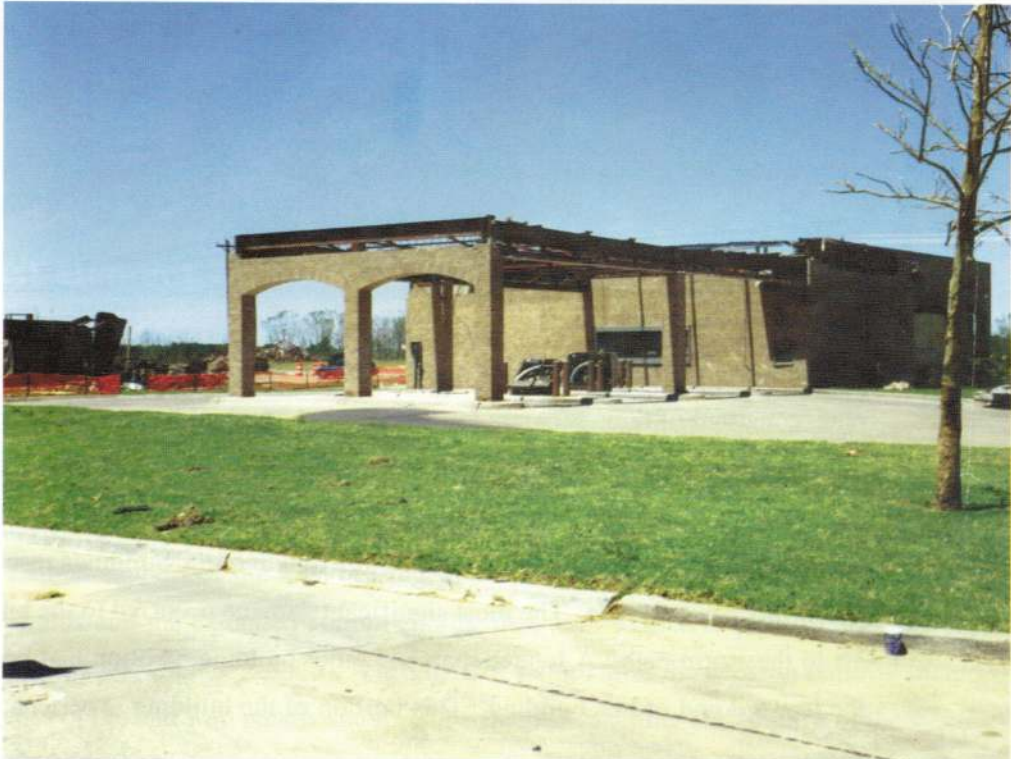
**FIGURE 24. MOORE BANK, MOORE, OK**

The second steel structure investigated was a bank building (Figure 24) located approximately four blocks from Kelly Elementary. Wind uplift accounted for the removal of the drive-through roofing material. Windborne debris compromised the building openings allowing internal pressures to combine with the external pressures, resulting in the removal of sections of the metal roofing. The steel structure was composed of heavy wide-flange beams and columns with high-strength bolted connections and stiffened beam webs. The building frame exhibited no signs of torsion or racking.

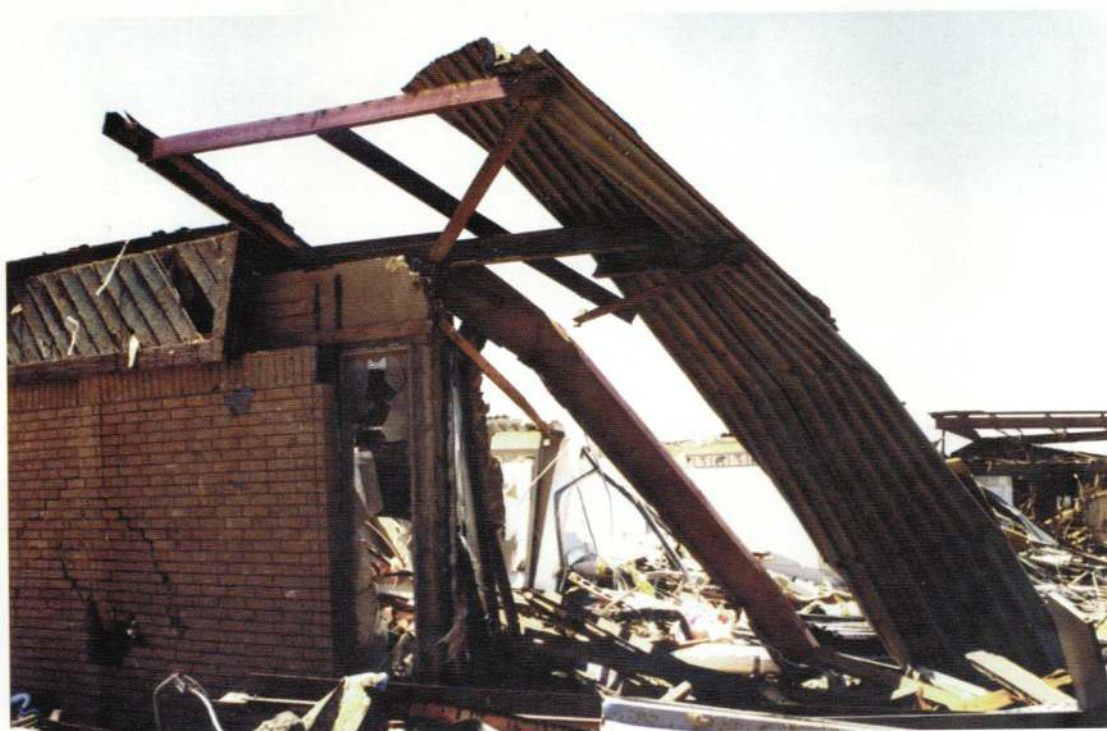
**FIGURE 25. OFFICE BUILDING, MOORE, OK**

The third steel structure was a single story office building (Figure 25), which was located adjacent to the bank shown in Figure 24. The structure was constructed of metal decking over bar joists bearing on lightweight beams and pipe columns. This structure would have experienced the same wind forces as the bank. However, the lighter steel structure was incapable of withstanding both the internal and external forces. Failure occurred at virtually all structural connections.

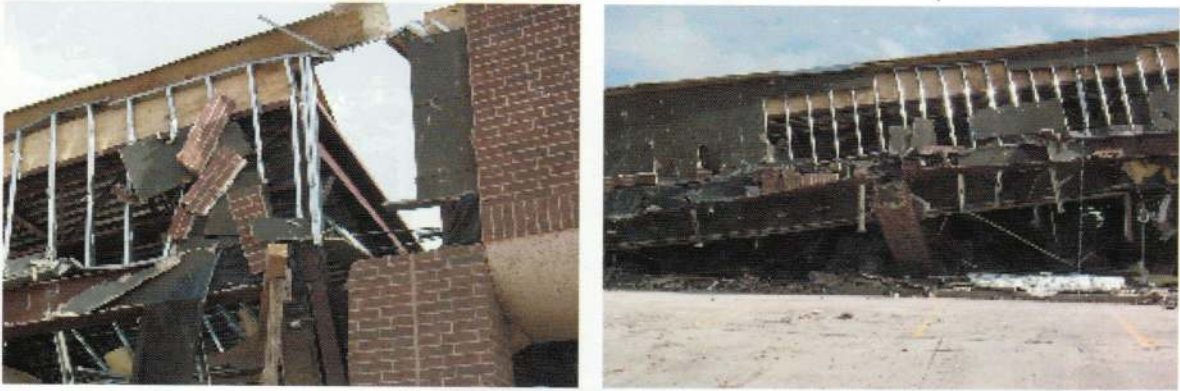
**FIGURE 26. TINKER INDUSTRIAL PARK, DEL CITY, OK**

The last steel structure investigated was at the Tinker Industrial Park. The office complex consisted of three separate long buildings. The buildings were constructed of a light steel frame with metal decking supported by bar joists and load bearing walls. Typical failure included debris compromising large windows on the narrow west end and the channeling of wind through the entire length of the buildings resulting in failure of the leeward walls. The most significant damage occurred to the building nearest to the storm path. A longer span and taller building addition had been added to the leeward end of this building. This portion of the building experienced consider-

able uplift causing the disconnection of the structural elements (Figure 26, left) and total collapse of the building addition (Figures 26, right). Storm damage in the immediate residential area was severe.

*Disconnection of structural elements (left); collapse of the building addition (right).*

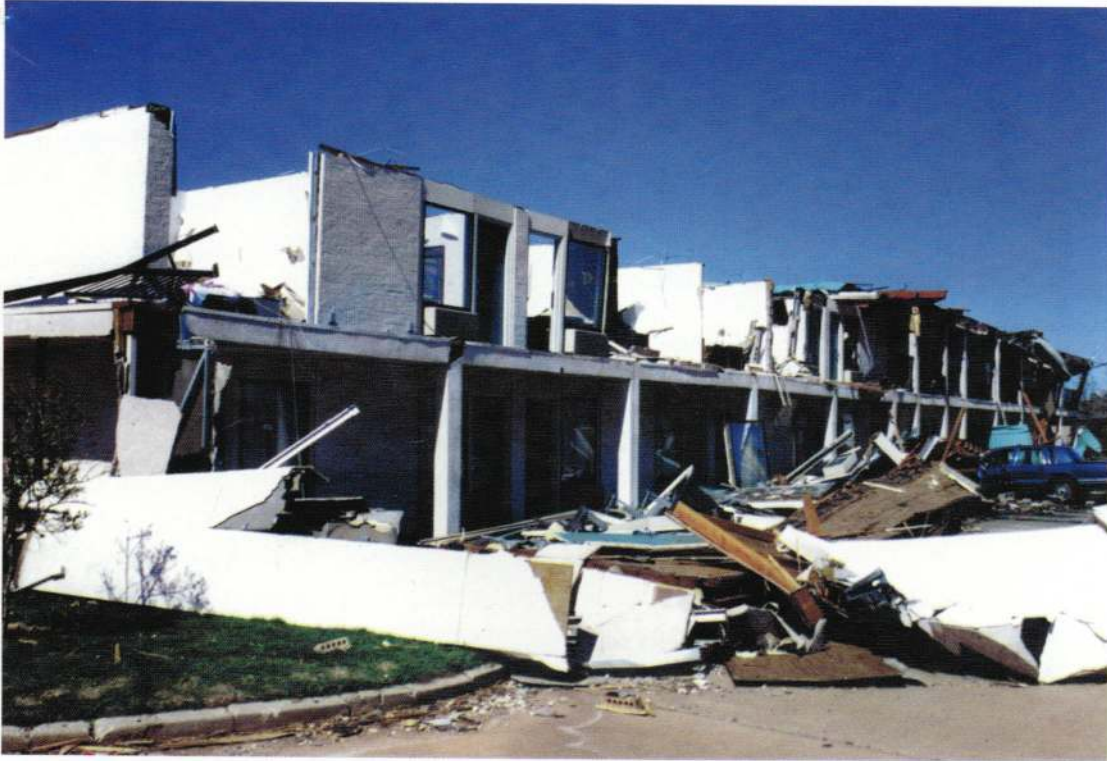
**FIGURE 29. BEST WESTERN MOTEL, MID-WEST CITY, OK**

The Best Western Motel was constructed with pre-cast hollow core concrete floor slabs supported on masonry walls. The architectural design consisted of back-to-back rooms stacked two stories with wide exterior corridors and roof overhangs ringing the building exterior. The wind forces acted on the top and bottom surfaces of the overhangs, and windborne debris compromised the large guest room windows. Many of the structural systems failed, including removal of some of the wood roof structure (Figure 29).

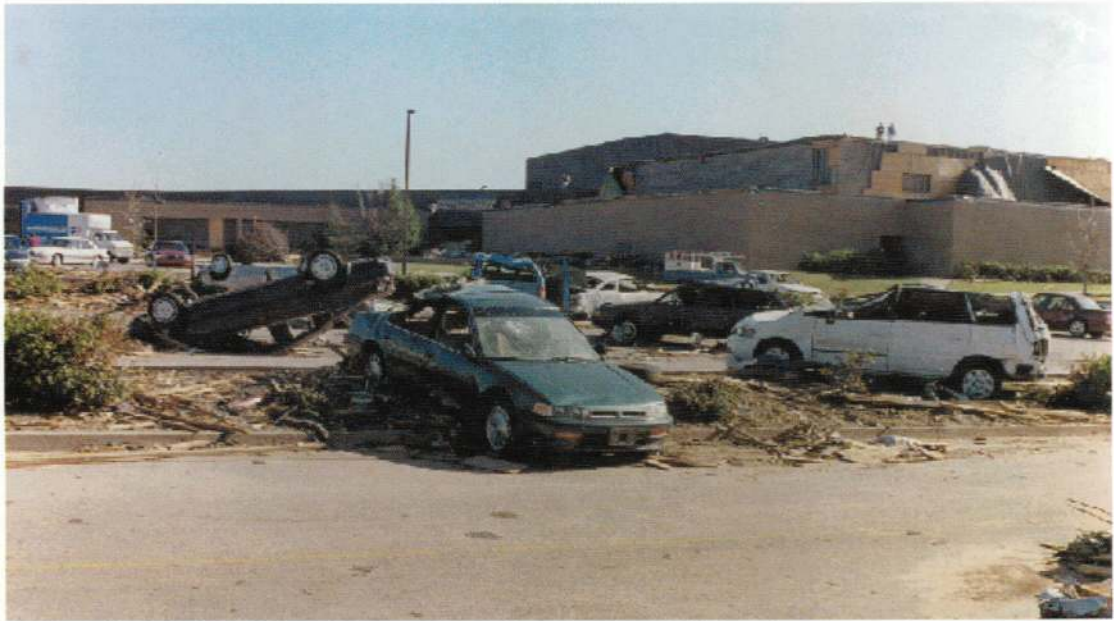
**FIGURE 30. WESTMOORE HIGH SCHOOL, MOORE, OK**

Westmoore High School was constructed with a metal deck over bar joists bearing on beams and columns and load bearing concrete and masonry walls. Observed failures of the components and cladding included removal of the roof membrane, some decking, ornamental steel wall cladding, and window glazing (Figure 30).

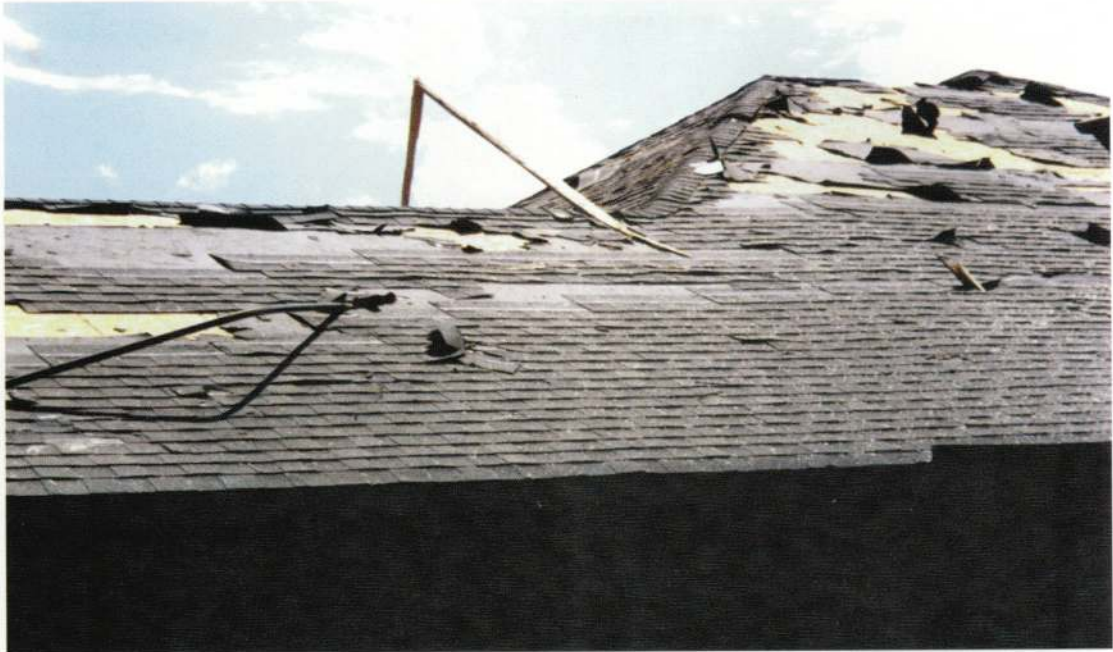
**Figure 38. Steel Gas Pipe Projectile**

Steel projectiles were rare since steel components were not widely used in residential construction. Failed steel buildings were normally found in agricultural areas, and their components typically did not completely separate from each other. Steel members were often found twisted and tangled in a mound (Figure 36). A short, lightweight **C-section steel** piece, 64 cm (25 in) long and 8 cm (3 in) wide, was found stuck in grass-covered ground (Figure 37). A **steel gas pipe** segment, about 1.5 m (5 ft) long, was found penetrating a wood roof deck (Figure 38).
