Formal Observation Report

Tornado: Moore, Oklahoma, May 20, 2013

Safe Room Performance, Observations, and Conclusions

FEMA P-1020 / August 2014

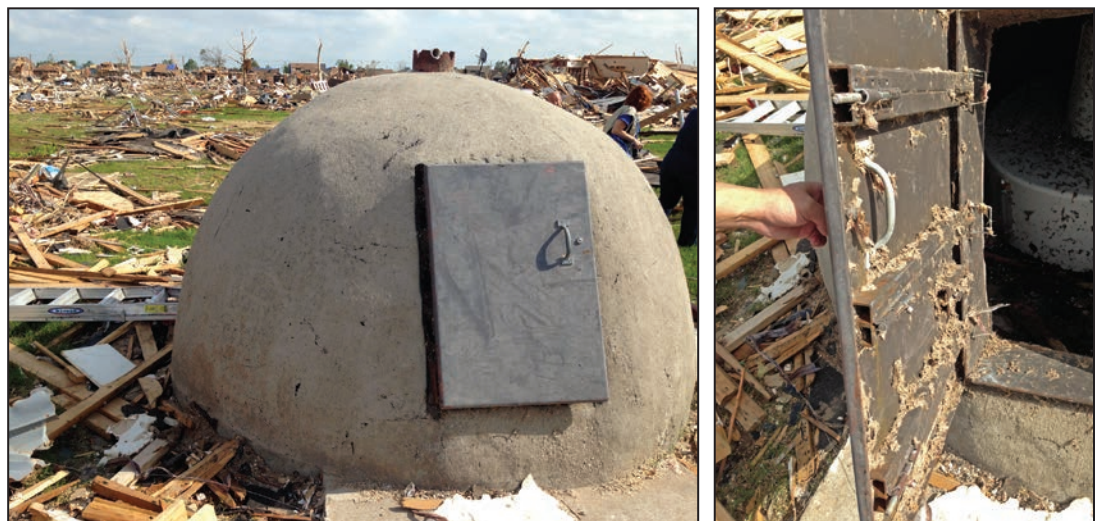
Observation 2: This shelter (Figure 3 left) was located in Oklahoma City in an area of heavy damage. No owners were present at the time of the investigation. It was approximately a 4 to 6 inch-thick concrete dome. It appeared to be an older structure, possibly from the post-1999 tornado reconstruction, though it could not

be determined if it had been constructed to any design criteria. The door was visibly damaged, and debris such as insulation, mud, and dirt were found inside the shelter (Figure 3 right). It was not clear whether anyone had taken refuge within it.

Figure 3.
Observation 2: Dome structure within the path of the tornado (left), the inside of the dome structure door was covered with small debris (right) (Oklahoma City, OK)

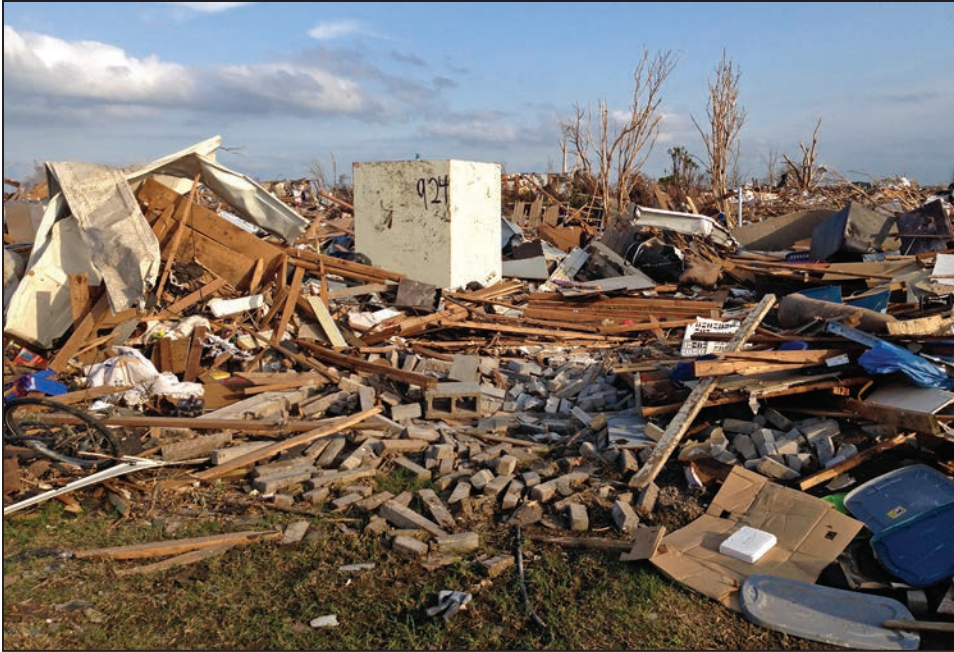
Observation 3: This metal above-ground shelter was located near Plaza Towers Elementary in a heavily damaged area of Moore, OK (Figure 4). There was nothing left of the home or nearby homes. The homeowner was not present at the time of the visit and

the door was locked. It appeared to have been installed in the garage of the home on a thick concrete slab. The side of the structure showed numerous marks from where wind-borne debris had impacted it, but it was otherwise in good condition.

Figure 4.
Observation 3: Above-ground shelter located near Plaza Towers Elementary School (Moore, OK)

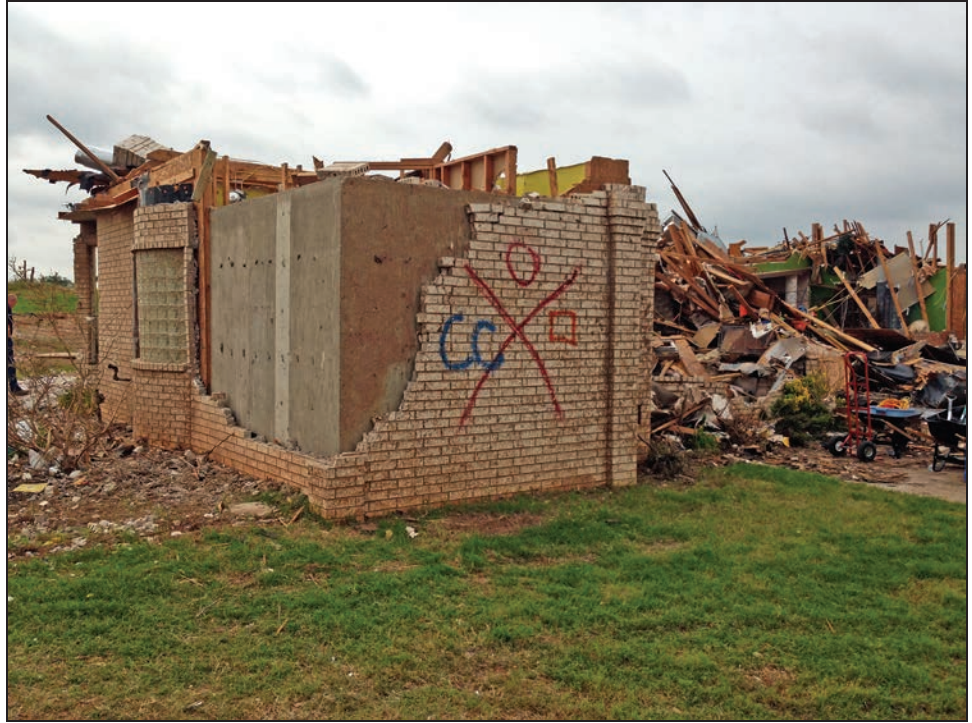
Figure 5.

Observation 4: This above-ground, concrete shelter (Figure 5 and Figure 6) was located in a newer neighborhood of Moore, OK, with many of the homes built in the early 2000s or later. No owner was home at the time of the visit. Most of the neighborhood was not in the direct path of the tornado and was not heavily damaged. This structure was one of the few site-built shelters the team found. Interviews with nearby neighbors indicated that the builder who constructed a number of homes in the neighborhood had included these shelters, although not every homeowner was aware of this. A nearby neighbor indicated that he had taken refuge in his garage, which experienced some breaching, and was unaware that the builder had

The neighbors did not know whether anyone had used the shelter in Observation 4 for refuge. The shelter's exterior was exposed due to loss of the building around it, allowing the team to observe more of the structure. The shelter was also a master bedroom closet and appeared to have at least a 6-inch thick concrete roof slab (see Figure 6). The shelter performed well although it had small debris particles and mud inside, which had entered through the inadequately screened ventilation holes.

Observation 4: Above-ground shelter that was also a walk-in closet for the master bedroom (Moore, OK)

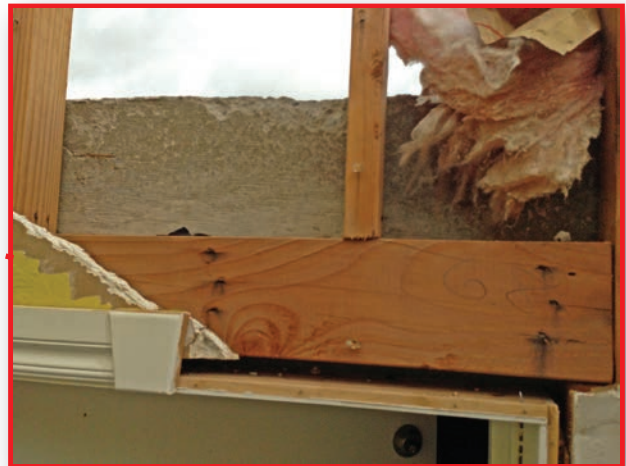
Figure 6.

Observation 4: Red arrow pointing to the entrance of the shelter (left) and a close-up of the concrete roof slab (right) (Moore, OK)

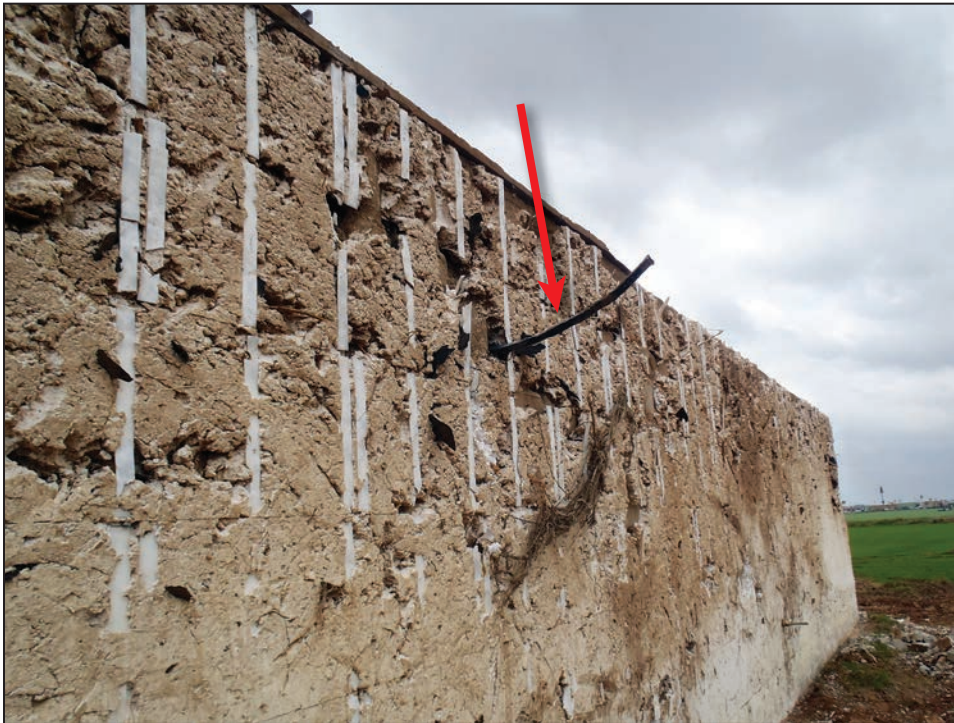
The team observed one metal wind-borne debris element that penetrated through the exterior wall (Figure 7). The metal debris was sticking out of the exterior wall approximately 8 inches and was embedded at least 24 inches through the shelter wall. The waffle grid thickness could be confirmed. The metal debris penetrated the thin section of the wall. The end of the metal debris sticking out of the wall was very sharp.

On closer examination, it appeared that there were many voids in the exterior ICF wall. These voids likely weakened the wall's resistance to wind-borne debris impacts and allowed the debris to penetrate the thin section of the waffle grid.

It is unknown what year this shelter was constructed, but this type of waffle grid construction is no longer one of the prescriptive plan material options in the 2014 edition of FEMA P-320. While ICF waffle grid safe rooms may still be designed and constructed per FEMA P-361 criteria, extreme care should be taken with all ICF walls when vibrating the concrete to ensure consolidation of concrete and eliminate voids in the wall. Likewise, care should be taken not to over-vibrate concrete and segregate the aggregate. Furthermore, when verifying that the selected waffle grid type has passed the tornado missile performance criteria described in FEMA P-361, it is important to look for the exact waffle grid type that passed since many different variations are available.

Figure 7.
Observation 5: ICF structure penetrated by metal wind-borne debris elements (Newcastle, OK)

The **ICF waffle grid structure** observed by the team was penetrated by at least one wind-borne debris element, providing an example of a shelter that did not perform adequately. The number of voids that were observed in the exterior wall indicates that careful attention must be paid when pouring concrete in an ICF wall.

Recommendation: Conduct outreach and update guidance to caution against using waffle grid walls in safe rooms.

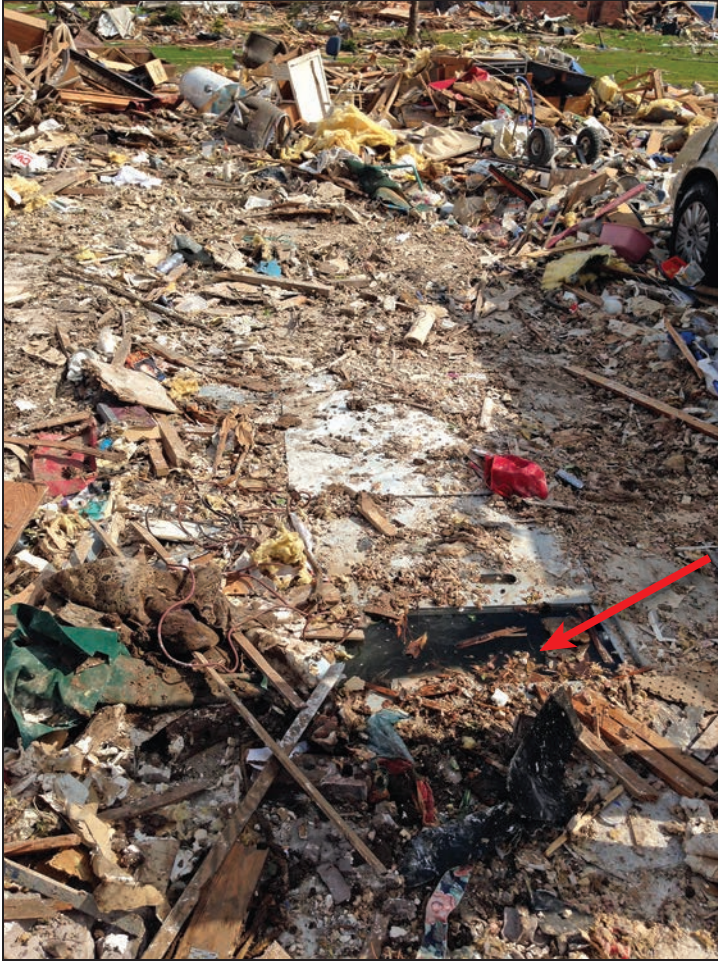
Observation 7: This below-ground shelter (Figure 9) was located in a heavily damaged area of Oklahoma City, OK. It was successfully used by four family members of the property owner who was at work at the time of the tornado. There was 2 feet of standing water from rain when they exited the shelter after the tornado passed, and the shelter was completely full by the time the investigation team arrived. The homeowner reported there were fatalities at a neighbor's house, where occupants took refuge in an interior closet.

Figure 9.
Observation 7: Below-ground shelter in a heavily damaged area (red arrow indicates entrance) (Oklahoma City, OK)

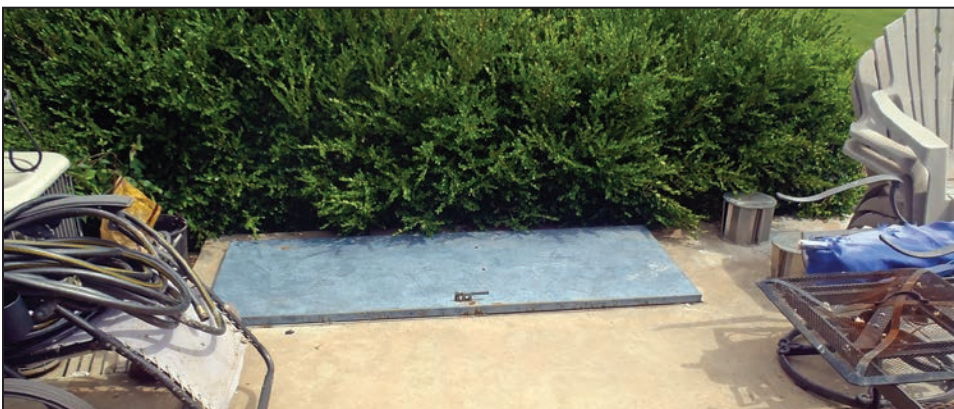
Observation 8: This outdoor below-ground shelter (Figure 10) was constructed in 2003 in Moore, OK. The owner was present when the team arrived, and indicated that his entire family and their pets took refuge in the shelter during the tornado, though the

home was not badly damaged as they were located outside of the track. The door to the shelter appeared to be an older style that did not have sufficient locking mechanisms, but the family did not experience any issues when taking refuge in the structure.

Figure 10.
Observation 8: Outdoor below-ground shelter located at a house with minimal damage (Moore, OK)

Recommendation: Conduct outreach to educate consumers regarding the need for an adequate door and how to select a safe room door.
