AIRCRAFT ACCIDENT REPORT 2/96

Air Accidents Investigation Branch

**Report on the accident to
EMB-110 Bandeirante, G-OEAA
at Dunkeswick, North Yorkshire
on 24 May 1995**

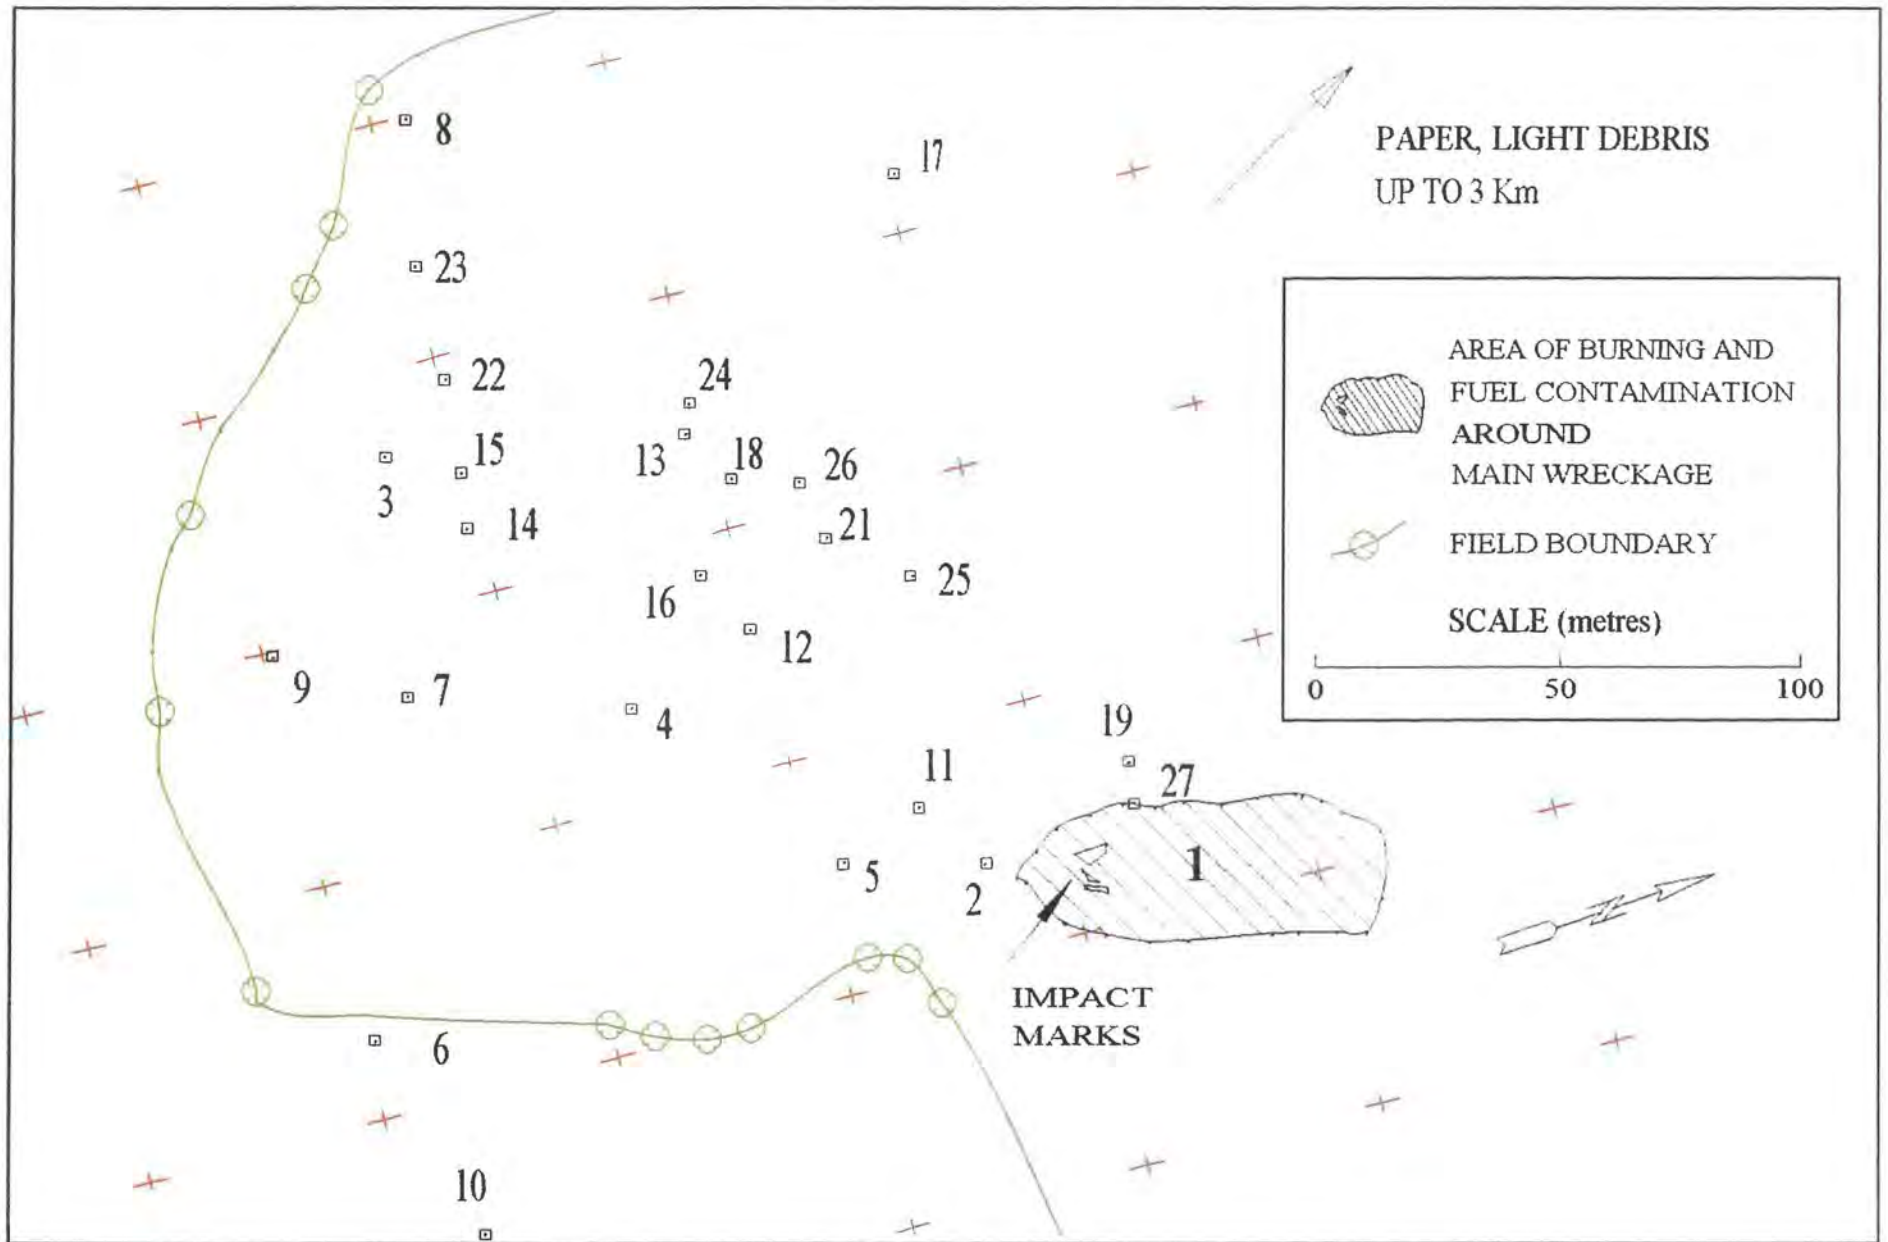
G-OEAA DISTRIBUTION OF MAJOR ITEMS OF WRECKAGE

- a. the main impact site with the burned remains of the fuselage, the starboard engine and most of the flying surfaces, was contained within a 14 acre field. The central axis was aligned with a heading of 345°;
- b. the surrounding area of approximately 350 x 250 metres containing aircraft structure, components and furnishings;
- c. a 'paper trail' of insulation material and lightweight items from inside the cabin, this extended for approximately 3 km into 19 other smaller fields on a heading of 330°.

The distribution of wreckage described above showed that there had been an in-flight break-up of the aircraft prior to impact but at a relatively low height. The overall spread of the wreckage was not large compared with that typically found in cases of airborne structural failure. The more extensive 'paper trail' was the result of wind drift on very light debris but also indicated that the fuselage was disrupted before the impact, since most of these objects originated from within the cabin. Many of the occupants, some still in and others separated from their seats, were found outside the main impact area suggesting extensive disruption of the fuselage. However, the debris pattern contained very few sizeable fuselage skin pieces making it unclear how this had occurred.

An analysis of the wreckage distribution, was made in order to equate the 'as found' locations of various key items of debris to a sequence of failure and height of break-up. Using estimated drag coefficients for each item combined with its known weight, the terminal velocity was calculated using a specially developed computer programme. With an approximate forward/vertical velocity of the aircraft at the time of separation, modified by the aftercast wind data from the time of the accident, and using conventional ballistic theory, an iterative process was followed until a height and sequence of failure was deduced which aligned with the known location of each piece of wreckage. This process estimated the height at which the aircraft began to break up as between 1,500 and 2,000 feet agl.

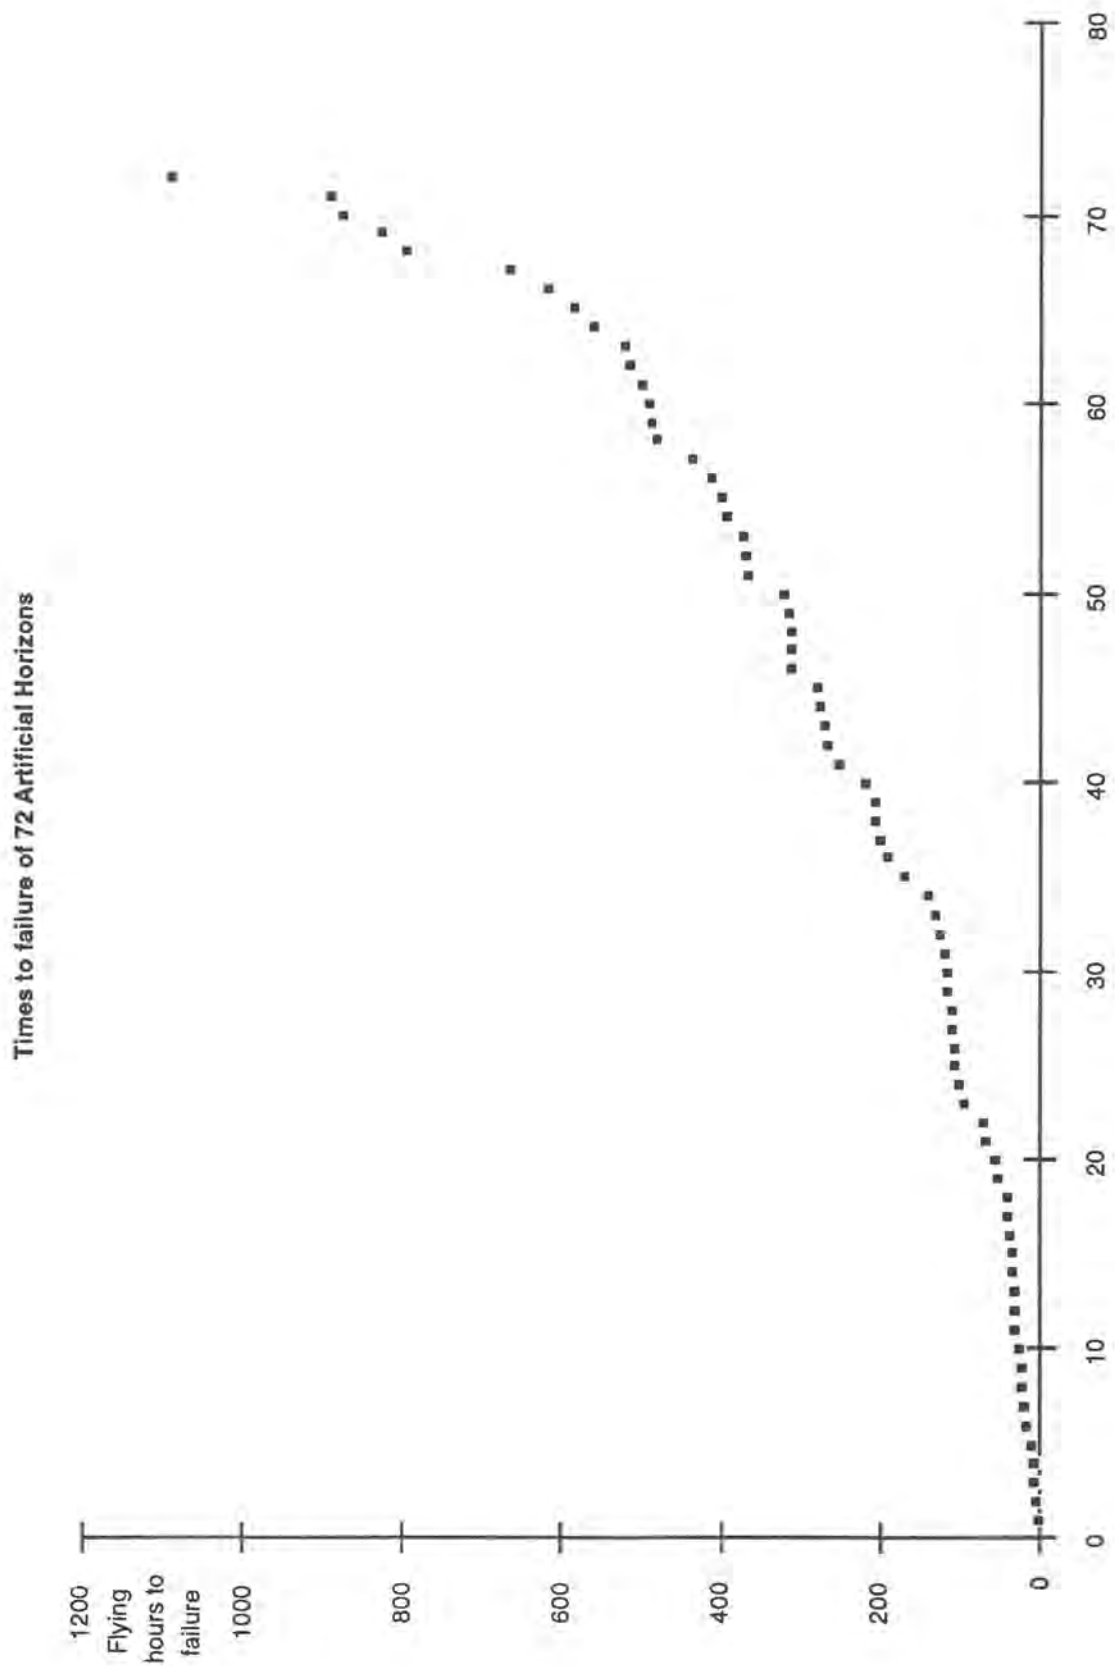
ARTIFICIAL HORIZONS - TIMES TO FAILURE

Examination of the technical records from G-OEAA produced a total of 41 entries concerning replacements of either the commander's or first officer's artificial horizon over the 15,347 flying hour life of the aircraft. These included the histories of the two instruments fitted to G-OEAA at the time of the accident. The data from which the MTBURs were derived does not include the first officer's horizons before 1984 as the second pilot only became mandatory on public transport work in 1984. However, first officer's data from after 1984 is included in this survey. The entries included 21 artificial horizons which were identified by serial number when fitted and removed from the aircraft, and from which times to removal could be calculated. These 21 artificial horizons had an MTBUR of 257 hours.

This figure was sufficiently low that the technical records from three other EMB-110s were examined to provide corroboration. The total flying hours for the three aircraft, up to 19 June 1995, was 51,860 hours, and a further 51 artificial horizon histories were identified representing over 25% of the total aircraft flying hours. These additional histories covered a period of approximately 15 years of use of each aircraft with a variety of operators and maintenance organisations. These data included the hours flown on the instruments currently fitted to the aircraft and gave an overall MTBUR of 260 hours for the 72 instrument changes. A table showing these histories is at Appendix E.
