Lessons from Texas City

A Case History

Michael P. Broadribb, C.Eng.

A major incident occurred in March 2005 on the Isomerization Unit at the BP refinery in Texas City, Texas, one of the largest refineries in the USA.

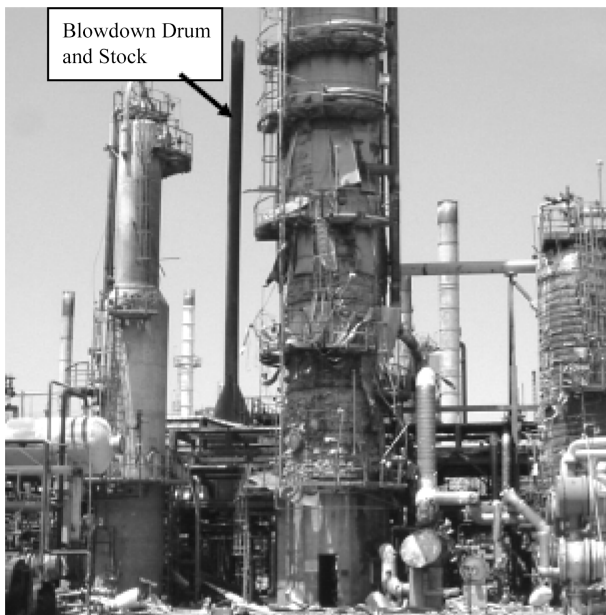
FIGURE 3: BLOWDOWN DRUM AND ISOM UNIT, AFTER THE INCIDENT

At about this time there were radio messages from at least two witnesses, who saw vapours and liquid emerging approximately 20 ft (6 m) above the top of the stack 'like a geyser' and running down and pooling around the base of the Blowdown Drum & Stack. Vapours were seen evaporating from the liquid pool. The F-20 high level alarm alarmed for the first time at 13:20 hrs.

Alerted by the radio messages and the shouting of at least one eyewitness, several personnel in the area of the ISOM left the immediate vicinity before the vapours ignited. The evacuation alarm was not sounded. At least one witness saw a pickup truck parked just north of the Blowdown Drum & Stack with its engine racing and exhaust glowing, but it is not known if this was the source of ignition. Several witnesses described two or more explosions; the first minor explosion(s) followed rapidly by a louder, more powerful blast at approximately 13:20 hrs, although subsequent modelling suggests that there was only one explosion. The explosion severely damaged the doublewide and other trailers on the west side of the ISOM, and resulted in 15 fatalities and over 170 individuals harmed. The blast resulted in damage to the ISOM, causing a number of secondary hydrocarbon releases and fires.
