Safety & Loss Prevention Briefings Compendium 2023

Compiled by IIMS

A COLLECTION OF WORLDWIDE MARINE INCIDENT AND
ACCIDENT REPORTS, LOSS PREVENTION BRIEFINGS
AND CASE STUDIES PUBLISHED IN 2023

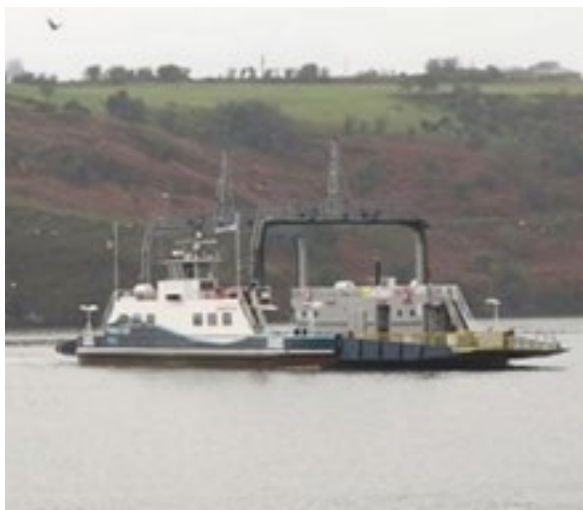
The return fuel lines on the main engines on the vessel were seen to be fixed using three distinct methods. The original fixing by the manufacturer was by use of spring clips, but other pipes were attached using cable ties or hose (jubilee) clips. The repair to the fuel line on the morning of the incident was made by fitting a hose clip. This may have contributed to return fuel line failure.

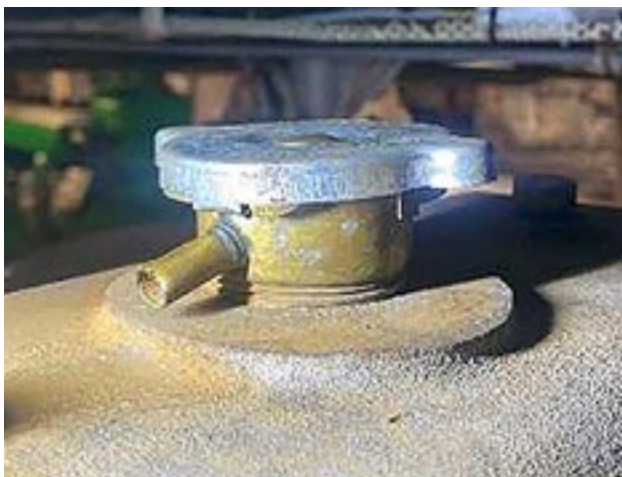
The propulsion engine of a small coastal passenger vessel began to overheat while on passage to its next port. One of the vessel's engineers stopped the engine and cleaned the sea water strainer, which had become clogged with debris and was restricting the flow of cooling water to the engine. The engineer also noticed that the engine's cooling system expansion cap (Figure 1) looked loose; he protected his hand with a rag and attempted to tighten the cap, which suddenly blew off. The engineer responded by instinctively turning his back to the unit but was sprayed with scalding hot water from the engine's pressurised cooling system.

Figure 1: Expansion cap in the fully closed position

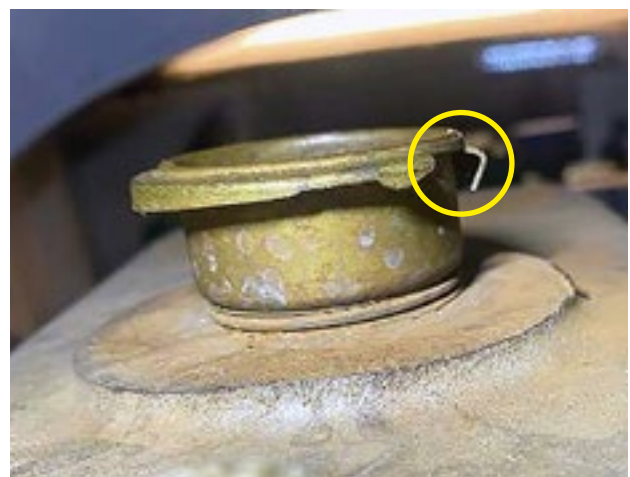
It was later found that the securing lugs for the engine cooling system expansion cap were bent (Figure 2), which had possibly prevented the cap from sealing correctly.

Figure 2: The bent securing lug

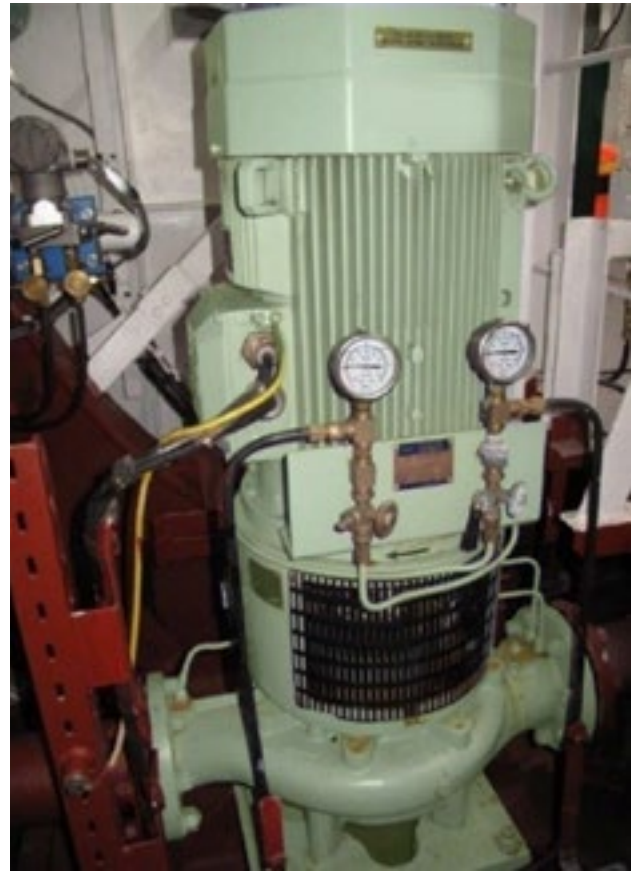
The cooling water had nowhere to go when the valves were closed and there was no flow through the cooling pump, which caused its mechanical seal to gradually overheat and generate smoke.

Figure: The sea water pump

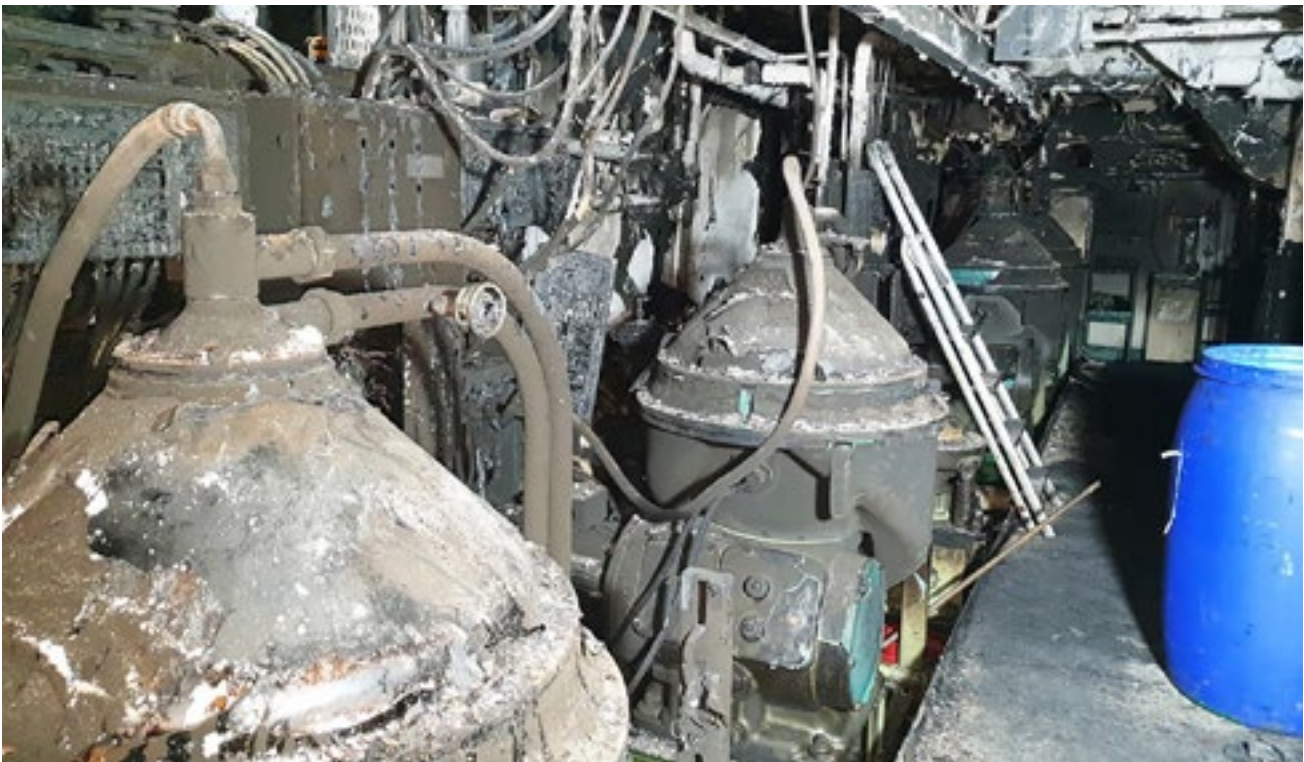
Examination of the equipment indicated that the fire had likely broken out due to gas oil spray emitted from a gas oil purifier system three-way

Figure 1: Fire-damaged fuel purifier room

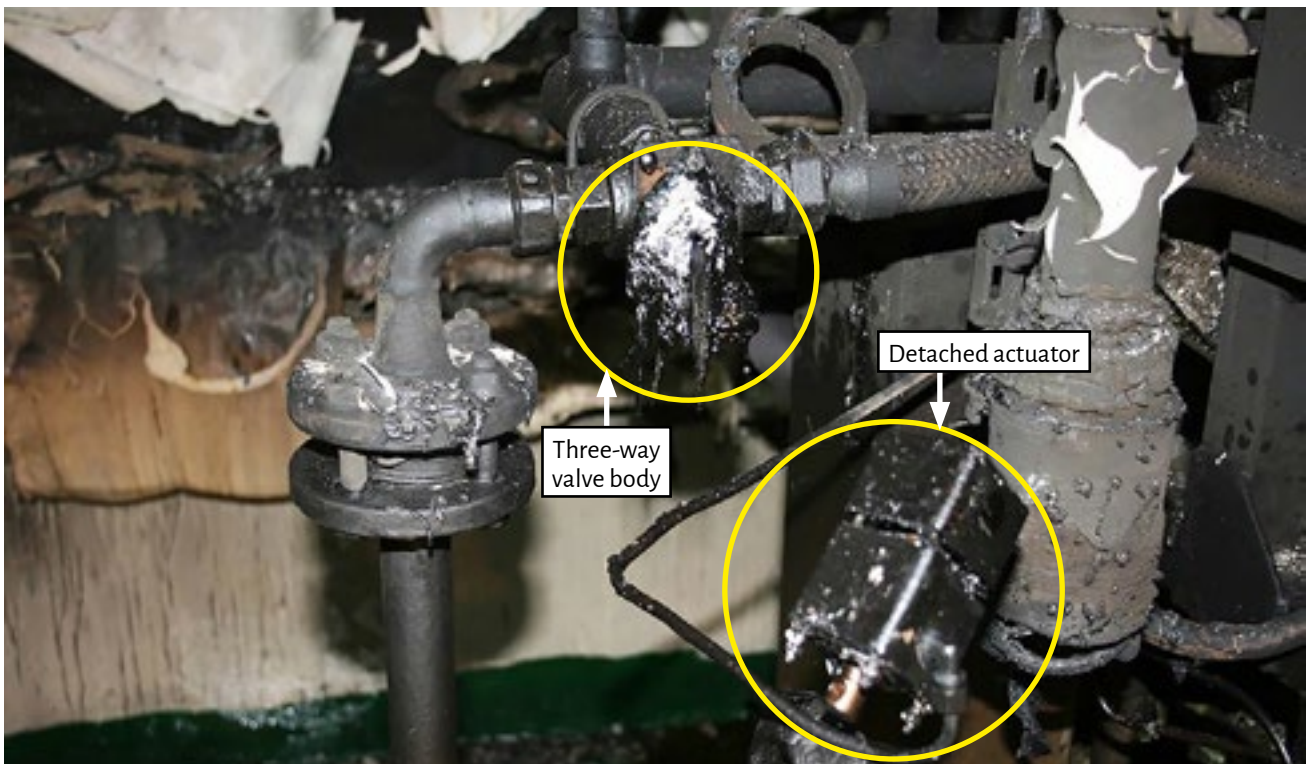
Figure 3: Fire-damaged fuel valve actuator

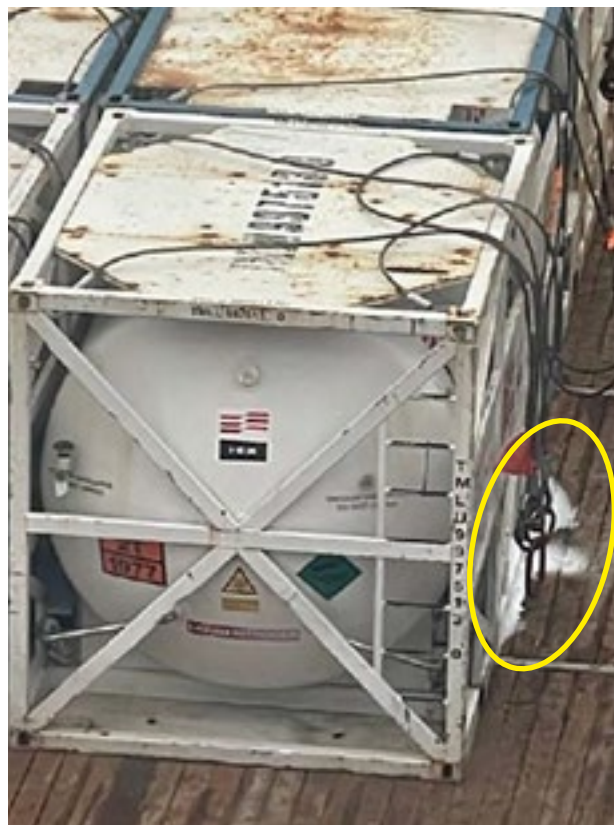
A post-incident inspection found that both the main outlet valve and the bleed valve on the nitrogen container, which was not locked, were slightly open and had allowed the nitrogen to leak out through the open bleed valve (Figure 3).

Figure 1: Icing of deck beneath nitrogen tank container

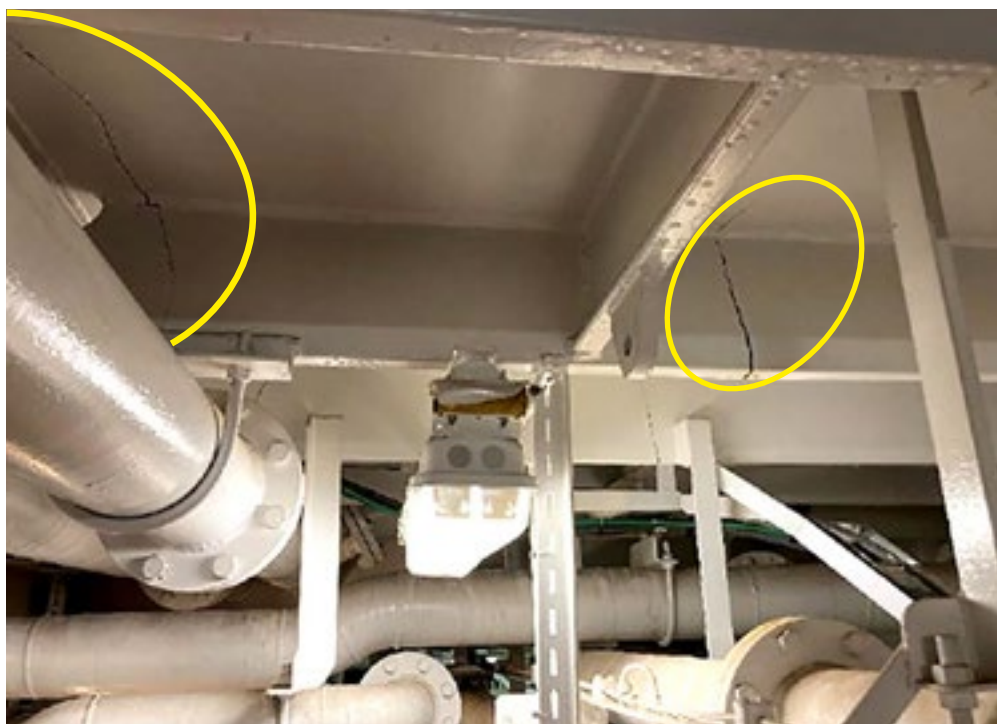
Figure 2: Cracks in the supporting steelwork

1. **Risk** → The carriage of cryogenic gases requires careful consideration of the risks they pose to materials. In this case the simplest hazard control, which was that of keeping the nitrogen in the tank designed to contain it, failed because the valves were unsecured and vulnerable to being knocked open.
2. **Action** → Once the crew had spotted the leak they made the right decision not to go dashing into areas where the atmosphere could be unsafe. Instead, they properly considered the risks before taking action.

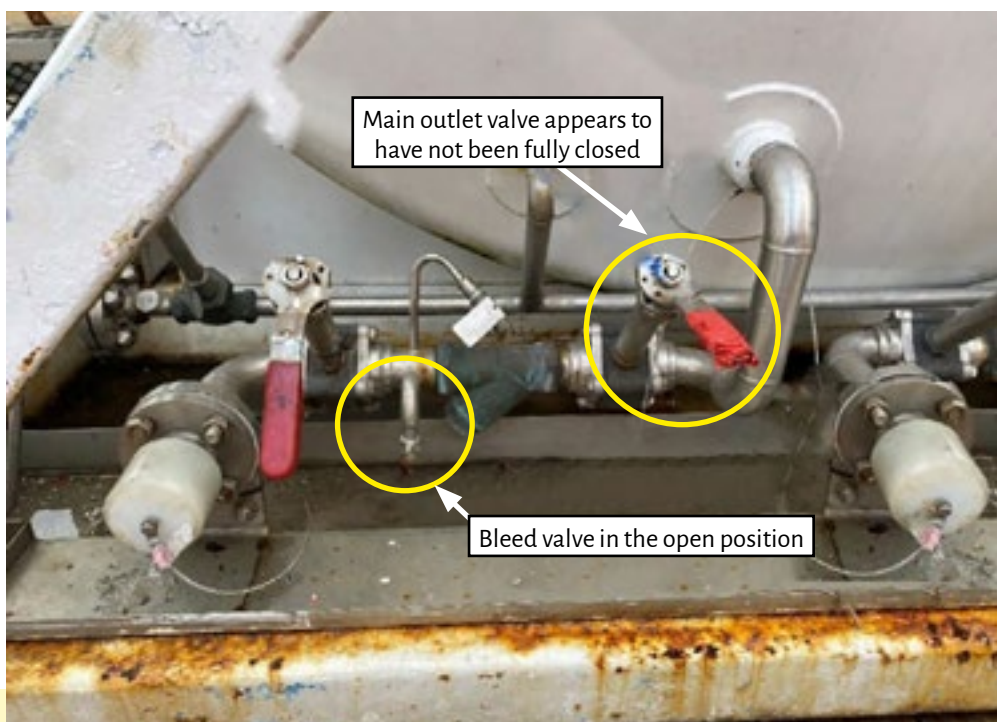
Figure 3: Tank outlet valves

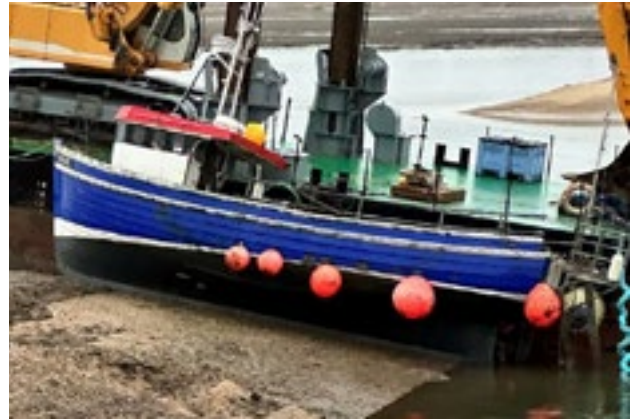
The wooden hull was fastened with nails, some of which the owner had identified in recent years as rusted below the waterline; these had been marked up and replaced when the vessel was lifted out of the water during its repair periods, although this had not taken place within the previous 12 months. The sunken vessel was eventually raised and the source of the leak was found to be failure of its hull due to a rusted and badly corroded nail.

Figure: The potting vessel

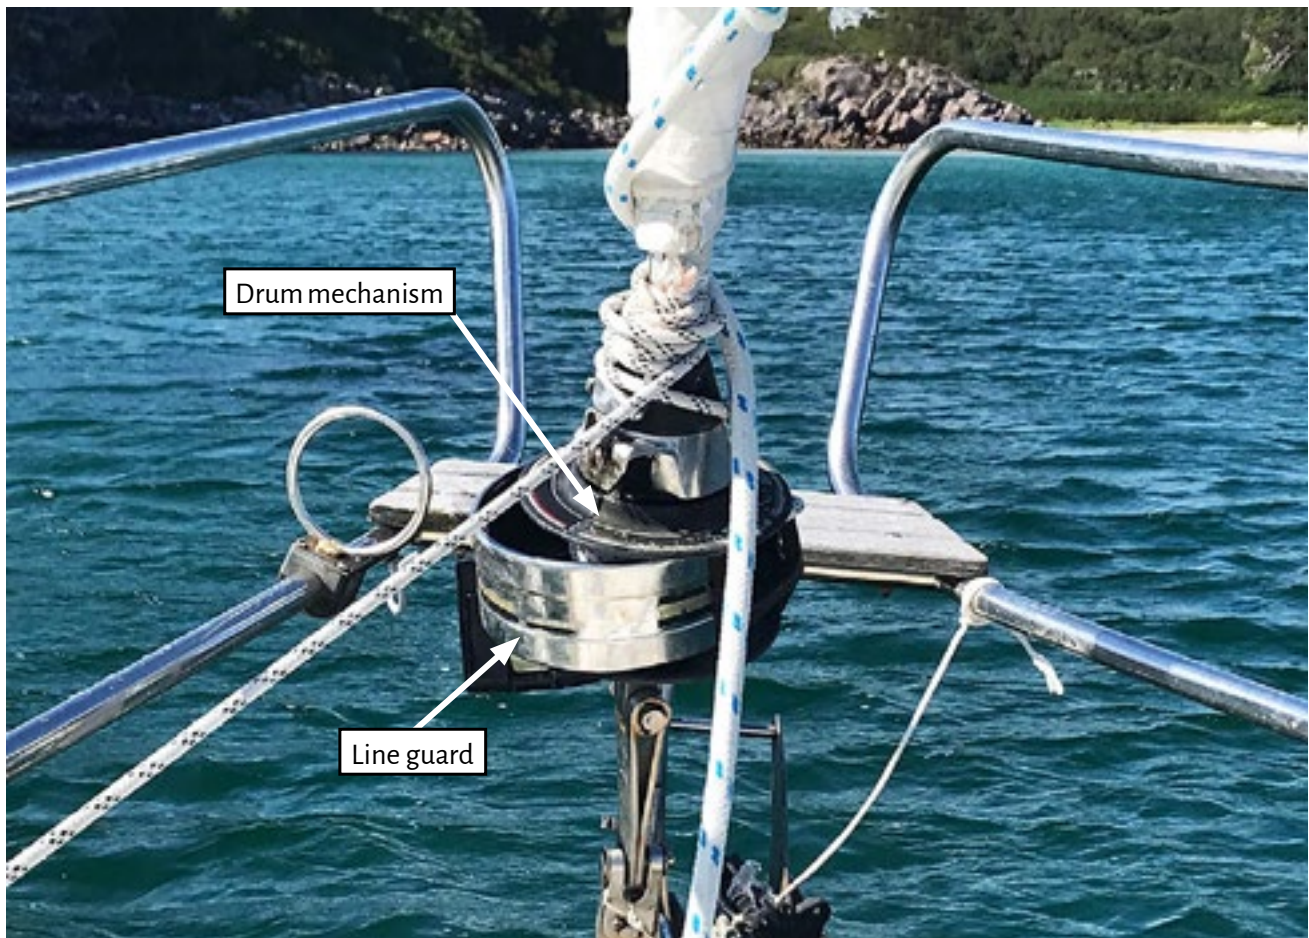
Figure: Defective furling gear with a gap between the line guard and the drum

1. **Maintain** → It can be tempting to ignore defects and make the most of precious holiday time. However, reporting problems to the charterer at the earliest opportunity can save everyone a deal of pain and heartache. Some repairs will be quick and allow a speedy return to the holiday, others may take much longer; the impact of avoidable injuries will last a lifetime. Be safe and get it fixed.
2. **Qualified** → The beauty of the remote Western Isles is counterbalanced by the fact that they are difficult to access and help is not always on hand. All crew must know how to raise a distress message and be able to clearly communicate the vessel location and nature of the problem to the coastguard.

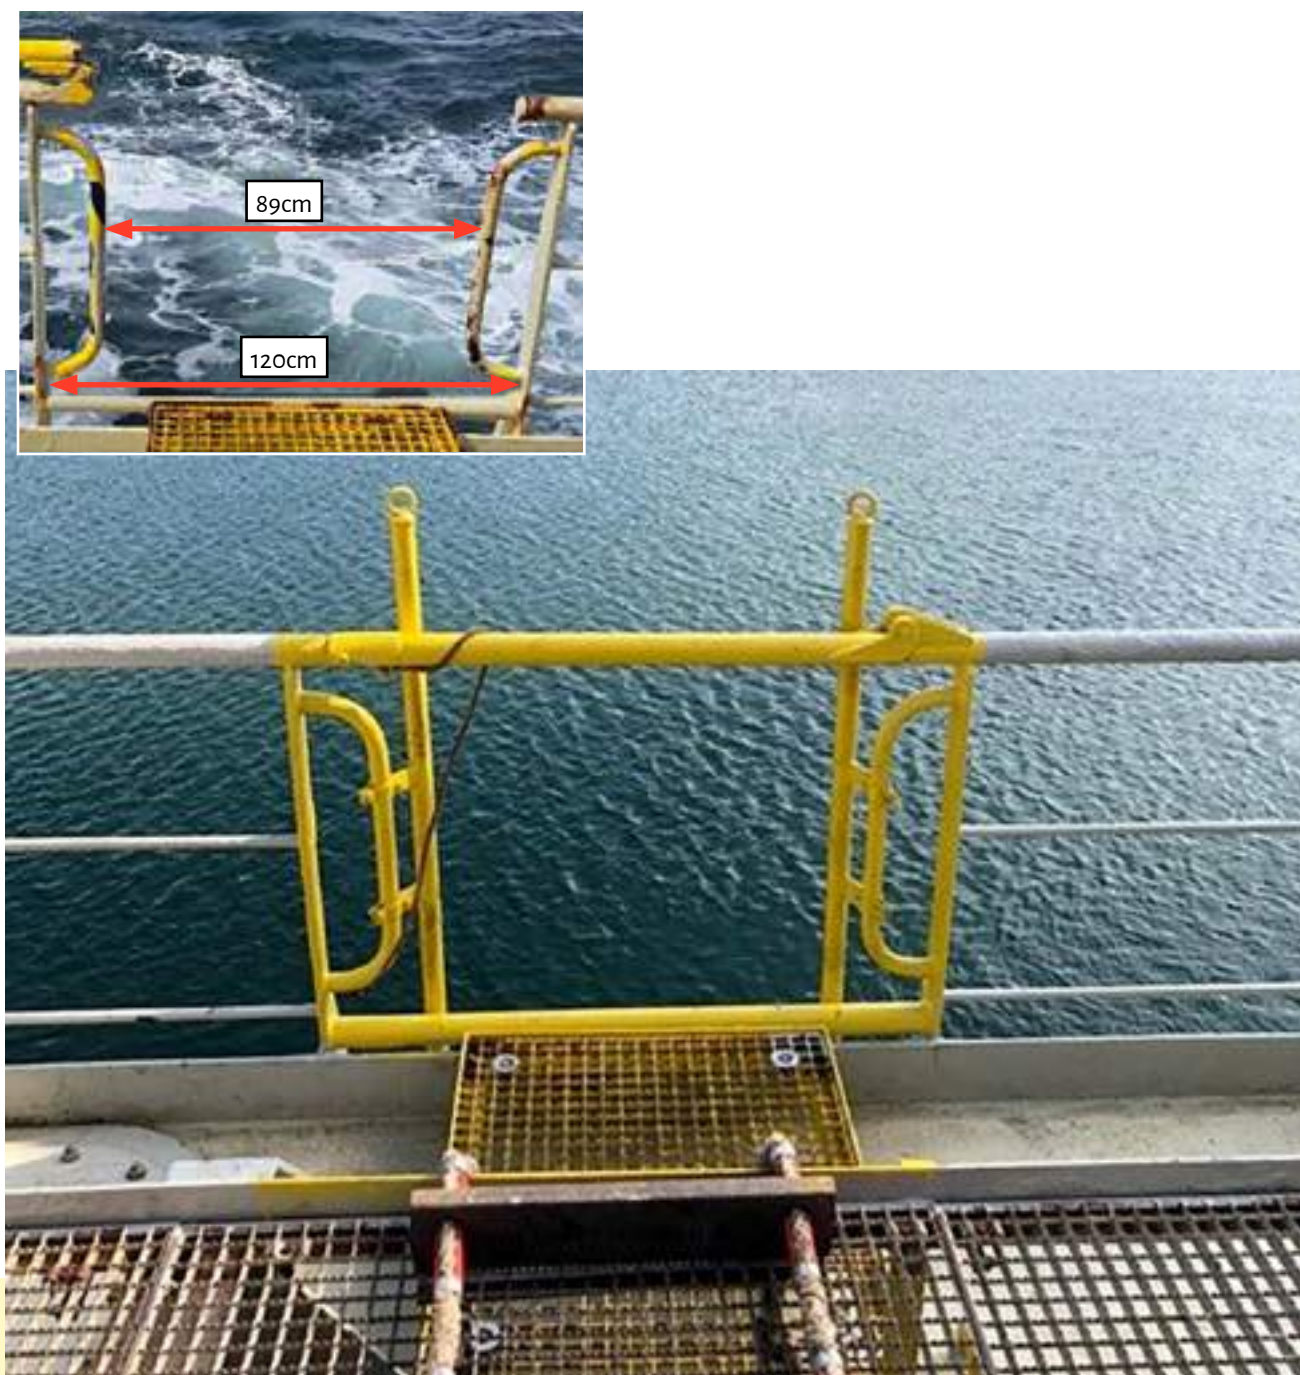
Figure 2: Guard rail gate at the top of the pilot ladder before (inset) and after modification to make it compliant

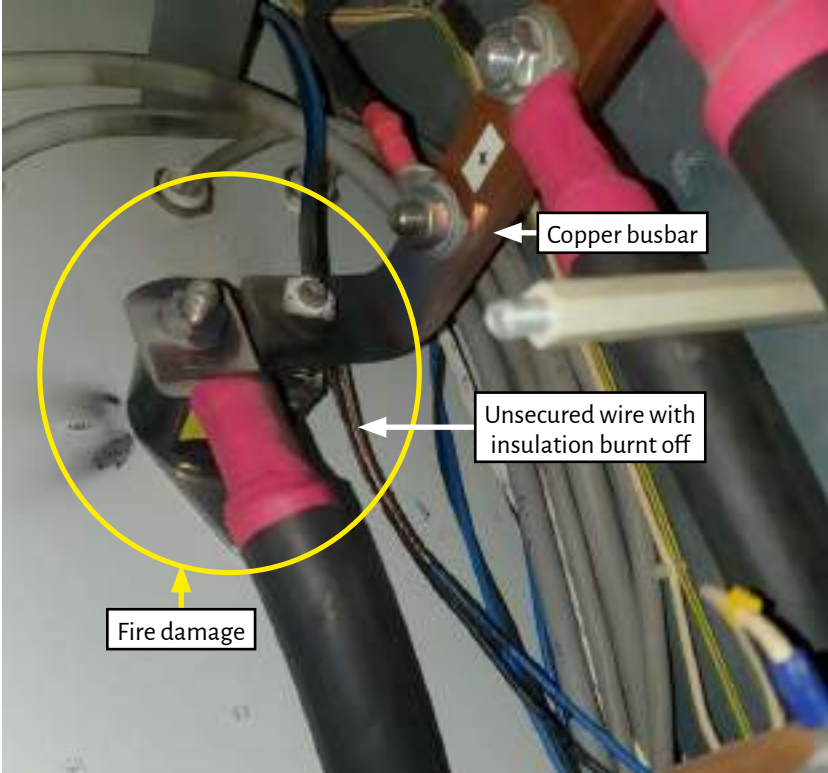
Figure 1: The burnt wire

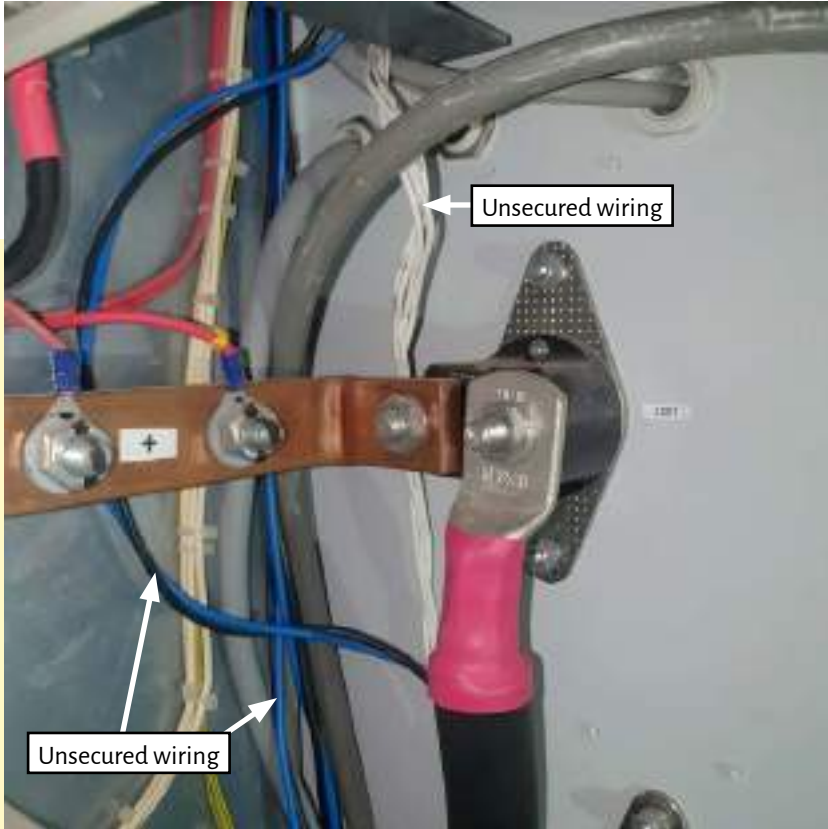
Figure 2: Unsecured wiring in the electrical control panel

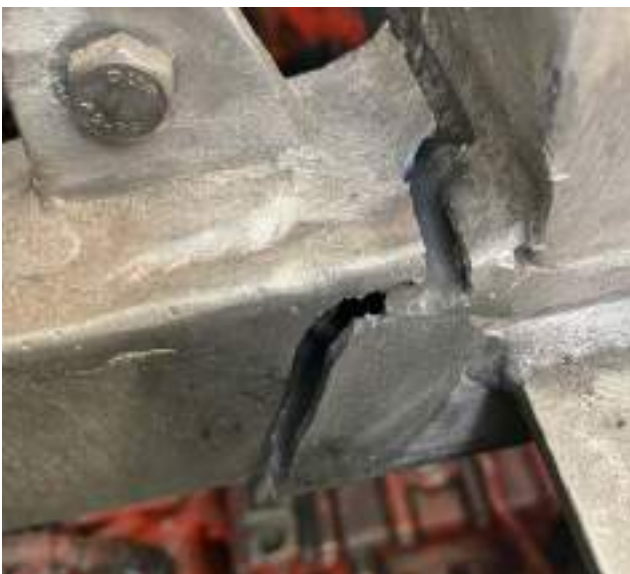
Figure 3: Fractured engine support

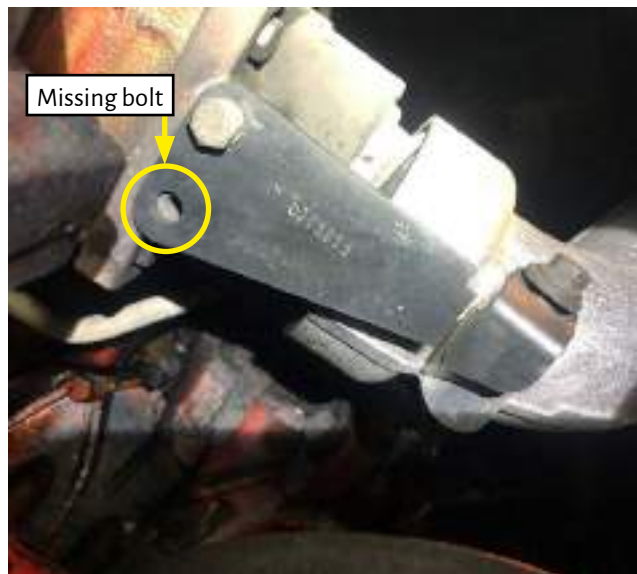
Figure 4: Fractured bracket and missing bolt

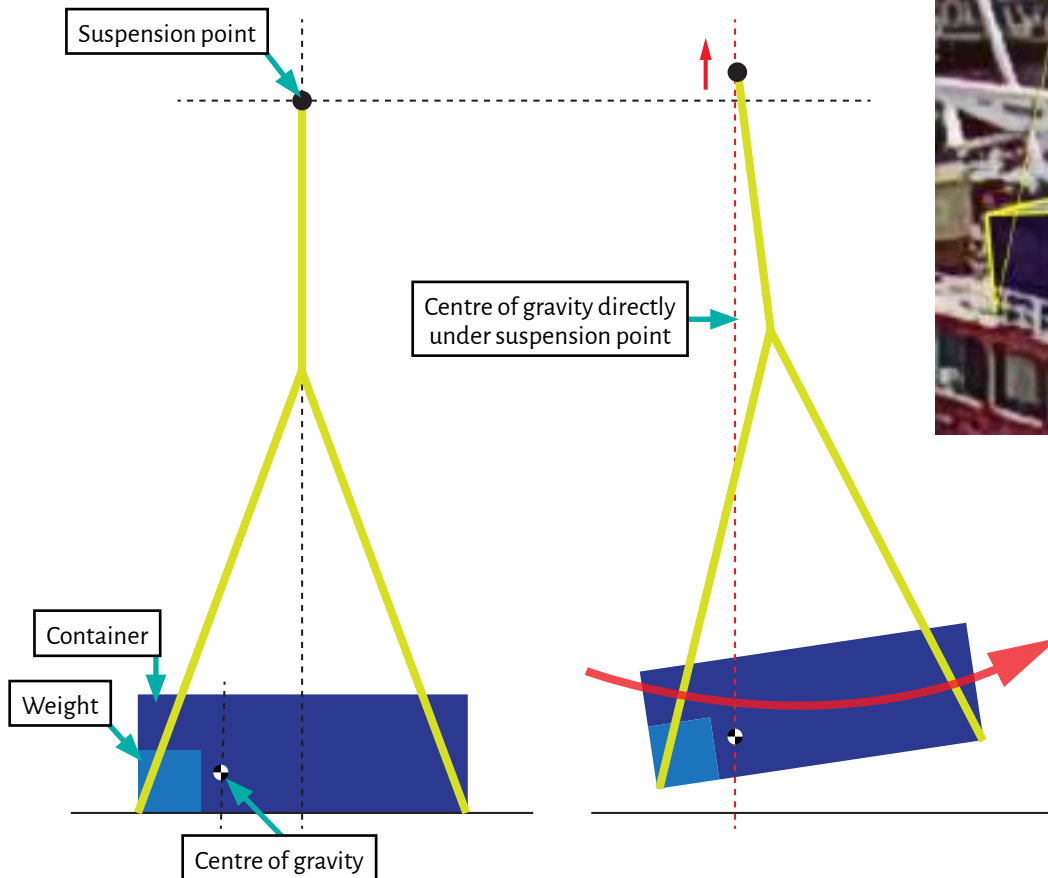
Figure 2: Effect of unbalanced load on lifting operation and (inset) CCTV still, showing container position following lift

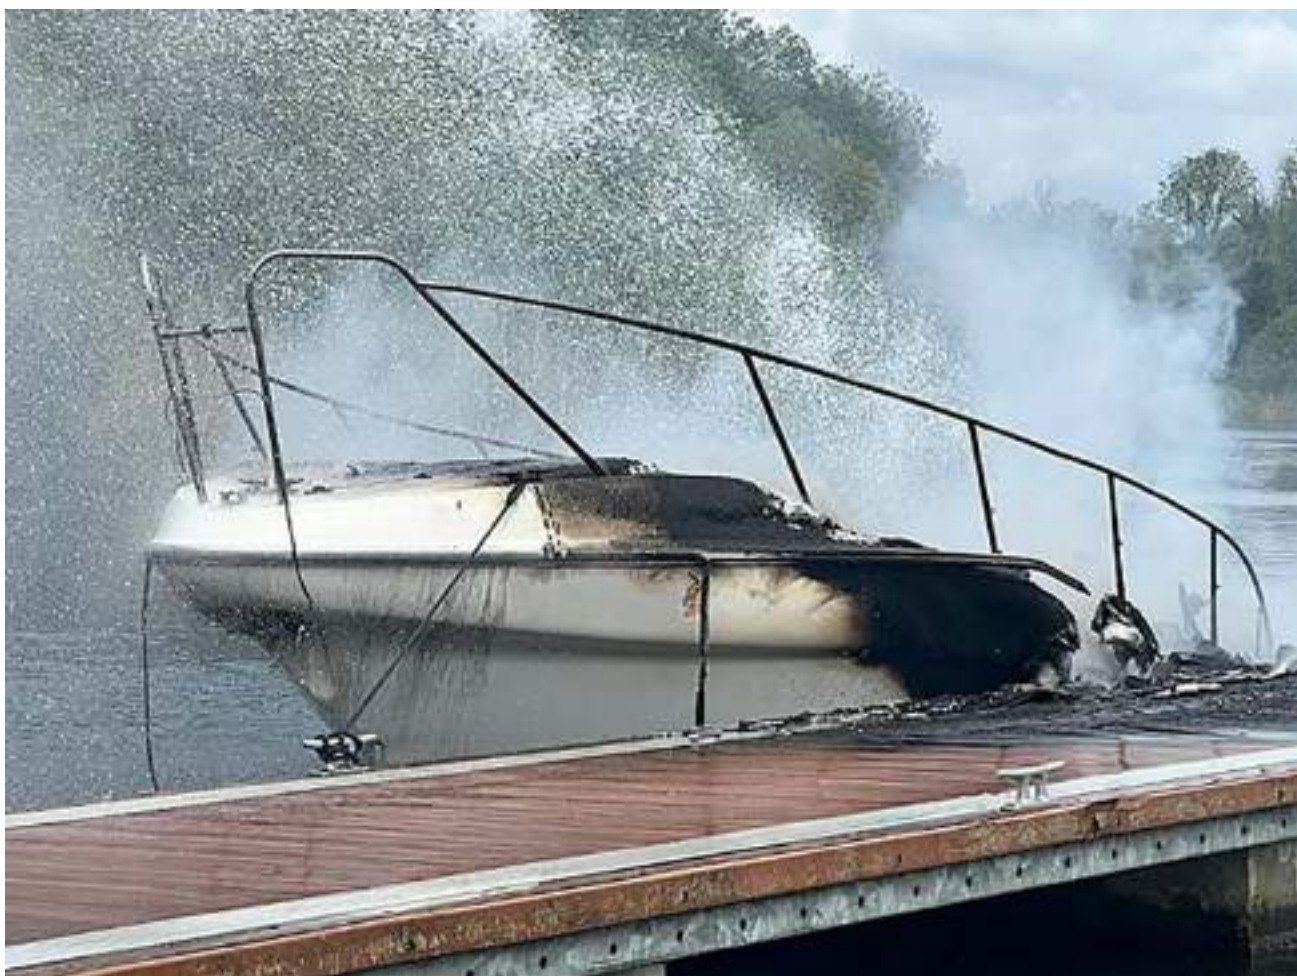
Figure 2: The burned-out motor yacht just before it sank
