C I V I L A E R O N A U T I C S B O A R D

ACCIDENT INVESTIGATION REPORT

PAGE AIRWAYS, INC. - WASHINGTON - APRIL 27, 1945

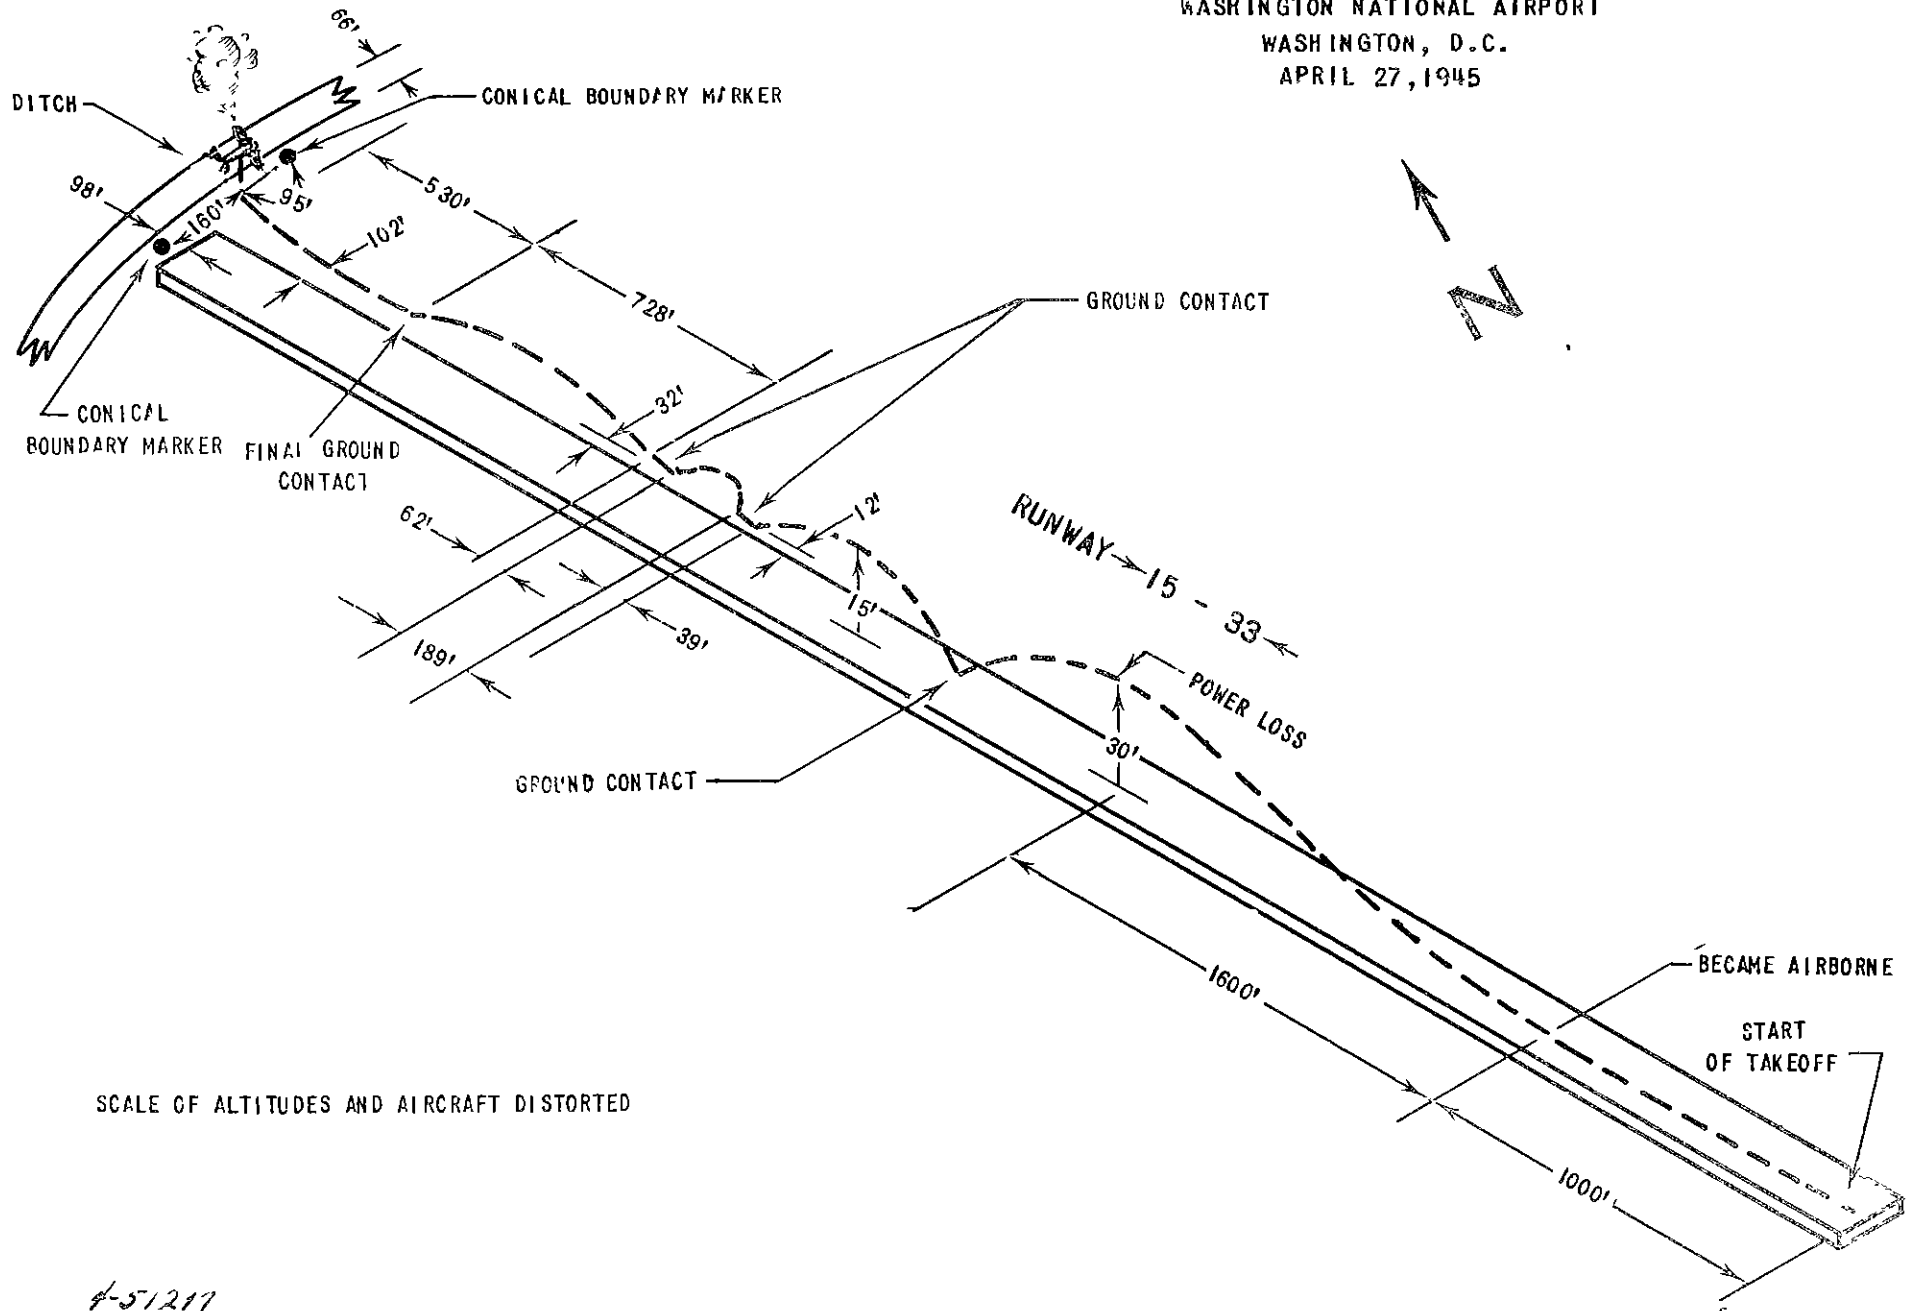
PAGE AIRWAYS ACCIDENT
 LOCKHEED "LODESTAR" NC 33328
 WASHINGTON NATIONAL AIRPORT
 WASHINGTON, D.C.
 APRIL 27, 1945

Just after take-off a loss of power occurred and the captain landed straight ahead. The aircraft bounced three times before it maintained ground contact and then rolled into a drainage ditch near the upwind end of the runway where it burned.

Take-off was started on Runway 33 and the aircraft became airborne after traveling approximately 1,000 feet. Upon gaining an altitude of 10 or 15 feet the captain ordered "gear up" and the copilot complied. A few seconds later, when the gear was up, or nearly up, the captain sensed a power interruption with the aircraft yawing to the left. Concurrently he called out "Single engine", throttled both engines, ordered the landing gear down and lowered the nose of the aircraft slightly. After a few seconds had elapsed the landing gear was fully down. At the time of throttling the engines the aircraft was approximately one-half way down the 5200-foot runway and was at an altitude of which the most plausible consensus is 30 feet. First contact with the ground was made on the same runway at a speed the pilot estimated as 100 miles per hour. The aircraft bounced to an estimated height of 15 or 20 feet and made contact again on the sodded ground a few feet to the right side of the same runway. From this point on it twice again left the ground for distances of 189 and 728 feet. Brakes were applied intermittently during the second, the third, and the final contact with the ground. At some undetermined point following initial contact the captain applied 20° of flap. Decelerating rapidly after the final contact the aircraft continued to roll to the right of the runway, diverging slightly, for a total distance of about 535 feet. It passed beyond the end of the runway and when an estimated 60 or 70 feet from a large drainage ditch nearly at right angles to the course, the pilot attempted to groundloop to the right. However, the plane turned

only about 20° to the right and rolled into the ditch, left wheel first, at an estimated speed of 10 or 15 m.p.h., about 95 feet to the left of a boundary marker. It rolled down the sloping side turning parallel with the ditch and stopped abruptly at the concrete-lined bottom where it immediately burned.

The drainage ditch previously mentioned is on airport property and is about 66 feet wide and about 15 feet deep with a concrete lined section at the bottom 18 feet wide by 4 feet deep. It is 98 feet from the end of Runway 33 to the near side of this ditch which does not have a raised edge or other distinguishing characteristic. Close to the edge of the ditch are standard colored conical airport boundary markers, placed about 250 feet apart, which definitely mark the limit of the usable area. They are suitably conspicuous but do not warn of the declivity beyond. Although Captain Decker had flown in and out of National Airport on a number of occasions he testified that he was unaware of the existence of this ditch and stated that he could have prevented the accident had he known it was there. This ditch, although beyond the marked limits of the field, constitutes a hazard to an overshooting aircraft and probably contributed to the seriousness of this accident.
