three mile island

**A REPORT TO THE
COMMISSIONERS
AND TO THE
PUBLIC**

**NUCLEAR REGULATORY COMMISSION
SPECIAL INQUIRY GROUP**

VOLUME II Part 2

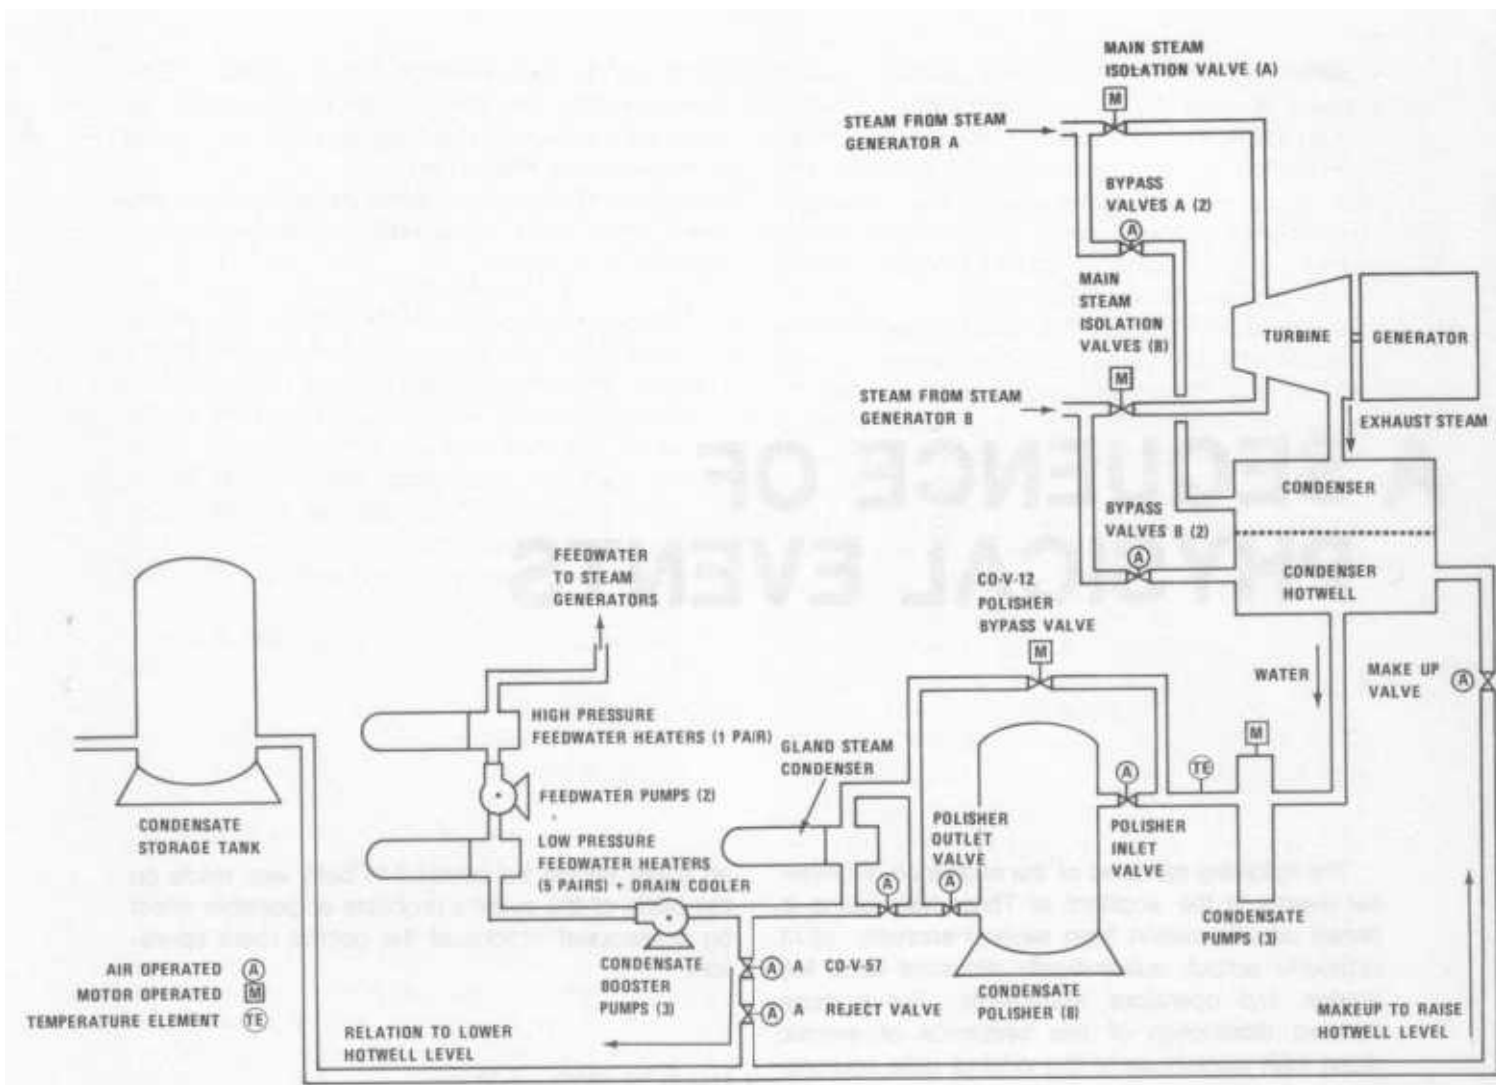
FIGURE II-1. The Condensate and Feedwater System

Under normal conditions, exhaust steam from the turbine is condensed in the condenser. Condensate (water) is pumped by the condensate pumps through the condensate polisher, where it is purified. The pressure is raised by the condensate booster pumps, and the temperature is increased in the low pressure feedwater heaters. The water is then pumped by the feedwater pumps through the high pressure feedwater heaters to the steam generators. The polisher bypass valve can be opened so that water flows directly from the condensate pumps to the condensate booster pumps. When the hotwell level is high, water flows through the reject valve to the condensate storage tank; this allows more water to leave the hotwell than is entering from the condenser. When the hotwell level is low, the makeup valve is opened and water is returned from the condensate water storage tank to the hotwell. The condenser and hotwell are always under vacuum. At the beginning of the accident, the inlet and outlet valves of the condensate polisher accidentally closed. The bypass valve would not open because of a control fault; this probably caused the condensate booster pumps to trip, followed by trip of one condensate pump and both steam generator feed pumps. A severe "water hammer" damaged the controls of valve CO-V57 and the reject valve so that condenser hotwell level could not be controlled.

In the accident at TMI-2, it has not been definitely determined what caused the condensate pump to trip, although it is a reasonable inference that the operations on the polisher were somehow involved. It has been established that condensate pump 1A tripped and that both main feedwater pumps then tripped almost simultaneously. Approximately 1 second later, the turbine and generator tripped.

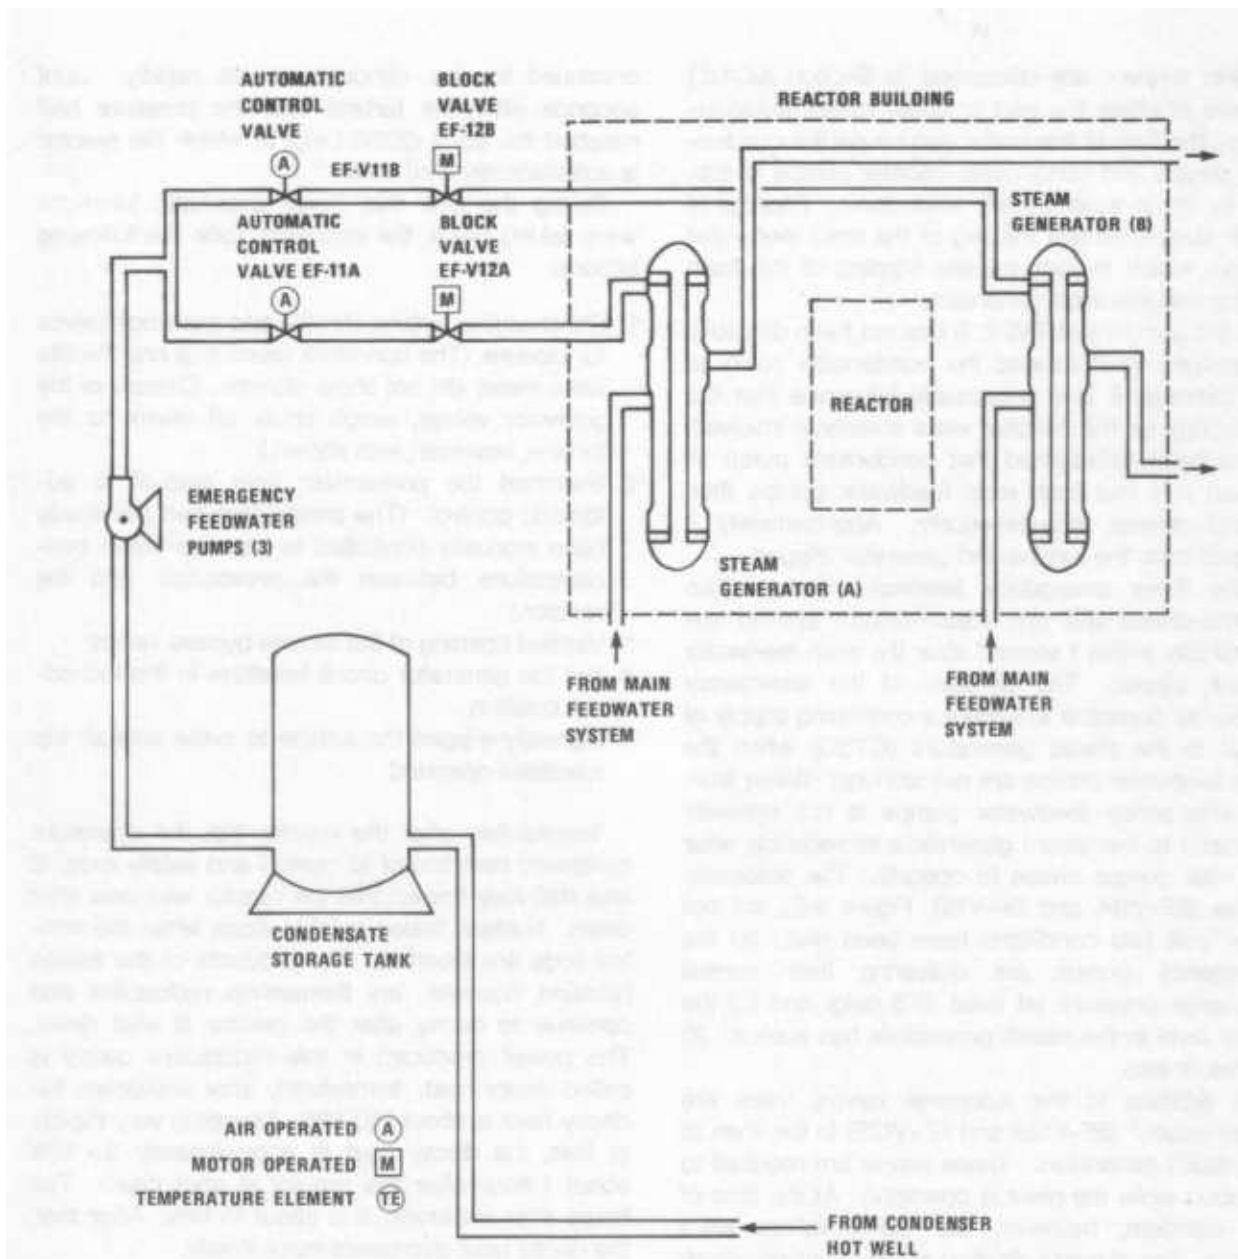
FIGURE 11-2. The Emergency Feedwater System

Three emergency feedwater pumps (two electric, one steam driven) are started automatically on loss of the main feedwater pumps (Figure II-1). The emergency feedwater pumps take suction from the condensate storage tank; in an emergency, they can also take suction directly from river water. The automatic control valves will open (a) when the discharge pressure of the emergency feedwater pumps is high enough and (b) when the water level in the steam generators falls to 30 inches or less. Until both conditions are satisfied, the control valves remain closed. The block valves should have been open at all times; however, at the time of the accident these valves were closed. When the conditions were met, the control valves slowly opened, but no water was admitted to the steam generators because the block valves were still closed. About 8 minutes after the start of the accident, the operator discovered that the block valves were closed, and opened them. This admitted water to the steam generators.

The block valves can be operated by switches in the control room, by switches in the auxiliary building, and manually at the valves. It is not known from **which point nor when the valves were closed.**

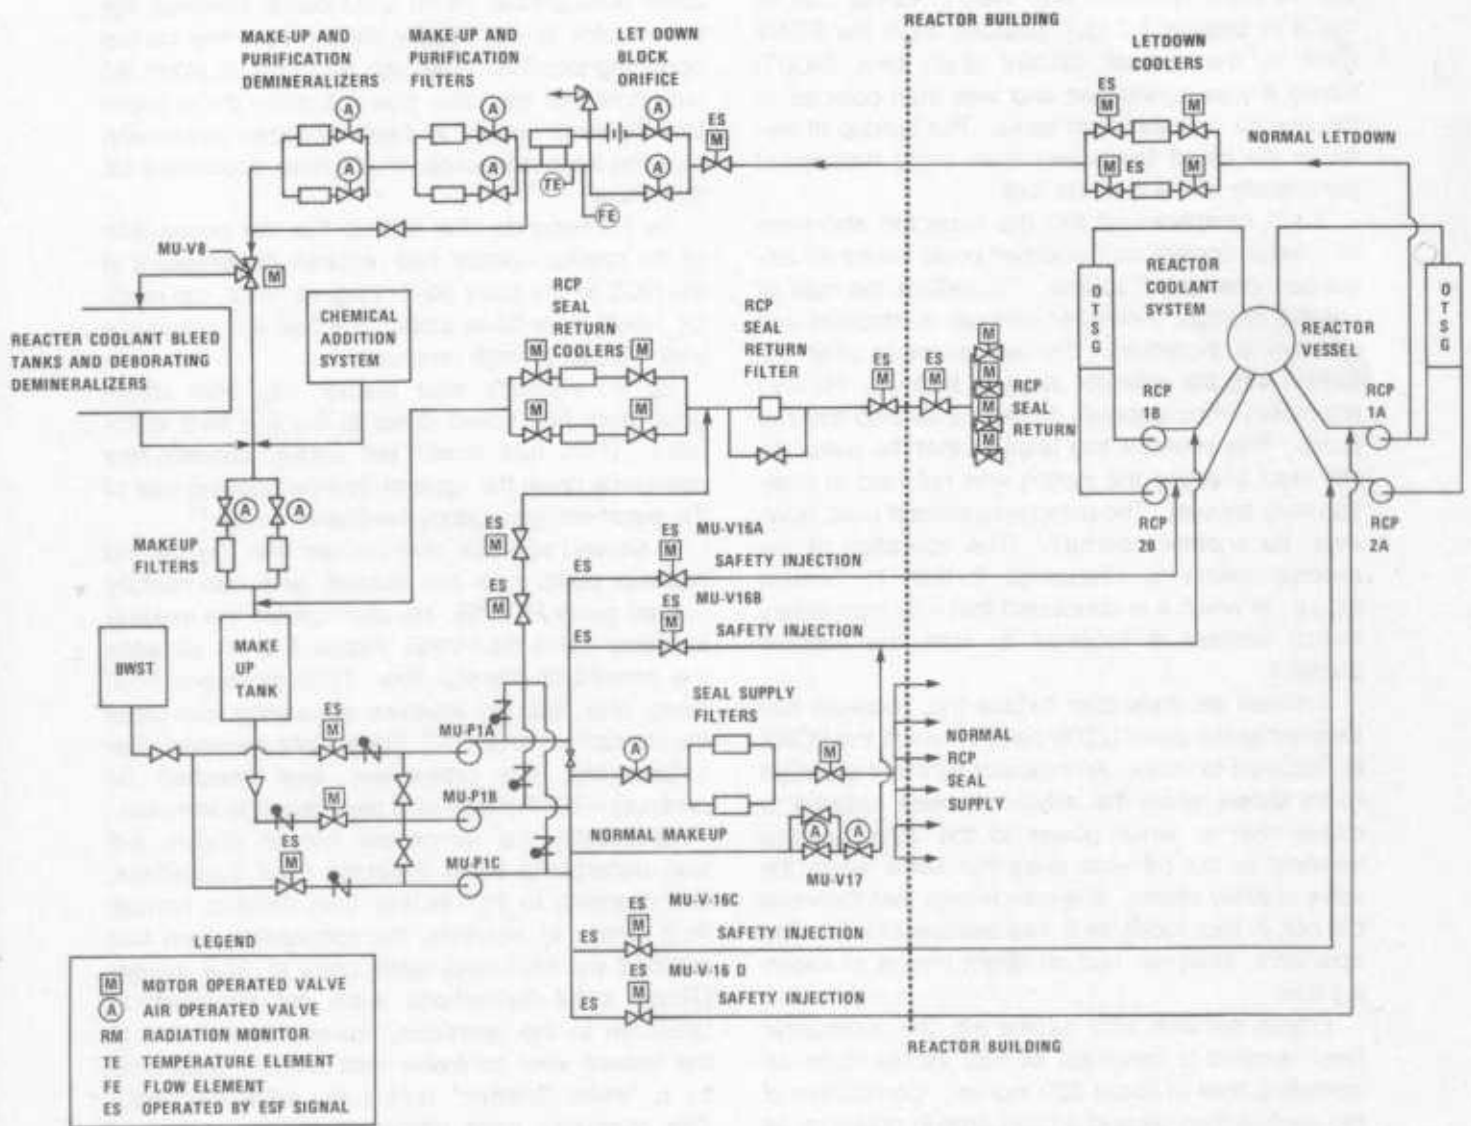
FIGURE 11-3. The Makeup and Letdown System

During normal operation, water is removed from the reactor coolant system (RCS) near the suction of the reactor coolant pump (RCP-1A). The water removed is purified and cooled and can be sent either to the reactor coolant bleed tanks or to the makeup tank. At least one makeup pump is always operating; this supplies water to the reactor coolant pump seals. A small amount of the seal water leaks out and is returned to the makeup tank through the seal return system; the remainder enters the RCS. Any additional water required to maintain the correct inventory in the RCS is regulated by valve MU-V17 and enters the discharge line of RCP-1A. In the high pressure injection mode (when the engineered safeguards are actuated), two makeup pumps (normally 1A and 1C) take water directly from the borated water storage tank, and pump through valves MU-V16A, 16B, and 16D—which are wide open—to all four RCS cold legs. Letdown is stopped during engineered safeguards operation.

sion of plant operation with leaking valves can be found in Section II.C.1.b.] Leakage from the PORV went to the reactor coolant drain tank (RCDT) where it was condensed and was then pumped to the reactor coolant bleed tanks. The buildup of water in the bleed tanks was then being transferred periodically to the makeup tank.

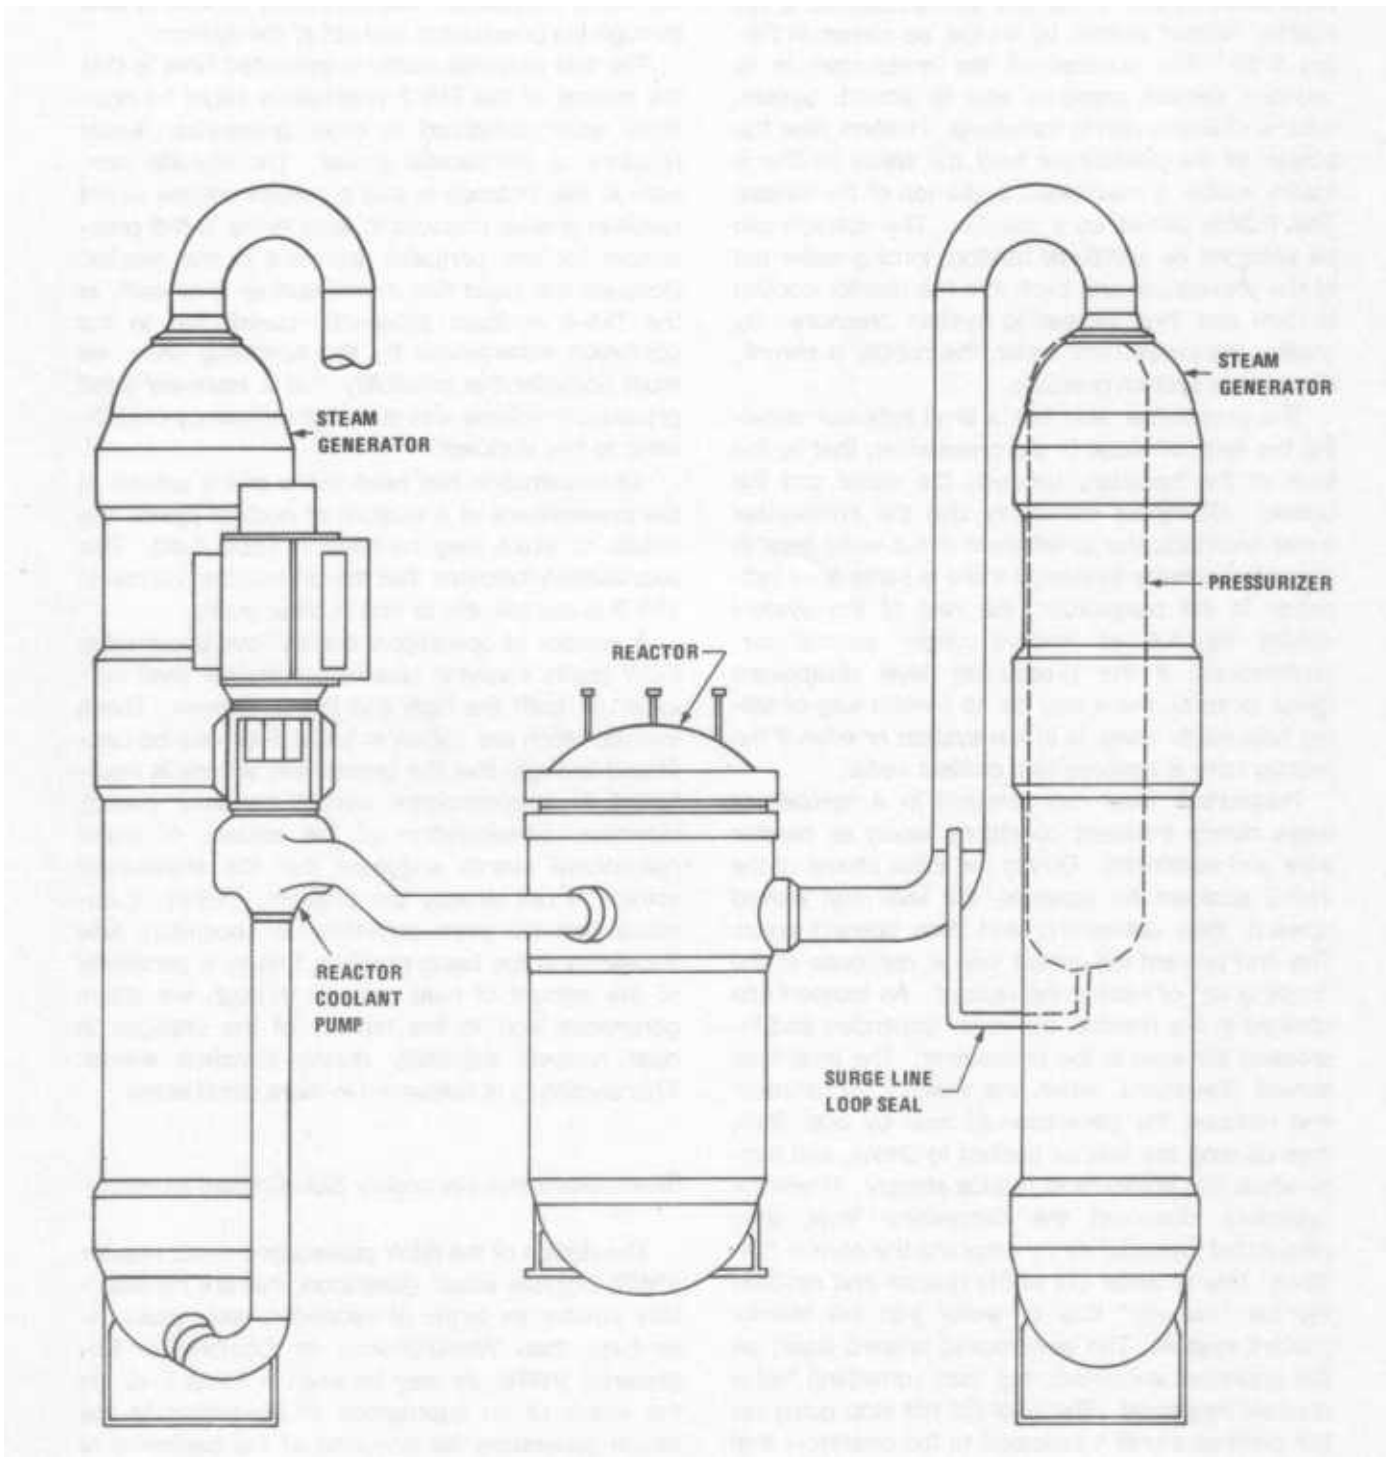
FIGURE 11-22. Pressurizer Surge Line Loop Seal Arrangement

The design of the B&W pressurized water reactor (PWR) includes steam generators that are considerably smaller (in terms of secondary side water inventory) than Westinghouse or Combustion Engineering PWRs, as may be seen in Table 11-42. In the event of an interruption of feedwater to the steam generators, as occurred at the beginning of the TMI-2 accident, the smaller size in the B&W design results in a more rapid drying out of the secondary side; this then results in a more rapid
