RAILWAY ACCIDENT

Report on the Derailment that occurred on 23rd November 1983 at Paddington Station

IN THE
WESTERN REGION
OF BRITISH RAILWAYS

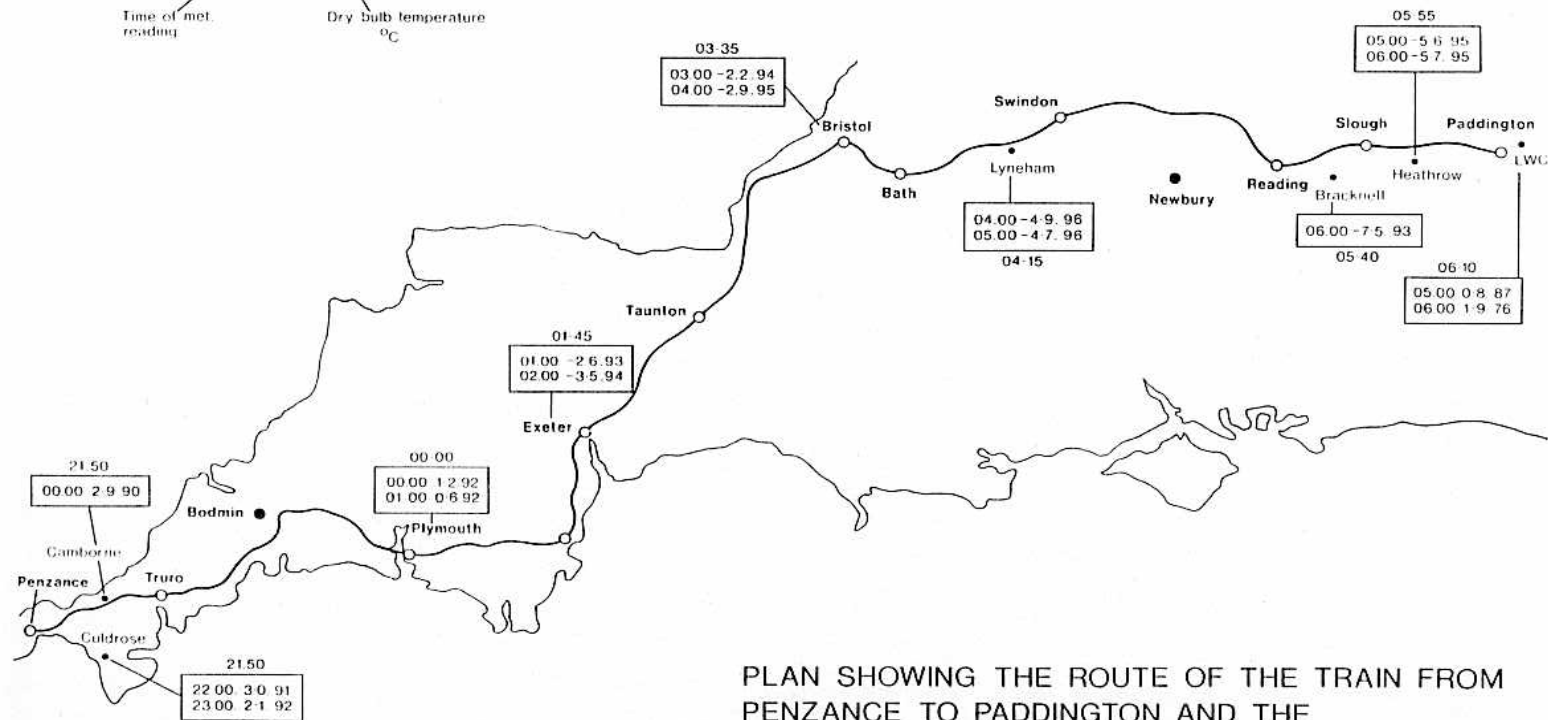
Along the route of the train the weather had become progressively colder during the night of 22/23 November. At the time the train left Penzance, the air temperature was about 3°C; at Plymouth it had dropped to just above freezing; it was about minus 3°C at Exeter, and only just above this at Bristol. From Bristol to Reading it became colder, the temperature dropping to about minus 5°C at Swindon with freezing fog from Chippenham onwards. The fog cleared at Twyford and conditions approaching Paddington were clear with good visibility although it was still dark. The relative humidity increased from about 90% at Penzance to between 93% and 95% all the way from Taunton to Paddington. Details are shown in Figure 1 at the back of the Report.

PLAN SHOWING THE ROUTE OF THE TRAIN FROM PENZANCE TO PADDINGTON AND THE METEOROLOGICAL CONDITIONS

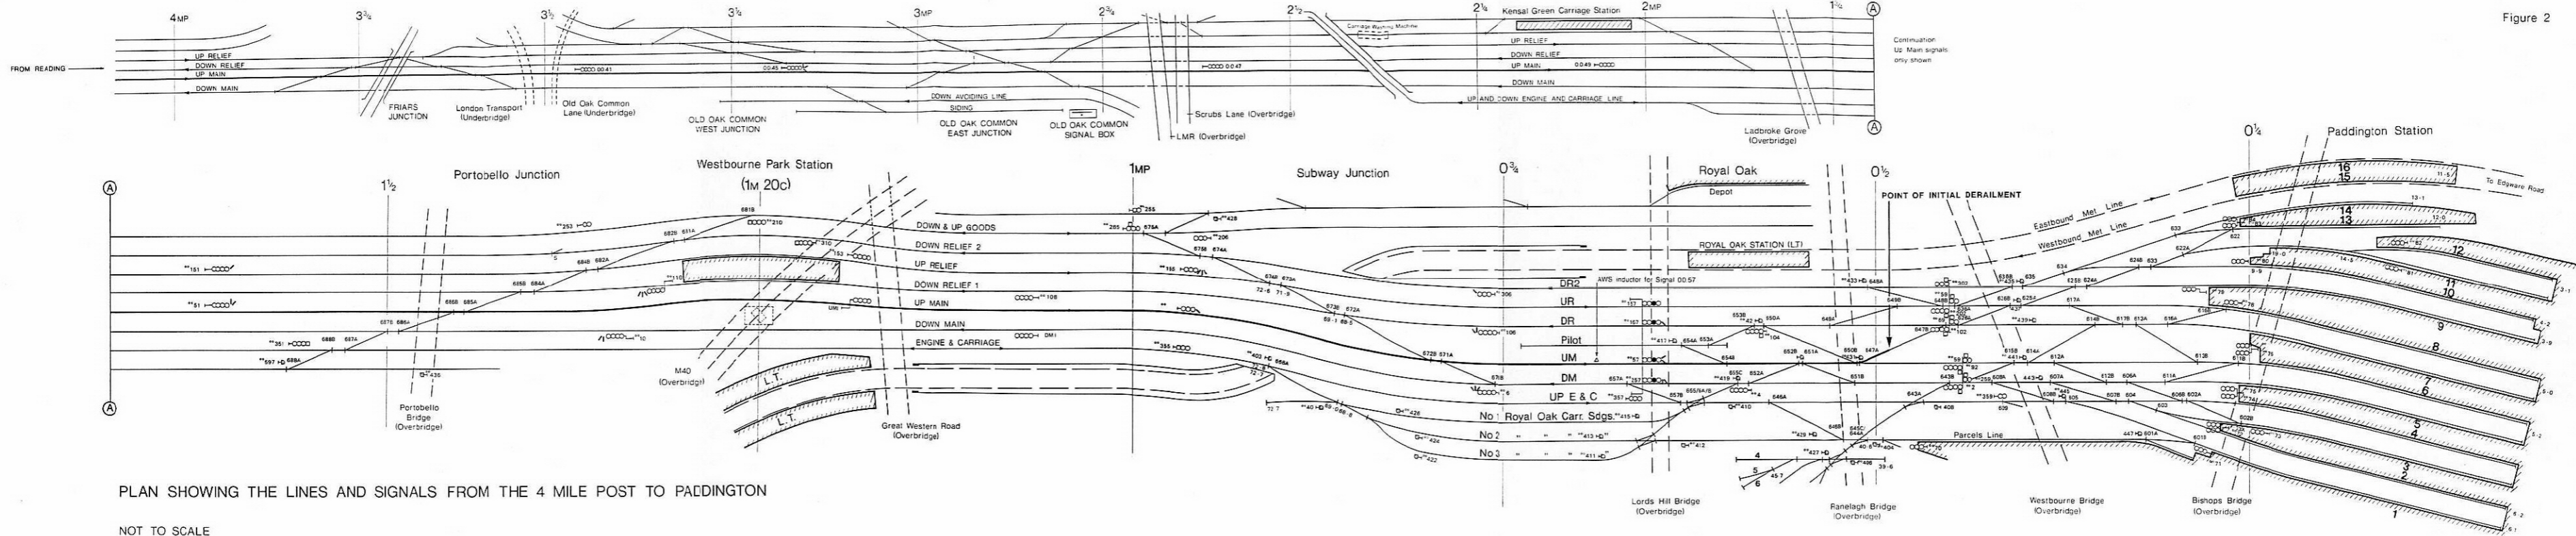
Figure 2

6. Diagrams showing the main features of the line and the signalling, together with the position of the train after the derailment, are shown in Figs 2 and 3 at the back of the Report.

PLAN SHOWING THE LINES AND SIGNALS FROM THE 4 MILE POST TO PADDINGTON

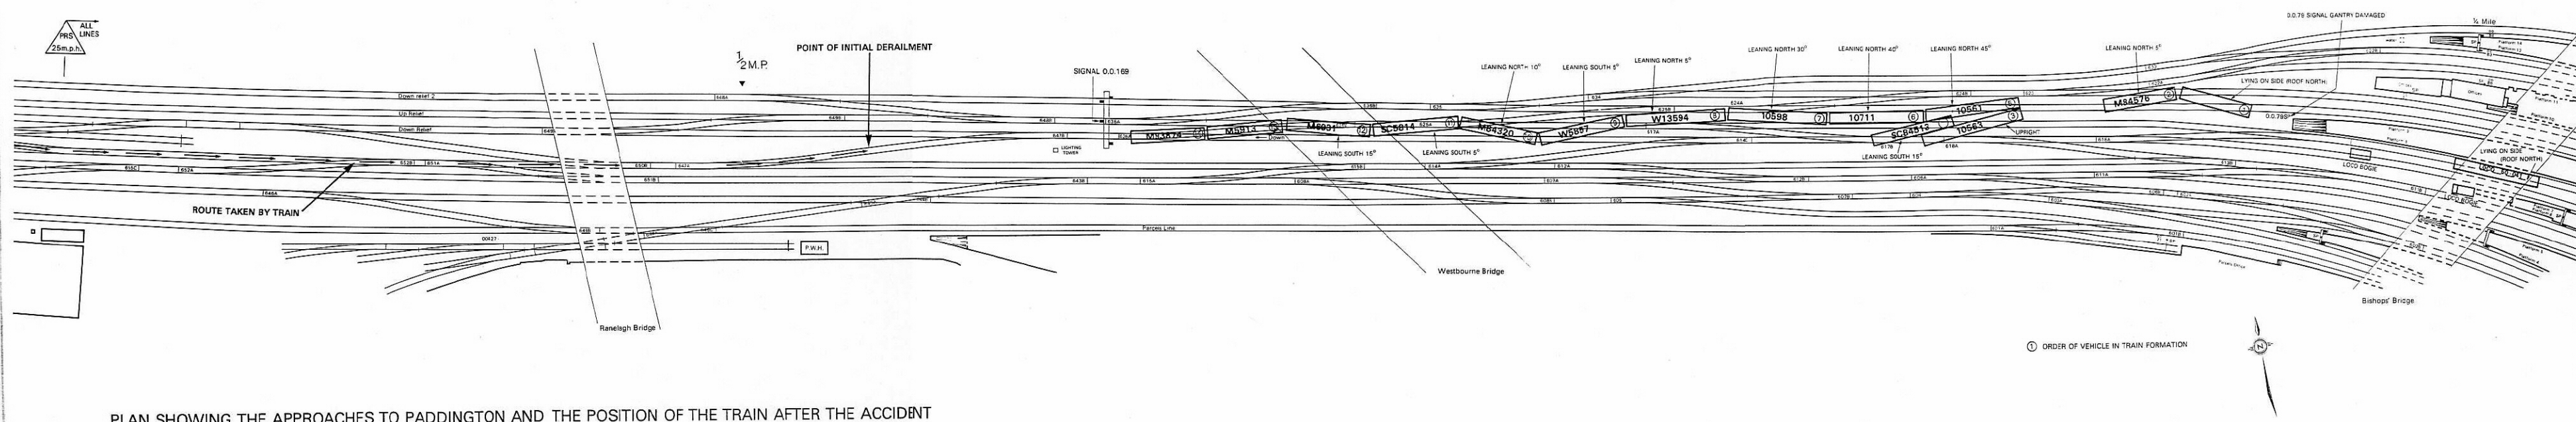
Figure 3

The locomotive was the first to become derailed and, after running thus for some distance, it became separated from the train, overturned on to its left side, and came to rest on the rails of No 8 Platform line under Bishops Bridge having run derailed for some 400 metres. Behind it, the first 12 of the 14 vehicles were completely derailed, some on their sides or leaning over, one axle of the 13th was derailed, and the 14th remained on the rails.

PLAN SHOWING THE APPROACHES TO PADDINGTON AND THE POSITION OF THE TRAIN AFTER THE ACCIDENT

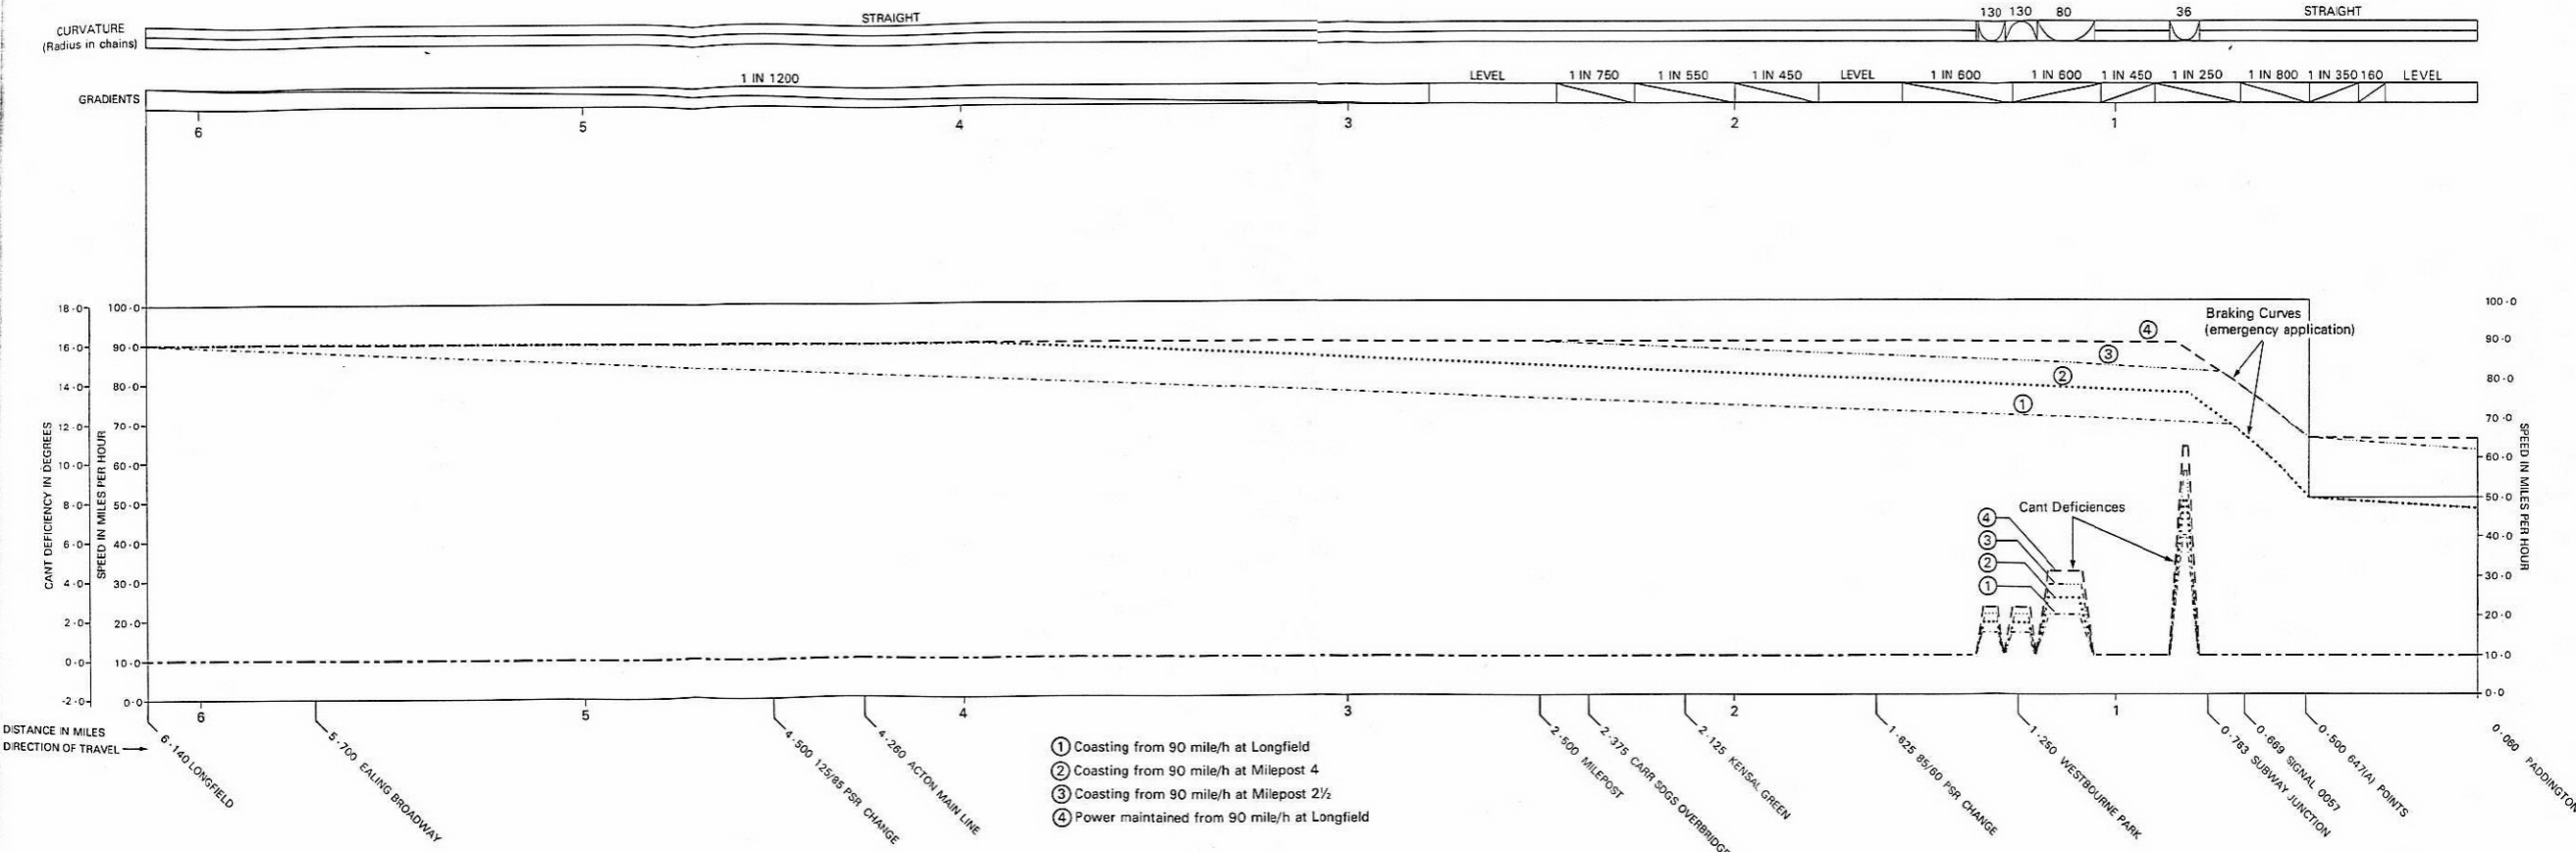
89. The graphs in Figure 4, presented in evidence by Mr McLoughlin, show speed profiles between Longfield Avenue and the point of derailment. They vary from full power applied to coasting throughout. Superimposed on the speed profiles are braking curves based on speeds through 647 points of 65 mile/h, the probable actual speed, and 50 mile/h, the minimum speed for a derailment to have occurred. They also show corresponding cant deficiencies through curves at Westbourne Park and Subway Junction. The permitted speed through the Subway Junction curve is 60 mile/h, and at this speed the cant deficiency is 4.5° and the rate of change of cant deficiency is 55 mm/s. This is close to the upper limits set by BR for passenger comfort. If the train had coasted, without any brake application, from a speed of 90 mile/h at Longfield Avenue, its speed at Subway Junction would have been approximately 68 mile/h. This would have produced a cant deficiency of 6° , with a rate of change of 82 mm/s. This would have been noticeable to passengers but unlikely to create the effects noted by Guard Tutton. If, however, the speed had been 80 mile/h, the corresponding figures would have been 9° and 147 mm/s (or at 85 mile/h, 10° and 170 mm/s) and these values would certainly be sufficient to inconvenience standing passengers, and even to bring crockery off a shelf.

COMPUTER SIMULATION OF TRAIN SPEEDS AND BRAKING - LONGFIELD AVENUE TO THE POINT OF DERAILMENT
