The Public Inquiry into the Piper Alpha Disaster

The Hon Lord Cullen

VOLUME ONE

Presented to Parliament
by the Secretary of State for Energy
by Command of Her Majesty
November 1990

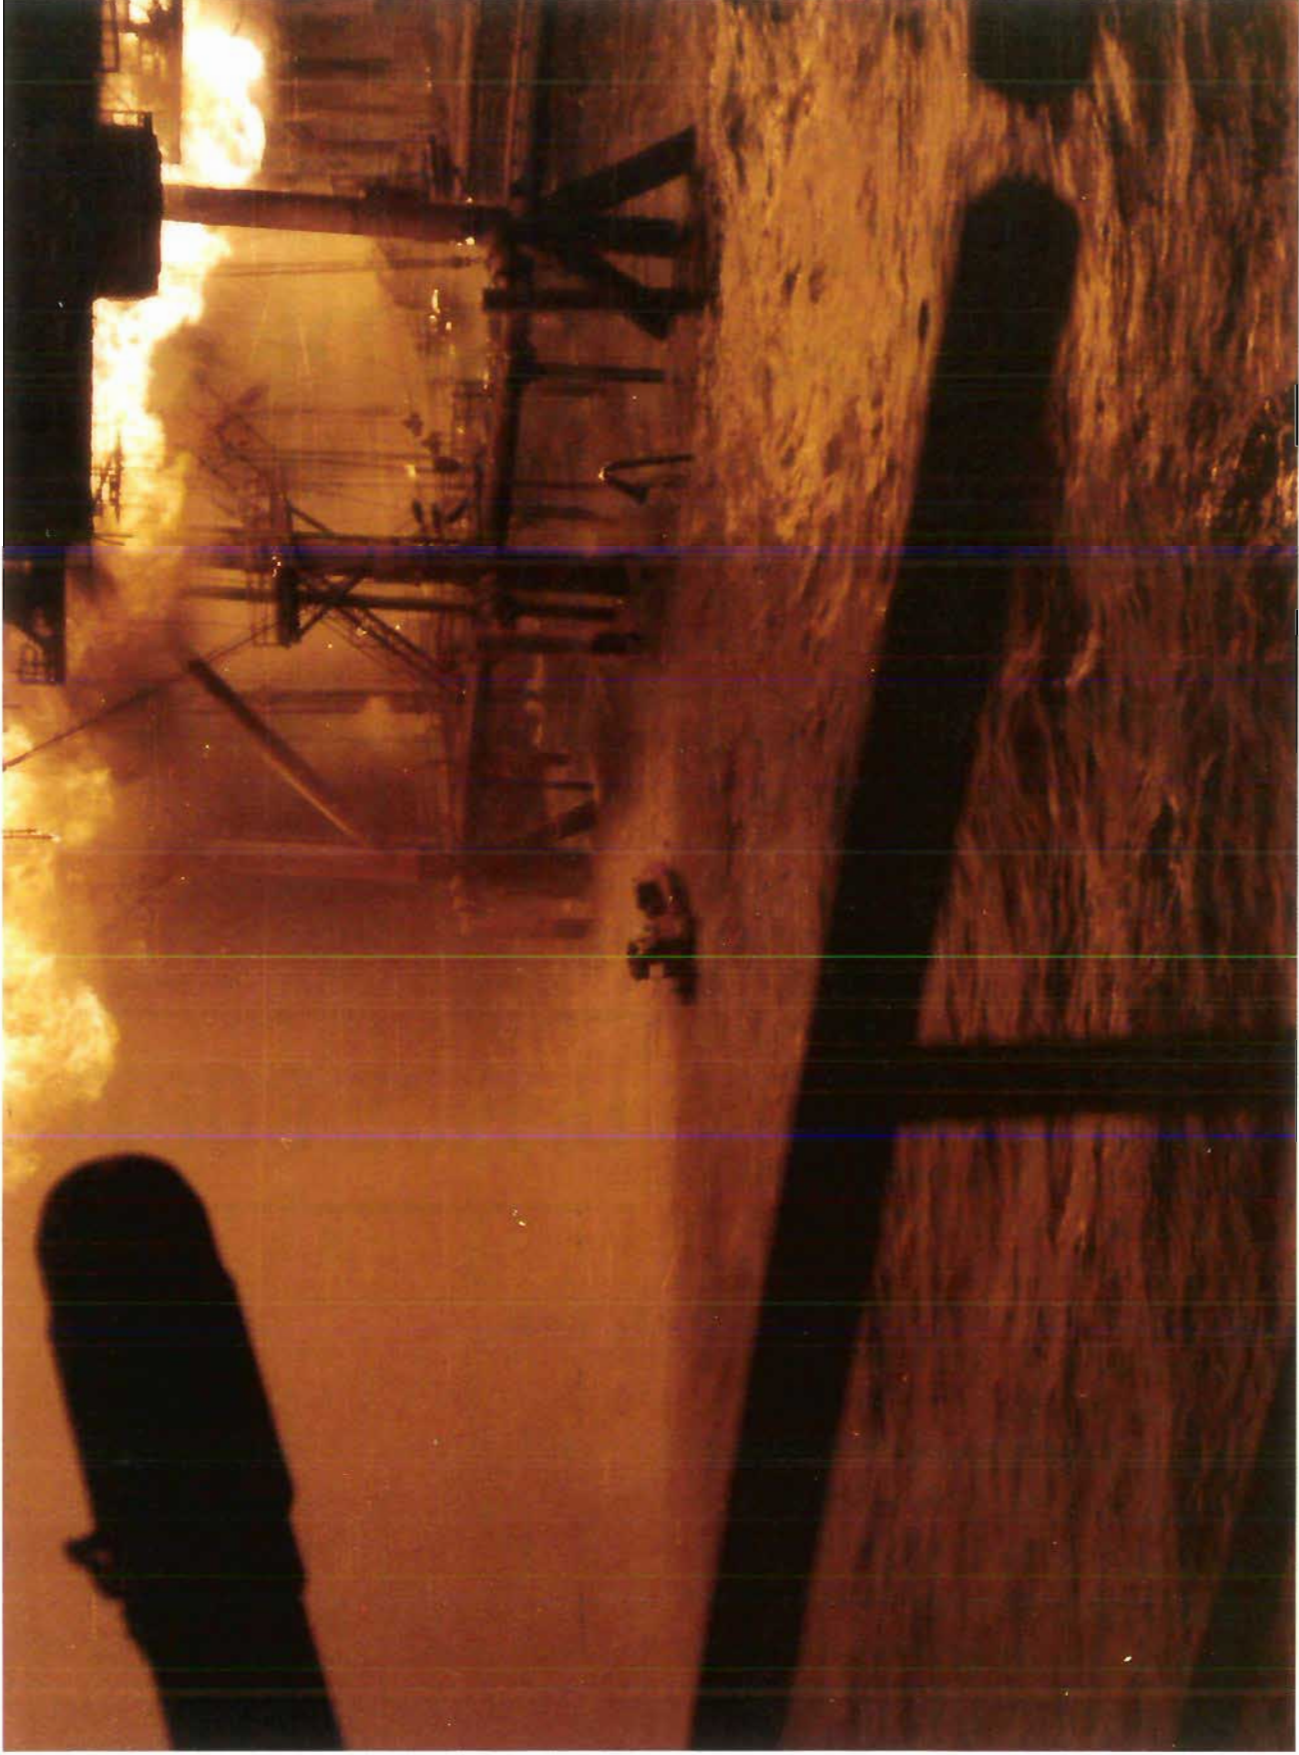
Frontispiece

A fast rescue craft near the 20ft level some time after the first riser rupture: photograph taken by Mr Miller from the *Tharos*.

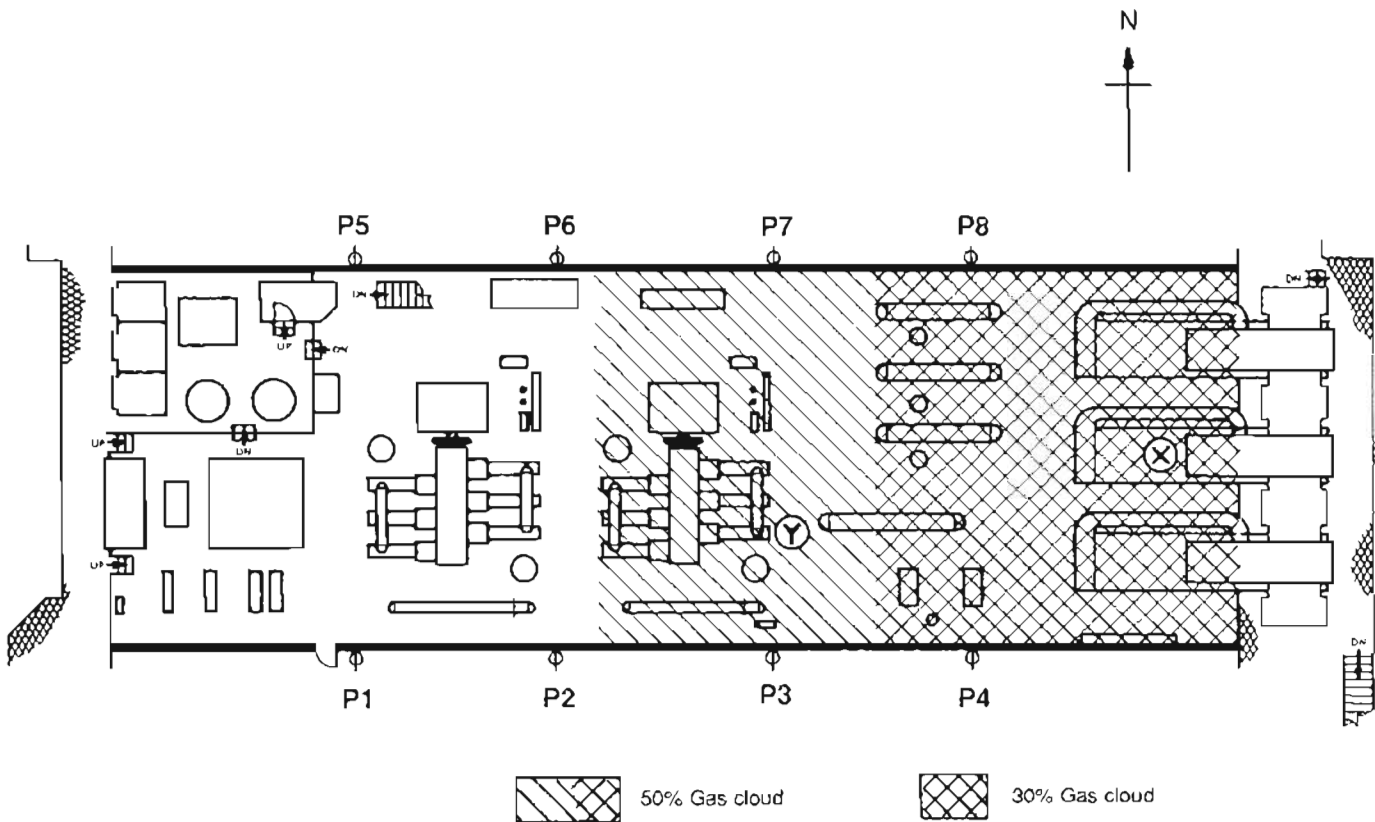
5.88 Shortly after the Piper disaster CMI was commissioned by the DEN to perform simulations using the FLACS code for a number of scenarios of explosions in C Module. The report on this work was spoken to by Dr Bakke. The layout of C Module entered into the code is shown in Fig 5.1. The figure also shows the 8 points, P1-P8, at which the pressures were measured and the locations X and Y of the ignition sources. 5 cases were considered. Cases 1, 2 and 4 involved natural gas and cases 3 and 5 condensate. The module fill was 50% in each case, except for case 4, for which it was 30%. Wall failure was allowed for in all cases except case 5. For cases 1 and 4 the location of the ignition source was at the eastern end of the cloud, for cases 2, 3 and 5 at the centre of the module. The details of and results for these cases 1-5 studied by CMI for the DEN are given in Table 5.1 as runs 1-5. This work showed that there are a number of scenarios which would lead to pressures high enough to cause failure of the firewalls. It also illustrated a number of important trends. It showed that higher over-pressures are generated if the hydrocarbon cloud is larger, if there is no failure of the firewalls, if the ignition source is at the centre and if the fuel is condensate rather than natural gas. Further details of the work are given in Appendix G.

Fig. 5.1 Plan view of C Module, showing pressure points P1-P8, 30% and 50% fill gas clouds and ignition sources X and Y used in the CMI explosion simulations.

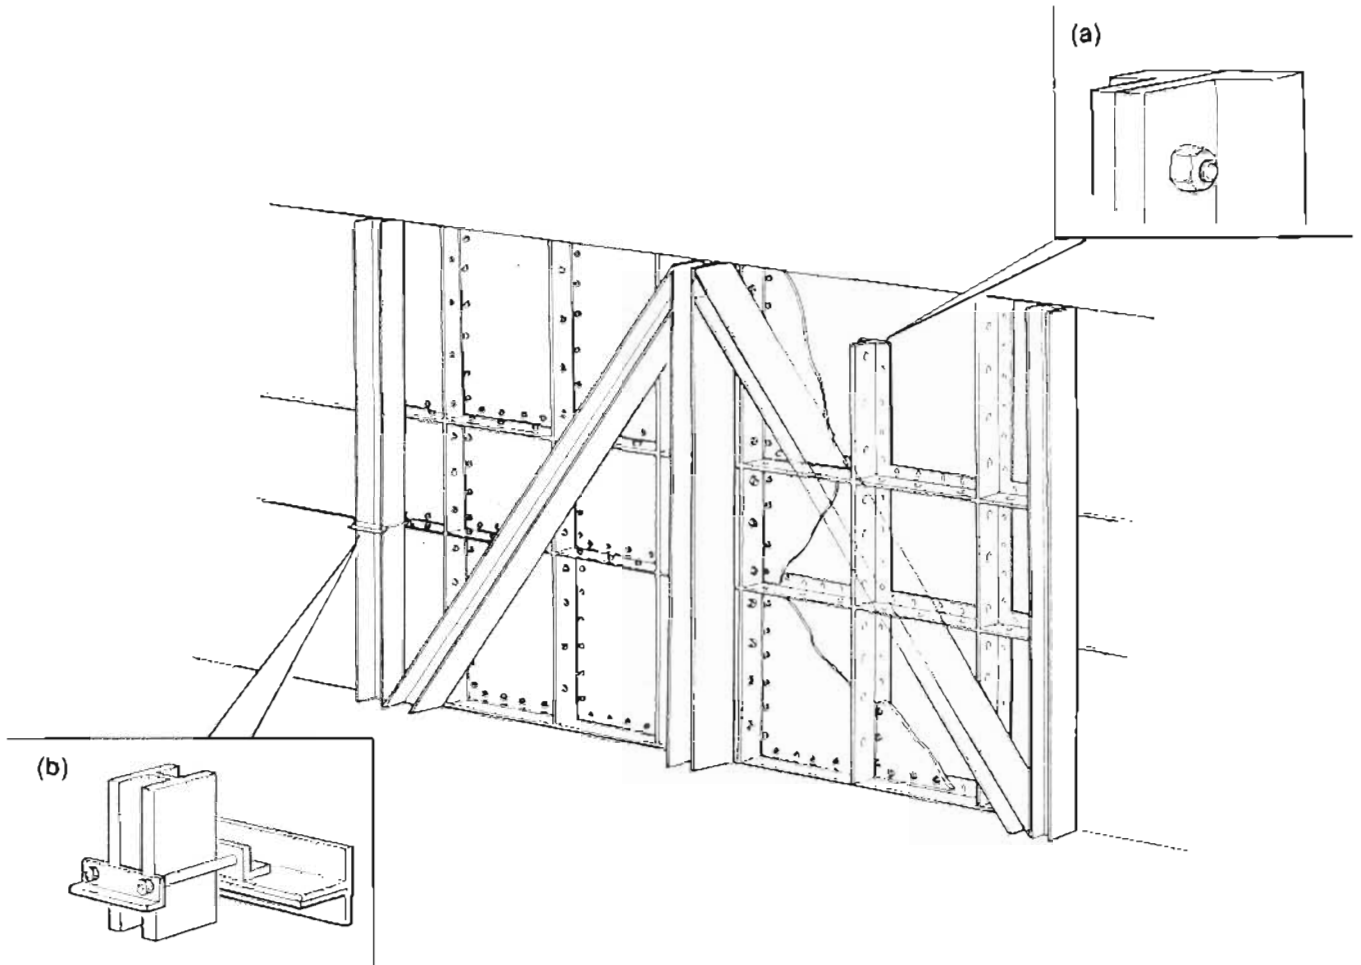
5.100 The B/C firewall was a single-layer 4.5 hour integrity wall. It consisted of an array of rectangular panels, bolted into rectangular frames, with adjacent frames bolted together, forming a 'lattice'. The lower edge of the wall was welded to the production deck and its top edge attached to the underside of the upper truss beam by an arrangement of bolted and welded joints. The wall was further supported by clamping to the truss columns. The firewall is illustrated in Fig 5.2; the figure is schematic and is not to a consistent scale. The view seen in the figure is that seen from the inside of C Module looking south. In the analysis of failure of the single-layer firewall the following failure modes were considered: panels, panel bolts, lattice framework, frame bolts, clamps and welds to the deck and to the truss. Dr Cox summarised the analysis as follows. The capacities of both panel and frame bolts would be exceeded at a pressure of about 0.1 barg. Of the 2, the frame bolts were more critical in that failure of these would lead to failure of the lattice. Failure of the clamps would occur at about 0.12 barg and of the panels themselves at about 0.15 barg. In effect, the firewall would disintegrate at over-pressures somewhere in the region of 0.1-0.15 barg. He took the effective failure pressure of the single-layer firewall as 0.1 barg. The behaviour of the single-layer firewall in failure would be as follows. At pressures below about 0.1 barg the panels would start to deflect; at about this pressure frame and panel bolts would start to fail; at pressures above it frames would start to separate and, where the lattice was still intact, panels would start to collapse, whilst the clamps holding the whole wall might start to fail.

Fig. 5.2 Schematic of single-layer firewall between B and C Modules: insert (a) frame bolt; insert (b) clamps.

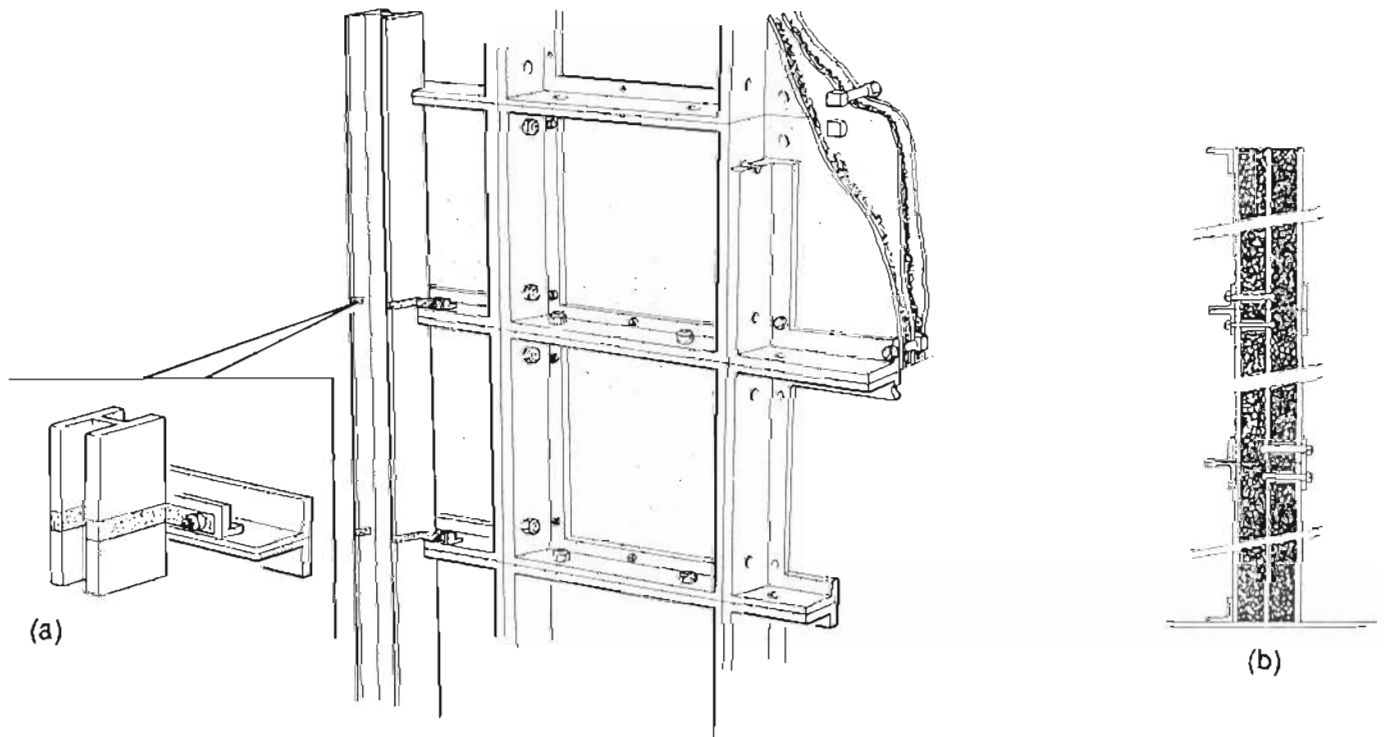
5.101 The C/D firewall was a triple-layer 6 hour integrity wall. This wall also differed from the single-layer wall in that the panels were of different size; the frames were smaller, being 7 rather than 3 frames high; there was a complex offset bolting arrangement; the arrangement of the panel and frame bolts was different in detail; and the clamping arrangements were different. The firewall is illustrated in Fig 5.3; the figure is again schematic but in this case the panelling is on the remote side of the lattice. The view in the figure is that seen from the inside of D Module looking south. An analysis similar to that on the single-layer firewall was performed on the triple-layer firewall. Again the frame bolts were the weakest component. Failure of these bolts was predicted to occur at a pressure of 0.12 barg. Failure of the panel bolts in

Fig. 5.3 Schematic of triple-layer firewall between C and D Modules: insert (a) clamps; insert (b) cross-section through fire wall, showing three sheets with mineral wool between.

shear loading or tearing of the panel would occur at about the same pressure. The outer sheet of the panels, supported only by very narrow bolts, would also start to fail at about 0.12 barg. However, the inner sheet, being more strongly supported, would not fail until a pressure of about 0.36 barg. This is a higher pressure than the failure pressure of the panels of the single-layer firewall because the panels of the latter are larger. Dr Cox took the effective failure pressure of the triple-layer firewall as 0.12 barg. As far as concerns the failure behaviour of the triple-layer firewall, at pressures below about 0.12 barg the panels would start to deflect; at about this pressure frame and panel bolts would start to fail and panels to tear; at pressures above it frames would start to separate and panels to separate from the frames but not to push through until higher pressures are reached.

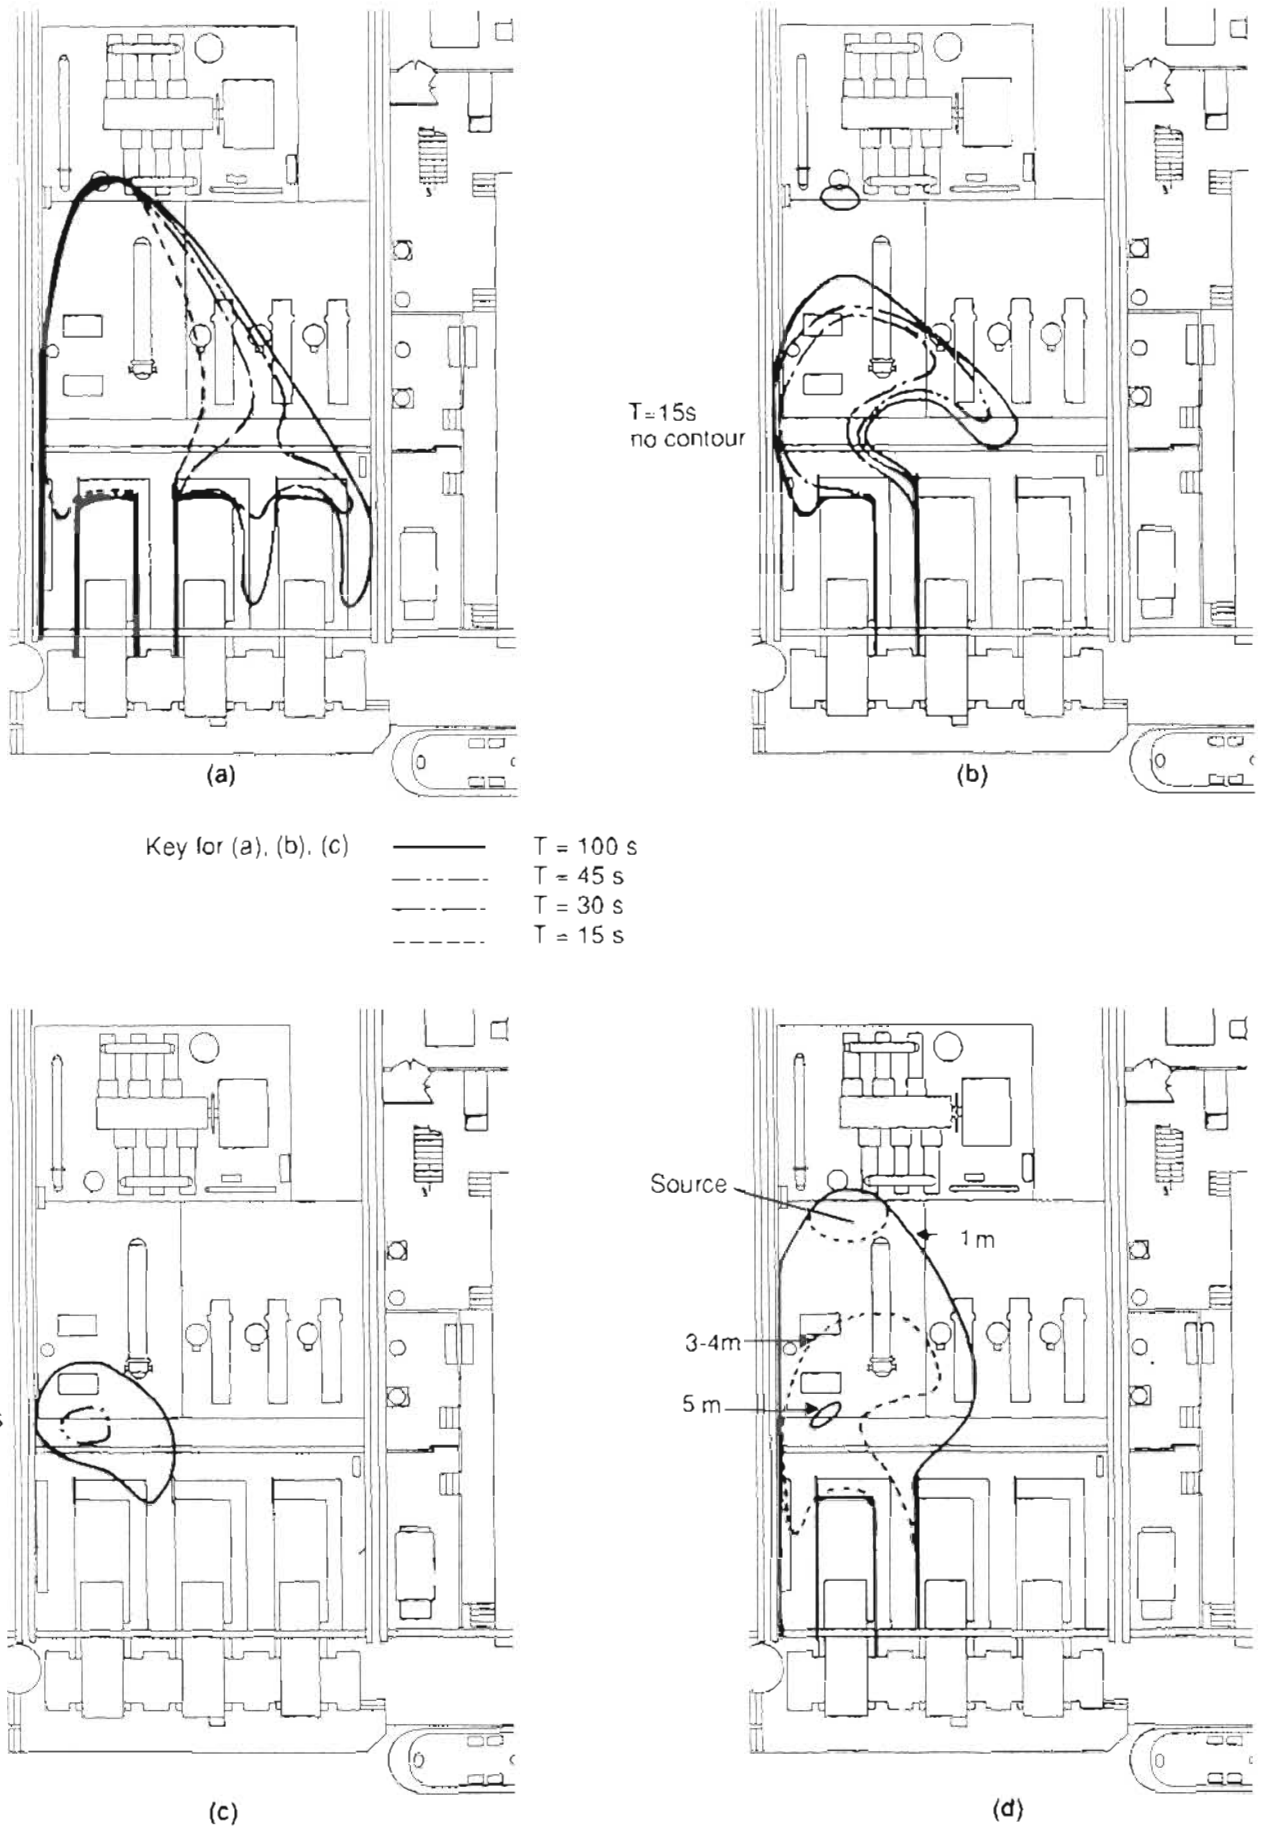
6.34 The tests point to the later, larger leak as being one of propane from position 1, from a downward pointing jet or partial fan. The 2 sets of test results given taken

Fig. 6.1 Growth of the flammable gas cloud for leak of 100 kg/min (Series 42) in the BMT wind tunnel tests: (a) LEL contours at low level ($< 1.7\text{m}$); (b) LEL contours at intermediate level (ca. 3.5m); (c) LEL contours at high level (ca. 5.5m); and (d) LEL contours at 30 seconds.

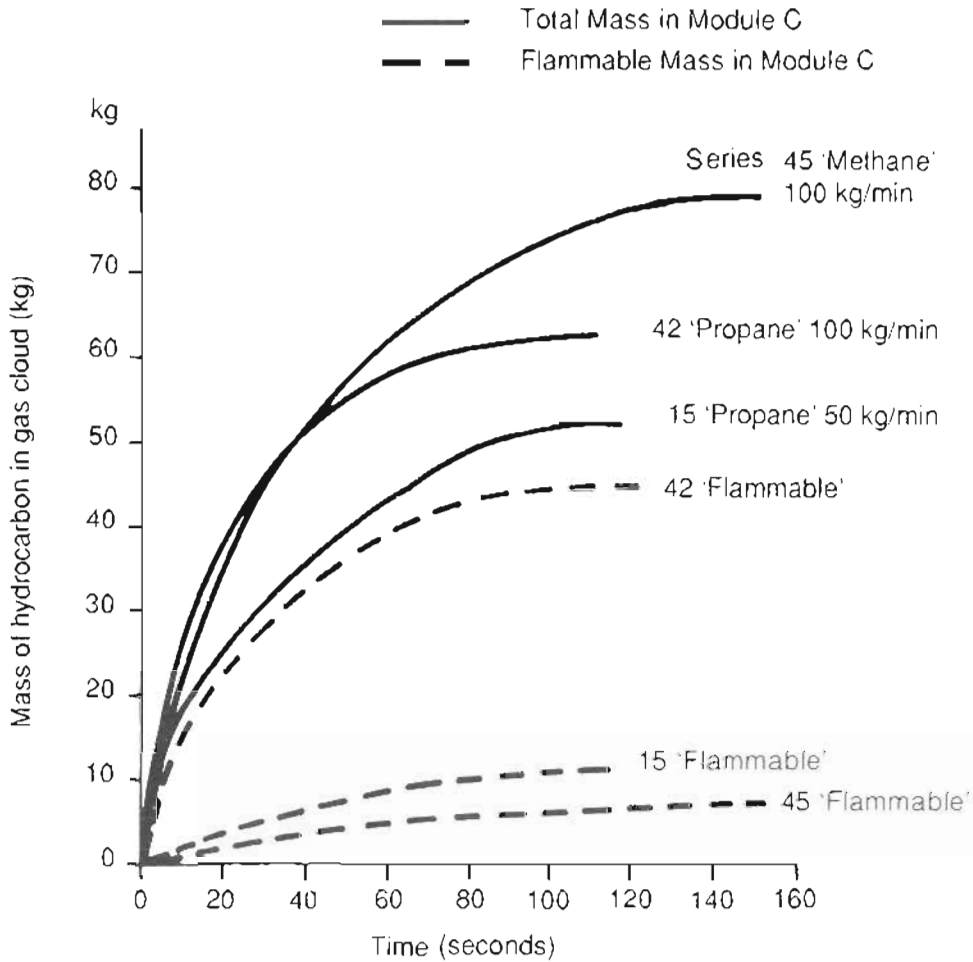
Fig. 6.2 Mass of fuel in the flammable gas cloud in BMT wind tunnel tests (total mass and mass within flammable range): variation with time.

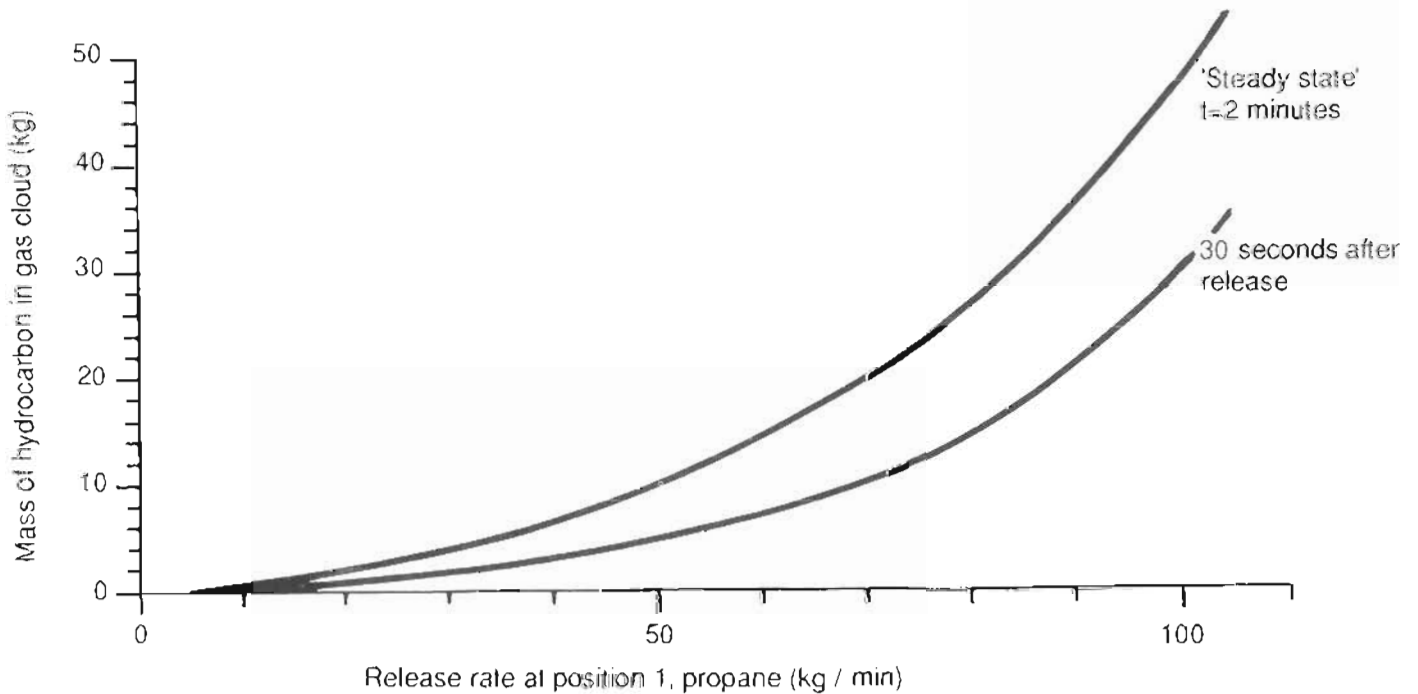
Fig. 6.3 Mass of fuel in the flammable gas cloud in the BMT wind tunnel tests (mass within flammable range): variation with leak rate.

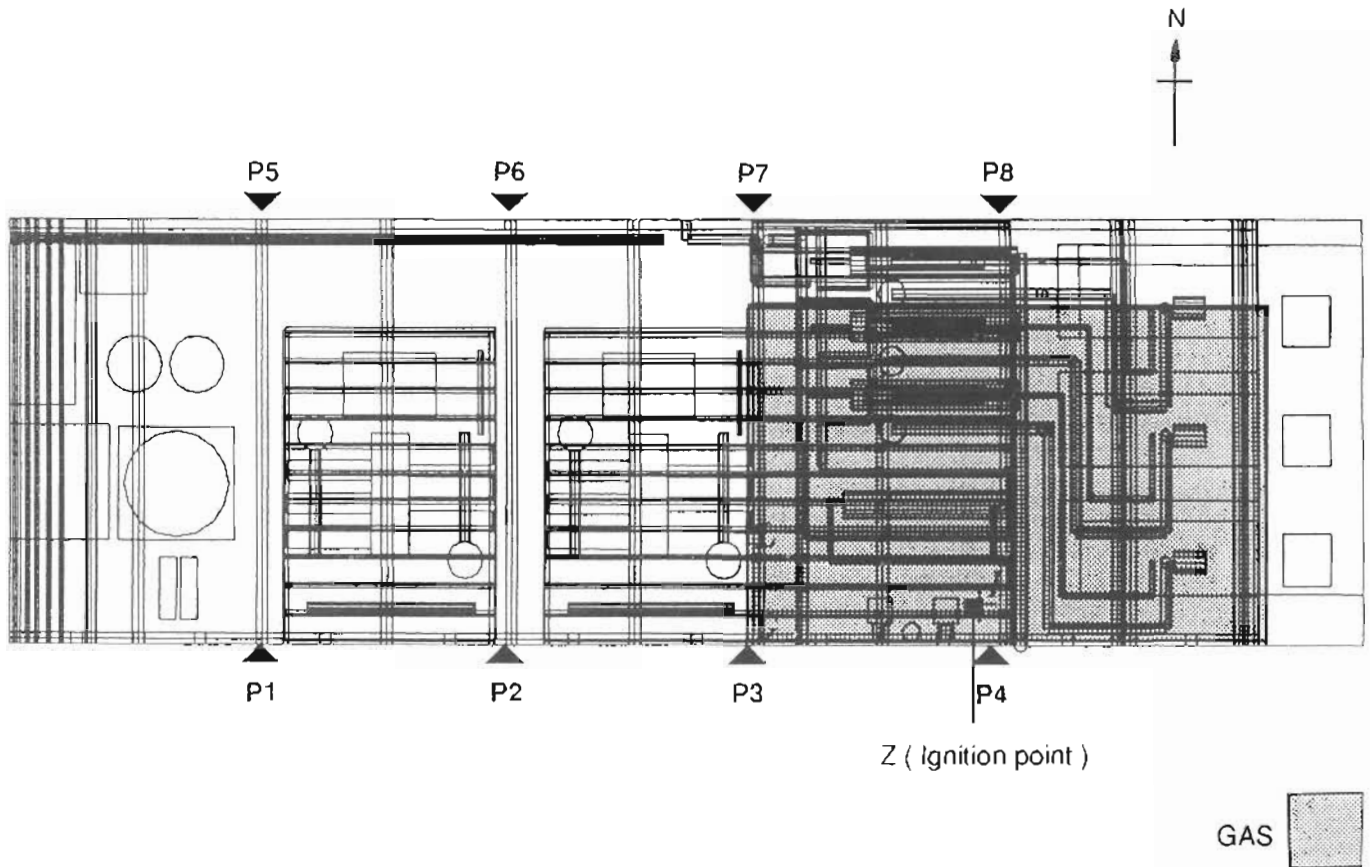
are shown in Figs 6.4 and 6.5. The firewall failure pressures used were revised values based on the evidence of Dr Cox, namely for the B/C firewall 0.10 bar and for the C/D firewall 0.12 bar. Wall porosities used were again for the B/C firewall 20%, and for the C/D firewall 40%. The results obtained are shown in Table 6.2 as case 6. For comparison the table also shows as cases 1-5 the results of the earlier runs for the DEn.

Fig. 6.4 Plan view of C Module showing pressure points P1-P8, 12% fill gas cloud and ignition source Z used in the final CMI explosion simulation.

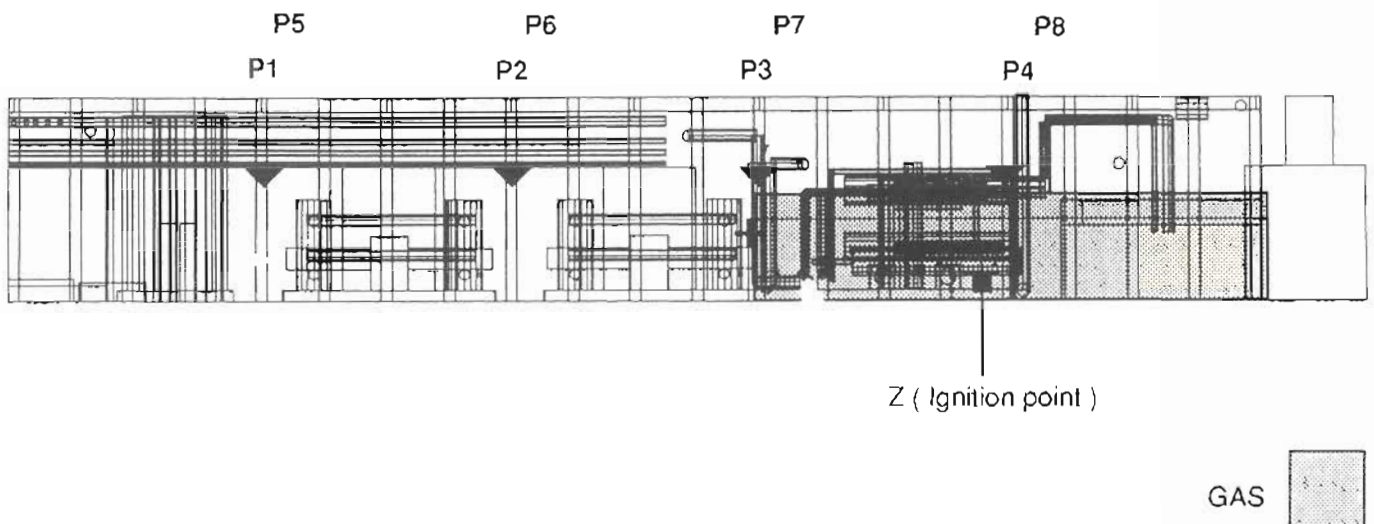
Fig. 6.5 Elevation view of C Module looking north, showing pressure points P1-P8, 12% fill gas cloud and ignition source Z used in the final CMI explosion simulation.

6.40 The simulation for case 6 showed that the B/C and C/D firewalls would fail along most of their length. However, although the pressures experienced at point 5 are sufficient to cause failure of the north wall at that point, the pressure plots indicated that there was a short section at the west end of that wall which did not see pressures high enough to cause failure. The mass of fuel in the flammable gas cloud in the case 6 simulation was judged by Dr Bakke to be close to the lower limit for a cloud capable of causing substantial failure of the firewalls.

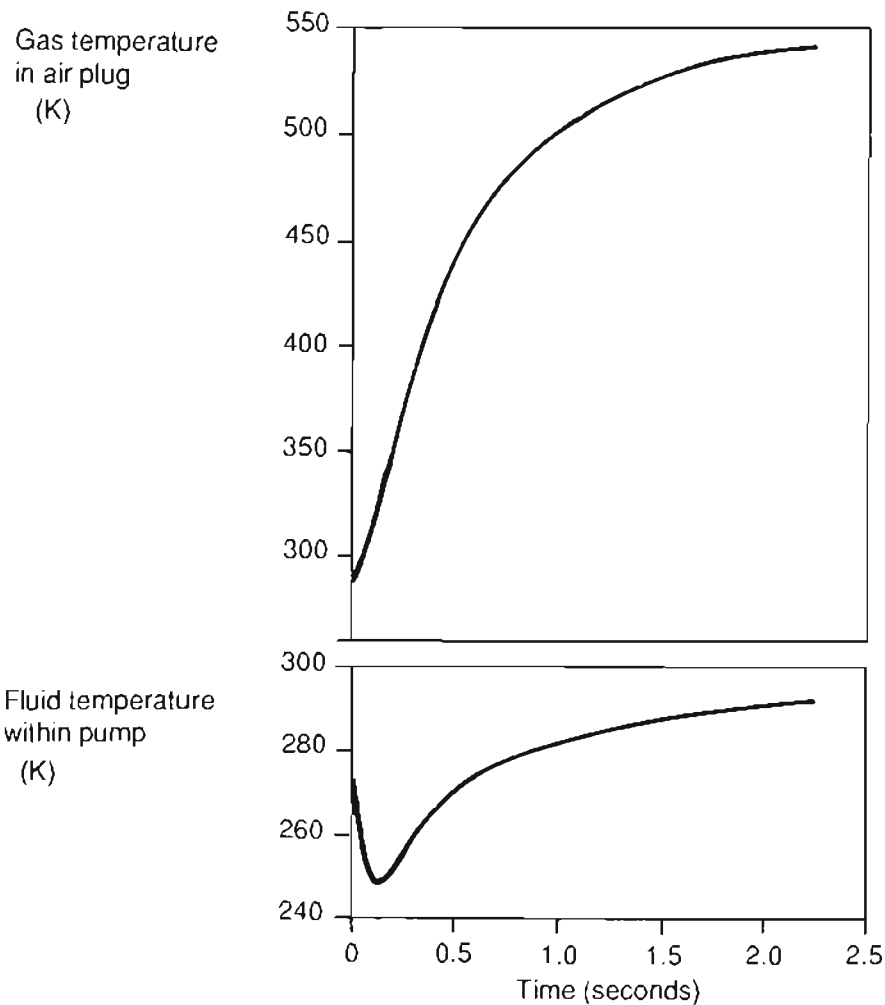
6.133 If a flammable mixture had accumulated in the relief line from the pump, sudden admission of condensate would cause compression of this mixture and could possibly result in ignition. Such autoignition would be similar to that which occurs in a diesel engine, where ignition is effected not by a spark plug but by compression, although the temperatures attained would be much lower. For ignition to occur, there would have to be a flammable mixture in the system. In other words, there would need to be ingress of air, which would depend on the extent of any openings to atmosphere. The evidence was that the flange at PSV 504 had been open for about an hour. There were also other possibilities. For example, if the valve used to vent the pump to flare had been left open, condensate vapour, being denser than air, would continue to stream out of this valve, drawing air in at the top through the flange at the site of PSV 504. It was not known how long the pump vent valve might have been open nor whether this coincided with the period when the flange was open. As far as

Fig. 6.6 Estimated temperatures of gas (air) and liquid on admission of condensate through GOV 5005 into condensate injection pump A system.

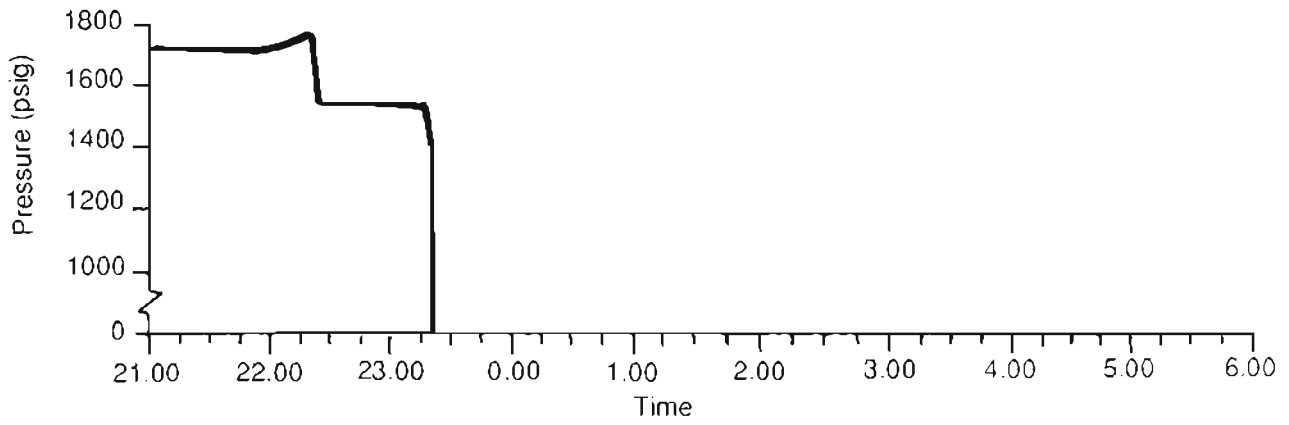
7.36 The depressurisation of the gas pipeline from Tartan to Piper was instructed on Tartan between 22.30 and 22.45 hours. This took until 23.20 hours to set up, the last step being the opening of the export gas valve ECV 54. As will be explained below, it was then found that the pipeline contained virtually no gas pressure which was capable of being measured at Tartan. The depressurisation of the gas pipeline from Piper to MCP-01 was carried out at MCP-01 starting just after 23.00 hours. This pipeline normally contained about 60 MMSCF. The flaring capacity at MCP-01 was 2.6 MMSCFD. The depressurisation of the gas pipeline between Piper and Claymore was instructed on Claymore about 23.00 hours and took about 5 minutes to set up. Depressurisation was carried out through FCV 970. In addition after 24.00 hours gas was taken through the separators to the low pressure flare. It is uncertain how quickly this pipeline lost pressure. According to Mr J Davidson, Operating Superintendent on Claymore, a pressure of 400 psi was reached in about 4 hours, whereas the trend record for this line given in the Petrie Report, which was based apparently on readings taken on Claymore, showed that this pressure was reached after about 45 minutes. The pressure records for all 3 gas pipelines are given in Figs 9.1, 9.3 and 9.5 of the Petrie Report and are here reproduced in Figs 7.1-3.

Fig. 7.1 Trend record of the Tartan gas export pipeline pressure on 6/7 July.

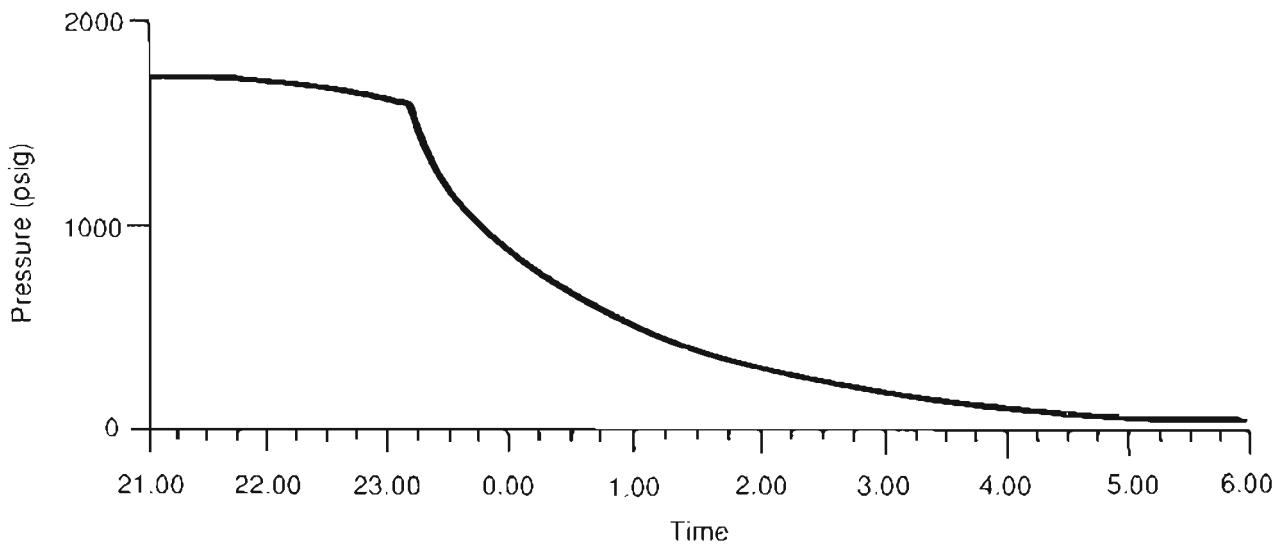
Fig. 7.2 Trend record of the MCP-01 gas import pipeline pressure on 6/7 July.

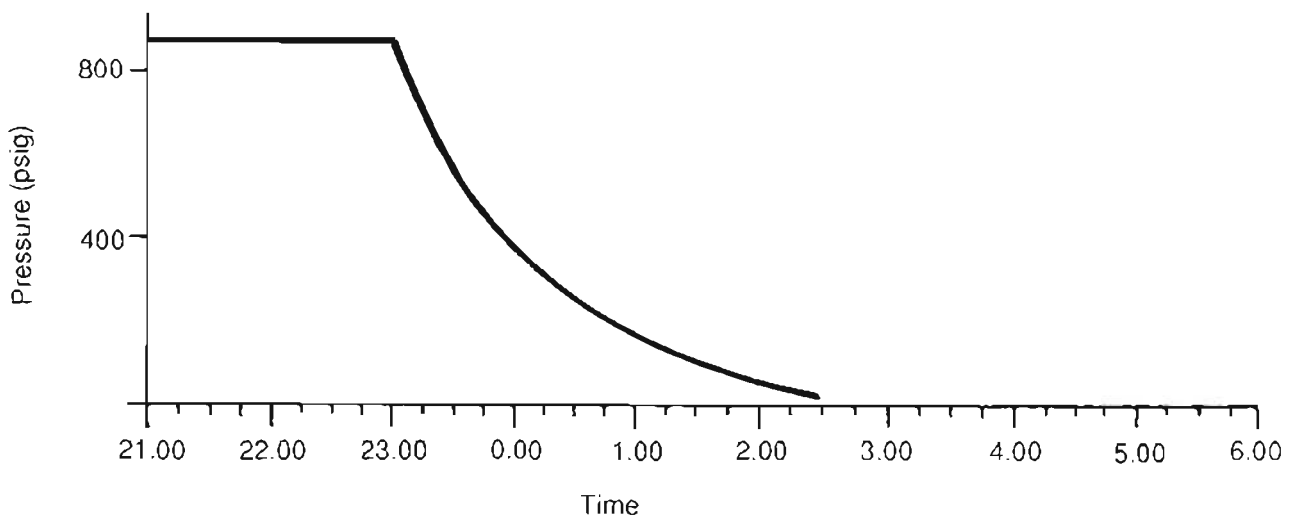
Fig. 7.3 Trend record of the Piper-Claymore gas pipeline pressure on 6/7 July.
