Release Notes for XC Series Hyper-Converged Appliances

This document includes release notes and other important information about the XC Series Hyper-Converged Appliances.

November 2017

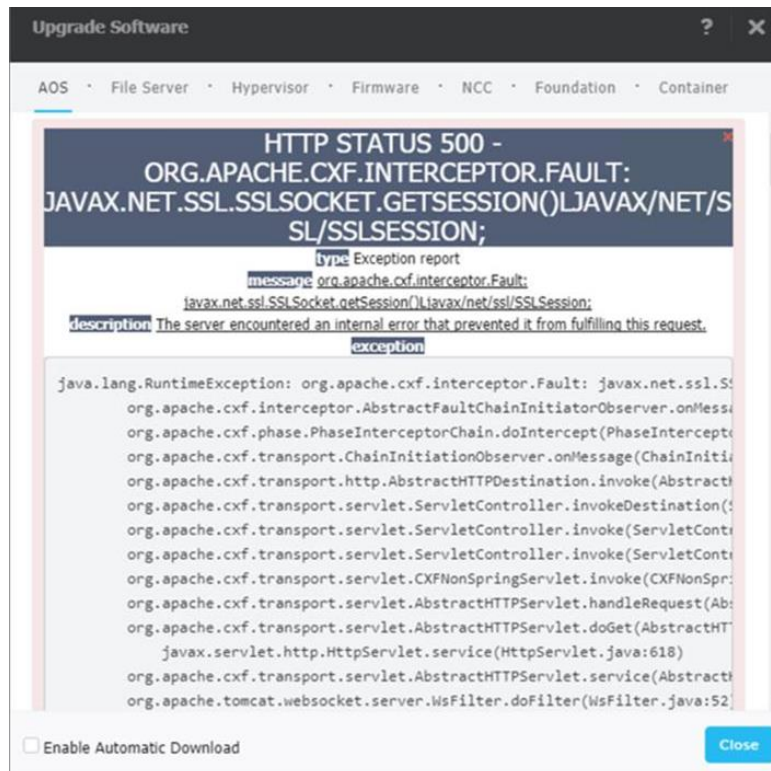
On 14th Generation XC Series appliances, an error message has been seen in Prism while navigating to the Settings Gear Icon, registering the Nutanix cluster with vCenter. Then completing the HTTP Proxy setup and going to Upgrade Software. In addition, this was seen with Hyper-V 2012 R2 clusters in the process creating a failover cluster.

Figure 1 Example screen of the error message.

Nutanix is aware of this issue and a fix will be included in a future update.
