***NIST Technical Note 1426***

***The Fujita Tornado Intensity Scale: A Critique  
Based on Observations of the Jarrell  
Tornado of May 27, 1997***

***Long T. Phan and Emil Simiu***

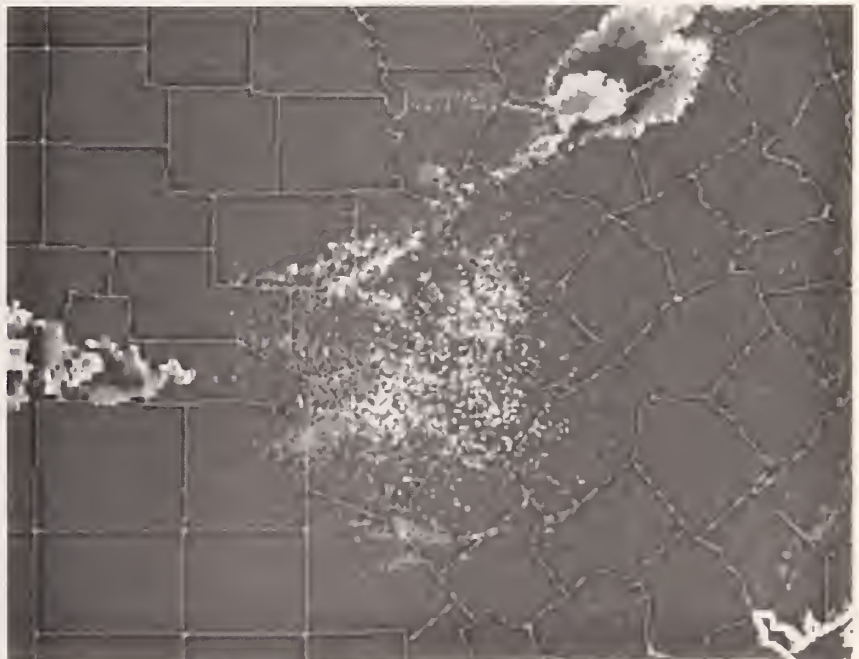
Figure 2b. Radar reflectivity image of the thunderstorm that produced the Jarrell tornado (picture from NOAA SPC web site).

Shortly before 3:40 P.M. (CDT), tornado sirens were sounded alerting residents in Jarrell of tornado sightings. Shortly before 3:45 P.M. (CDT), the most violent of all tornadoes that were spawned on May 27, 1997, now known as the Jarrell tornado, first struck areas of Bell County and then crossed into Williamson County. The city of Jarrell suffered 27 confirmed deaths and more than 40 structures were destroyed, including single-family homes, a commercial light steel frame structure, and several mobile homes. Most of the deaths and structural damage occurred in Jarrell's Double Creek Estates subdivision. Images of the thunderstorm that produced this tornado were captured by the NOAA GOES-8 satellite and the Austin, Texas WSR-88D radar site (see figs. 2a and 2b).

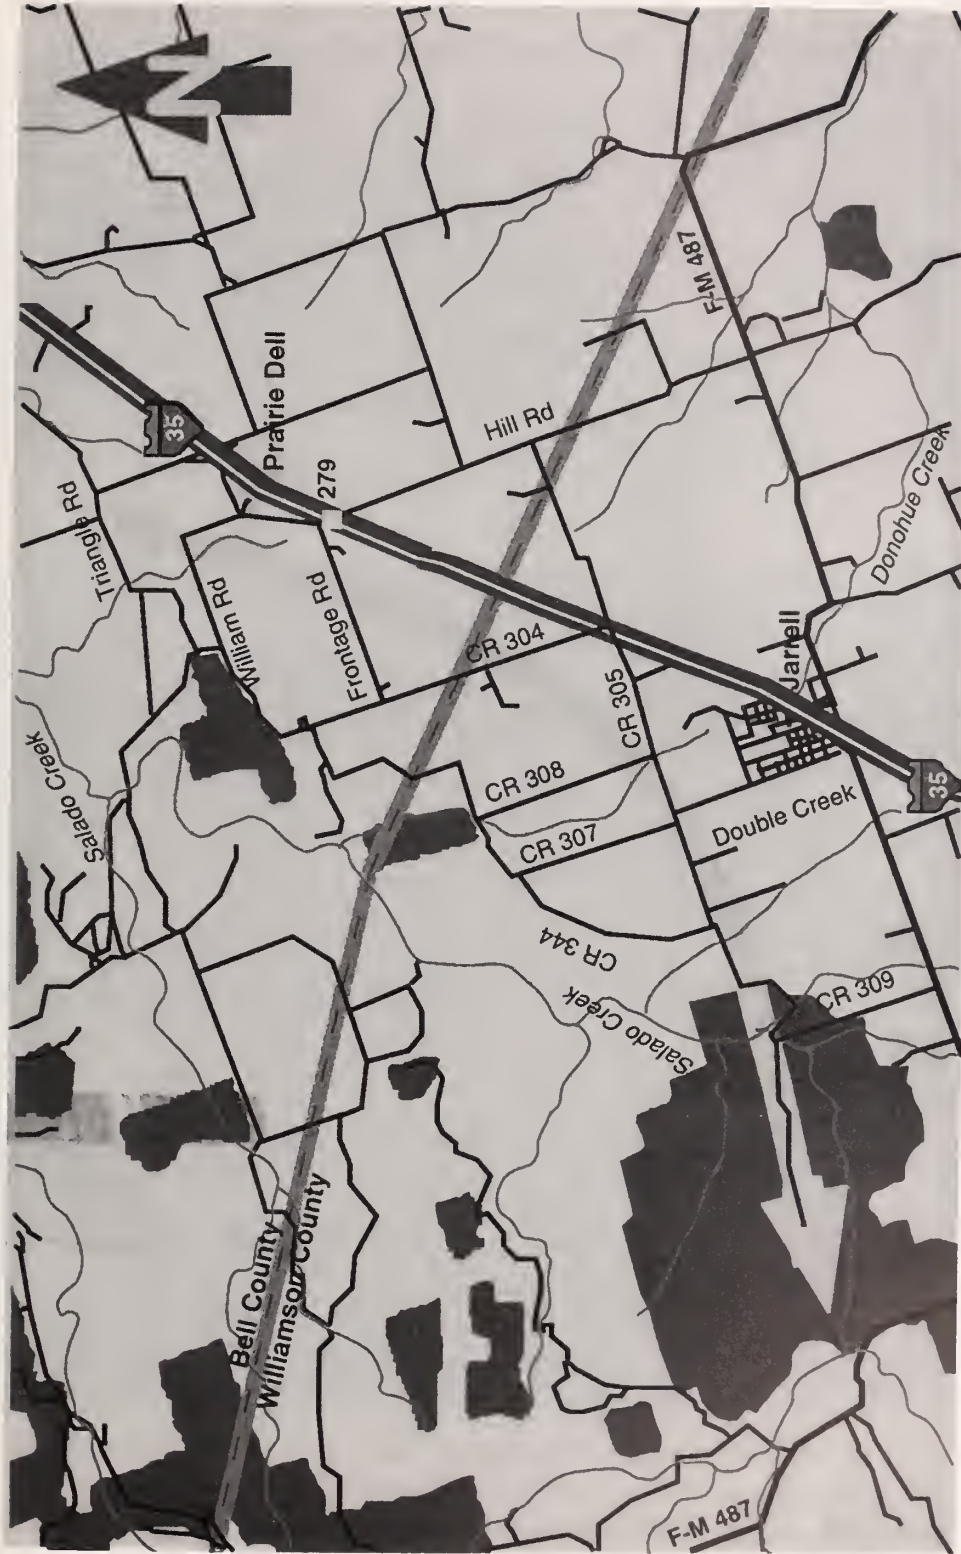
Figure 3 shows the path of the Jarrell tornado, based on information obtained in the OFCM damage survey. The path began in Bell County at a point about 1.3 km northwest of the Prairie Dell exit from Interstate 35 (coordinates 30° 53.90' N/97° 35.20' W). The tornado tracked southwestward, almost parallel to Interstate 35, then crossed the Bell/Williamson County line where it assumed a more westerly course. The tornado path ended in a heavily wooded area southwest of Jarrell in Williamson County (coordinates 30° 49.18' N/97° 40.12' W). Based on the information from the GPS, the path length of the tornado was estimated to be 12.2 km (7.6 mi), of which 3.9 km (2.4 mi) was in Bell County and 8.3 km (5.2 mi) was in Williamson County. The Double Creek Estates subdivision was located in open terrain, slightly rolling, with few trees. The tornado's maximum path width was measured in that subdivision to be approximately 1.2 km (0.75 mi). Witnesses estimated that its translational speed was between 8 km/hr and 16 km/hr (5 mph to 10 mph).

Figure 3. Jarrell tomado path.

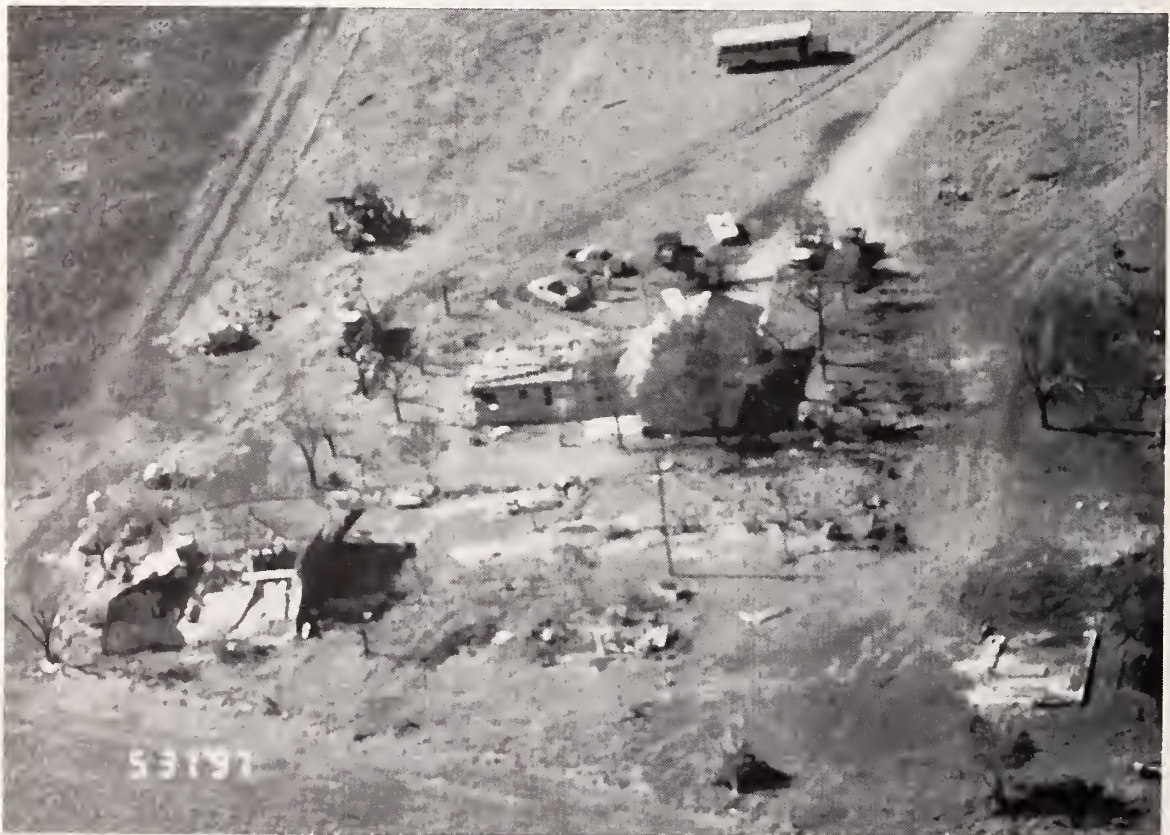
Damage began in open terrain in Bell County and was limited primarily to trees and the roofs of a few residential structures (see fig. 4). The tornado then crossed the Bell/Williamson County line and moved across County Road (CR) 308, CR 305, and CR 307. The locations where the tornado crossed these roadways were clearly marked by strips of scoured asphalt road surface (see fig. 5), typically as wide as the road and with lengths of 1.5 m (5 ft) to more than 100 m (330 ft). The top layer of the asphalt pavement was approximately 20 mm (0.8 in) thick. We ascribe the scouring of the asphalt to differences between the atmospheric pressure of pockets of air trapped underneath the asphalt and the lower atmospheric pressure at the center of the tornado.

Figure 4. Damage to roof of residences in Bell County at the beginning of the Jarrell tornado track.

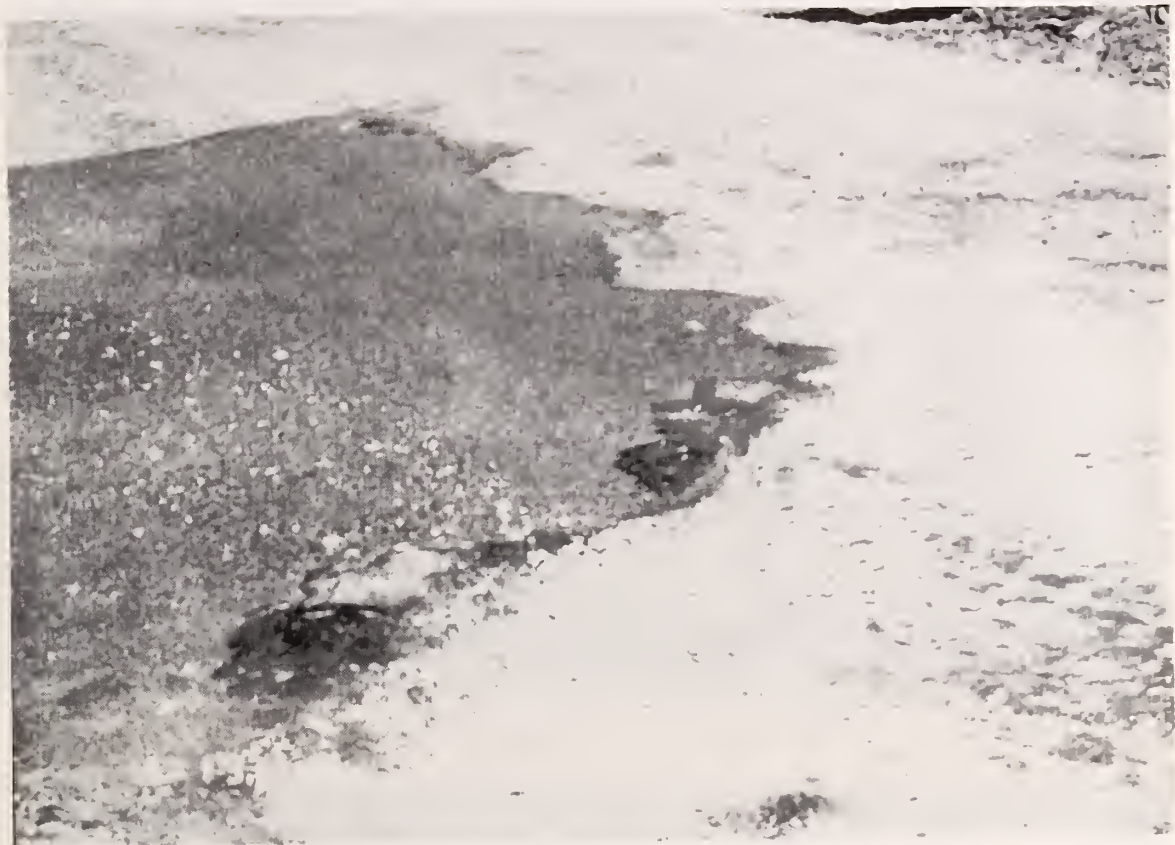
Figure 5. Scoured asphalt road surface in the vicinity of Double Creek Estates subdivision.

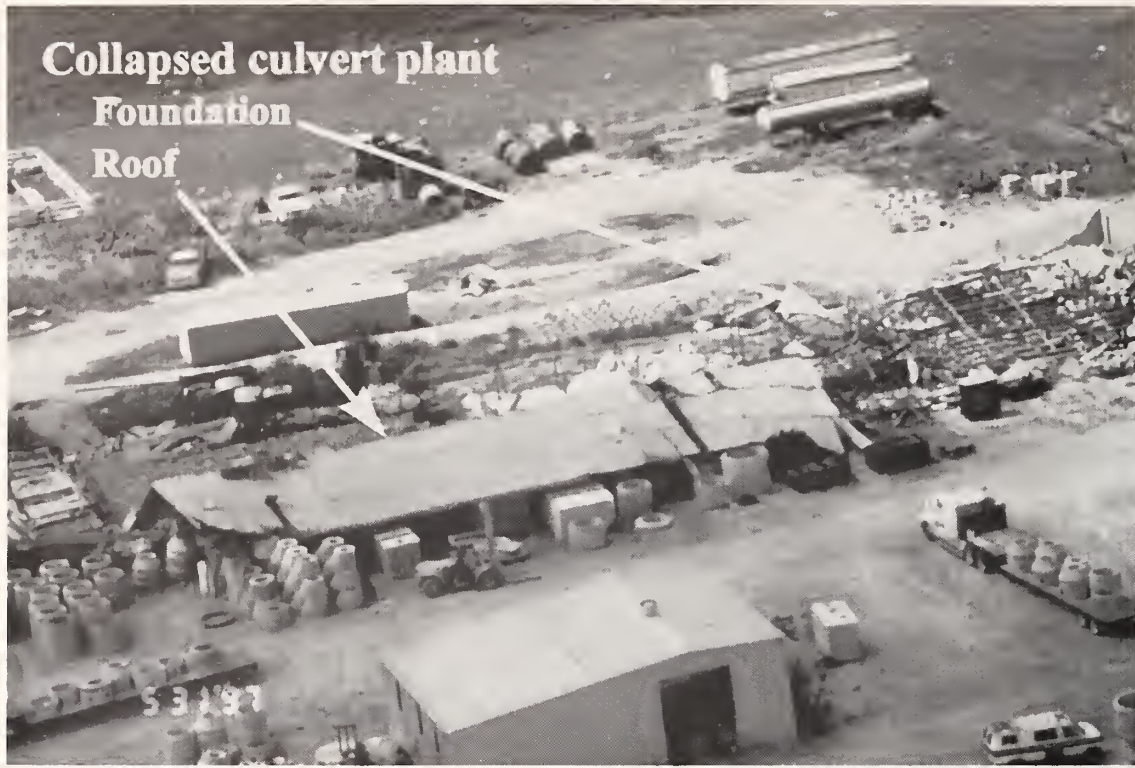
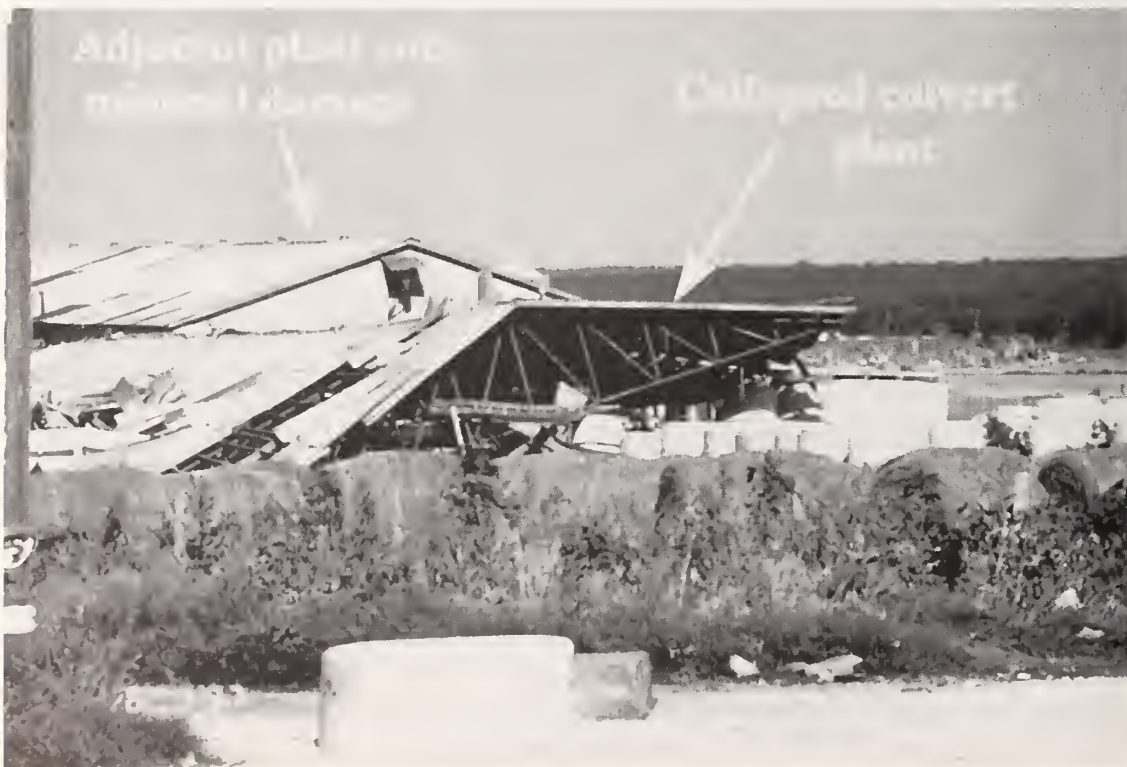
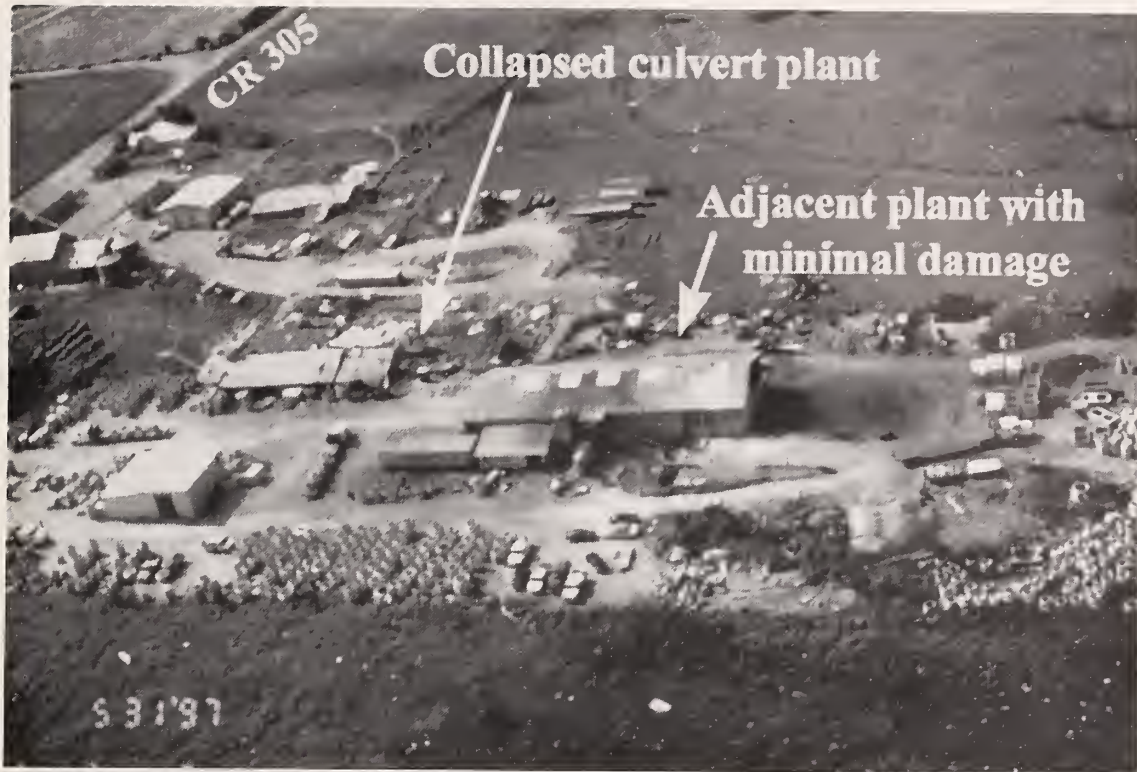
The next structural damage along the tornado path occurred at the corner of CR 305 and CR 307 in Williamson County, where a culvert plant collapsed (figs. 6 to 8). The plant was of light steel frame construction with non-reinforced masonry and steel tube columns supporting steel pipe, gable roof trusses. The steel tube columns were cast into a concrete mat foundation on grade. The roofing, supported by wood purlins, consisted of corrugated sheet metal. An identical plant approximately 15 m (50 ft) away from the collapsed culvert plant, and other surrounding structures, suffered only minimal damage (fig. 8). A mobile home used as an office was hit by a conventional “two by four” timber member 1.2 m (4 ft) long, but the missile did not penetrate into the home. A mobile home located about 150 m (500 ft) north-northwest of the plant had only minor damage. Its occupants fled to a house that was in the center of the damage path, where they were reportedly killed.

Figure 6. Aerial view of collapsed culvert plant.

Figure 7. Ground view of collapsed culvert plant.

Figure 8. Aerial view of entire culvert plant complex.

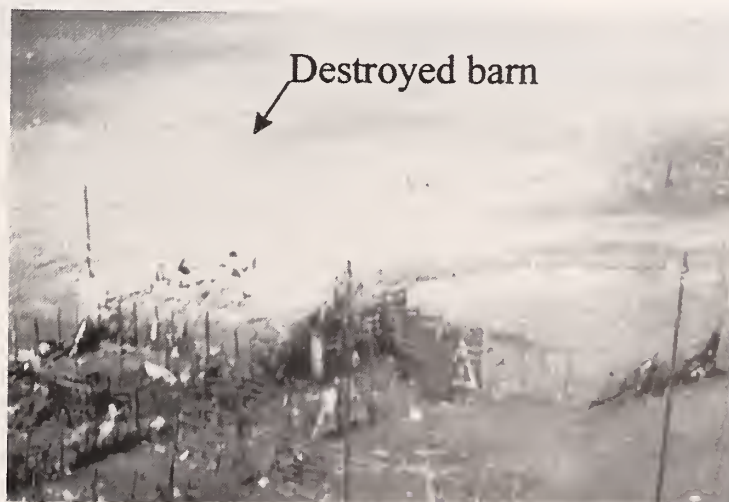
As the tornado continued its track south southwestward, a barn located just southwest of the culvert plant and just north of the Double Creek Estates subdivision was destroyed (fig. 9). The tornado then moved through the Double Creek Estates subdivision and the surrounding areas, where the destructive path widened to its maximum of 1.2 km (0.75 mi) and the tornado became most deadly.

Figure 9. Destroyed barn located between culvert plant complex and Double Creek Estates subdivision.

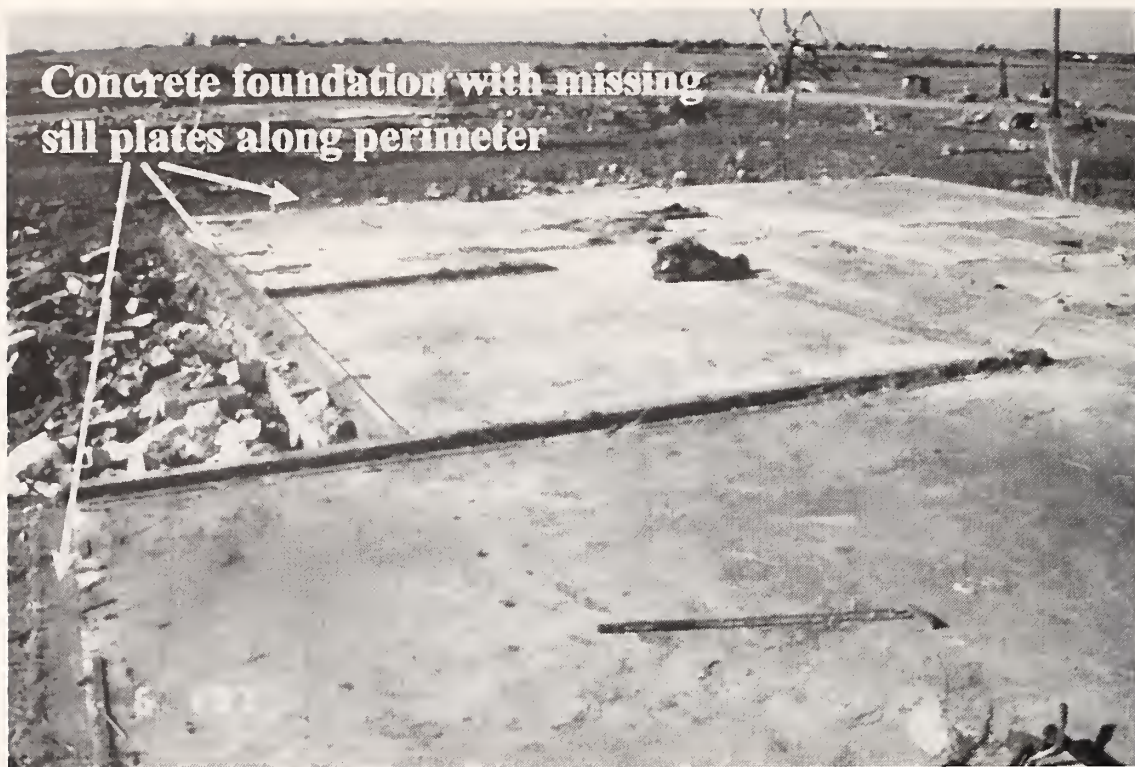
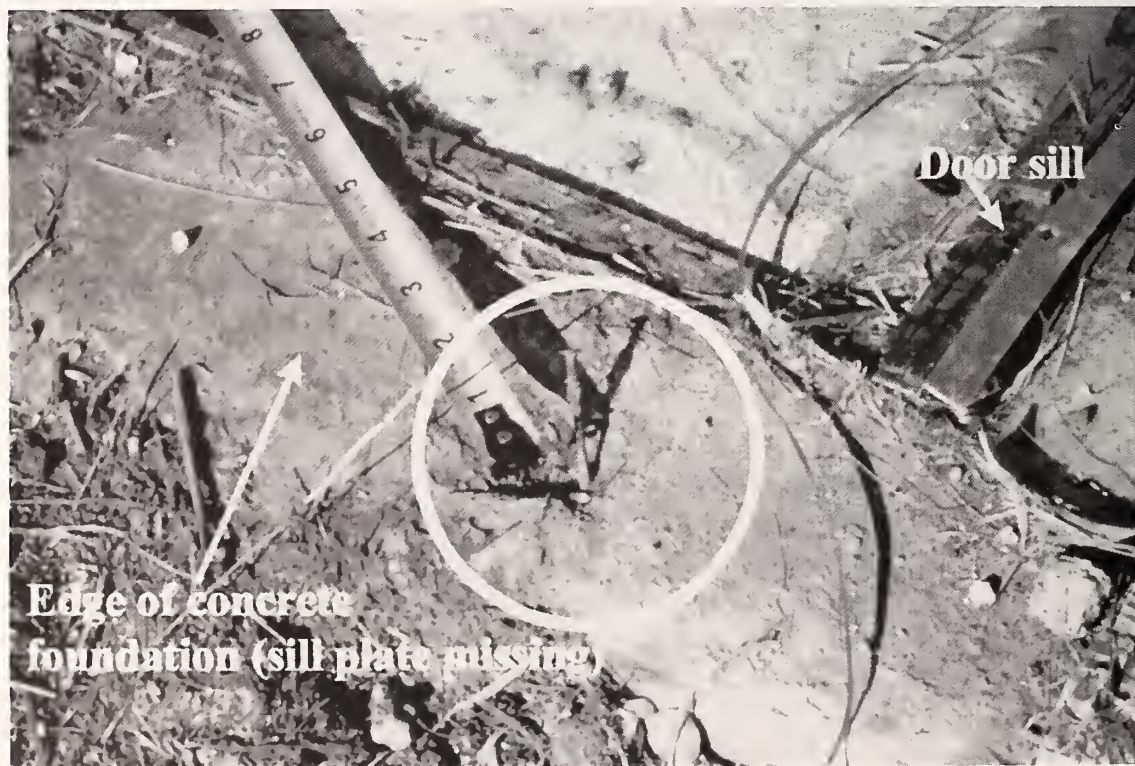
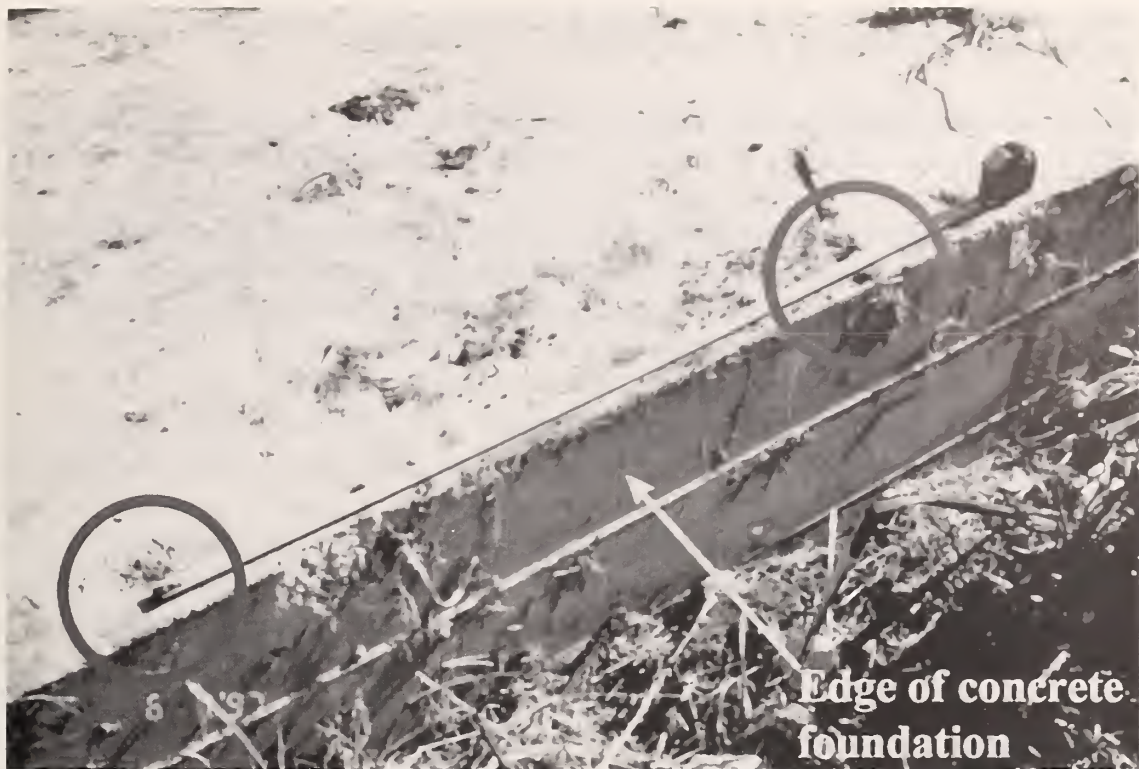
Inspections of the concrete slab-on-grade foundations performed during the ground surveys revealed that, in many cases, even the sill plates that connected the wood frames to the concrete foundations were blown away (see fig. 11). This suggests that the connections between the sill plates and the foundations were not as strong as those between the sill plate and the wood frames. Random, close examination of a few concrete foundations suggested that the houses in this subdivision may not have been well built. For some houses, there was evidence that the sill plates had been connected to the foundations by nails. Figure 12 shows a nail that remained in the foundation, but pulled through the sill plate. Figure 13 shows examples where the nails, which appeared to have been spaced 0.9 m (3 ft) apart, pulled out of the foundation. There was no evidence of anchor bolts or steel straps used at the few random foundations where close inspections were performed. We note

that the Council of American Building Officials (CABO) One and Two-Family Dwelling Code (1995) requires that sill plates of exterior walls for wood-frame construction be anchored to the concrete foundation by 13 mm-diameter (1/2-inch) anchor bolts not more than 1.83 m apart and less than 0.31 m from corners. We also note that Williamson County has not adopted a building code, even though Jarrell had been hit by a tornado on May 17, 1987.

Figure 11. Close-up view of a typical slab-on-grade foundation of houses in the Double Creek Estates subdivision. Only one sill plate remains connected to the concrete foundation.

Figure 12. Evidence of nail that was used for connecting sill plate to concrete foundation.

Figure 13. Evidence of pullout of nails used to fasten sill plates to concrete foundation.

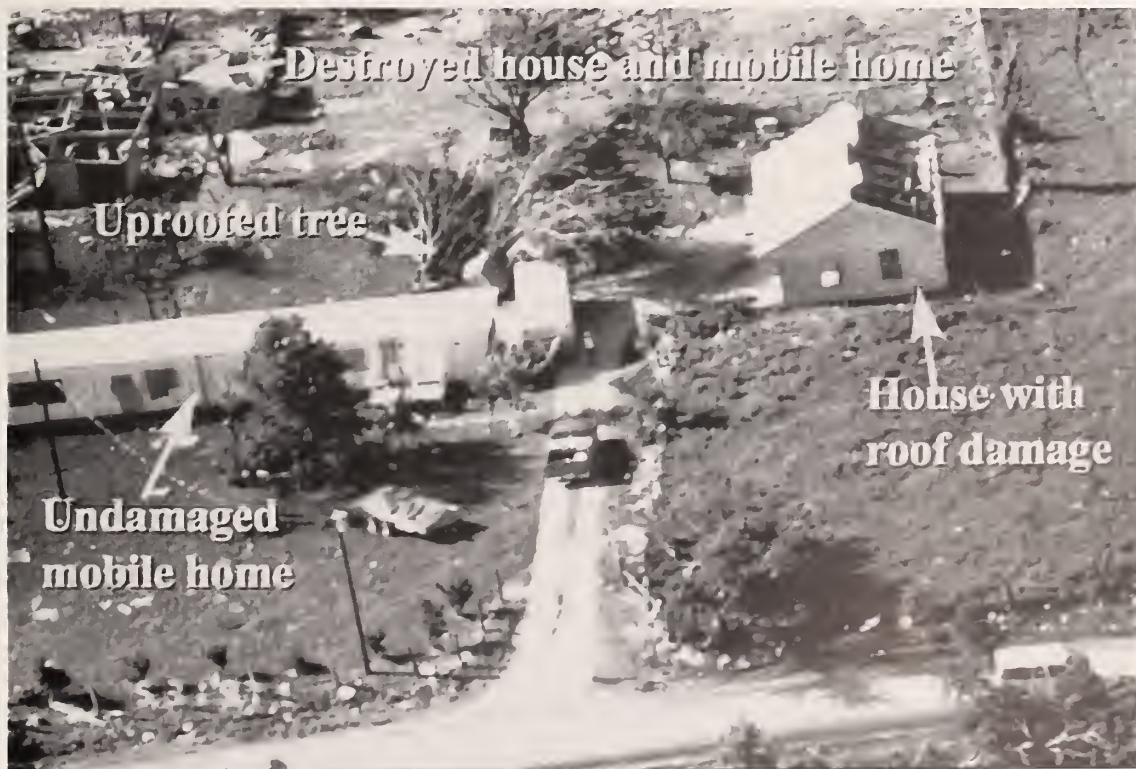
The path of destruction narrowed as the tornado moved to the outlying areas of the Double Creek Estates subdivision. Here the destruction became random. Figure 14 shows a mobile home that sustained only minor damage, while a short distance away a large tree was uprooted and another house lost half of its roof. The tornado then moved across CR 309 and ended in a heavily wooded area southwest of Jarrell.

Figure 14. Structural damage near the end of the path of the Jarrel tornado.
