Article: Chinoiserie/Chinese Export: A Comparison of Conditions and Treatments of Two Wallcoverings in Comparable Oceanside Environments

Author: T.K. McClintock, Deborah LaCamera, and Lorraine Bigrigg

Source: Book and Paper Group Annual 41, 2022

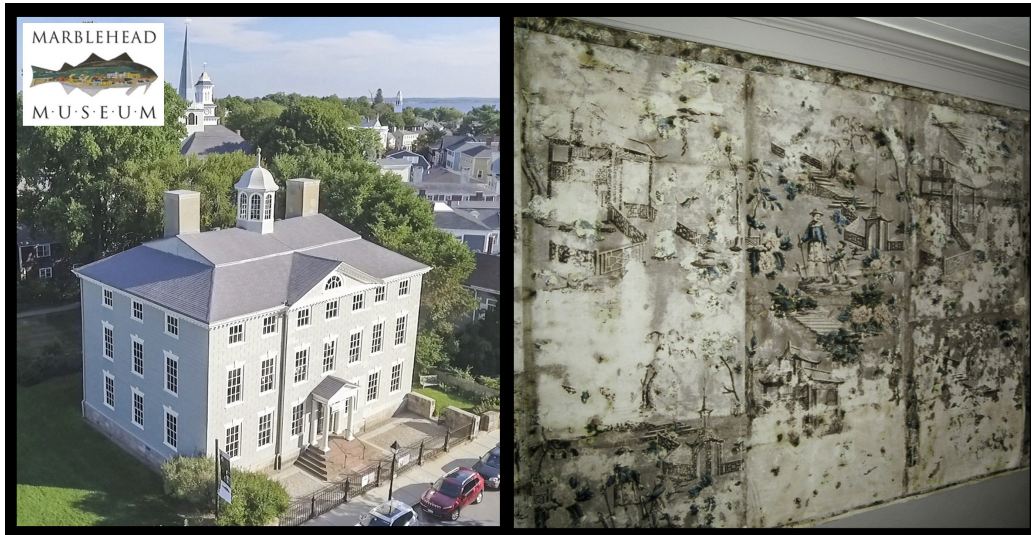
Fig. 1. Ca. 1765 Jeremiah Lee Mansion, photo courtesy of the Marblehead Museum, and English Chinoiserie Wallpaper, photo Studio TKM.

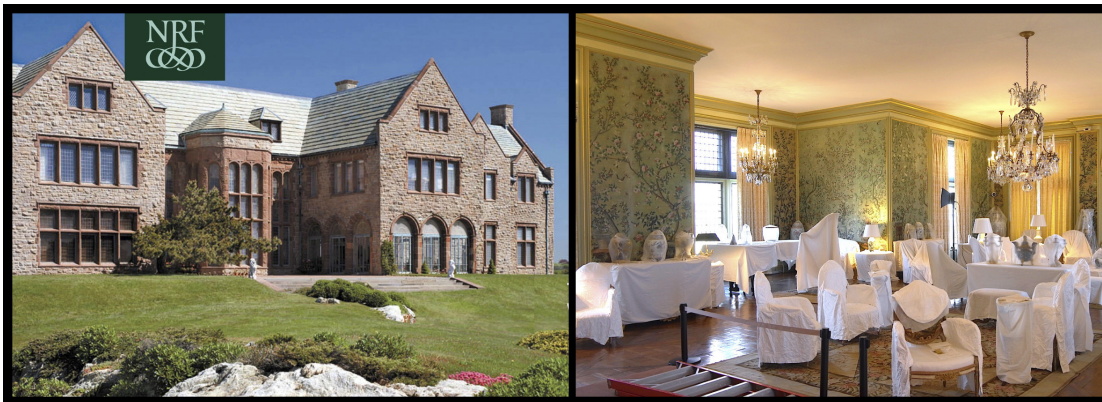
Fig. 2. Ca. 1891/1922 Rough Point, photo courtesy of the Newport Restoration Foundation, and Ballroom with c. 1780 Chinese export wallpaintings, photo Studio TKM.

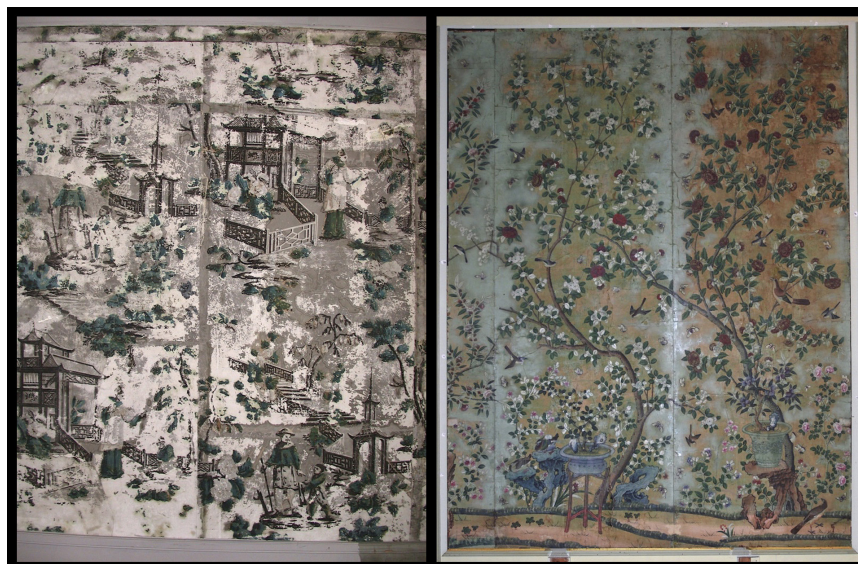
With the exception of several cracks, the plaster walls were sound with a granular final coat typical of the period. The paper exhibited planar distortions and widespread separation from the walls, marked fragility and numerous tears. There was overall discoloration from exposure, local areas of staining, tidemarks, and water damage. There were also localized areas of discoloration from the use of copper-based Blue Verditer pigment. The loss of media from cleavage and

Fig. 3. Marblehead Chinoiserie and Newport Chinese export wallcoverings, photos Studio TKM.

paper to which the painting sections were mounted overall using shellac and protein adhesives. The separation of the Masonite at overlaps and the failure of the adhesives generated large jagged tears in the wall paintings, as well as widespread areas of local separation from the panels. Interlayer separation of the original laminate structure and associated losses in the top layer of paper were also widespread. There was overall discoloration from exposure, contact with the poor quality Western lining paper and adhesives, and repair materials. The background malachite exhibited widespread loss. Earlier repairs were especially intrusive, including extensive poor quality overpainting as well as a thin application of a resin coating that was presumed to function as a consolidant or to uniformly saturate the design. To date, this project has been executed in two phases to address the three largest and most compromised assemblies, with the completion of the second phase awaiting repair of the building envelope.

For the wallcoverings to be insulated from these conditions by remounting and for their supports and media to be stabilized, overall removal for studio treatment was the only viable strategy (fig. 3). However, because of their different paper supports, media application, mounting formats, degree of individually identified compromises in condition and appearance, and history of care, the overall treatment designs differed appreciably in their complexity and priority of treatment objectives. Therefore, the degree of intervention and the procedures and materials used were appreciably different. These differences can be highlighted by introducing the relatively more straightforward project first.

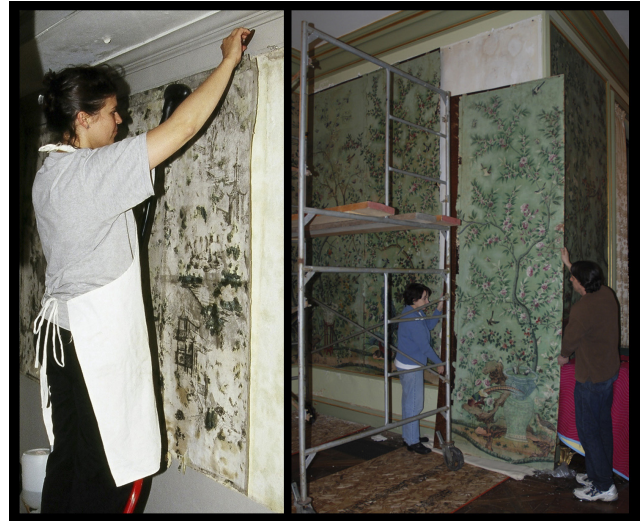
Fig. 4. Removal of Marblehead Chinoiserie and Newport Chinese export wallcoverings, photos Studio TKM.

Since it was so poorly adhered already, the Marblehead paper was straightforward to separate at the seams and remove as rolls using steam, and laid out to dry before transport to the studio in cardboard folders with newsprint interleaves

(fig. 4). In comparison, the overlapping Masonite panels from Newport were separated by reaching behind the large tears in the wall paintings caused by the separated overlaps and prying away or cutting the rivets and screws. The individual panels could then be lifted from the walls.

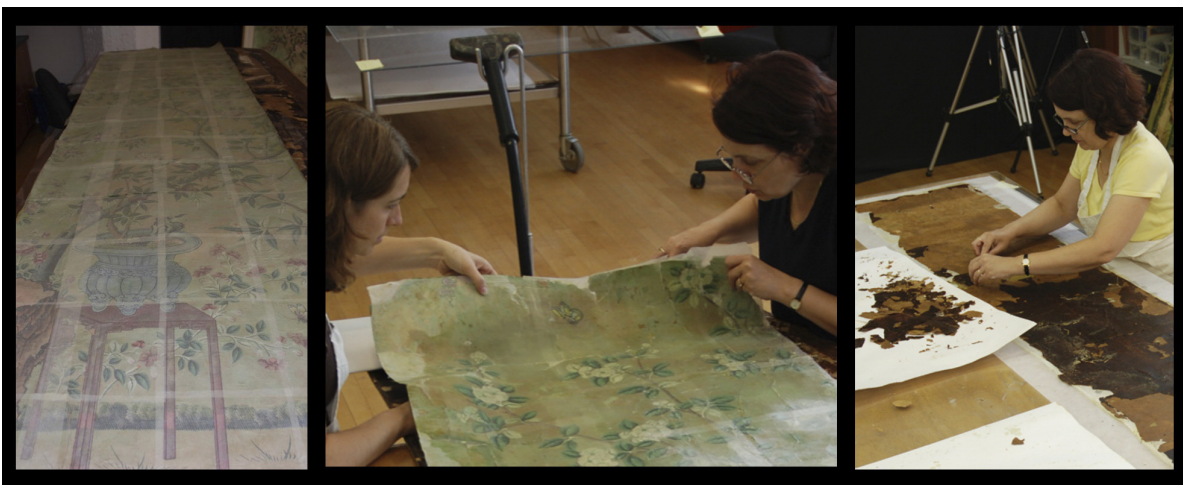
Fig. 5. Newport facing, removal from Masonite, removal of mounting remnants, photos Studio TKM.

Unlike the Marblehead wallpapers, the Newport wall paintings needed considerable attention prior to their removal from the panels. After surface cleaning with fire recovery sponges, consolidation of some media with multiple applications of gelatin depending on their sensitivity, local separations were reattached using starch paste. To take advantage of the surface resistance afforded by the still rigid assembly, the overall resinous glaze was reduced as possible, primarily with acetone, and overpaint was reduced or removed as possible with solvents and moisture.

To protect and support the Newport wall painting sections during removal from the panels, 8 × 10 in. pieces of overlapping thin rayon paper were brushed on with water without adhesive. This first facing of small sheets of thin rayon paper conformed to and protected the fragile surface while also saturating the original support and linings. Steam introduced both through the facings, and from underneath once separation began, assisted as necessary (fig. 5). Following separation from the panel and additional reinforcement of the surface with a single large sheet each of heavier weight rayon and Mylar, the large sections were safely turned over for removal of the heavyweight western lining paper. The three layers of bast fiber paper were distinguished from each other by their relative quality, color, and weight. It was removal of the thicker, more coarse third layer of bast fiber lining paper that would make possible the readhesion and reinforcement of the original support by lining. In addition to reinforcing and protecting the surface during the backing removal and linings, the facing functions as an important element of the cleaning process by wicking away the solubilized discoloration.

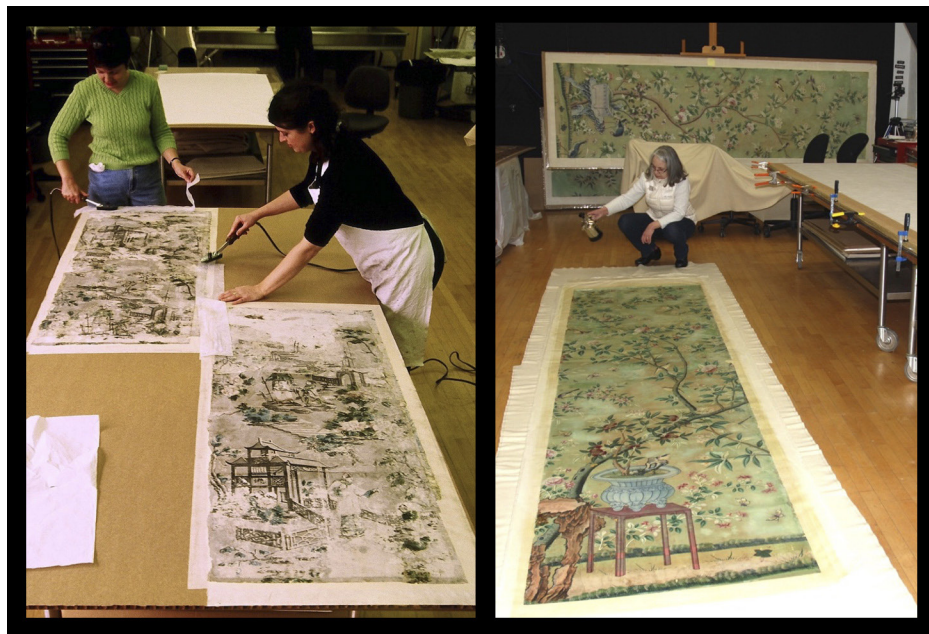
Fig. 6. Stretch flattening Marblehead and Newport wallcoverings, photos Studio TKM.

Both wallpapers and wall paintings were similarly flattened by humidification and stretch drying on sheets of 0.5 in. thick honeycomb board (fig. 6). These are a good alternative to the traditional *karibari*² when it is preferable to have the board bend somewhat to avoid over tensioning the object while drying and for projects where many panels are necessary. A large, even, unobstructed, and clean floor can also be used for lining and flattening oversize works.

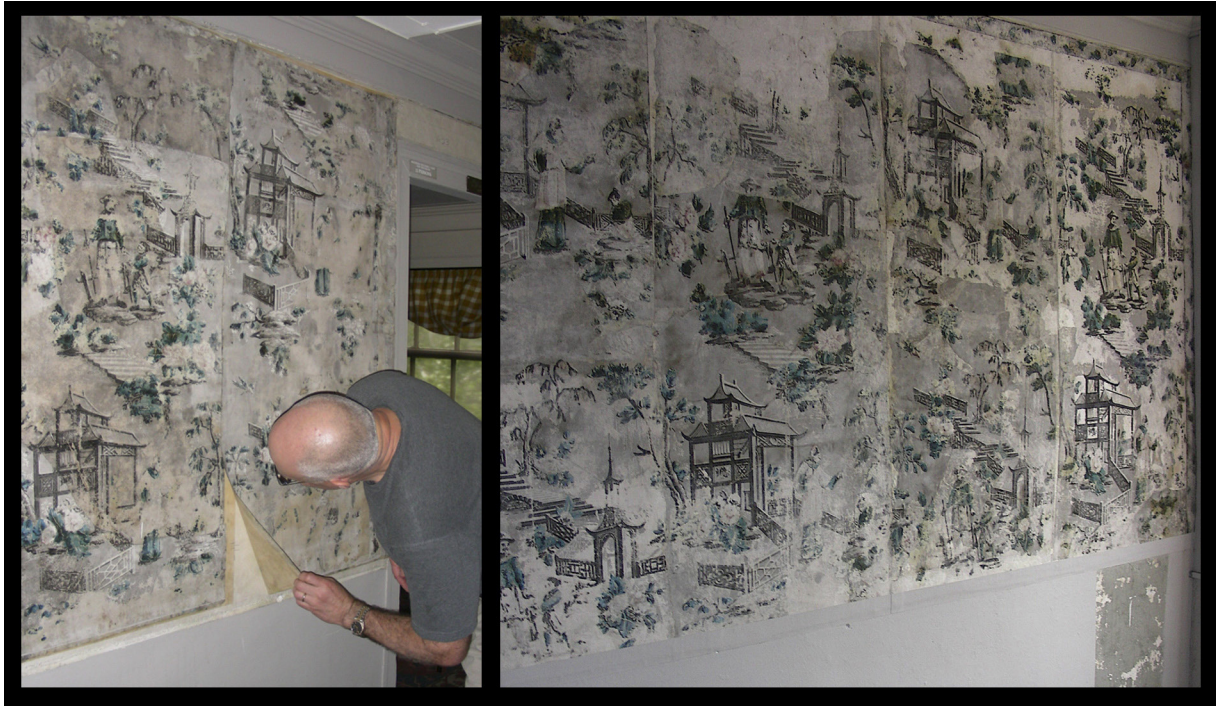
Fig.7. Marblehead remounting, photos Studio TKM.

archeological in appearance and therefore retouching was only carried out at a few tear edges and on the lining where visible under losses. The walls were prepared months beforehand with layers of pre-washed and shrunk cotton and heavyweight machine made Japanese paper (Paper Nao RK29), followed by sizing with wheat starch paste. During the actual remounting, it is critical to first hang the rolls dry to identify where edges should fall and, especially with pattern papers, to identify where each numbered roll should be located. It's also essential to apply enough adhesive (starch paste/cellulose ether combination) with the right viscosity both to prevent oversaturation and to lubricate adjustments in position—the surface sizing mentioned above contributes to this lubrication by preventing premature absorption of the adhesive (fig. 7). Rubbing the surface through newsprint protects the surface while promoting overall contact with the wall and absorbs excess moisture or adhesive that finds its way onto the surface.

For the Marblehead wallpaper, constraining expansion and contraction to mitigate further cleavage of the media was the rationale for mounting overall to a rigid surface. On the other hand, for many Asian paintings that are thinner assemblies, it is preferable to accommodate seasonal expansion and contraction while providing overall support. The use of aluminum honeycomb panels covered on one side

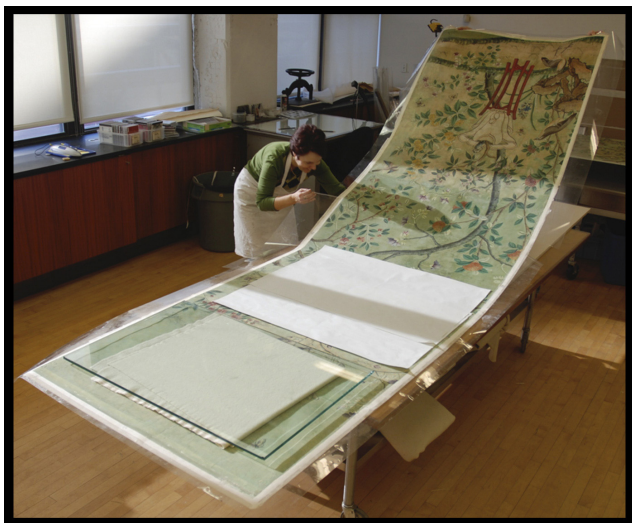
Fig. 8. Newport mounting section on panel, photos Studio TKM.

with matboard and the system of paper layers found on the Japanese screen surface³ (*shitabari*) was identified early in the process as the preferred mounting format for the Newport wall paintings. The surface of the Japanese panel structure performs that function exceptionally well, in addition to providing ease of future removal of the paintings due to the *ukekake* release layer. A critical feature of the aluminum panels vs. the traditional lattice structure was their impermeability and isolation of the paintings from the exterior walls. The client also wanted a system that was easily removed in the event of an emergency. However, single honeycomb panels for sections three rolls wide (135×126 in.) would not fit through the doors to the ballroom so it was necessary to join separate panels that mirror in width the original seam locations of the wall paintings. Two procedures are particularly useful in mounting works this large. First, instead of marking where the corners of the panel would fall on the back of the painting sections, registration marks are made at the center of each side of both the panel and the painting. In this way, expansion of the object during mounting will not affect alignment. Second is to place two or more slightly overlapping sheets of Mylar on the reverse of the object after pasting to facilitate positioning of such large works—after the object is precisely registered and weighted at one end, the first Mylar sheet is removed to establish contact, after which the remaining sheets of Mylar are removed and full surface contact is made using the newsprint as explained above (fig. 8). With exposure to moisture concluded, a final
