# Cultural Landscape Report

## Jacob Riis Park

Gateway National Recreation Area

1992

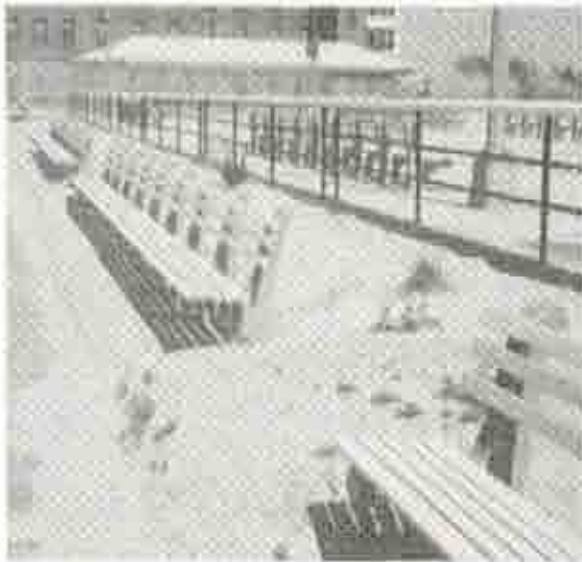
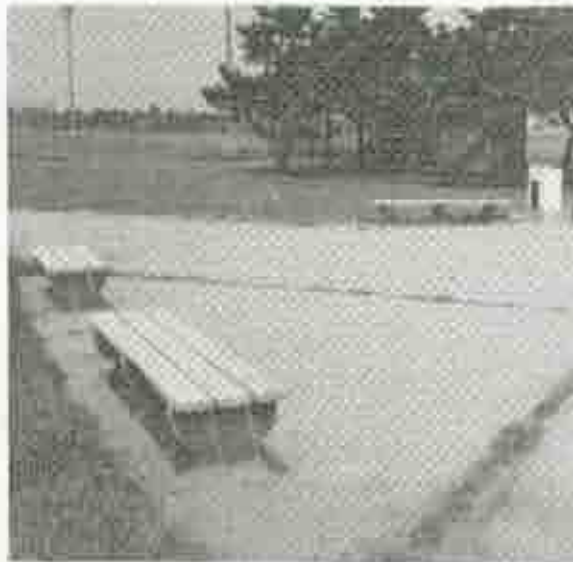
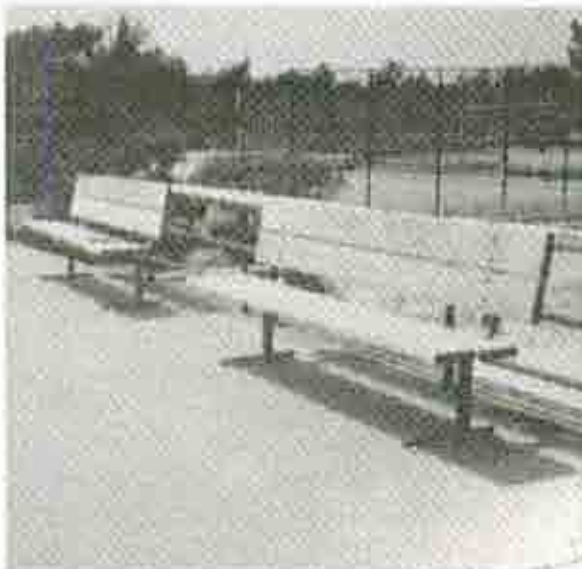
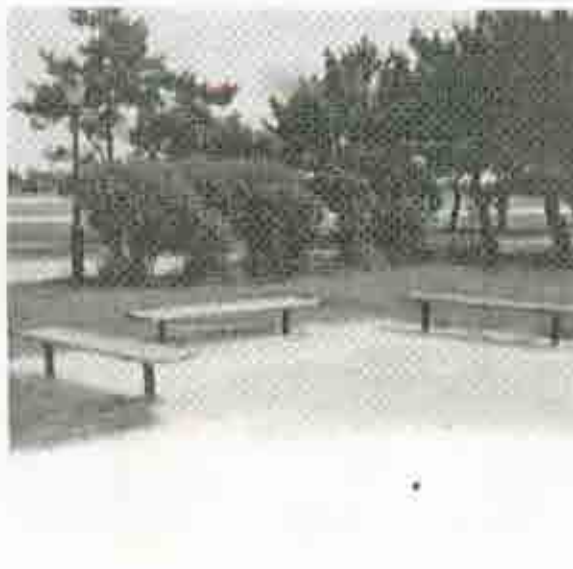
Figure 18: Existing Benches at Jacob Riis Park

The four main Bench types currently in use at the Park are indicated in Figure 18. Two of these types were indicated in original plans and appear in historic photos (see Figure A-9); these are "Lundino" benches with an exposed aggregate concrete base with wooden slats used as the seat, both with and without a wooden back. In most cases, paint is peeling, some wooden slats are missing or damaged and some concrete bases are broken. The third and fourth type of benches which now exist in the park, mostly behind the Bathhouse and along the Promenade / Boardwalk, have been more recently introduced (post 1960), with galvanized metal supports and a wooden seat and back. These benches are incompatible with the style of site furniture used in the original 1936-37 park design, although these newer, post mounted benches do not show as much deterioration as the older, concrete base benches.

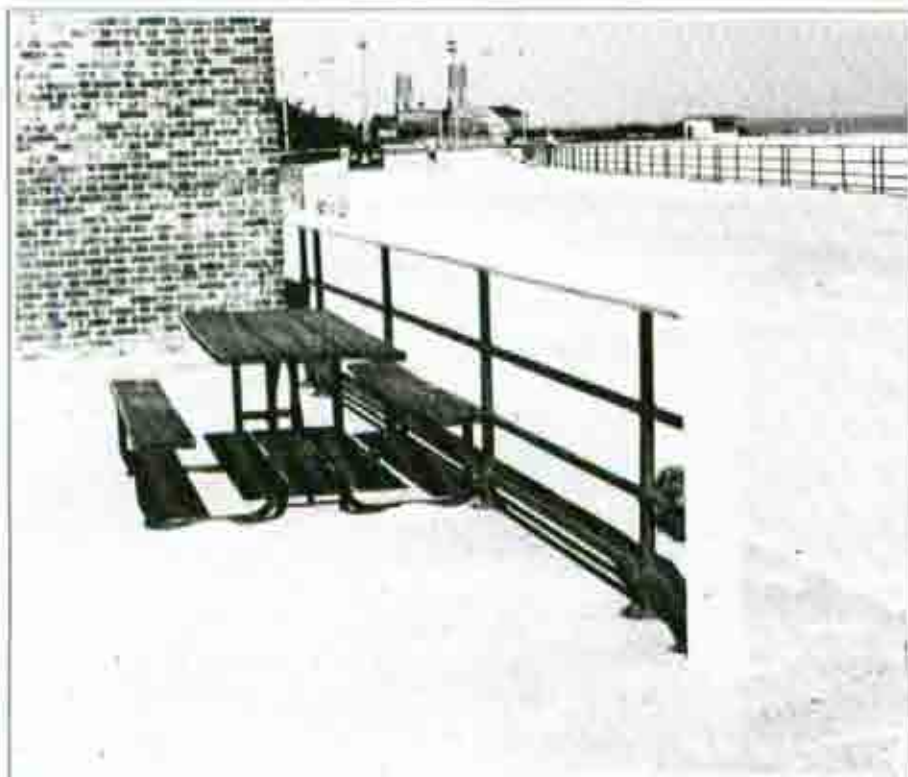
Figure 20: Ships railing and contemporary picnic table

The Picnic Tables now used in the park, installed to meet contemporary recreational demands, are seasonally used in the Mall (see Figure 20). It is not known exactly when these items were introduced. Each table is a one piece modular design of galvanized tubular steel with a wooden top and seats. Most appeared to be in good condition. These items are not historic, as there is no documented evidence of picnic tables having been in use at Jacob Riis Park in the initial plans or site photographs.

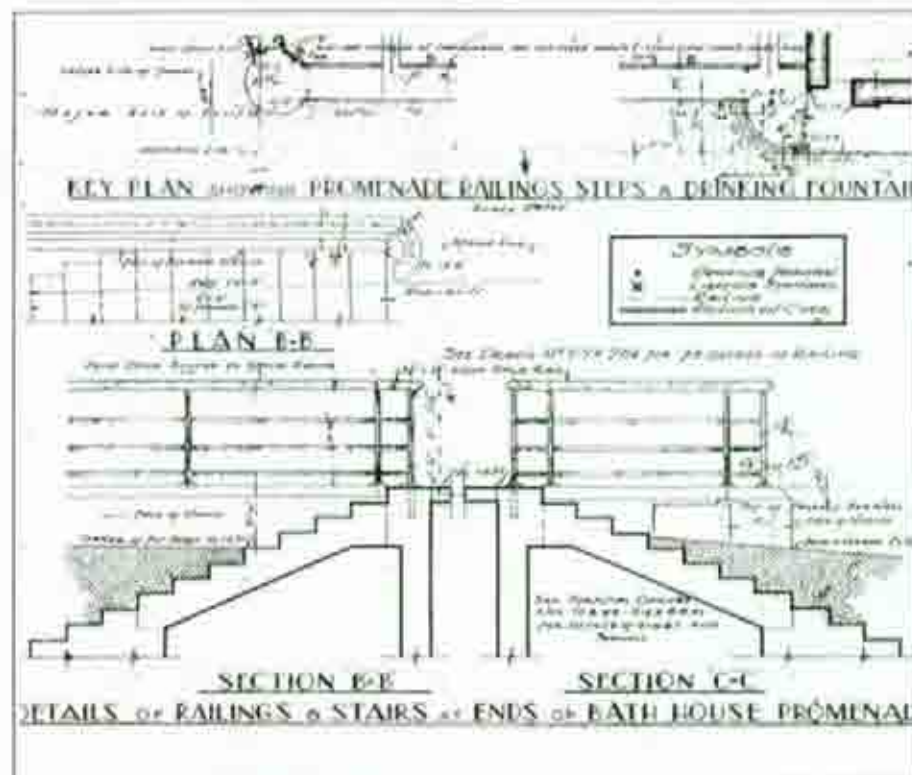
Figure 21: Original cross-section of ships railing

The Ships Railing used along the Boardwalk / Promenade was installed during the 1936-37 park expansion and is a prominent site element which provides continuity and scale to the park (see Figures A-14, A-25, and A-30). The Ships Railing is a design made up of round section steel pipe topped with a wooden cap made of Douglas Fir. This cap is in various states of disrepair. Some sections are thoroughly rotted, some are broken and splintered, while others are missing altogether. A few sections have been replaced and are in an adequate condition, other sections have been replaced with pieces

of wood that are not similar to the original wooden railing.

surface. Original details are shown in Figure 21. The finish of the wooden caps also varies from a white painted finish, to varnish, to bare wood depending degree of exposure to sun, wind, and water. Records do not indicate how the original rail was finished. Exposure to the elements has also caused much of the pipe railings to become rusted, pitted and blistered. The worst damage has occurred on the ocean (south) side of the railing and in some places pipe sections are almost completely rusted through.

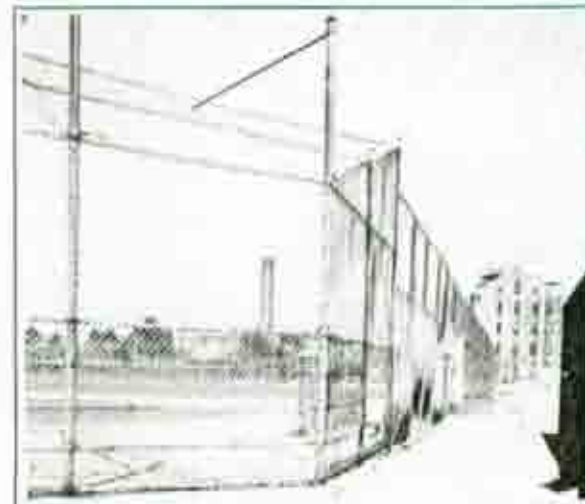
Figure 22: Existing Chain Link fence

Chain link fencing is called for on a number of plans and drawings from the 1930's. Photographs and notes on plans indicate heights as great as sixteen feet in some of the game court areas (see Figures A-9 and A-14, which indicate that these fences separated game court activities from one another and from the Boardwalk). Some proportion of this chain link fence has been removed, as indicated in comparative plans in Chapter 6, dealing with the Back Beach. Chain link around ball fields was added later, as these uses were not part of the original design. This material has also suffered from the effects of time, weather and use as evidenced by rusted and torn sections of fencing that in many places have fallen away from their supports (see Figure 22).

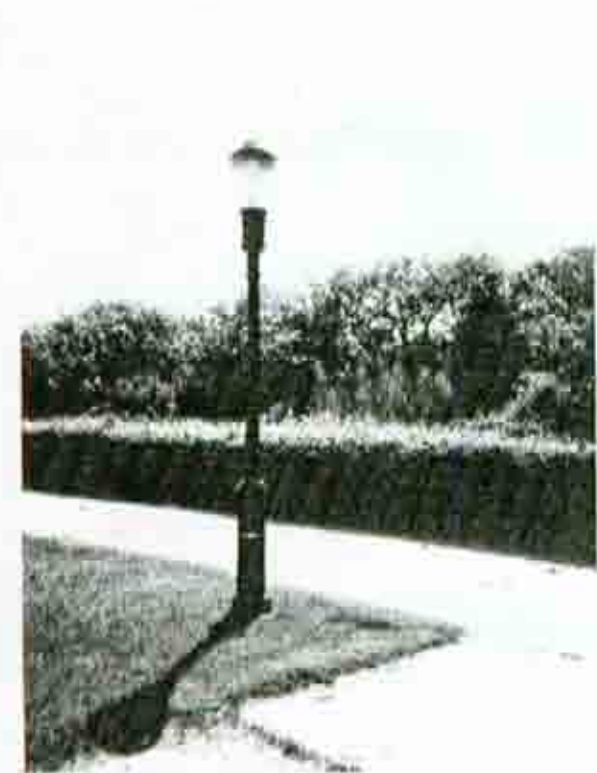
Type B Light

- o **Type B** -- The style of light used in the Back Beach area along the eastern ball fields and Mall areas, is a New York pedestrian scale fixture, manufactured out of cast metal and most are in working order. Most of the globes, however, appear dirty and are partially filled with debris. The

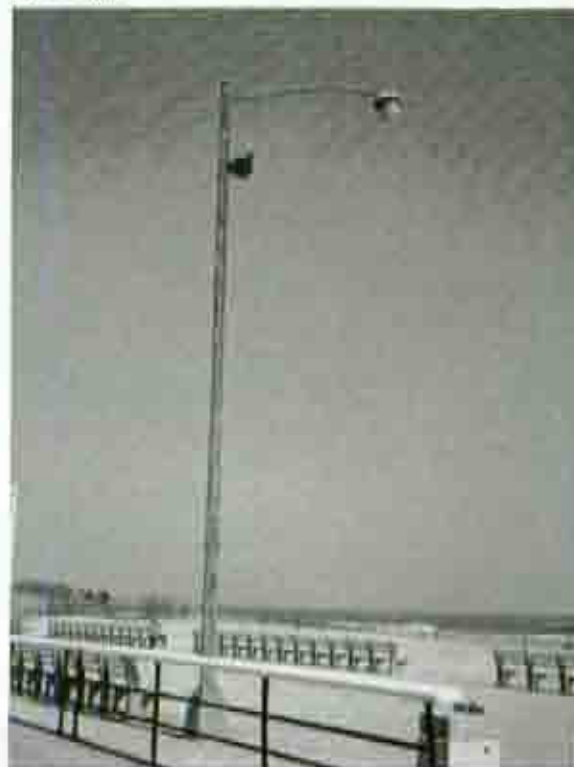
Type C Light

o **Type C** -- The third style of light is used only at the far east end of the Promenade. These lights were introduced in 1960 as part of the park extension to the east and are not of historic importance. These lights are standard aluminum street light all of which are in fair condition but have deteriorating finishes.

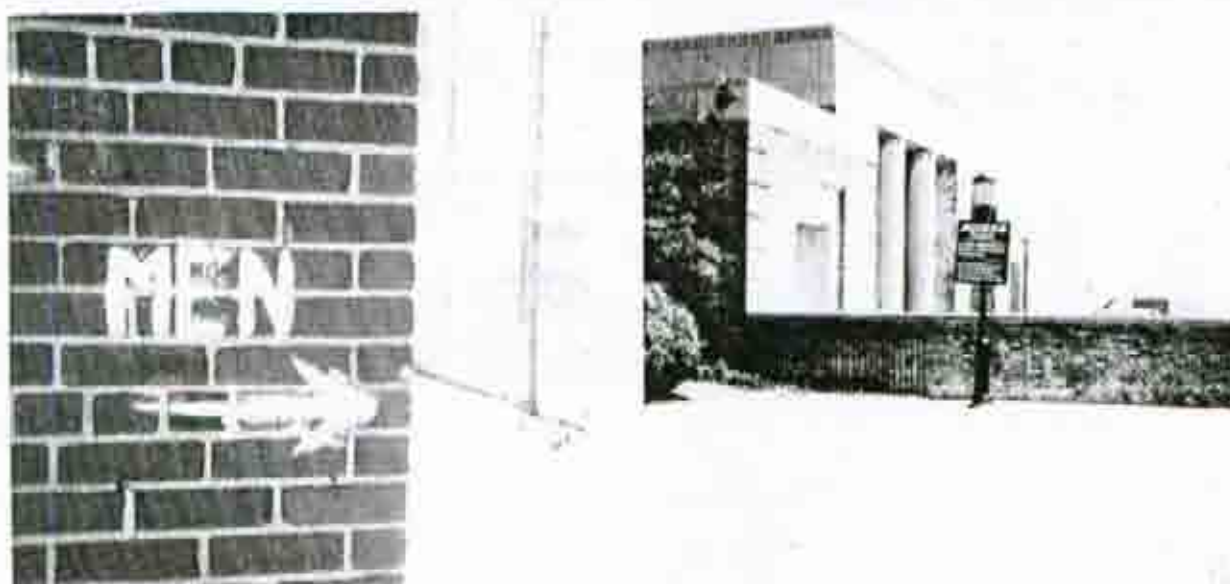
Figure 25: Two types of existing signage

Nearly all original signs have been lost and those signs which remain are contemporary, comprising a mix of standard NPS identification signs, prohibitory signs, and handicapped access emblems. Several types of Signs are encountered in the Park (see Figure 25). The standard park identification signs used by the National Park Service are sited along heavily traveled pedestrian access points and are in a well maintained condition. The Directional/ Informational signs are also in good condition. These describe a very limited number of user rules and Park fares, and are placed on light poles at an approximate height of eight feet with the sign

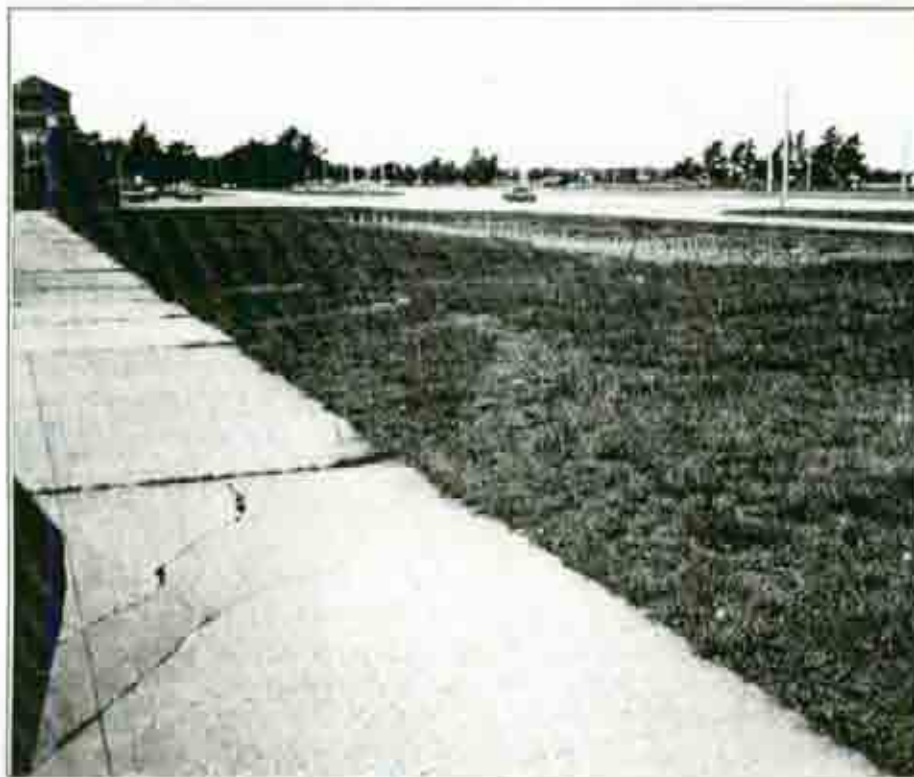
Figure 28: Open lawn and entry plaza to Bathhouse

tions. The plaza and walks north of the building have some cracking and weed growth but are in good condition (see Figure 28). The walks to east and west of the building are in good condition also, although several panels have been replaced with new concrete. The concrete paving in the parking lot does not appear to have been altered since it was installed and is in fair condition, although it has experienced settlement in some areas, causing puddling when it rains.

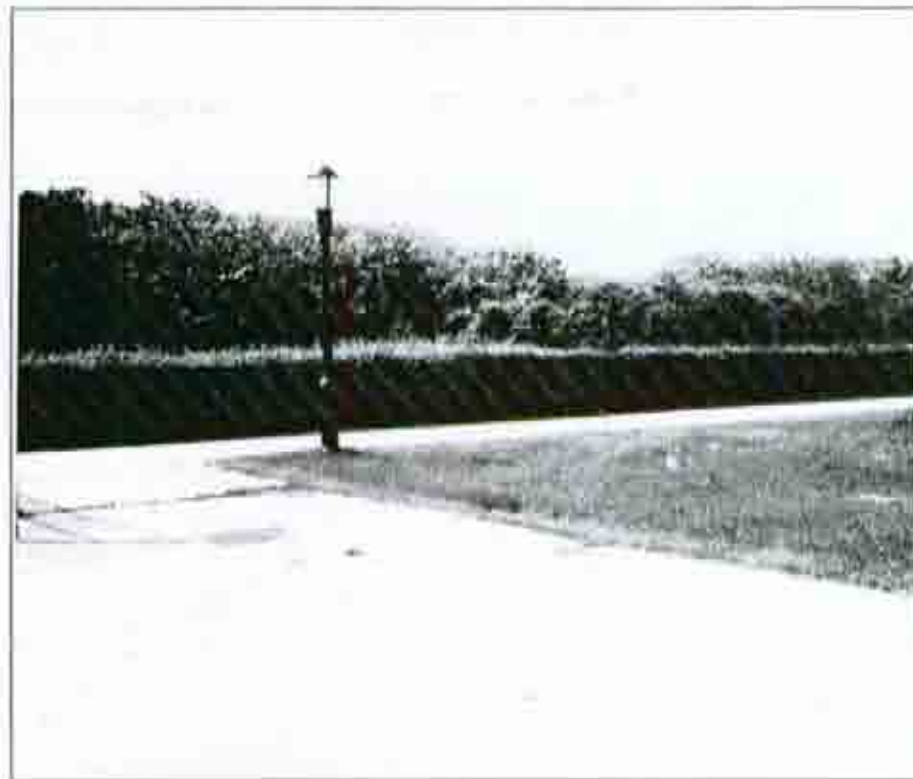
Figure 33: New York Type "B" cast metal light in Bathhouse area

The predominant lighting that is used within the Bathhouse area is the cast metal New York Type "B" (B) pedestrian scale light that is used in several other locations throughout the park. These lights were installed as part of the 1937 construction and supplemented in 1948 to serve pedestrian areas, and seem to be an important and consistent site element throughout the park, although some of them appear to require maintenance (see Figure 33). Other lights which were installed in 1932, since removed, included a square wooden pole with square cross-arm type lights in use around the Bathhouse in the 1930's. These lights were similar to those now in use at nearby Jones Beach. One of these lights remains in the parking lot.

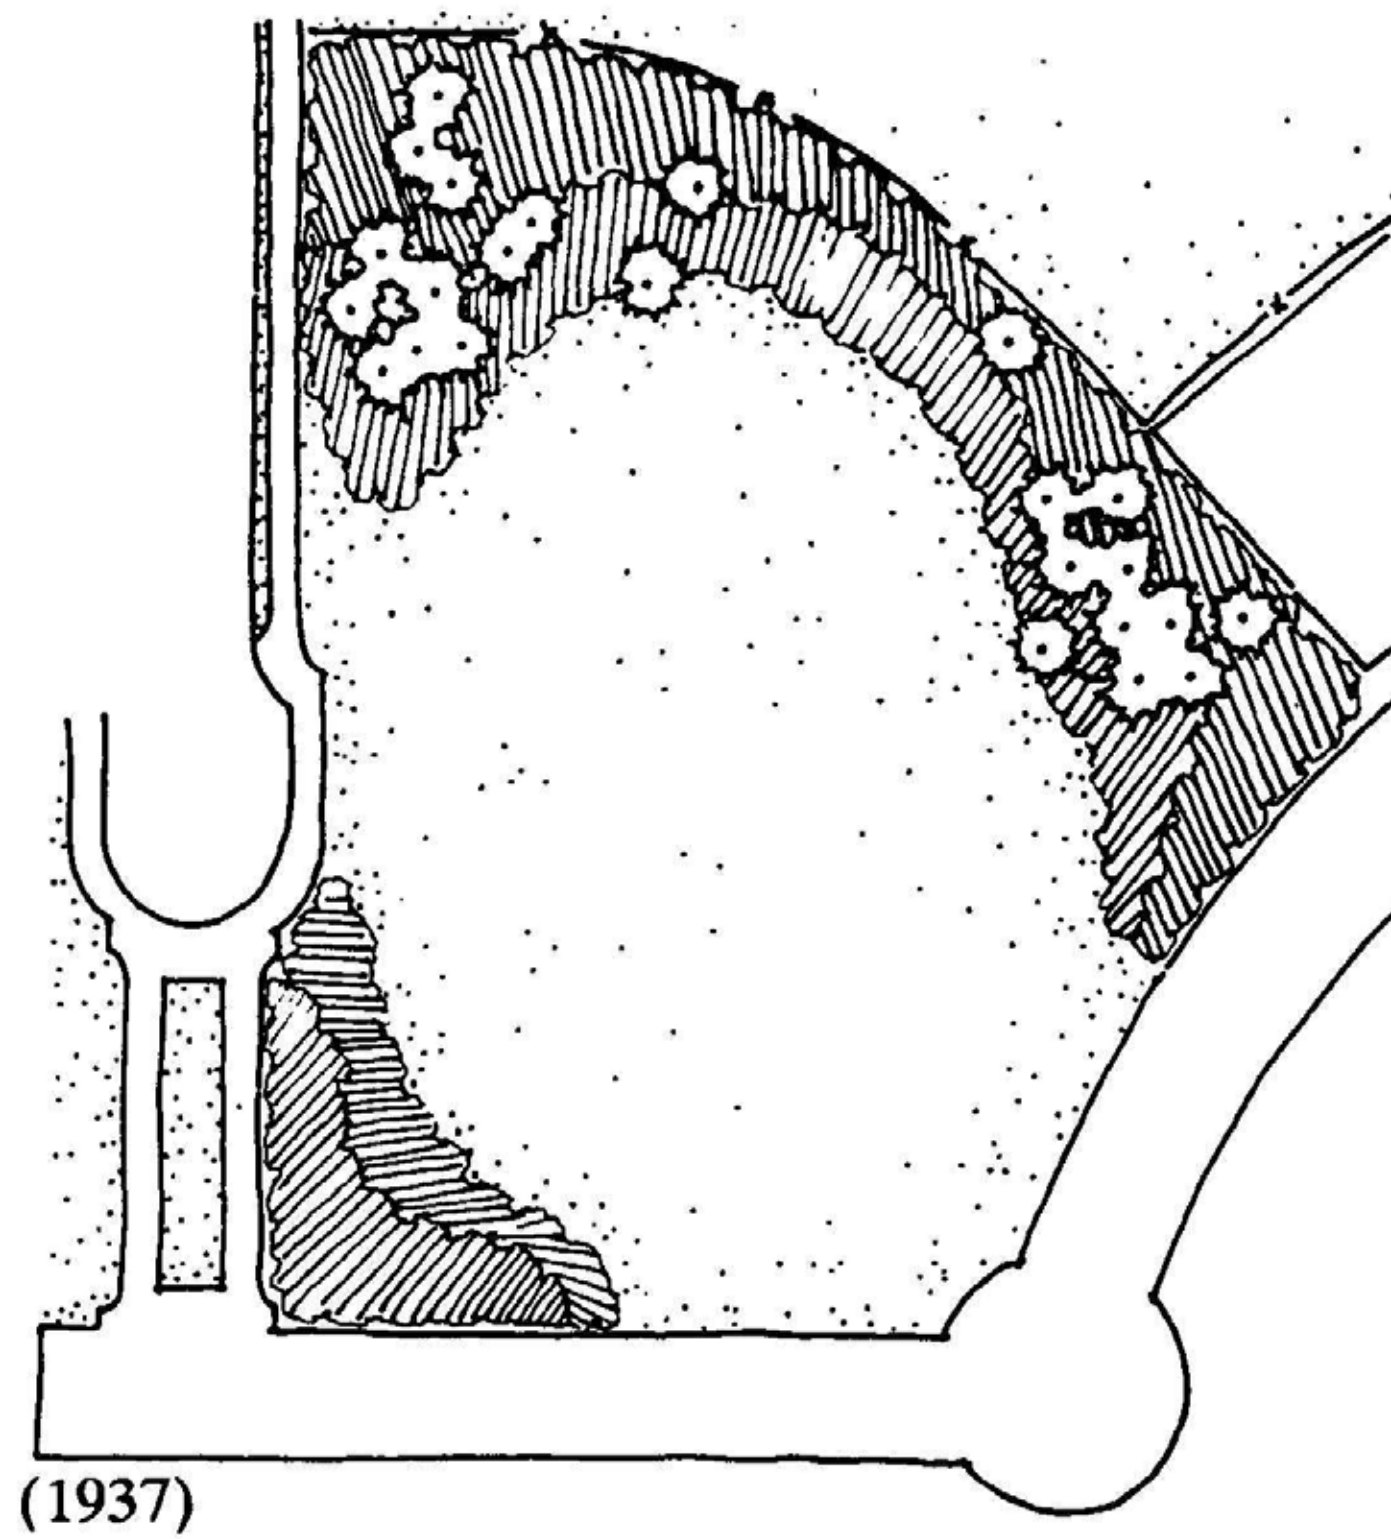
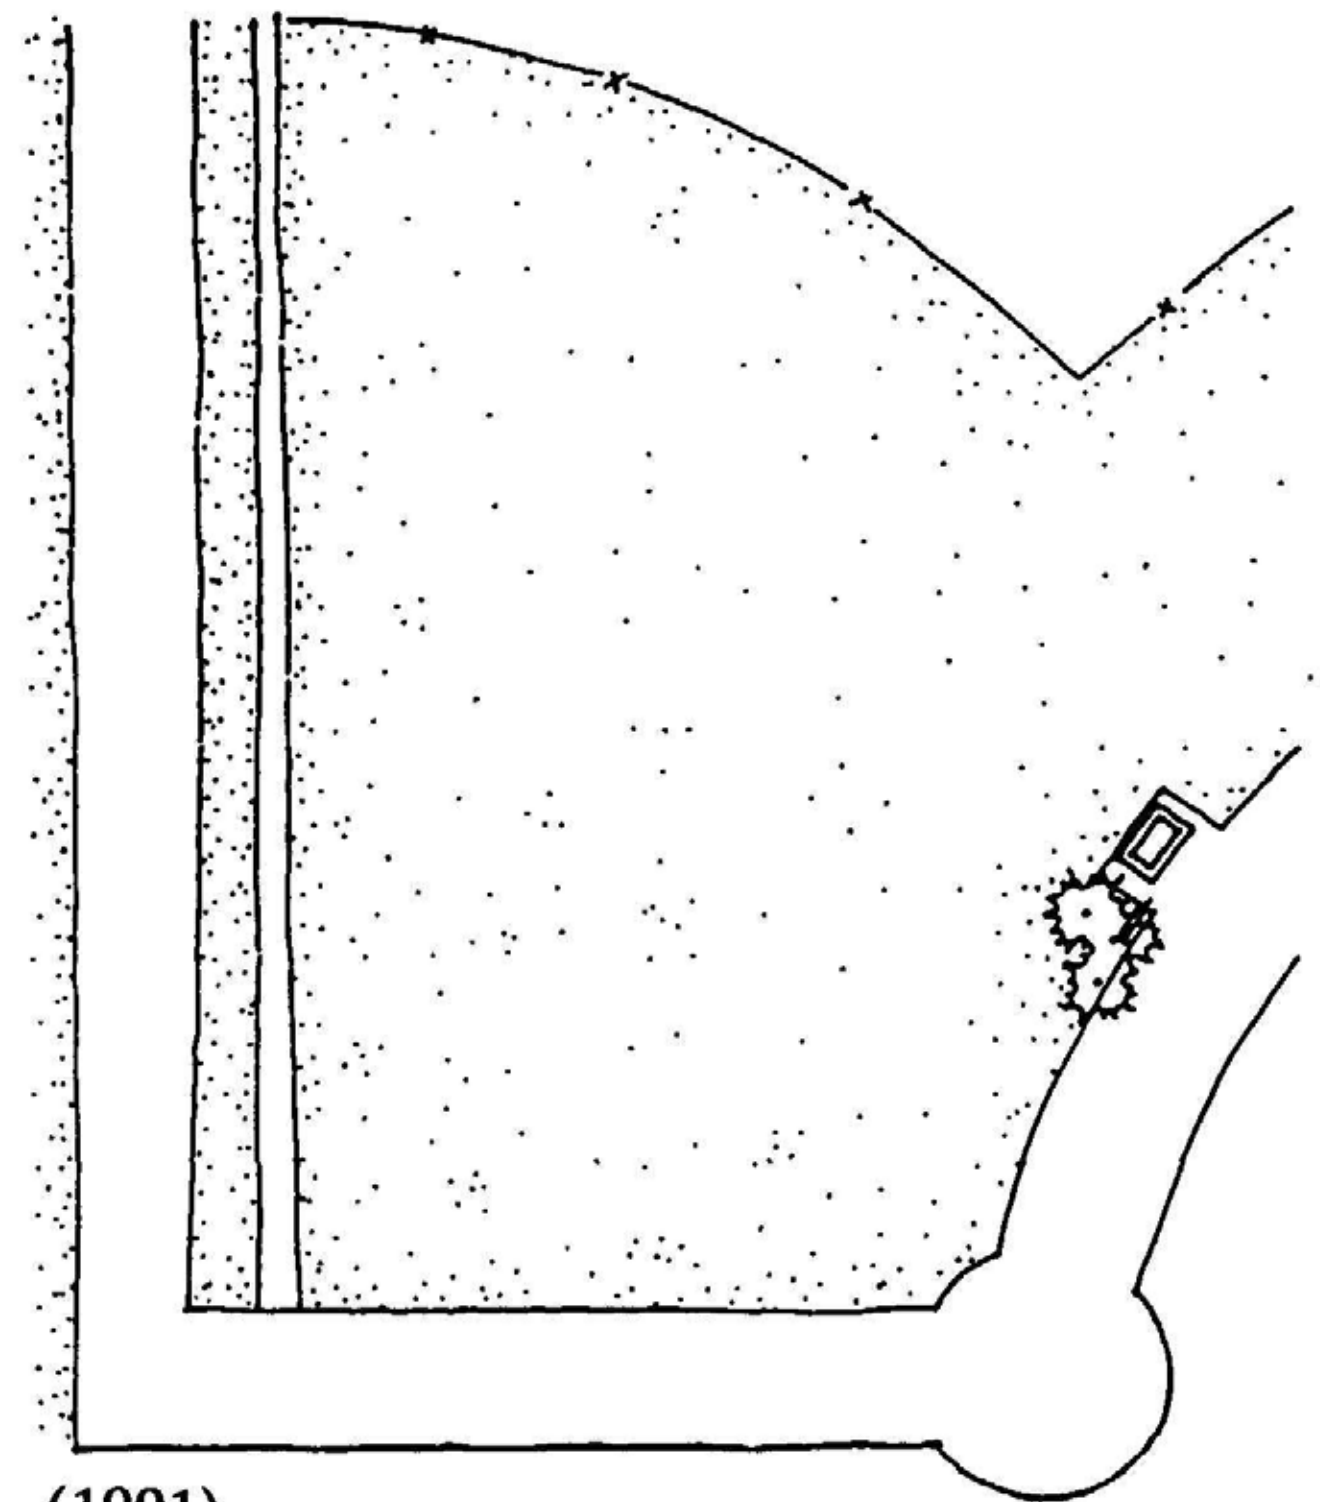
Figure 50: Back Beach Area comparison of 1937 and 1991 configuration

- o Figure 50 shows the westernmost open space area, which was shown as open, passive space in 1937 and remains undeveloped today, with the exception of the Concession Stand along the Boardwalk, added in 1947 (see Figure B - 2, Appendix B);

In the case of the area to the extreme west of the Back Beach, no plantings remain today that were included in the 1937 design. This is simply an under-utilized open space that is beginning a successional process which, if not changed, eventually will return itself to a natural beach/dune environment. (see Figure 50)

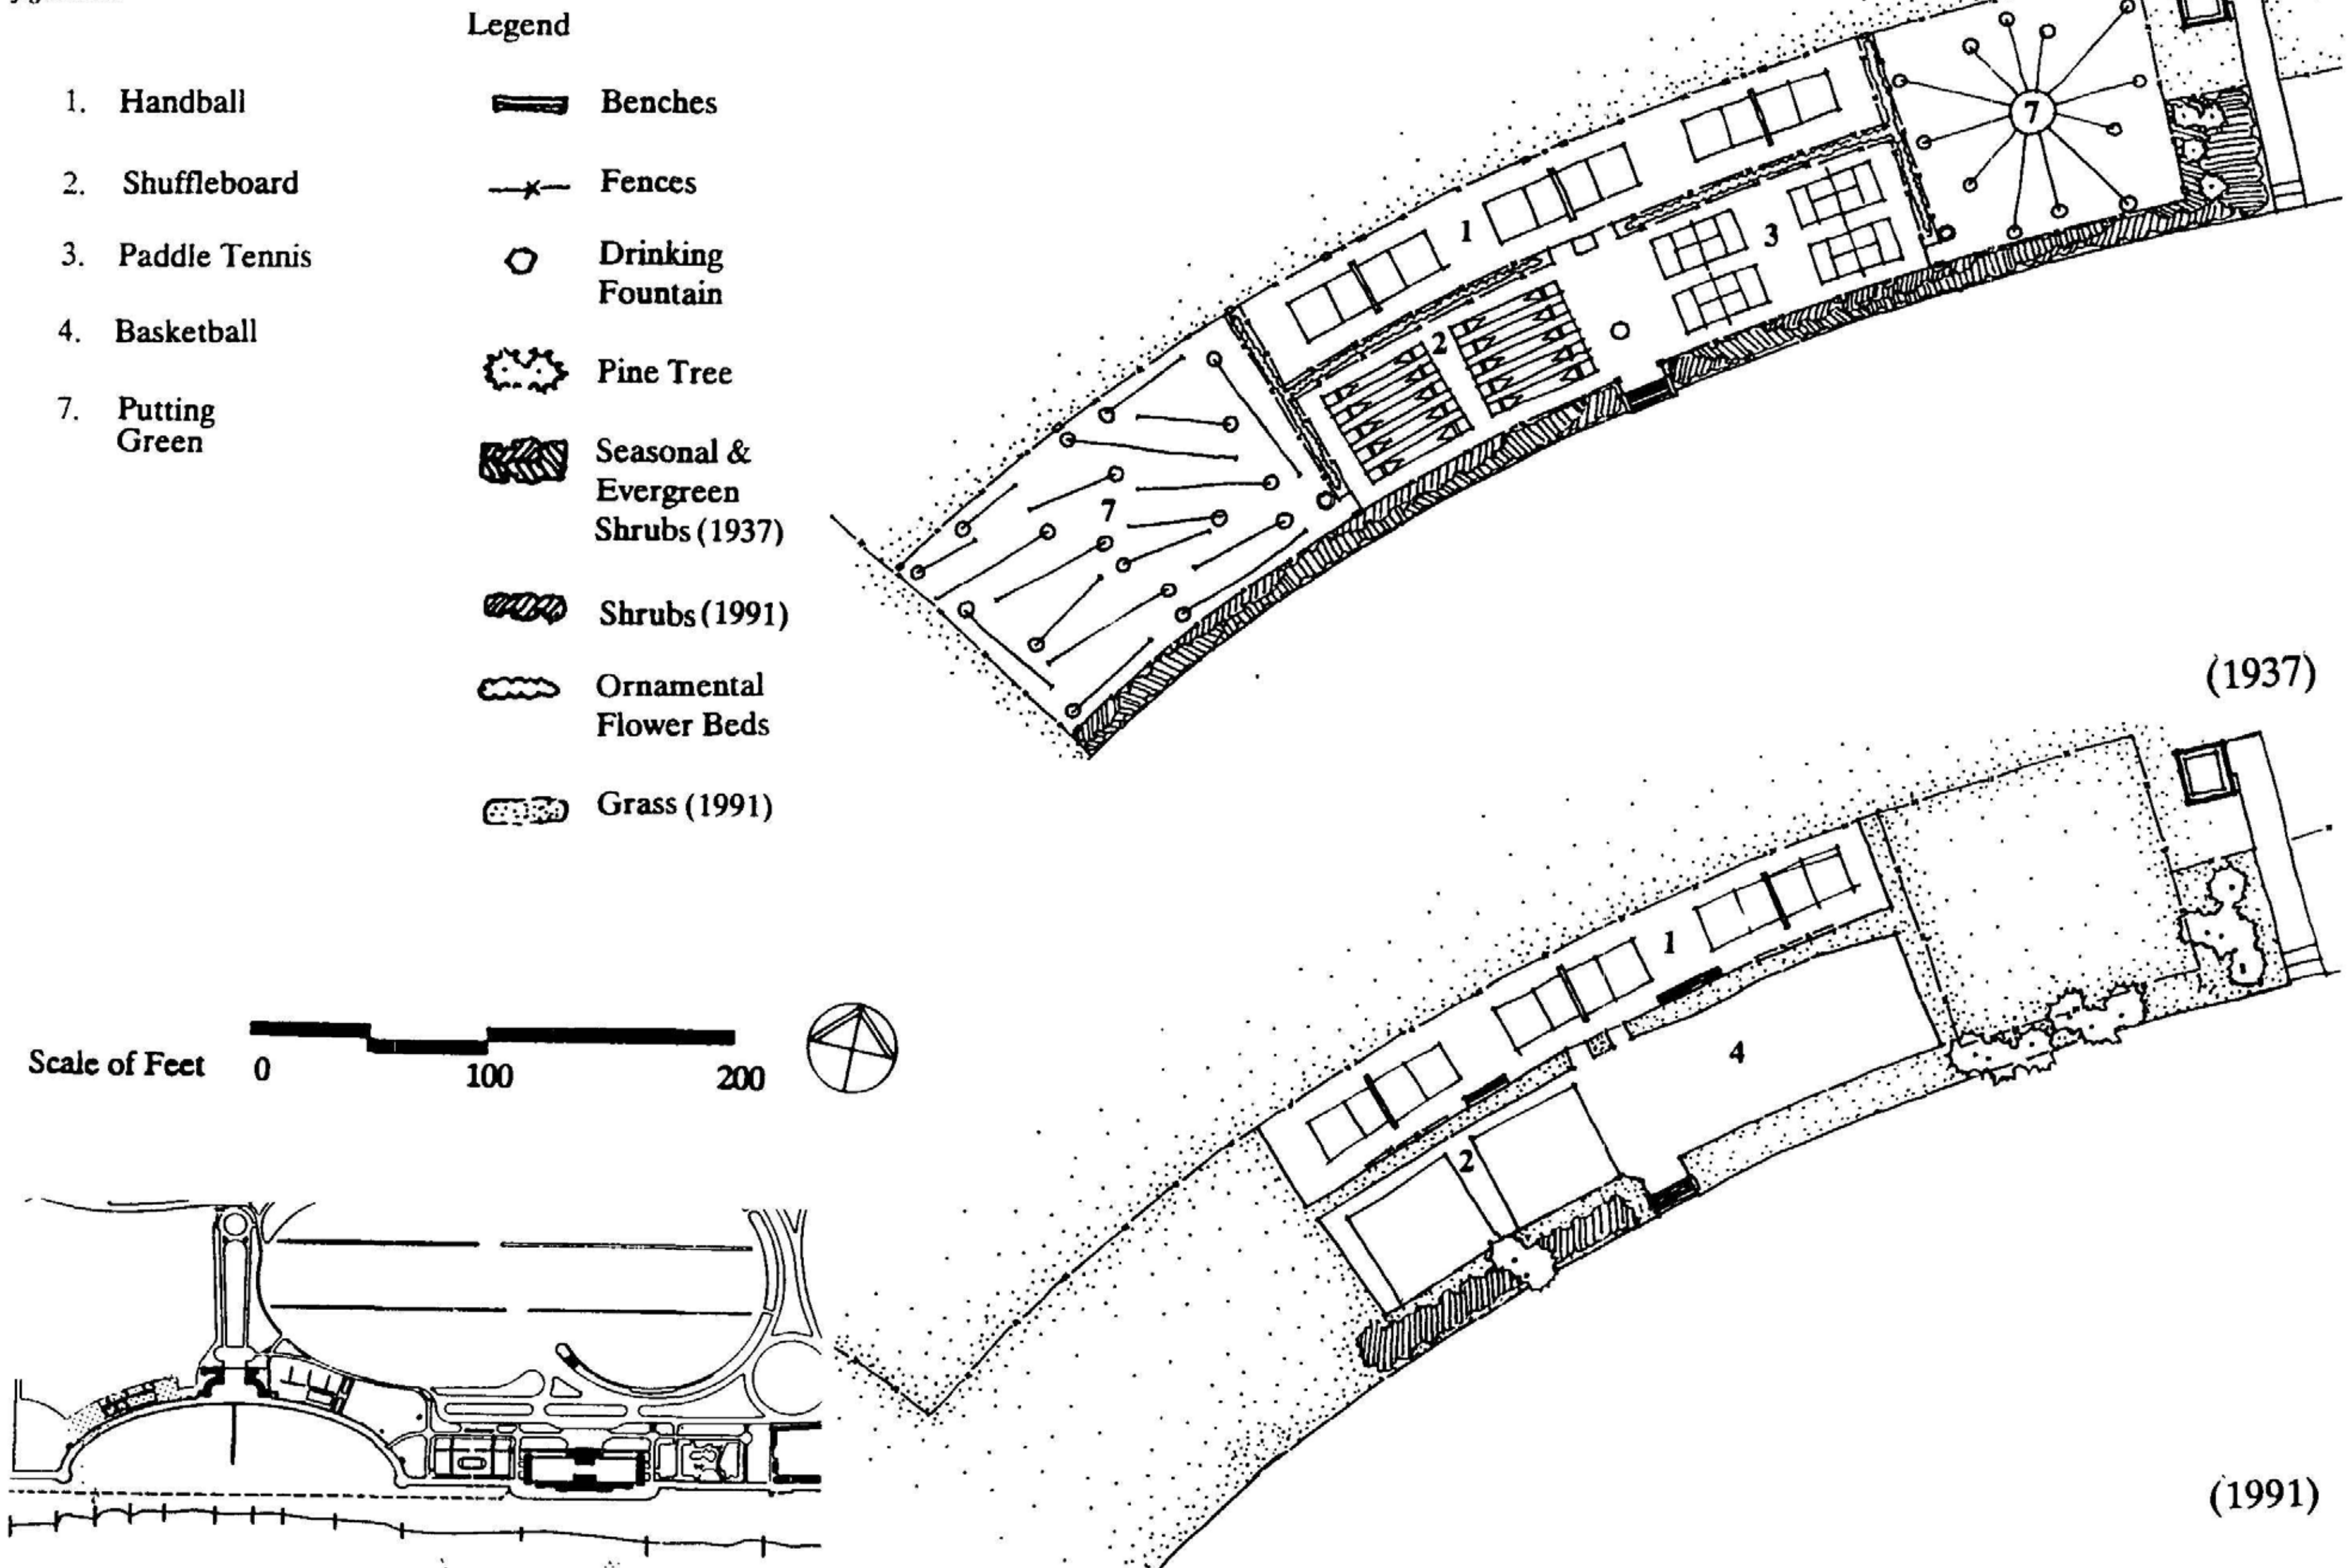
Figure 51: Back Beach Area, comparison of 1937 and 1991 configuration

- o Figure 51 shows the game court area to the west of the Mall Buildings. This area was originally planned to have miniature golf, shuffleboard, paddle tennis, and handball. Another use which is not defined on the drawings or immediately apparent from its shape is shown to the far east of this area (see Figure B - 3, Appendix B). This area originally had the typical center entrance from the Boardwalk, entry kiosk, and fenced perimeters. Separate entries and fee collection areas were shown to the extreme east and west. This area retains the basic pattern within the paved center portion, with relatively unchanged handball courts and shuffleboard layouts, although a large proportion of the fencing is missing or deteriorated. Basketball backboards have been placed in the former paddle tennis area. The east and west areas have reverted to grass, having lost the activities originally designed for them.

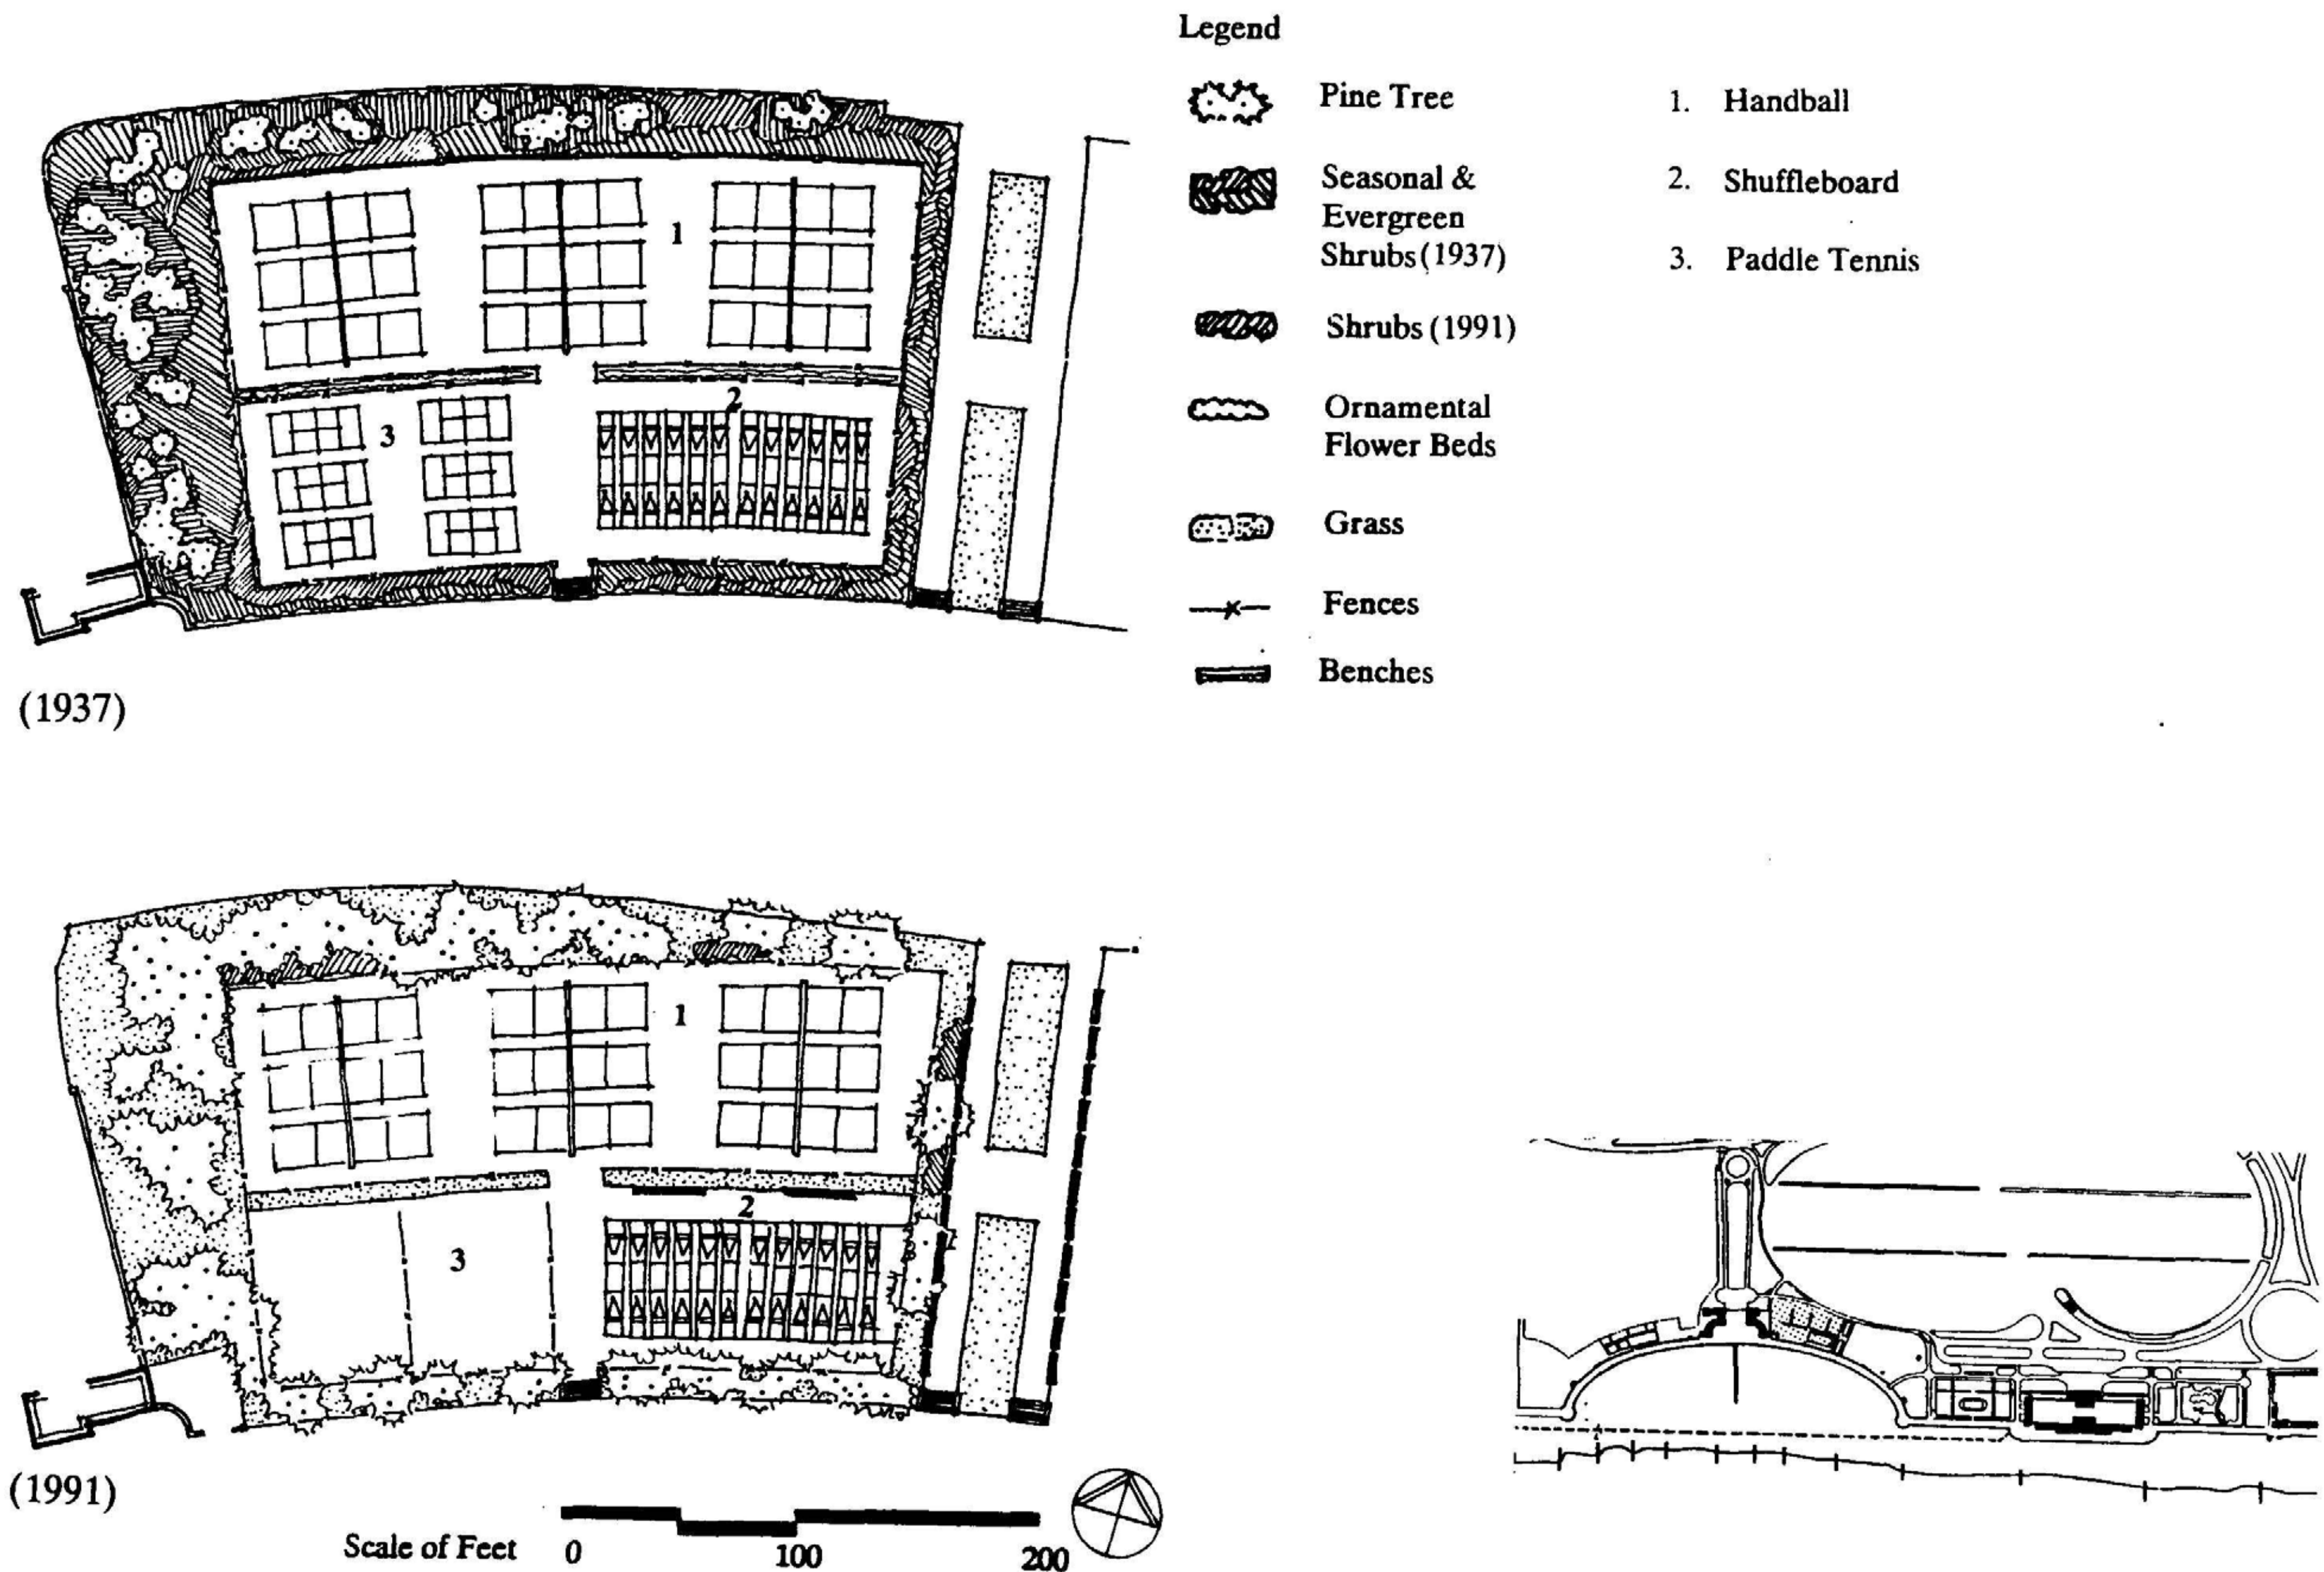
Figure 52: Back Beach Area, comparison of 1937 and 1991 configurations

- o Figure 52 shows the game court area east of the Mall Buildings (see Figure B - 5, Appendix B). This was originally designed for paddle tennis, handball, and shuffleboard. These basic delineations remain, although the paddle tennis area has been reoriented. Portions of the fencing remain, although other fences have been added.
