# Cultural Landscape Report

## Jacob Riis Park

Gateway National Recreation Area

1992

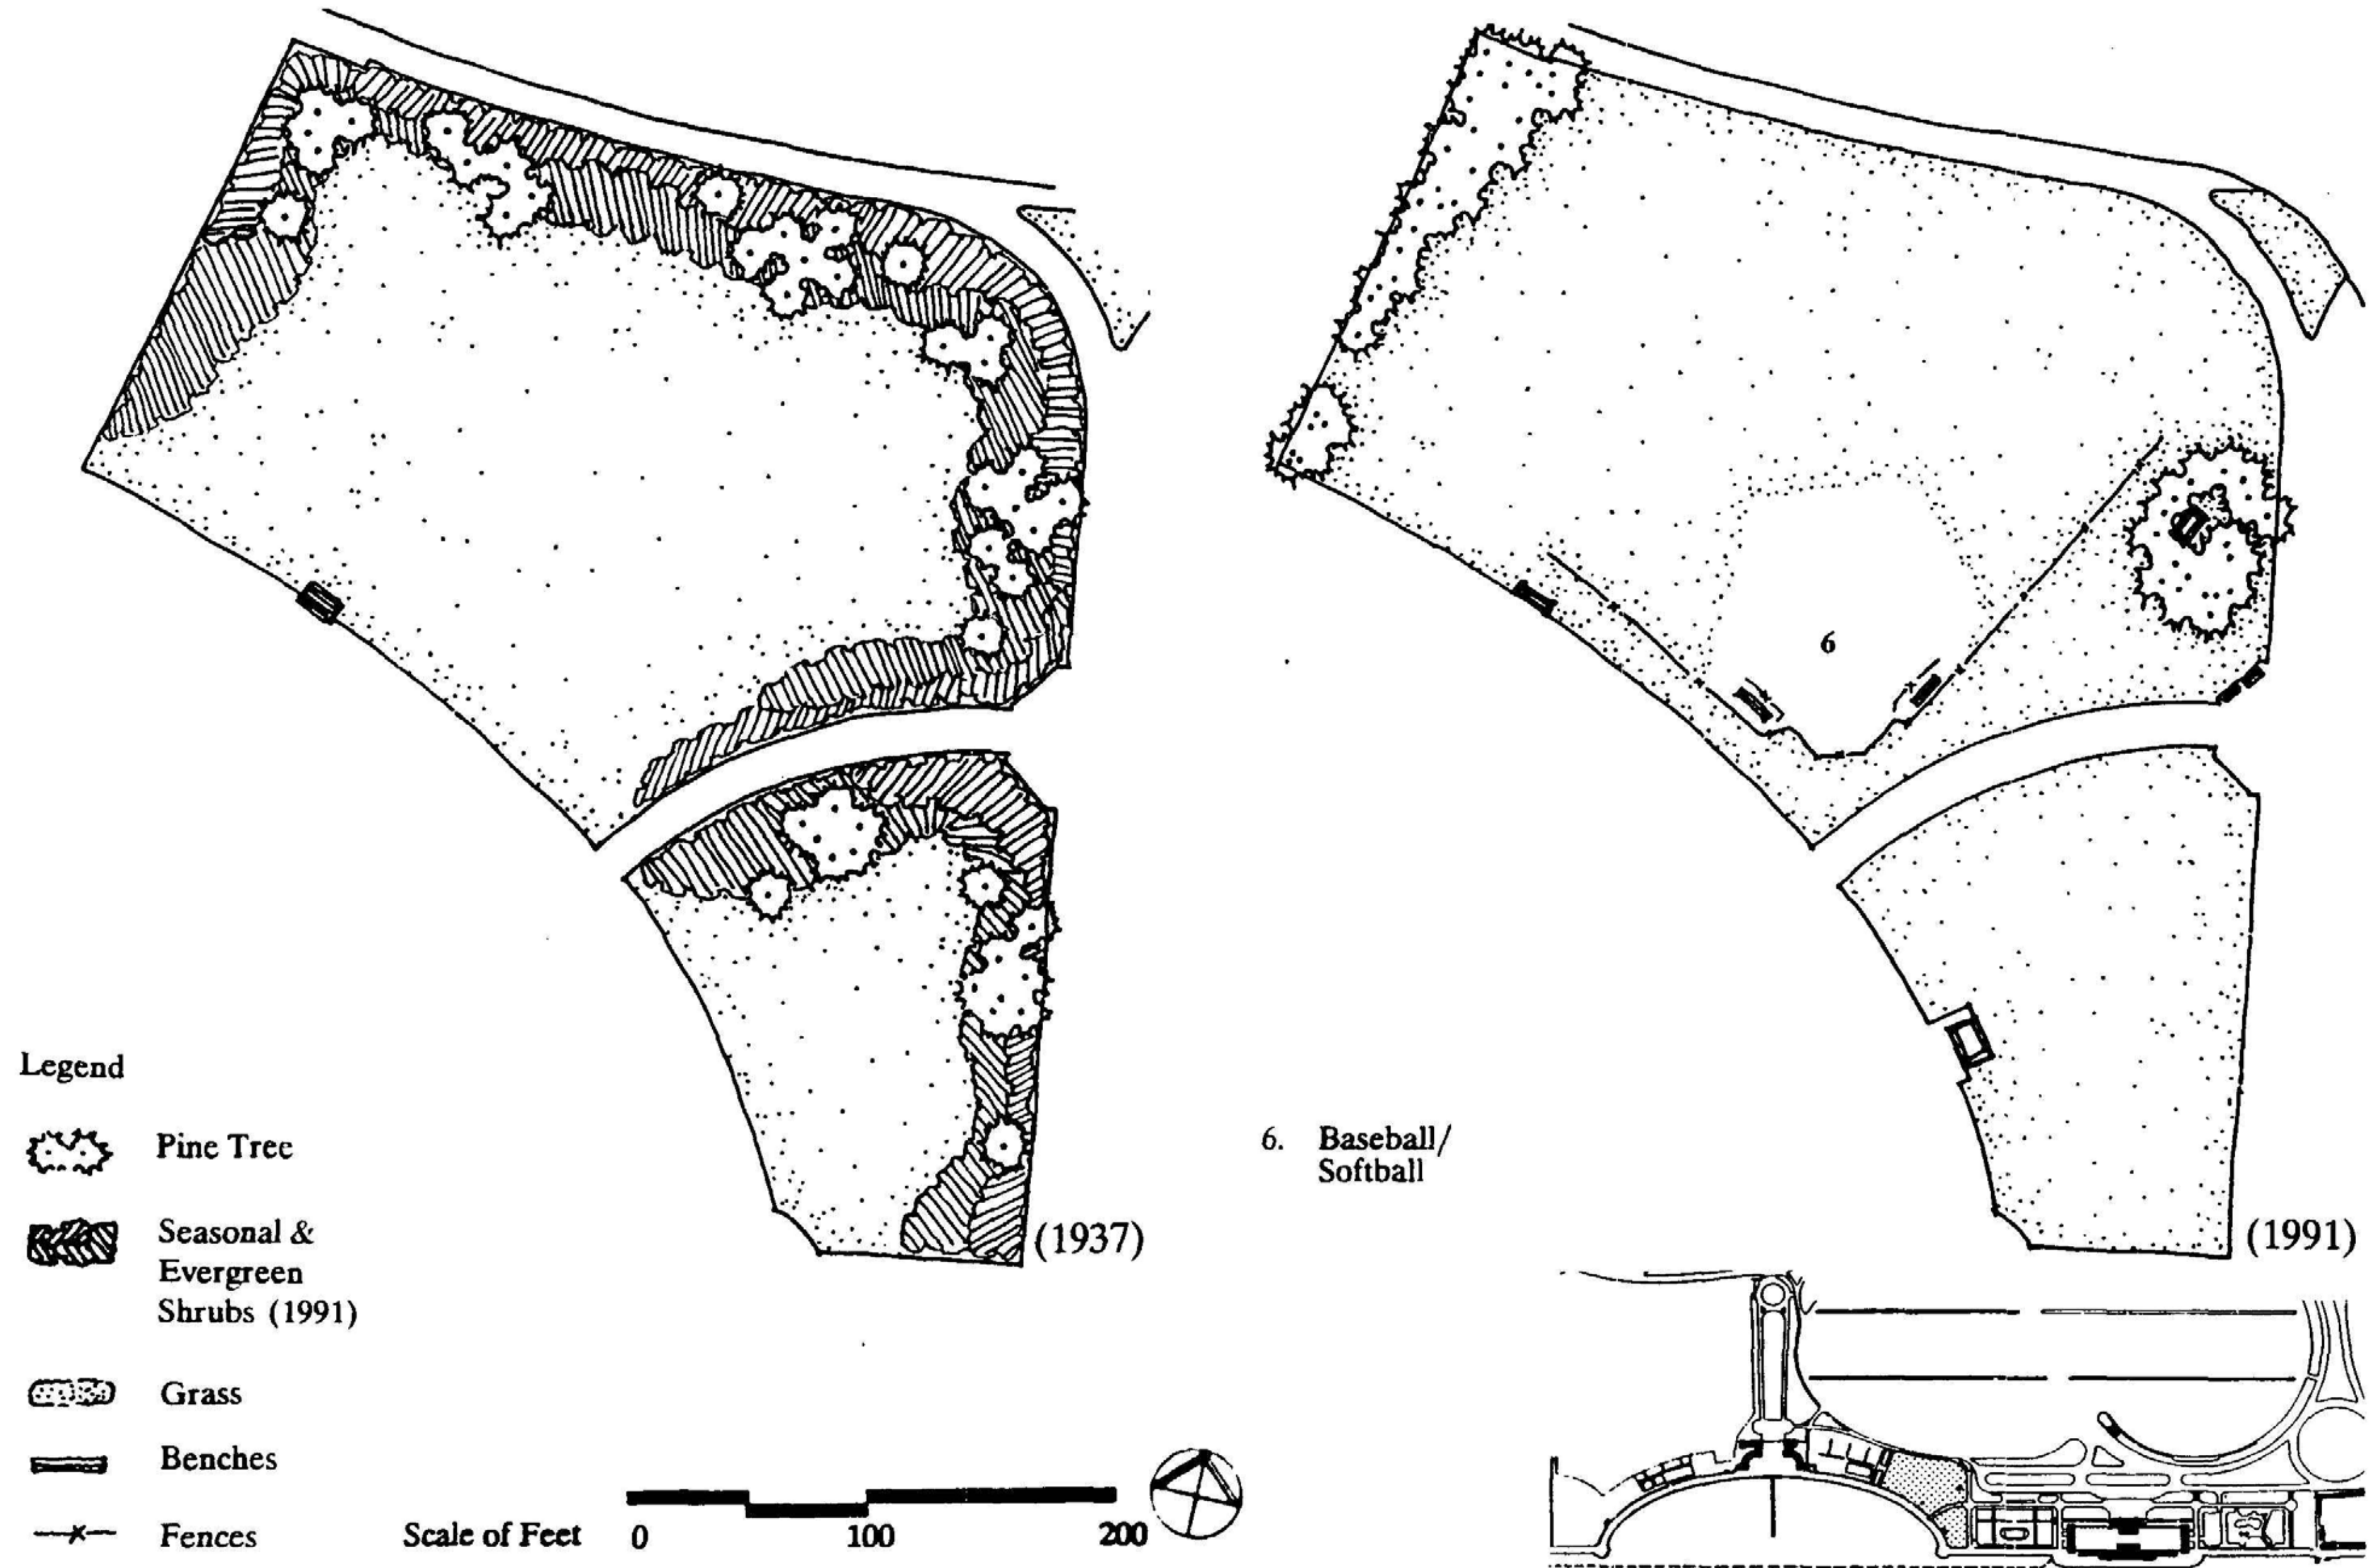
Figure 53: Back Beach Area, comparison of 1937 and 1991 configurations

- o Figure 53 shows the planted areas at the east end of the Boardwalk (see Figure B - 6, Appendix B). The original layout had a grassy lawn at the center of each area with perimeter plantings to the northeast. The larger of these areas changed with the addition of the lighted ball field, which required removal of plant materials and installation of light standards and an electrical transformer building. The more southerly area remains undeveloped, with the exception of the concession stand, added in 1947.

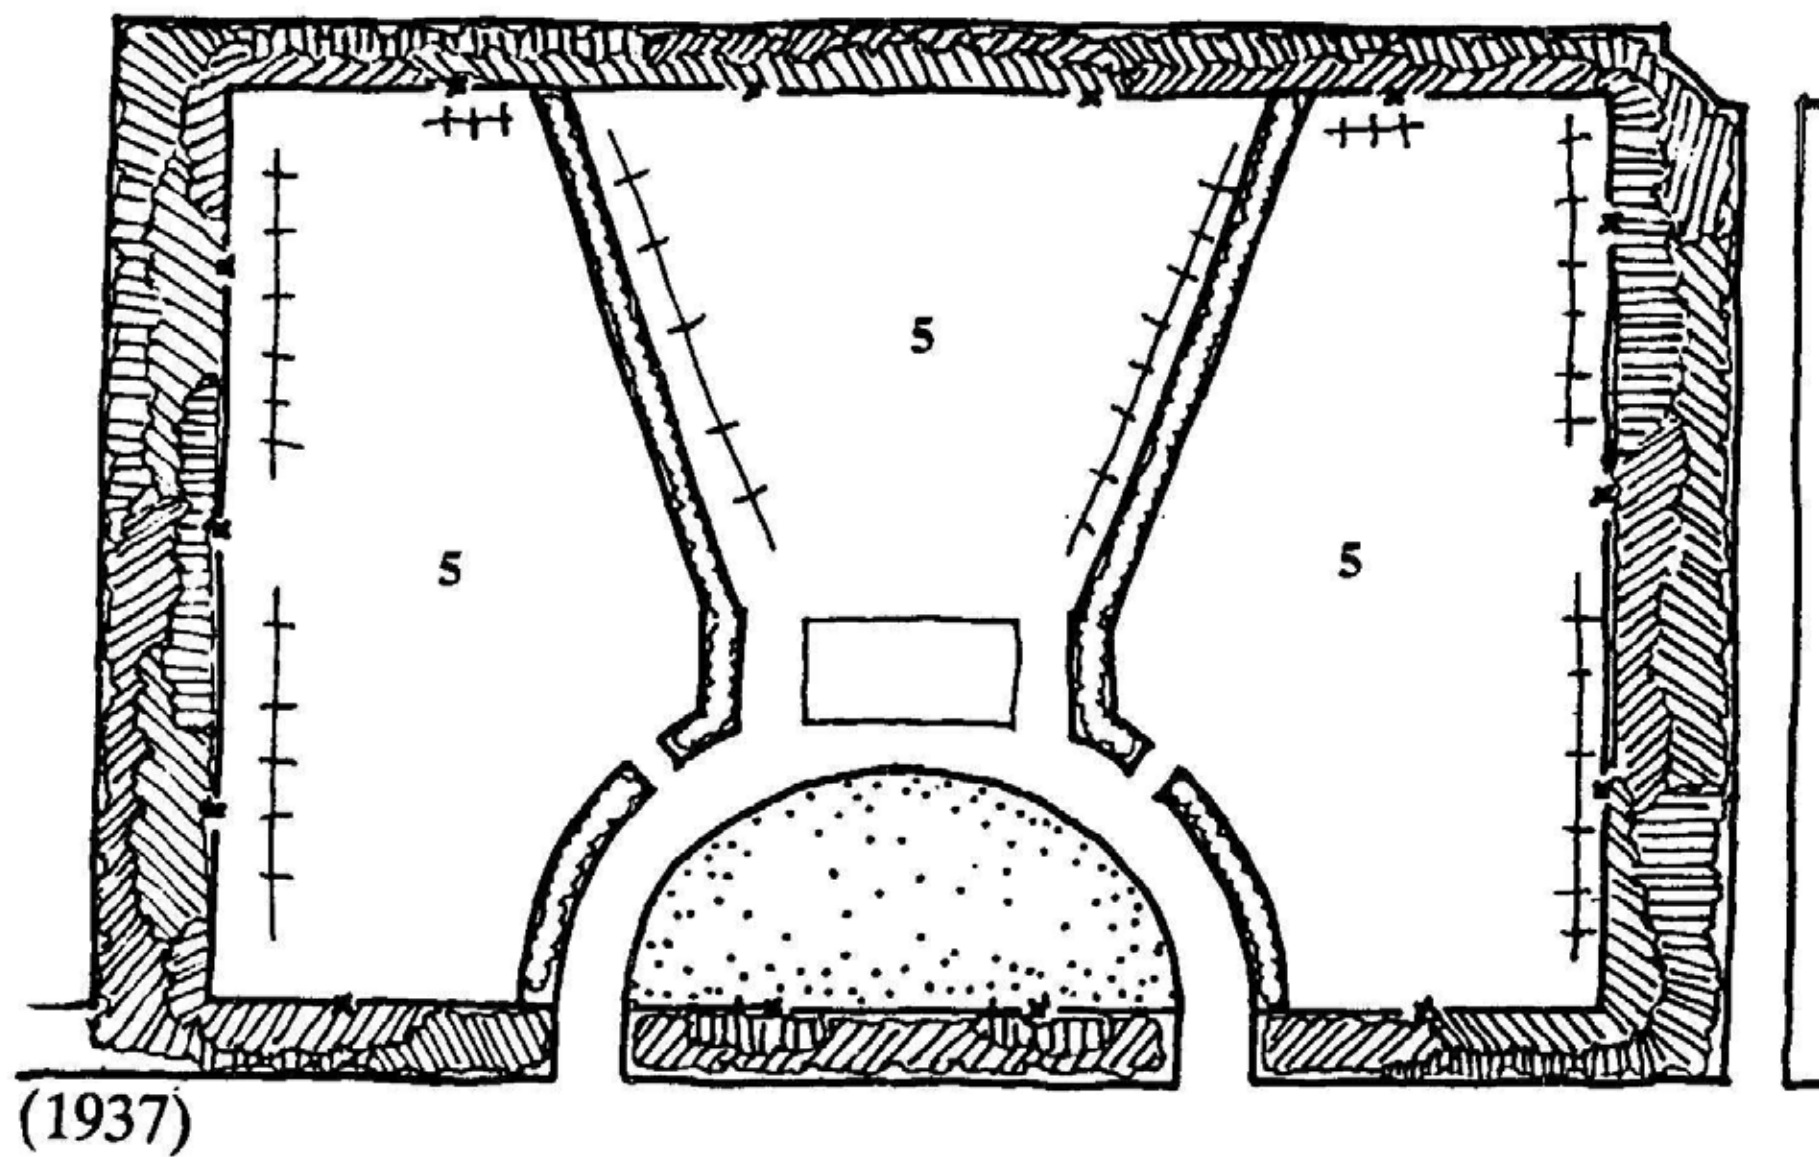
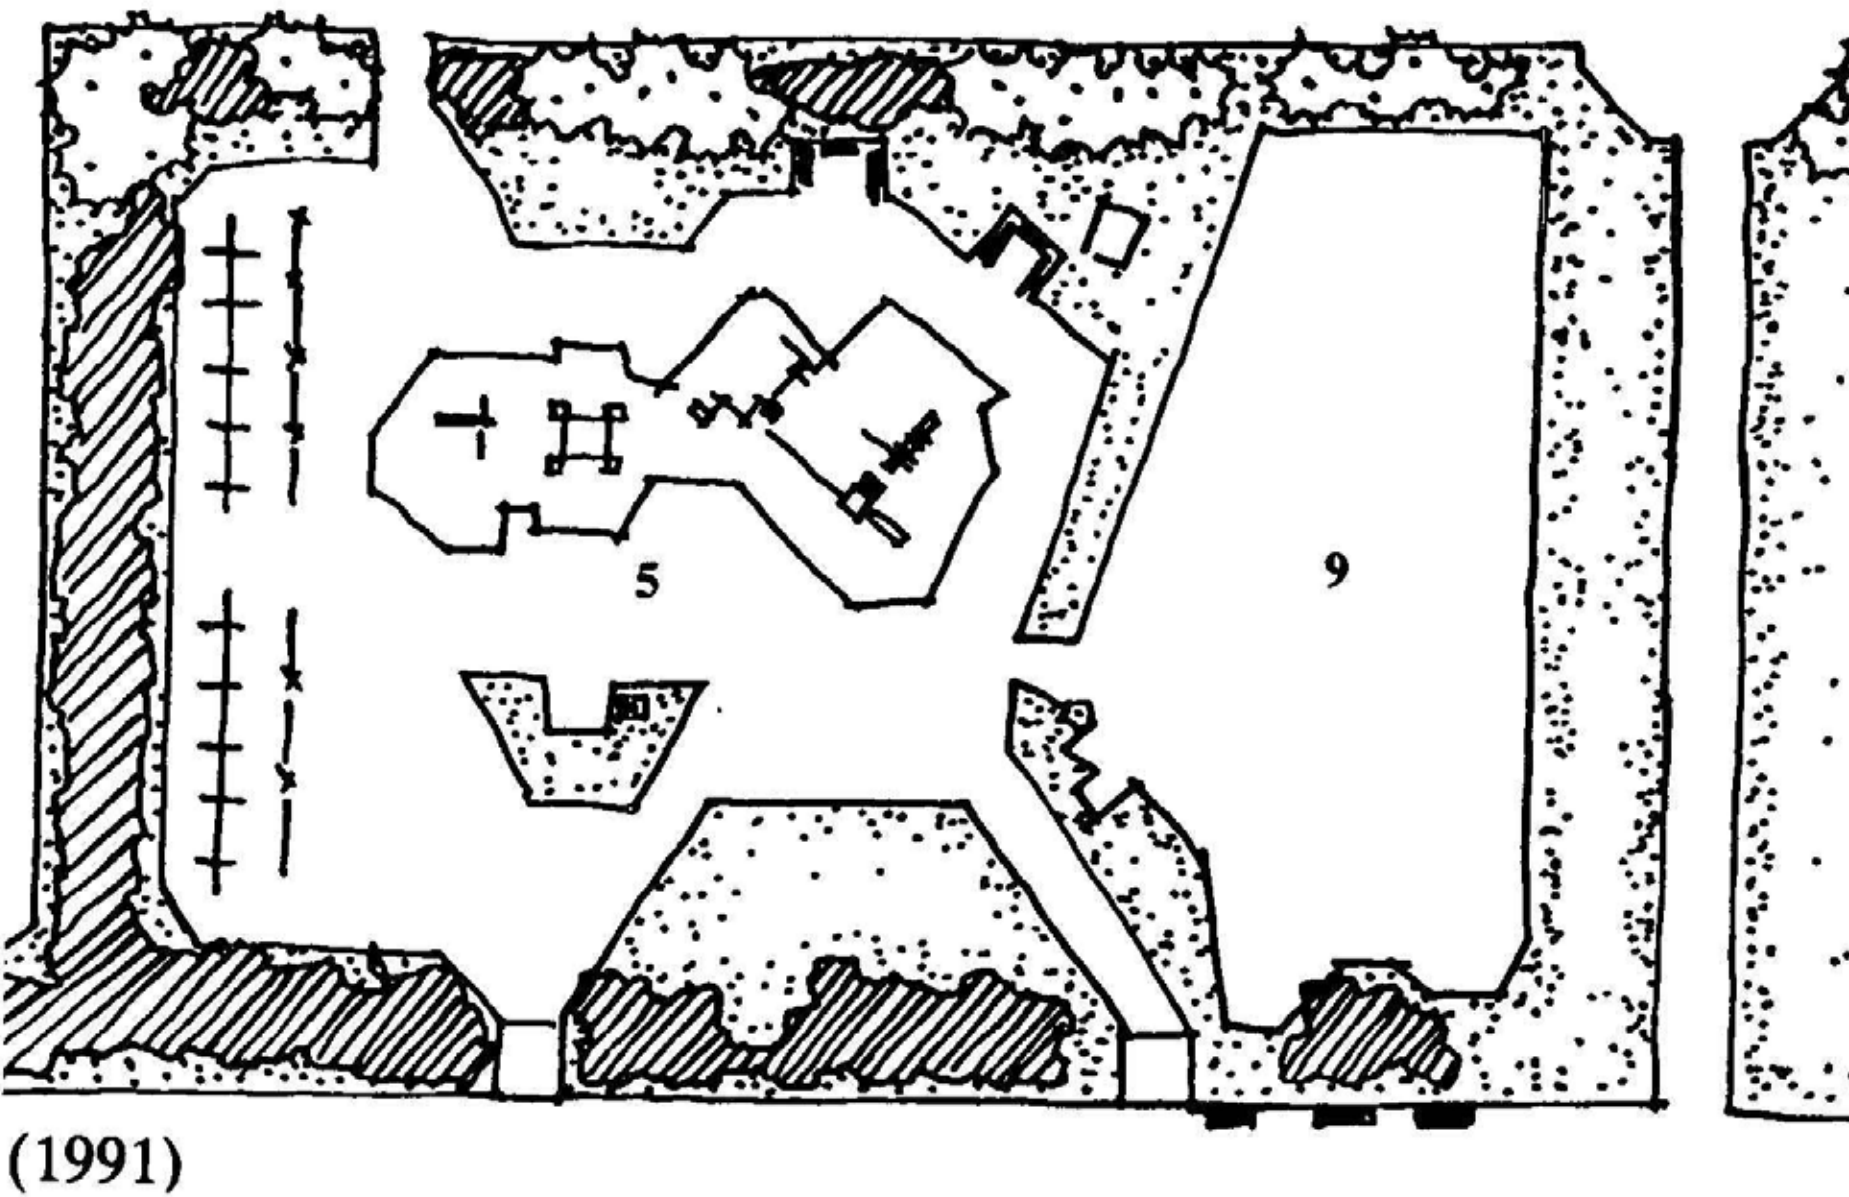
Figure 55: Back Beach Area, comparison of 1937 and 1991 configurations

- o Figure 55 shows the childrens play area to the east of the Bathhouse. The original layout (see Figure B - 8 and Figure A - 18) had play apparatus to the perimeter, including swings, slides, seesaws, and other play equipment. Fences were placed to protect passersby from the swings. This area has changed substantially through introduction of new play equipment and climbing structures, although the westerly swings may be original.

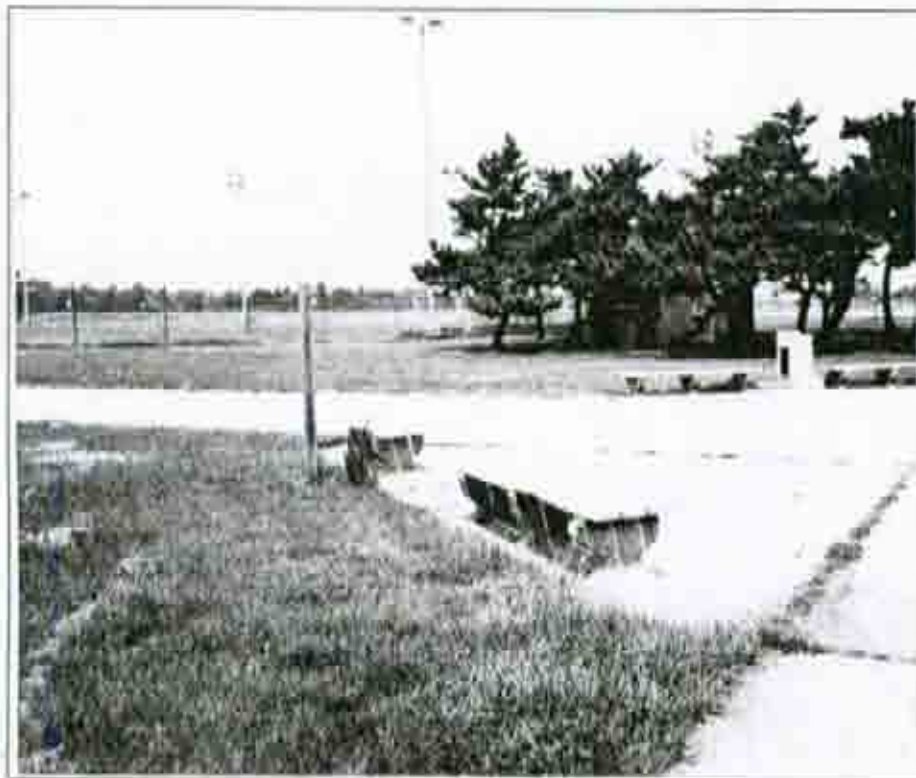
Figure 57: Ballfield electrical hut

The structures that exist inside the Back Beach area are limited to two small one story utility buildings: the first structure is located adjacent to the lighted ballfield, built in 1940 to house floodlight controls and transformer (HS605A, see Figure 57); the second structure is a pump house located just west of the Bathhouse. These struc-

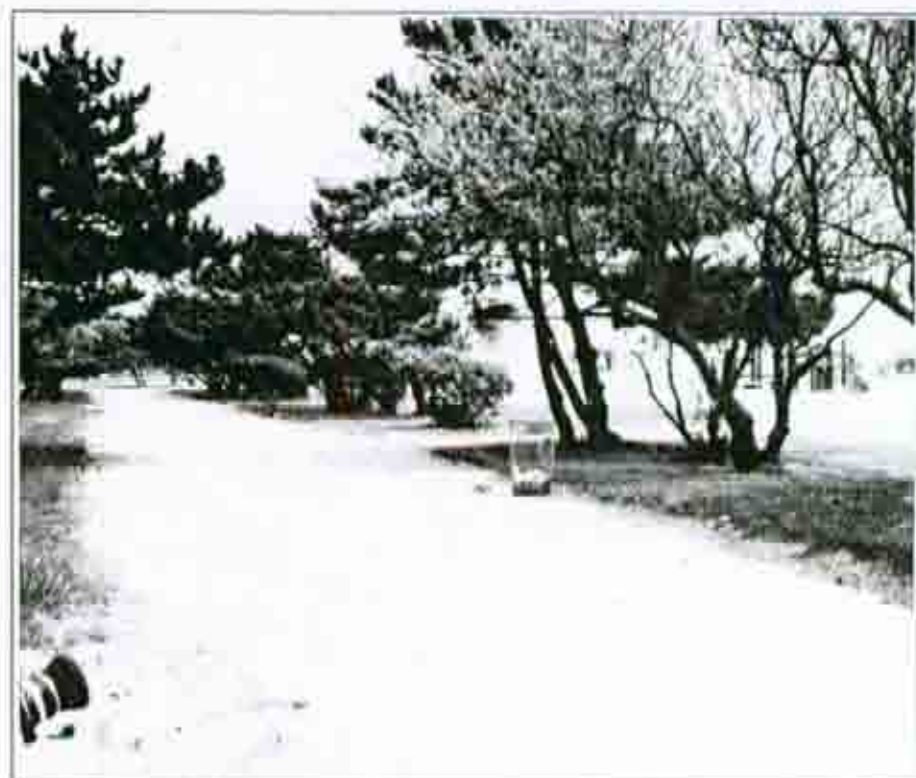
Figure 58: Back Beach walkways

Concrete pavement was used for all walkways and is in satisfactory condition. Some cracking has occurred, but not to the extent that structural integrity is threatened. There are many steps between the Back Beach and Boardwalk areas, posing an obstacle for handicapped accessibility between these areas.

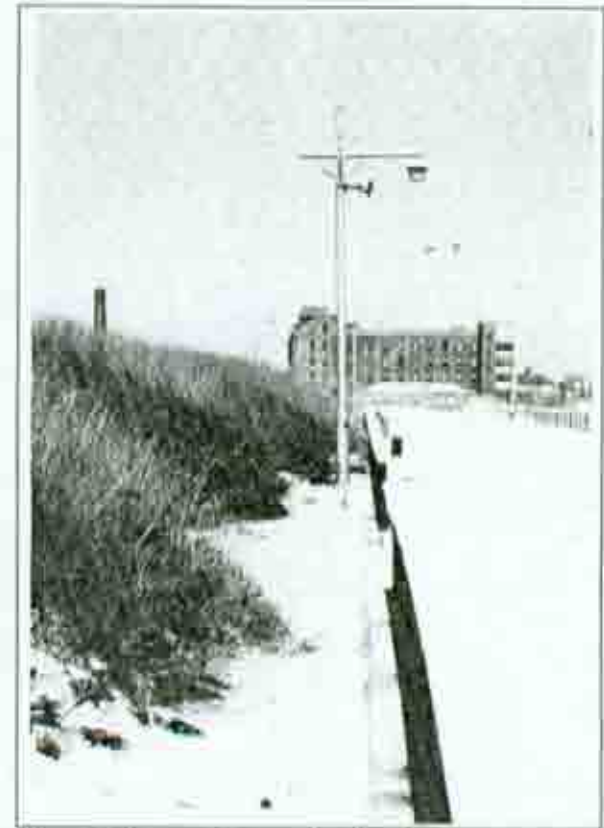
Figure 39: *Eleagnus* plantings stabilizing a low dune structure

In the areas where borders were planned, a variety of species were indicated on the plans. The most visually predominant remaining plant material is a thick planting of *Eleagnus* (*Eleagnus angustifolia*), bayberry, and ligustrum cuonymous (see Figure 39).

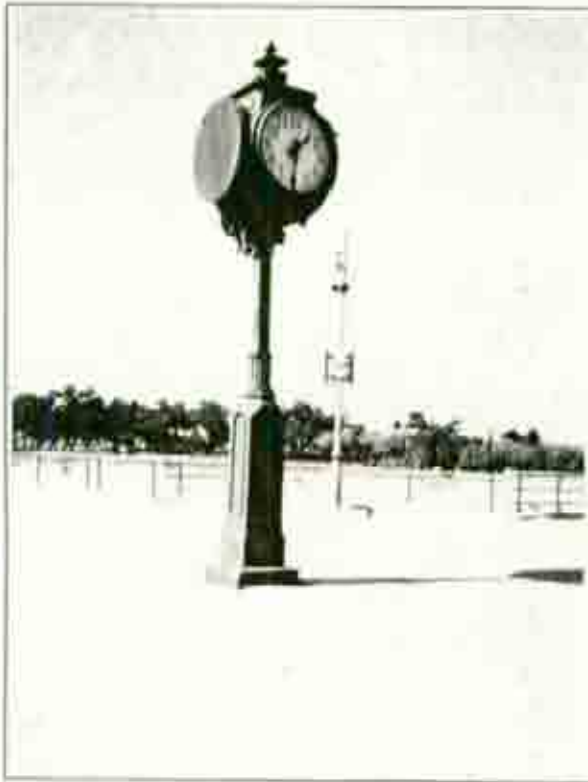
Figure 40: The Wise Clock

was changed, glass replaced and each face was given an individual mechanism instead of one mechanism for all four faces (Unrau 1981: 208). The clock is currently out of service. It is located at the eastern terminus of the crescent boardwalk and is visible from most locations along the walkway (see Figure 47). It is currently in poor condition with peeling paint and several of the clock faces are boarded up.

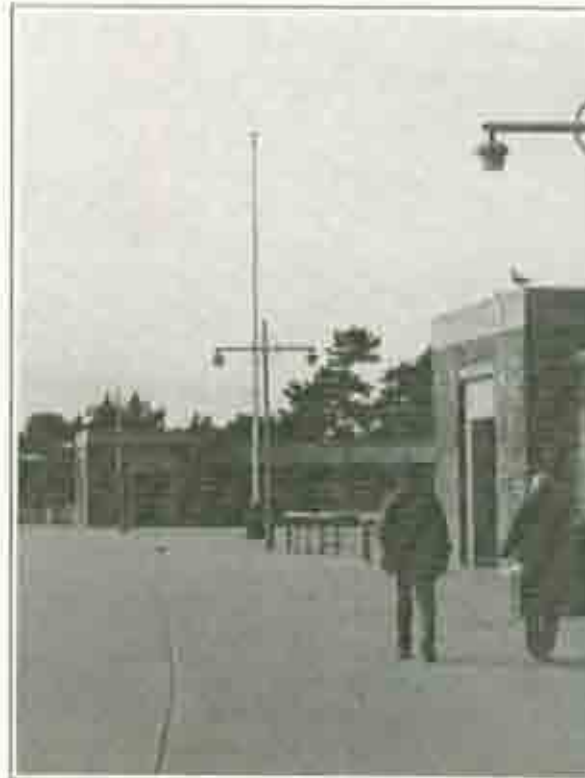
Figure 41: Flagpole at Mall Buildings

- o **A flagpole** -- exists on the central axis of the crescent Boardwalk at the site of an earlier bandstand and dance floor. The pole is metal and is in fair condition with peeling paint and some material deterioration. Spars and flags are missing (see Figure 41), compared to the original pole shown in historic photographs (see Figure A-25)

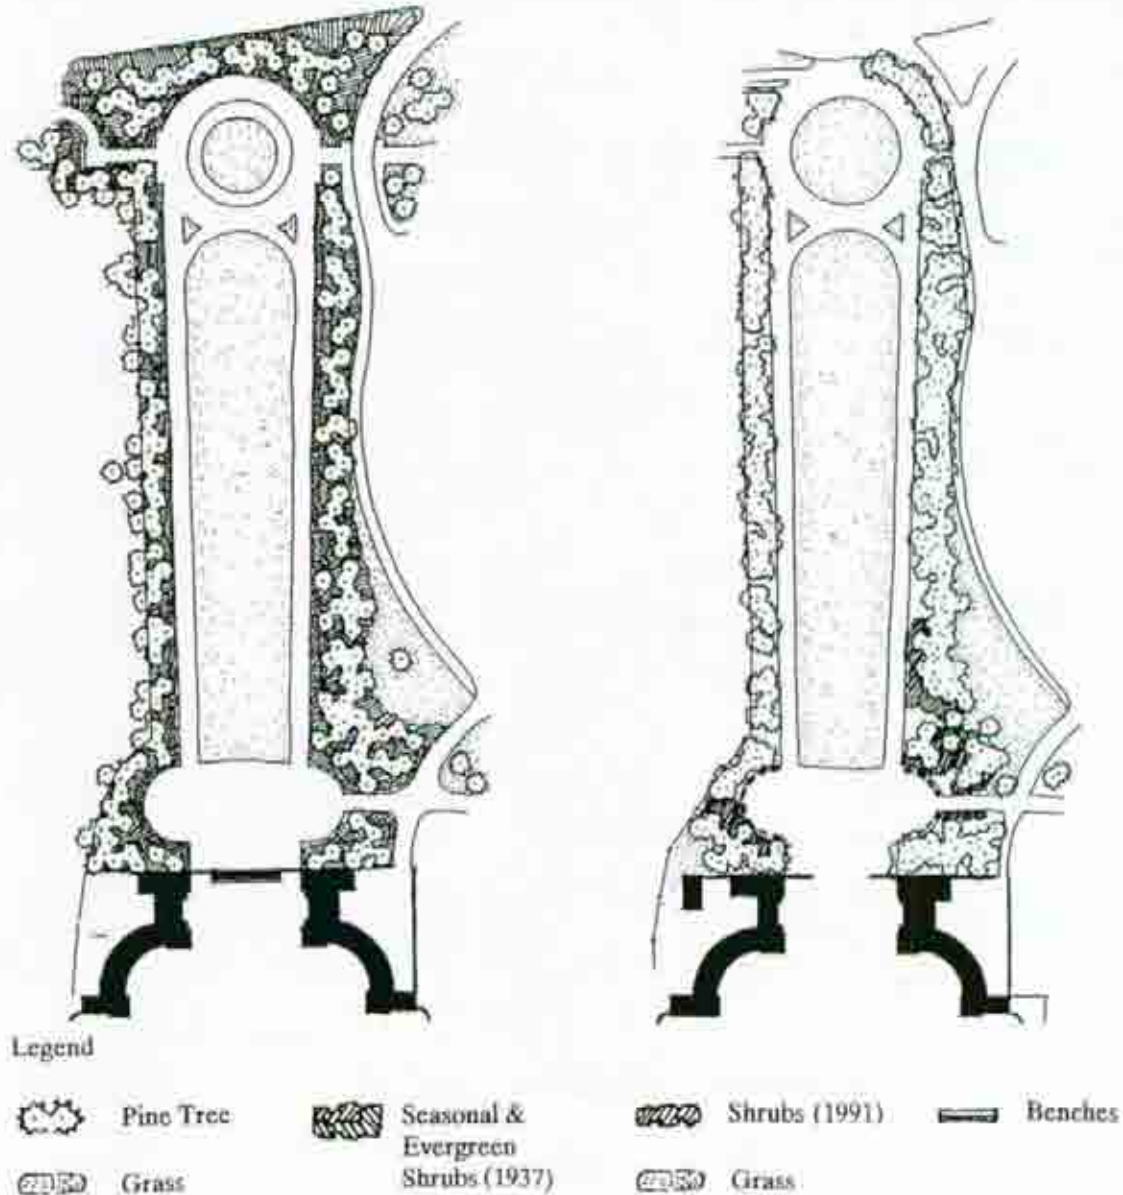
Figure 46: The Mall Area - Comparison of 1937 Plan and 1991 configuration

Figure 46 compares the original 1936-37 design for the Mall with the current condition. The original planting plans (see Figure B-4, Appendix C) for the Mall indicated predominant Japanese Black Pine (*Pinus thunbergi*) of several sizes to define the outer east and west boundaries of the Mall, with a varied understory, including materials used elsewhere in the park, such as *Eleagnus umbellata* and *Rosa rugosa* (see Figure 47). Aerial photographs indicate that by 1939 the planting cover was dense and continuous (see Figure A-23, from 1939). The planting reinforced the spatial and formal qualities of the Mall and created continuity of

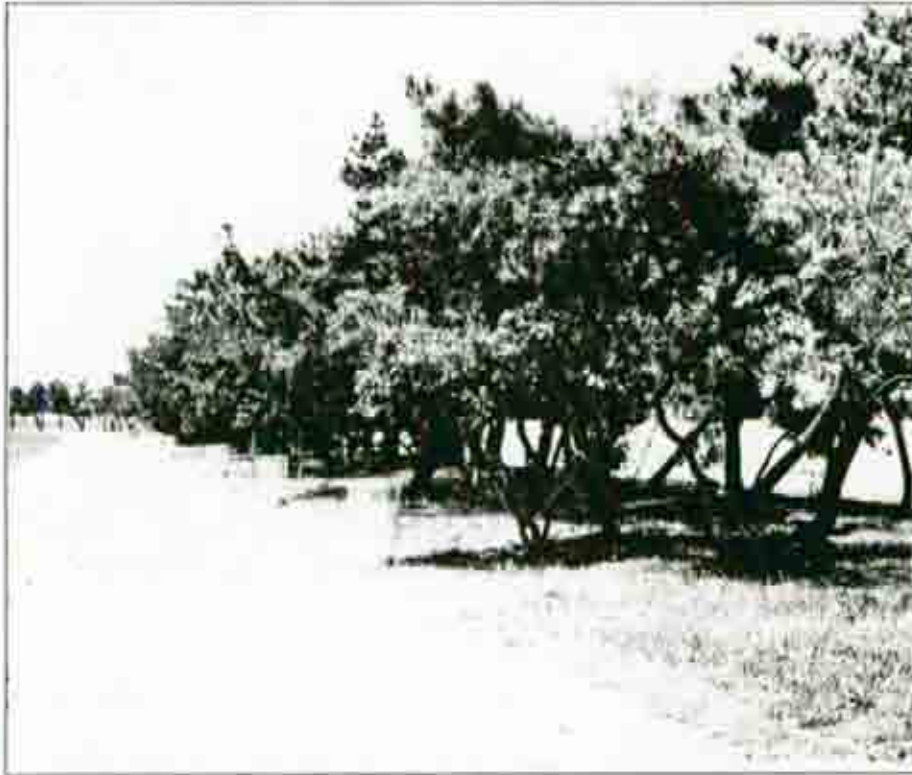
Figure 47: Black pines along the East side of the Mall

The Black Pines appear to be in good condition and in the general location indicated by the original plans (see Figure 46). The secondary shrub and small tree plantings in front of the pines appear healthy, but show evidence of pest and/or insect problems. Many of the shrubs have been severely pruned into a shape which is very uncharacteristic of their natural forms. In support of the stand of Black Pine are secondary plantings of *Euonymus* sp., *Ligustrum* (*Ligustrum* sp.), Flowering Cherries (*Prunus* sp.), American Holly (*Ilex opaca*), and *Eleaegnus* (*Eleagnus angustifolia*). Most of these plantings have been pruned up to a

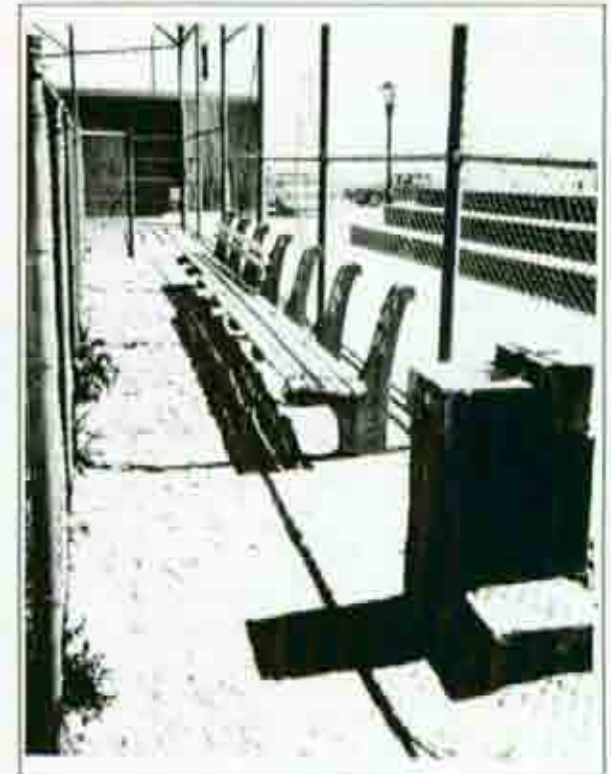
Figure 62: Deteriorating Benches

original benches or simply the original style of bench used. These two benches have concrete bases with wood slat seats and one possesses a back also of wood slats. Many benches are in advanced states of deterioration (see Figure 62).

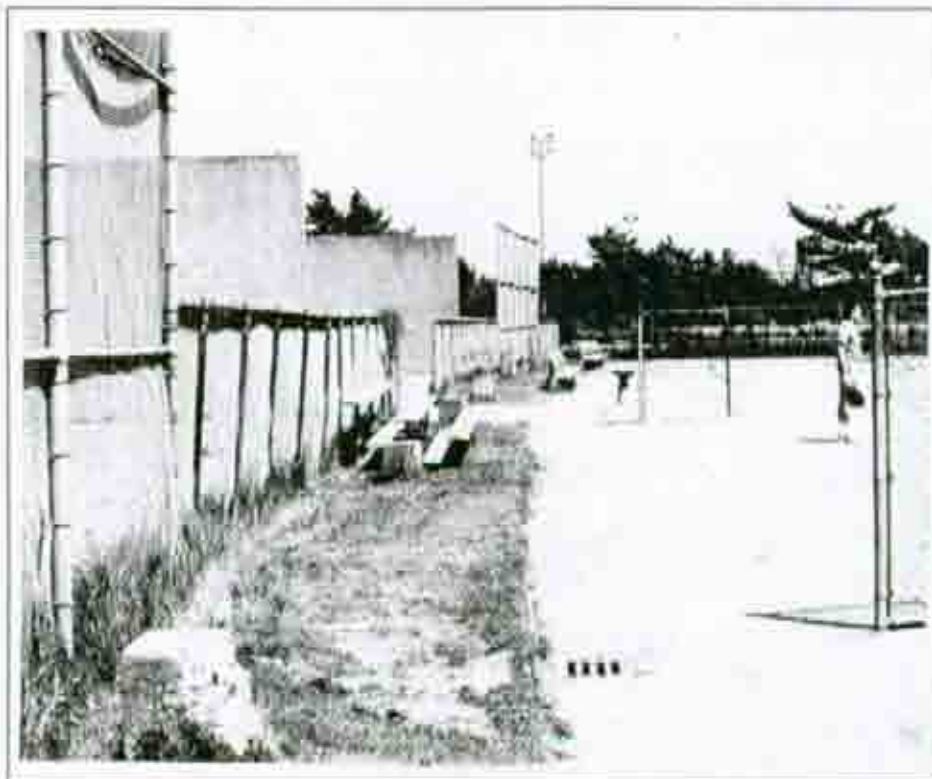
Figure 63: Typical chain link fences in poor repale

Other site furnishings found today in the Back Beach areas include two additional bench types both of modern design, assorted swings, basketball backboards, play equipment, chain link fences, and wire mesh trash receptacles. Site furnishings in the Back Beach areas are uniformly deteriorated. Chain link fences are often torn or bent (see Figure 63). Of the site furnishings that exist today in

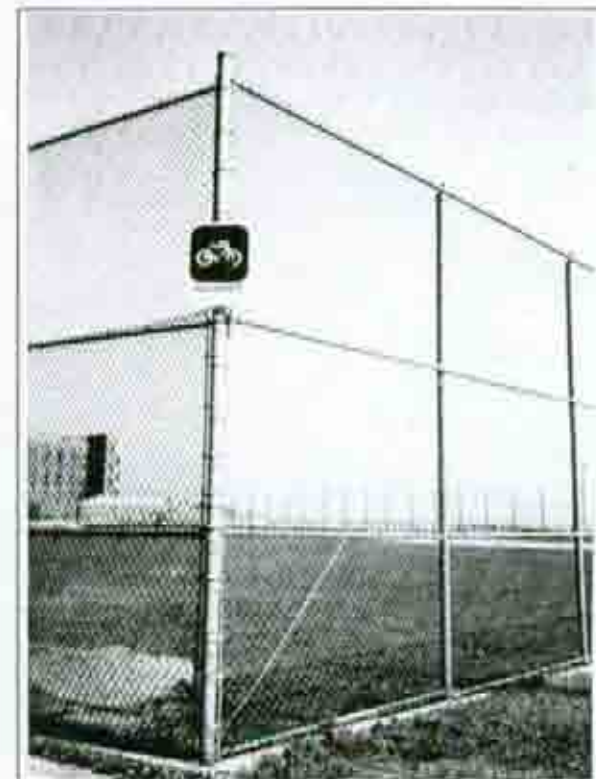
Figure 64: Most signs serve a prohibitory function

The 1937 plans do not include information on signage. Where it exists today, it is usually prohibitory (see Figure 64). No system of identification or directional signage is currently in place.

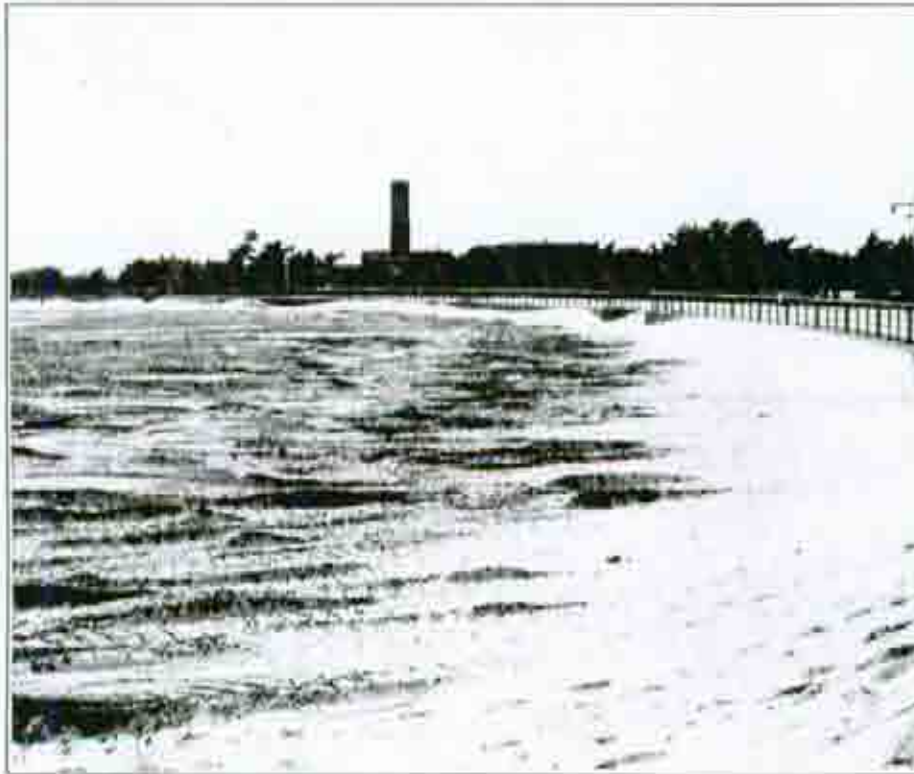
Figure 66: Windblown sand

The topography of the Beach is a flat expanse of sand slightly sloped toward the ocean. The flat, open nature help define the character of the Beach and is characteristic of this type of resource. Wind-blown sand drifts on the Beach and beyond and is regraded each spring (see Figure 66).

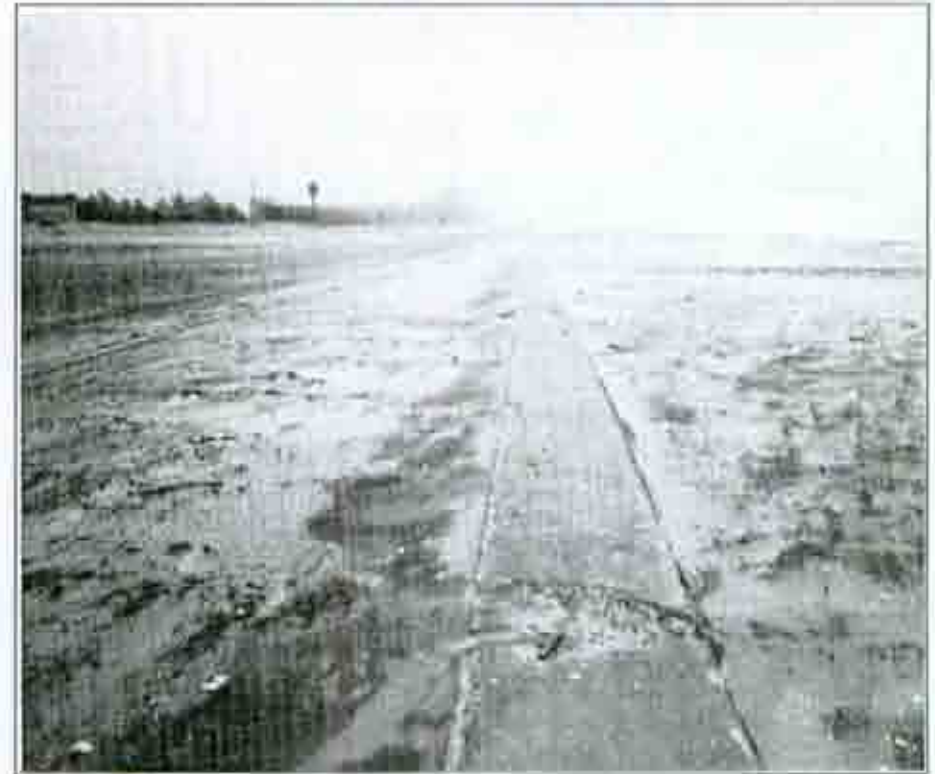
Figure 67: Old concrete seawall

The only paving that occurs on the Beach is the exposed aggregate concrete walk in the center of the crescent Beach and portions of the old sea wall. The walk is in good condition with few minor cracks. This was not part of the 1937 plans but was installed in 1953. Broken and deteriorating sections of the concrete sea wall still exist in the crescent Beach, dating from the 1931 plans (see Figure 67).

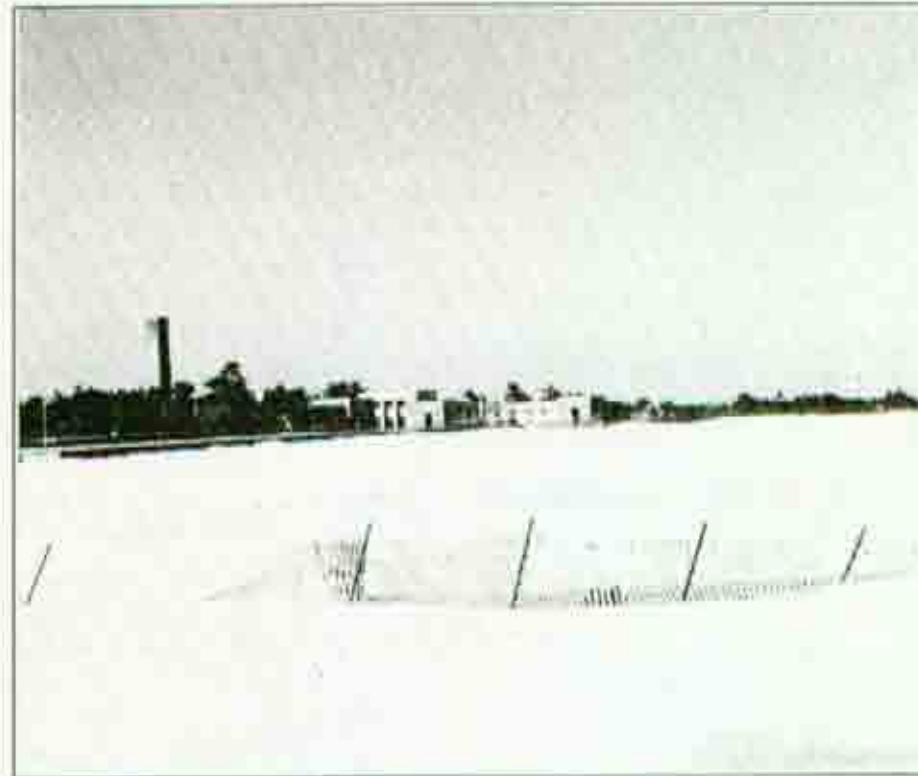
Figure 68: Typical deteriorated jetty

The shoreline of Jacob Riis Park is stabilized by thirteen jetties and groins located along the Beach. Most of these structures are wooden and appear to function but portions of the bulkheads have rotted away (see Figure 68). A couple of the groins are reinforced concrete and although the concrete is badly spalled exposing the reinforcement, they still appear to function. The jetties at the western end of the park crescent Beach appear to exist from the 1934, 1936 and 1939 jetty extension plans while the jetties along the eastern half of the park appear to be from the 1936 and 1939 extension plans. Several

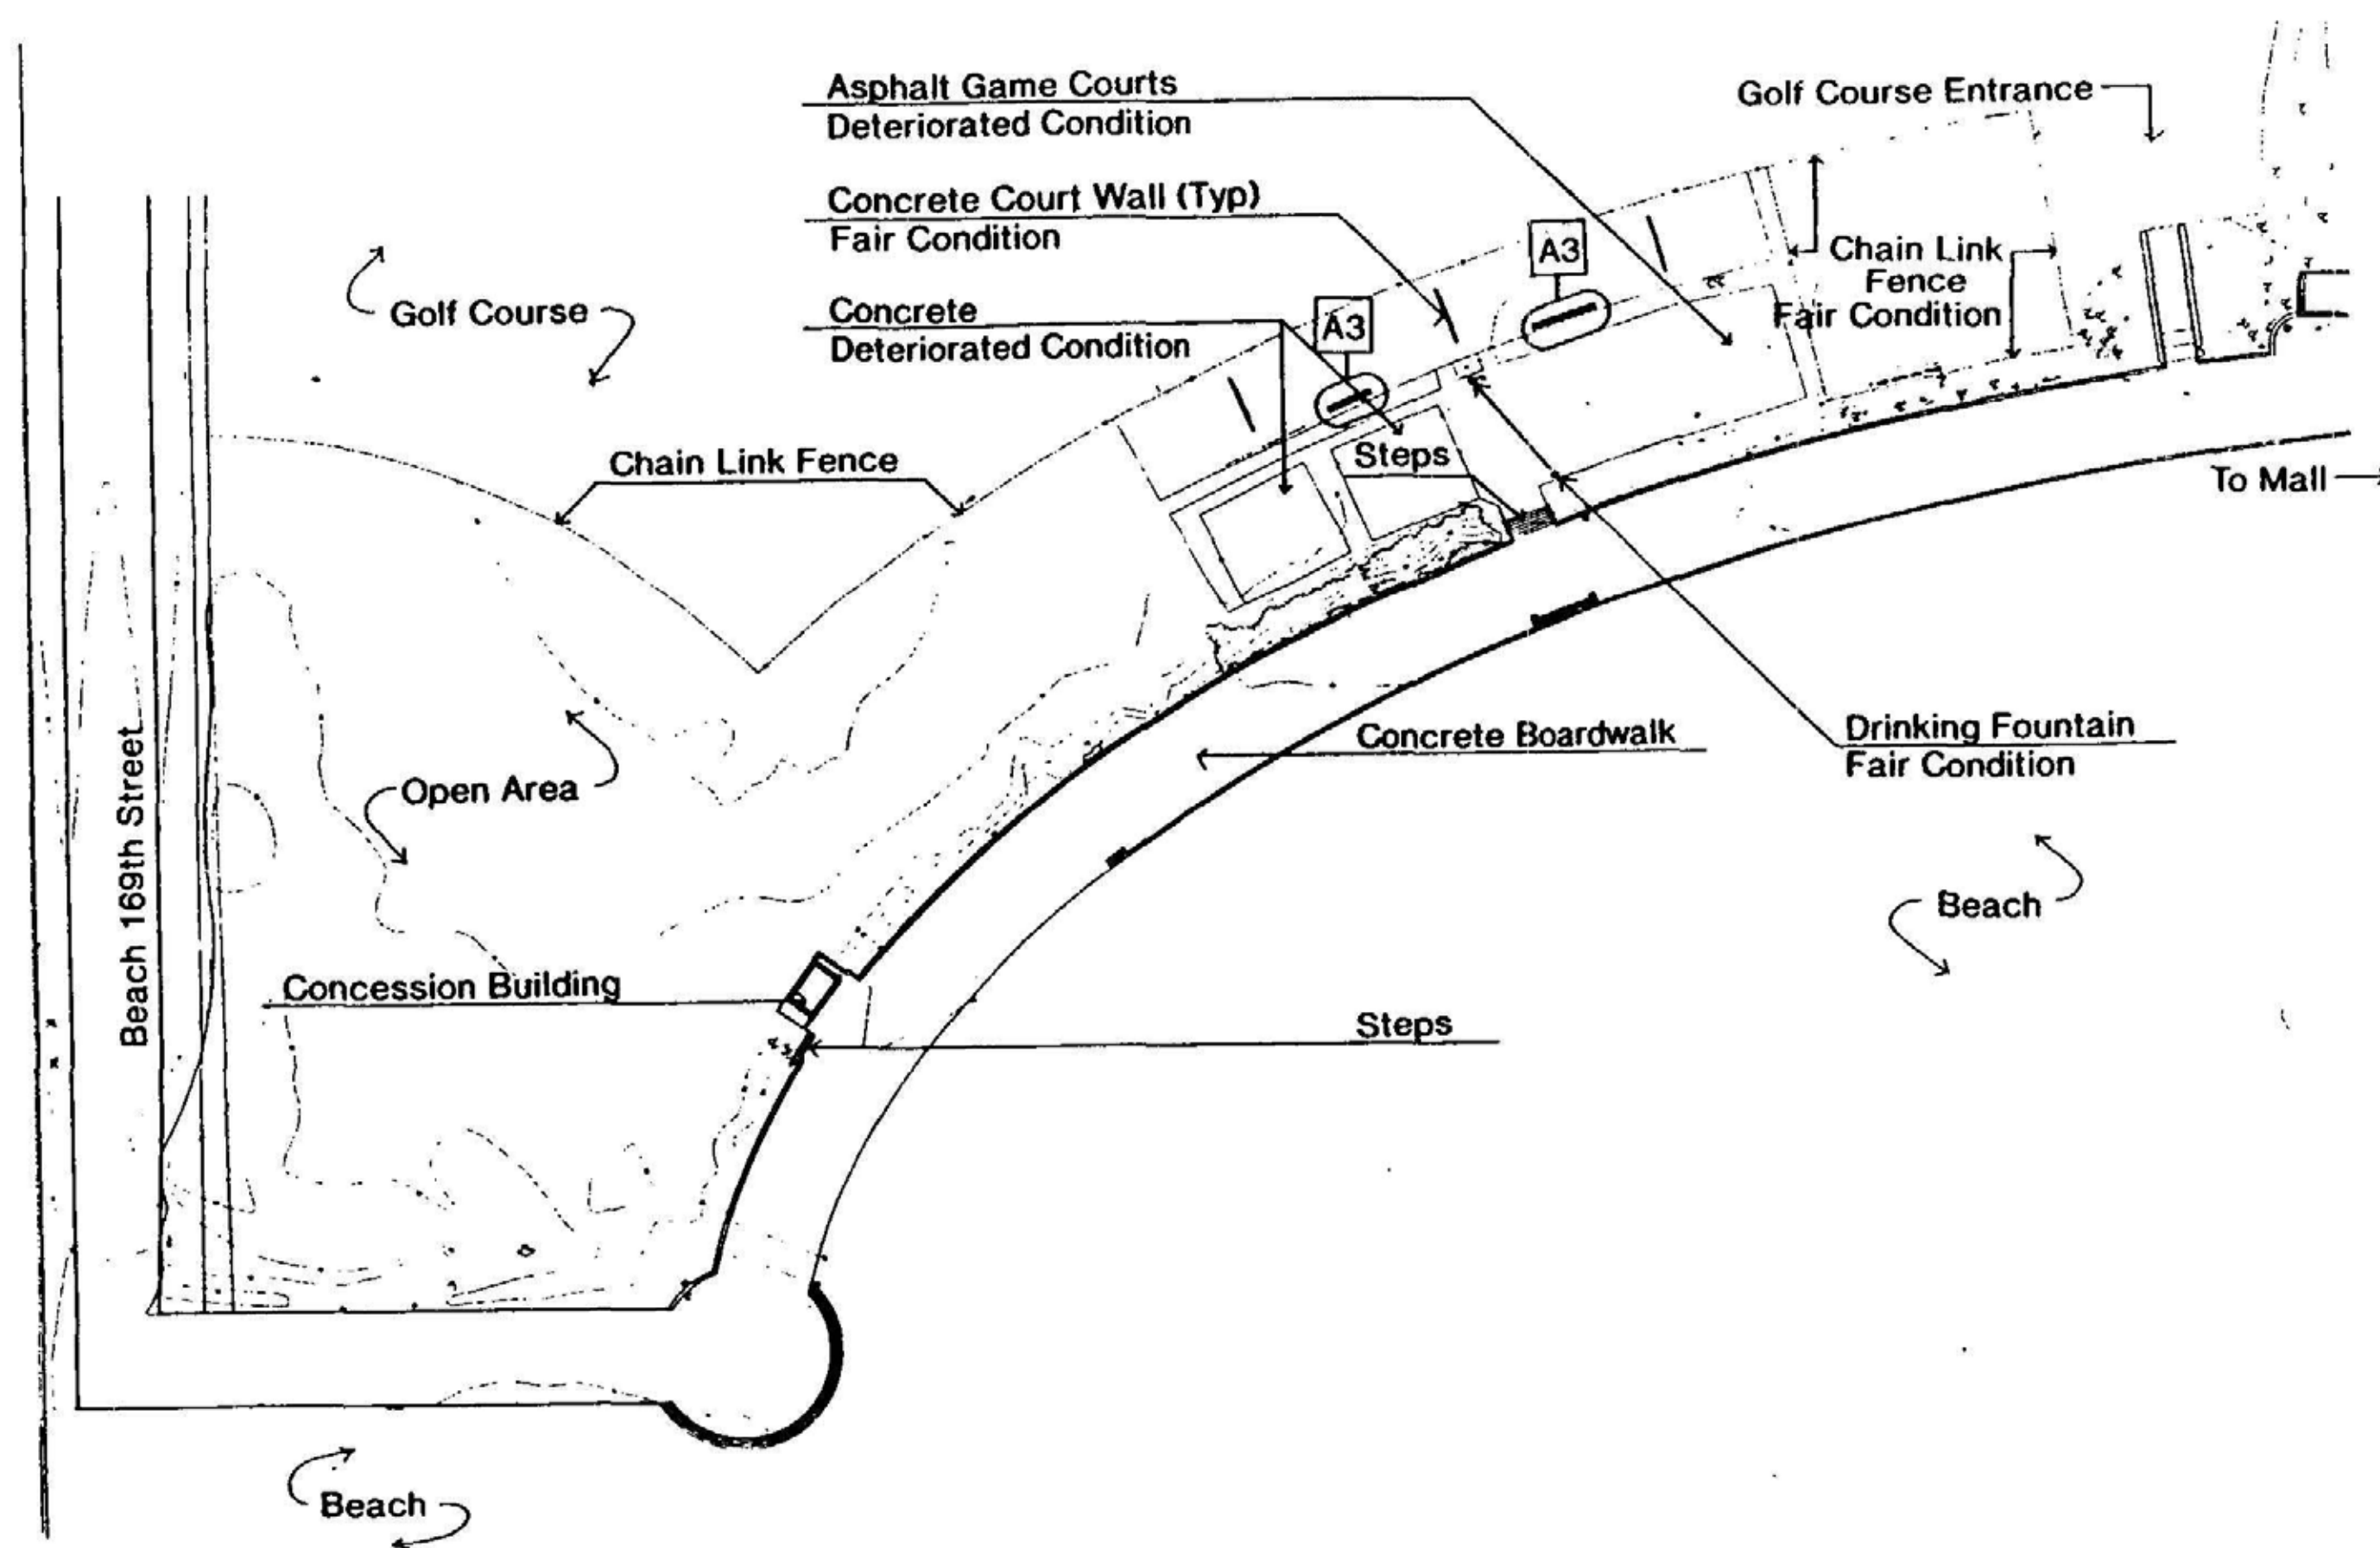
Fig. C-8 Site Furnishings and Existing Conditions: Back Beach Area (Plan 1 of 3)

Major problems of the Back Beach area that should be addressed include planted areas overgrown with weeds, pavement edges overgrown by adjacent lawns, and site furnishings that are broken and deteriorated. Additionally, many paved court

game areas are cracked and in poor repair. There is an overall lack of signage, and lighting in the area. Recommendations for the area include:

- C. Restore and/or replace in kind the concrete and wood slat "Lundino" benches adjacent to activity areas. In the original design, most benches at Jacob Riis Park were in the Back Beach area. Remove the modern metal benches, which date from later periods and are inappropriate.

- D. Repair and/or replace in kind damaged court surfaces and separating fences, where appropriate to proposed uses.
  - E. Retain "Type B" pedestrian lighting within Back Beach walkway areas, and consider overhead flood lights for those areas where night outdoor recreation is to be permitted.
