# Cultural Landscape Report

## Jacob Riis Park

Gateway National Recreation Area

1992

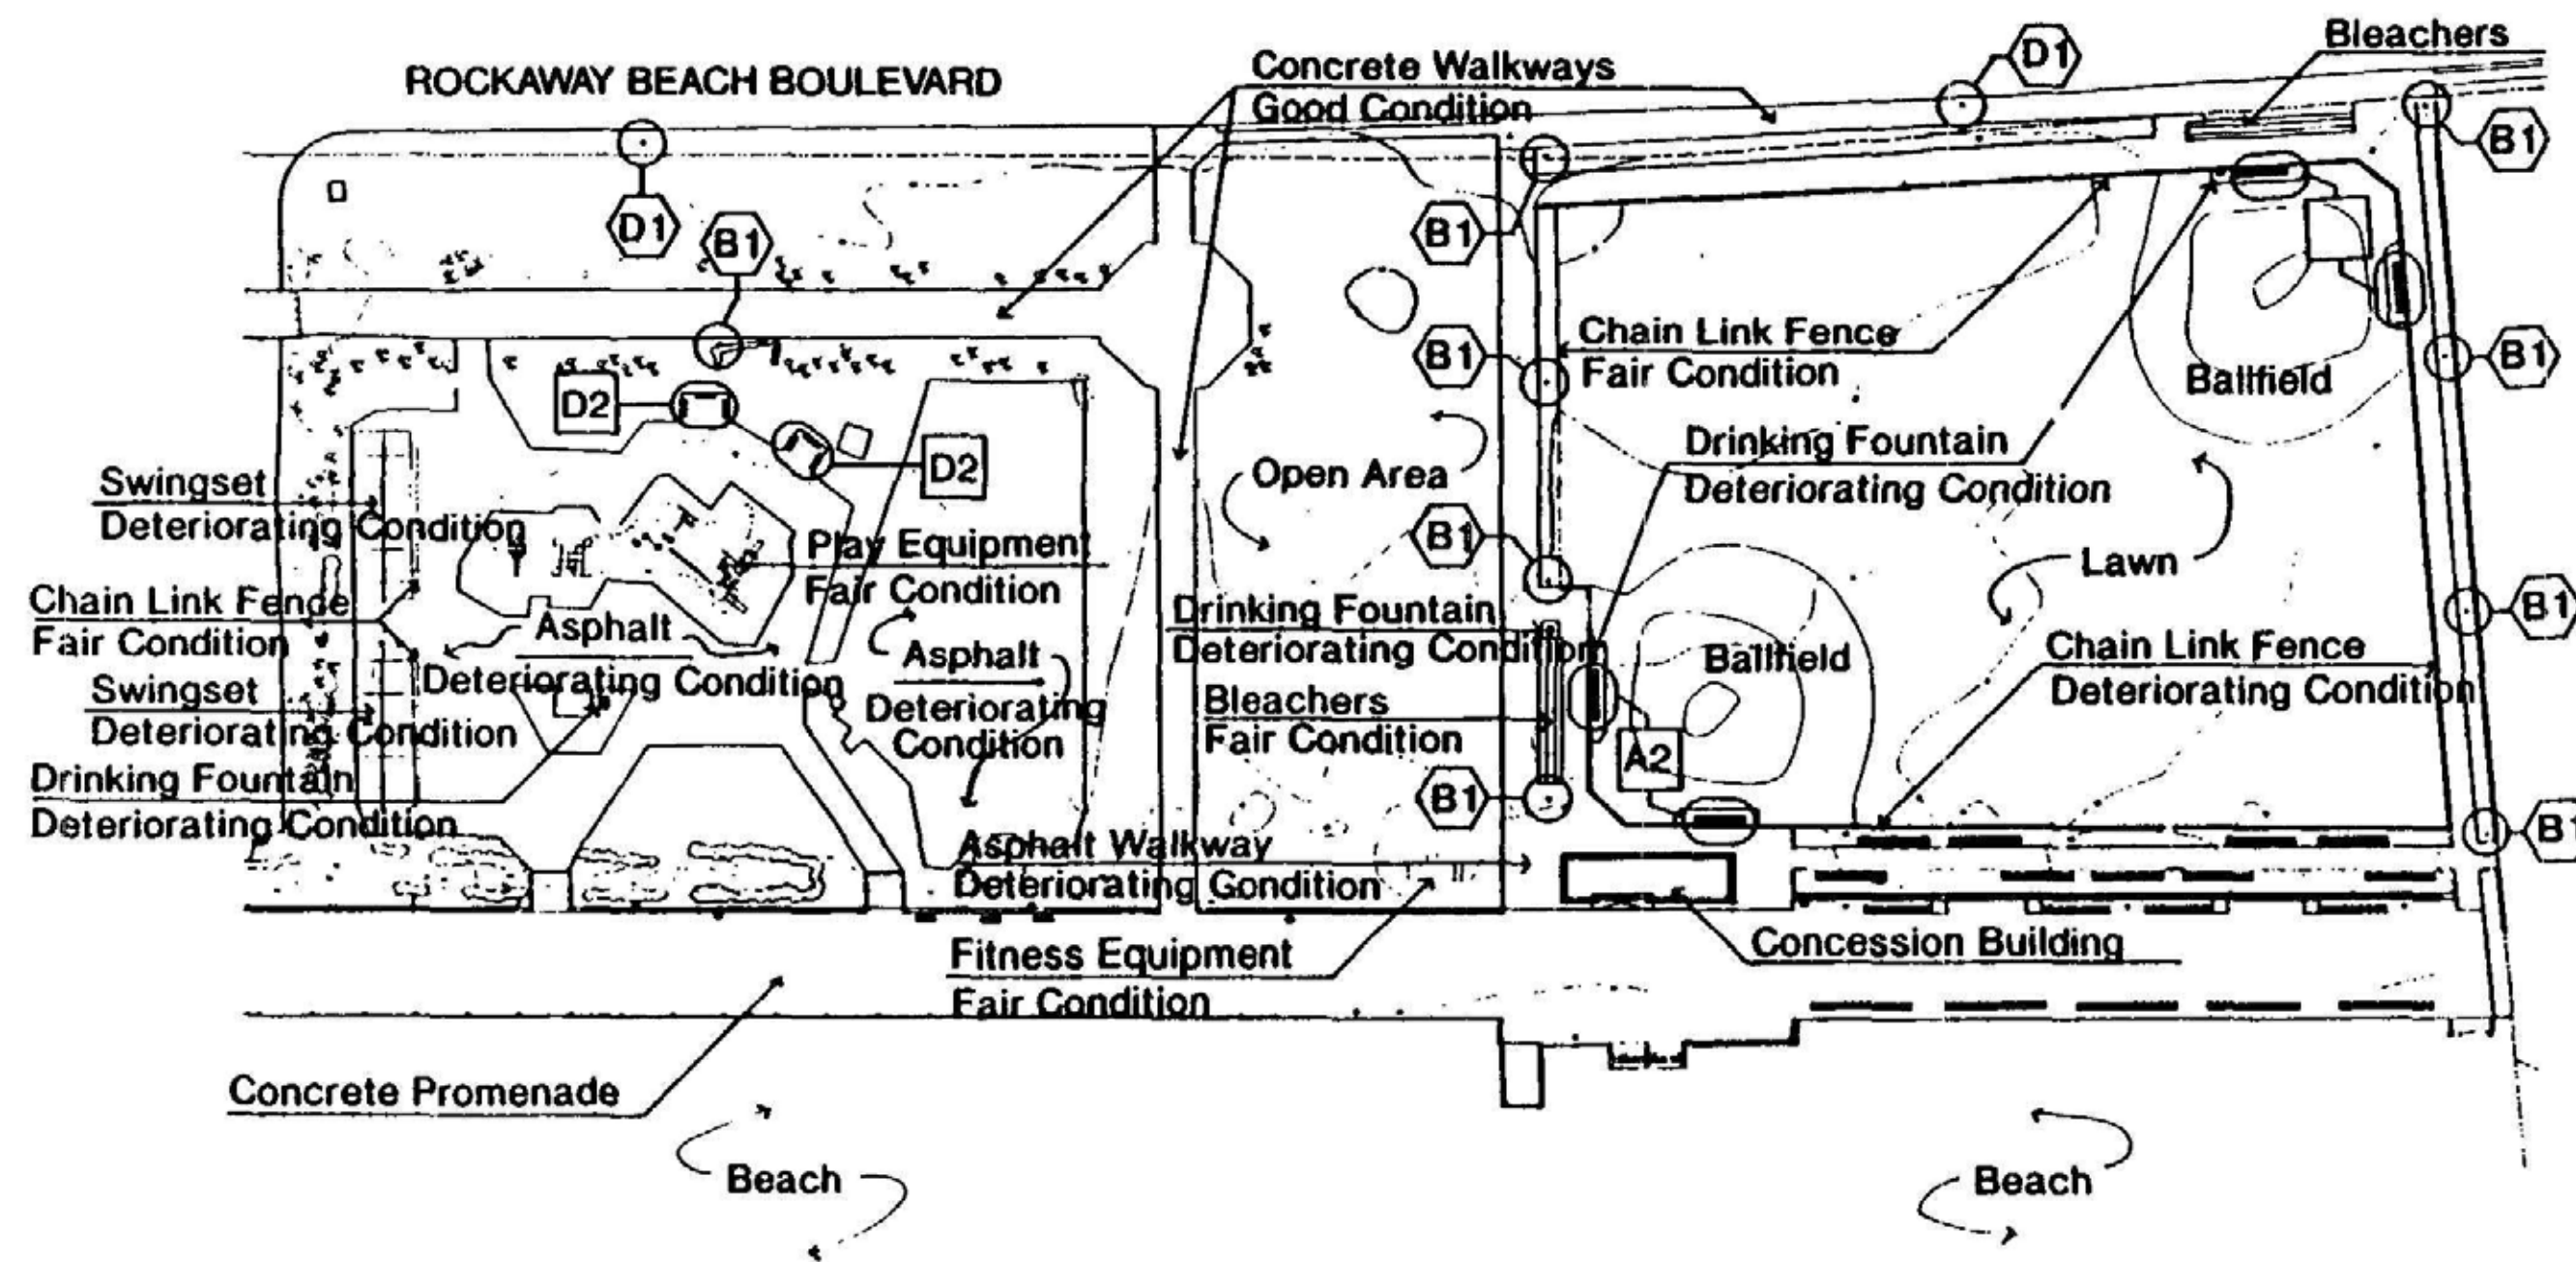
Fig. C-10 Site Furnishings and Existing Conditions: Back Beach Area (Plan 3 of 3)

Major problems of the Back Beach area that should be addressed include planted areas overgrown with weeds, pavement edges overgrown by adjacent lawns, and site furnishings that are broken and deteriorated. Additionally, many paved court

game areas are cracked and in poor repair. There is an overall lack of signage, and lighting in the area. Recommendations for the area include:

- C. Restore and/or replace in kind the concrete and wood slat "Lundino" benches adjacent to activity areas. In the original design, most benches at Jacob Riis Park were in the Back Beach area. Remove the modern metal benches, which date from later periods and are inappropriate.

- D. Repair and/or replace in kind damaged court surfaces and separating fences, where appropriate to proposed uses.
  - E. Retain "Type B" pedestrian lighting within Back Beach walkway areas, and consider overhead flood lights for those areas where night outdoor recreation is to be permitted.
