# Service Bulletin

Bulletin No.: 01-08-42-001L

**Subject:** Exterior Lamp Condensation and Replacement Guidelines

**Models:** 2019 and Prior GM Passenger Cars and Trucks

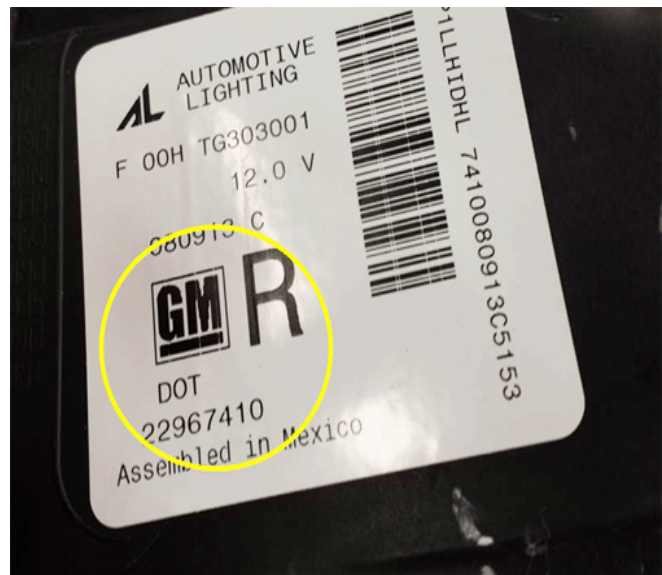
#### 2014 Cadillac XTS

**Note:** The graphics below are examples of GM Trademarks that may appear on lamp assemblies. Not all lamp assemblies currently have the trademark, however future assemblies will contain the trademark on a label affixed to the assembly.
