13.1 Ground-based damage survey and radar analysis of the El Reno, Oklahoma Tornado

Timothy P. Marshall¹, D. Burgess², G. Garfield², R. Smith³, D. Speheger³, J. Snyder⁴, H. Bluestein⁴

¹Haag Engineering Company, Irving Texas

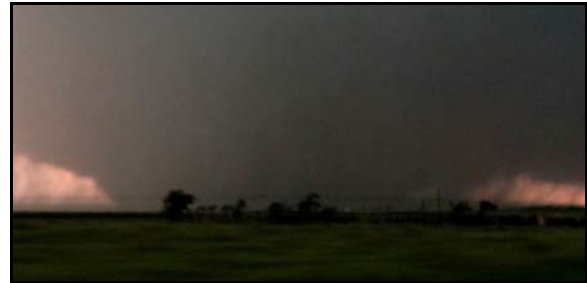
Figure 1. Wedge-shaped tornado approaching from the southwest taken from 0.8 km east of Radio and Jensen roads at 2326 UTC. The tornado crossed the image location approximately two minutes later. Image by Tim Marshall.

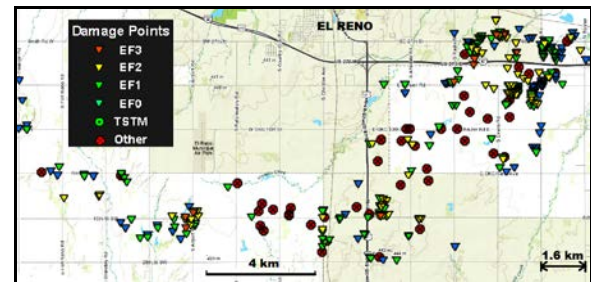
Teams rated and plotted a total of 257 DIs on a DAT map and identified an additional 344 non-standard DIs which included 112 oil tank batteries (Fig. 3).

Figure 3. DAT plot of DIs and non-standard DIs for the El Reno tornado. EF-scale intensity is shown by the colored triangles. Non-standard DIs (including oil tank sites) are indicated by red dots.

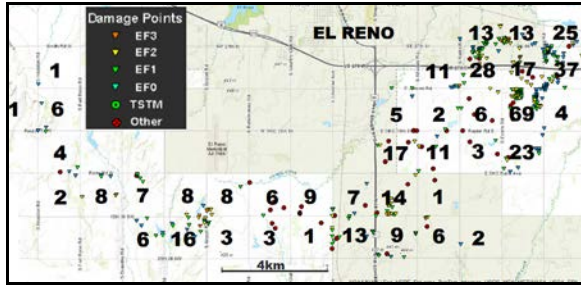
Tornado damage occurred within 39 square mile blocks (Fig. 4). The number of DIs was not uniform along the tornado path but concentrated near the end of the tornado path, near Interstate 40. There were 25 square mile blocks with fewer than 10 DIs each. By comparison, the greatest number of DIs per square mile was 69 due to a concentration of manufactured homes just south of Interstate 40.

Figure 4. DAT plot showing the numbers of DIs per square mile in the El Reno tornado. The greatest concentration of DIs occurred near the end of the tornado path, near Interstate 40.

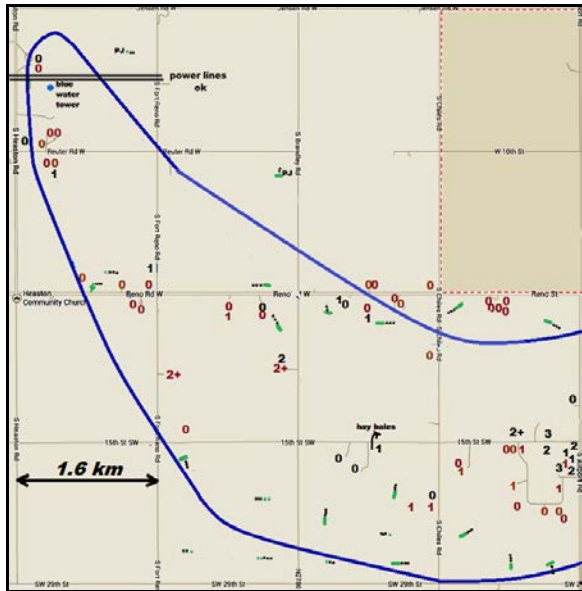
The tornado developed around 2303 UTC in a sparsely populated area about 10 km west of El Reno (Fig. 6). Initially, the tornado traveled southeast causing occasional EF0 and EF1 damage to rural homes and outbuildings. On average, there were about 4 DIs per square mile. The first EF2 damage occurred to a home which lost its roof on South Brandley Road. Storm chasers had observed a multi-vortex tornado at this time which continued to widen.

Around 2309 UTC, the tornado turned east as it crossed Chiles Road and paralleled, but did not cross, SW 29th Street to the south. At this time, the tornado damage track was approximately 2.6 km wide. The tornado struck several oil tank batteries causing little to no damage. Damage to rural homes remained in the EF0 to EF1 range. Then, the core of the tornado passed through a subdivision consisting of about a dozen homes and inflicted up to EF3 damage. Roofs were removed and perimeter walls were toppled on three homes, leaving only interior walls standing.

Figure 6. The beginning of the tornado damage path showing EF ratings. The blue outline is the approximate boundary of the tornado damage track determined by analysis of RaXPol velocity data. Oil tank batteries are black dots. Gas separators and heater treaters are green dots. The initials “PJ” indicate pump jacks. Arrows indicate the directions various items were moved.

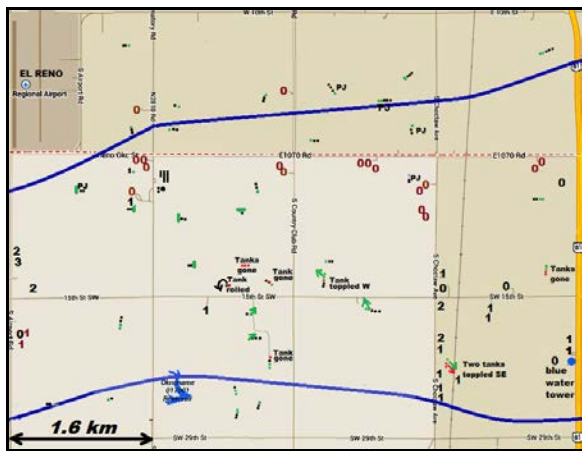
As the tornado passed south of the El Reno Municipal Airport, it again traversed sparsely populated areas with only a small number of DIs (Figure 7). However, the tornado struck more than a dozen oil tank batteries. Oil tank batteries consisted of one or more steel tanks, a gas separator tank, and occasional heater treater tanks. These items were not anchored to the ground. Gas separator tanks were oriented either vertically or horizontally and sat on concrete pads. Heater treaters were tall vertical tanks that also sat on concrete pads. Along 15th Street, a steel tank overturned to the north while a separator tank fell to the northwest on an adjacent facility.

As the tornado approached Highway 81, about 6 km south of El Reno, it reached its maximum width of 4.2 km, at about 2319 UTC. Team members observed the most severe damage to oil tank batteries in this area. Six sites had tanks knocked over or missing. Some of these tanks rolled as far as 4 km.

Figure 7. The tornado damage path between the El Reno Regional Airport and Highway 81 showing EF ratings. The remaining caption is the same as Figure 6.

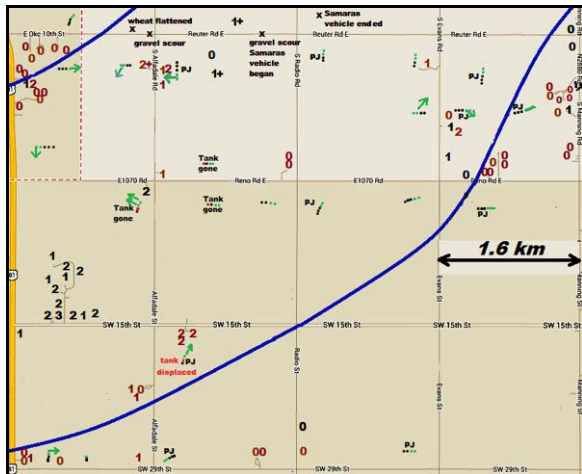
After crossing Highway 81, the tornado struck a subdivision of ten homes along SW 15th Street causing up to EF3 damage (Fig. 8). Here, several people sought refuge in underground shelters. It was at this time that the tornado began to turn northeast and intensify. Oil tank batteries were damaged in a swath that extended 4 km wide and most of the damage consisted of toppled gas separators and heater treaters. Four gas separator tanks fell in a converging pattern near Alfadale Road at four different sites. A portion of the wheat crop was flattened near Reuter Road but was not scoured. Also, some loose gravel was scoured in two locations along Reuter Road. Three storm researchers were killed when their vehicle was blown off Reuter Road around 2323 UTC. Numerous trees were uprooted in the creek bed on both sides of Reuter Road, yielding EF1 ratings.

Figure 8. The tornado damage path east of Highway 81 and south of Reuter Road showing EF ratings. The remaining caption is the same as Figure 6.

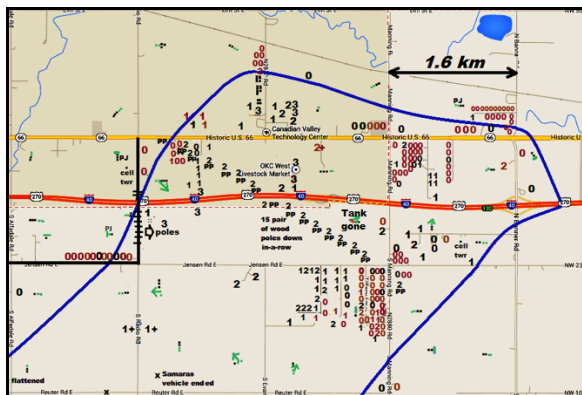
As the tornado continued northeast, it struck a subdivision south of Jensen Road containing about 60 manufactured homes (Fig 9). A few homes were completely destroyed yielding EF2 ratings. Along Interstate 40, the tornado downed 15 pairs of wood power poles over a distance of 3km. Just north of Interstate 40, three metal buildings were destroyed at the Oklahoma West Cattle Market. The buildings failed where steel columns were bolted to the concrete slabs.

Figure 9. Terminus of the tornado damage path along Interstate 40 east of El Reno showing EF ratings. The remaining caption is the same as Figure 6.

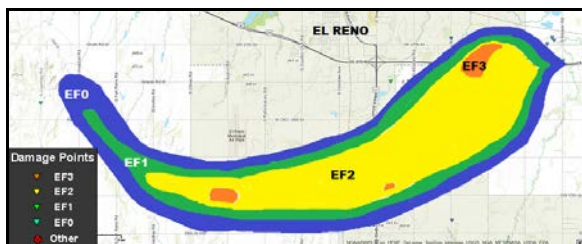
A color map of the El Reno tornado was drawn (Fig. 10). EF ratings were smoothed, contoured, and colored. Overall, team members found three distinct spots of EF3 damage.

Figure 10. Contoured and colored map of EF ratings for the El Reno tornado. There were three distinct spots of EF3 damage.

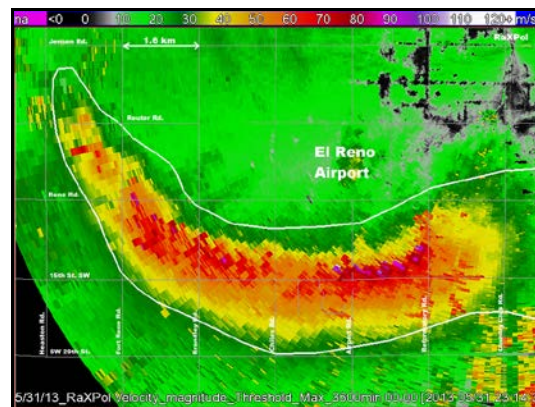
Figure 26. Maximum velocities of the El Reno tornado at zero degree elevation (not smoothed) obtained while the tornado was west of Highway 81. The white outline is the 30 m s^{-1} isodop.

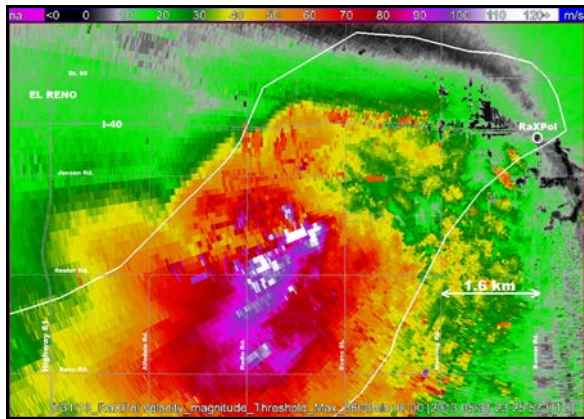
As the tornado crossed Highway 81, the RaXPoL radar moved east to the Interstate 40 and Banner Road location and scanned the tornado from 2324 through 2326 UTC. The tornado became quite intense east of Highway 81 with maximum velocities exceeding 120 m s^{-1} (Fig. 27) within subvortices just northeast of the intersection of Radio and Reuter roads. It was at this location that three storm researchers were killed. The radar truck had to move again when the tornado turned northeast and closed to within 3 km. At that time the leading edge of the RFD gust front was within 0.5 to 1 km of the radar location.

Figure 27. Maximum velocities of the El Reno tornado at zero degree elevation (not smoothed) obtained from 2324 to 2326 UCT while the tornado was east of Highway 81. The radar was located in the upper right corner of the image. The white outline is the edge of the tornado as determined by the 30 m s^{-1} isodop.

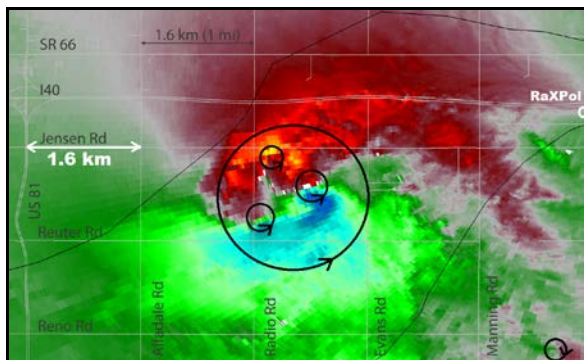
Analysis of radar velocities indicated there were vortices of various sizes. The largest circulation was the parent mesocyclone which included a strong RFD. The main tornadic circulation contained a persistent subvortex while intermittent subvortices rotated around the periphery of the main tornado (Fig. 28). Wurman et al. (2014) also observed these subvortices with the DOWs. In addition to the subvortices, there were satellite tornadoes moving southbound into the northwest flank of the main tornado and anticyclonic tornadoes east-southeast of the main tornado. Some of the subvortices, including the anticyclonic tornadoes, had smaller subvortices vortices. The various sizes and types of vortices made it more difficult for surveyors to determine what vortex caused what damage, especially in such a sparsely populated, rural area.

Figure 28. Radial velocity image taken at 2326 UTC showing the large tornadic circulation, and subvortices (circled). The anticyclonic tornado is located in the lower right corner of the image.

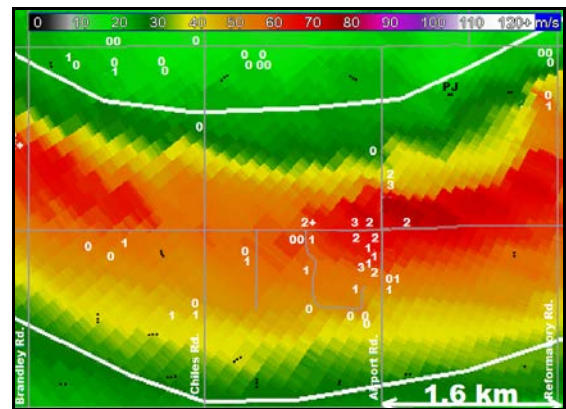
The El Reno tornado traveled through a subdivision west of Highway 81 causing EF1 to EF3 damage (Fig. 29). The associated EF wind speeds to cause such damage were between 38 and 74 m s^{-1} . By comparison, the RaXPol Vmax was between 50 and 80 m s^{-1} . Thus, RaXPol values were approximately 10-30% higher than EF values for reasons mentioned previously. Wurman and Alexander (2005) made the same observation in their paper.

Figure 29. Color-coded map of smoothed Vmax west of Highway 81 where the center of the tornado traveled through a subdivision. EF ratings are overlaid. The white outline is the boundary of the tornado as determined by the 30 m s^{-1} isodop.

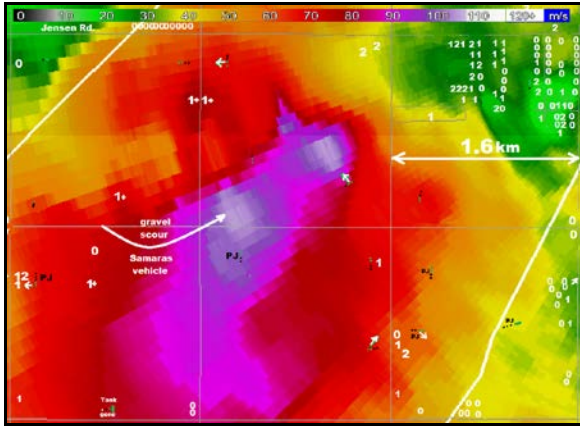
The highest velocity measurements from the RaXPol radar occurred east of Highway 81 near Radio and Reuter roads (Fig. 30). This was a sparsely populated area with open fields. Even when smoothed, the velocities exceeded 100 m s^{-1} . Radar measurements indicated this tornado could well have reached EF5 intensity, however, there were no DIs where Vmax was highest. That said, however, there was an absence of ground scouring or substantial damage to nearby oil field equipment in this area.

Figure 30. Color-coded map of smoothed Vmax east of Highway 81 where the tornado traveled through open fields where there were no buildings. EF ratings are overlaid. The white outline is the boundary of the tornado as determined by the 30 m s⁻¹ isodop.
