# **Collision Reconstruction Report**

**Fatal Collision 23 / 2009**

**Bloor Street West near Avenue Road  
City of Toronto, Ontario**

**Monday, August 31, 2009**

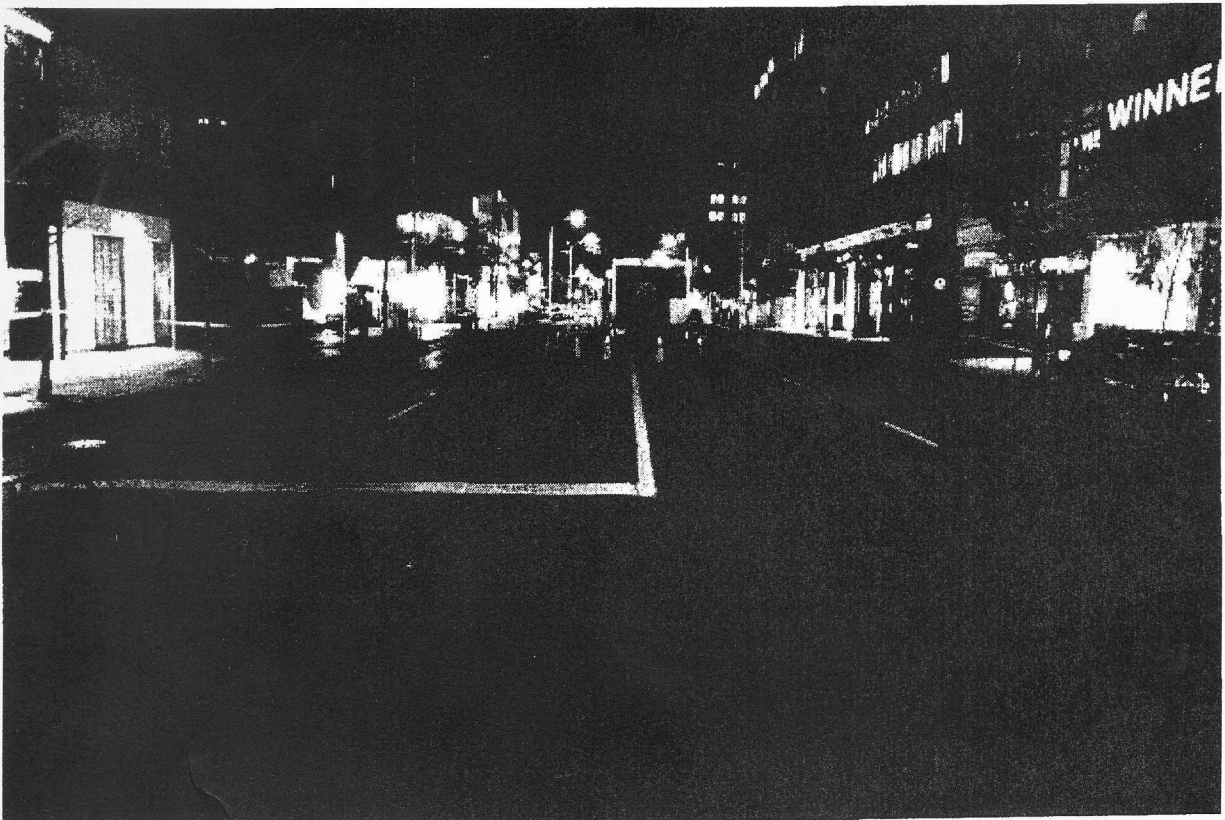
Fig 1.1 Bloor Street West facing westbound, west of #102 . (TSV00392.09 058)

Bloor Street West was a major arterial, east-west, four-lane roadway. The road surface was constructed of asphalt. The pavement was dry and the level road surface was in fair to poor condition. The asphalt on the roadway was patchy and uneven. The two lanes in the each direction were separated by an intermittent white line while opposing traffic was separated by a single solid yellow line. Concrete curbs lined the street with concrete sidewalks.

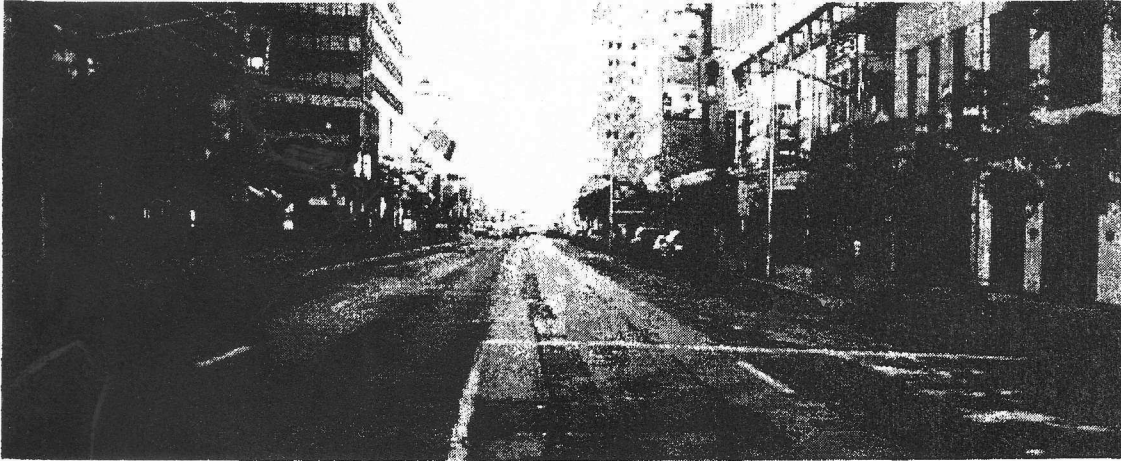
Fig 1.2 The signalized pedestrian crosswalk near #102 Bloor Street West facing west. (TSV00392.09 057)

There was a stop line for eastbound and westbound traffic with two thinner white lines designating a pedestrian crossing area. There was not an intersecting roadway.

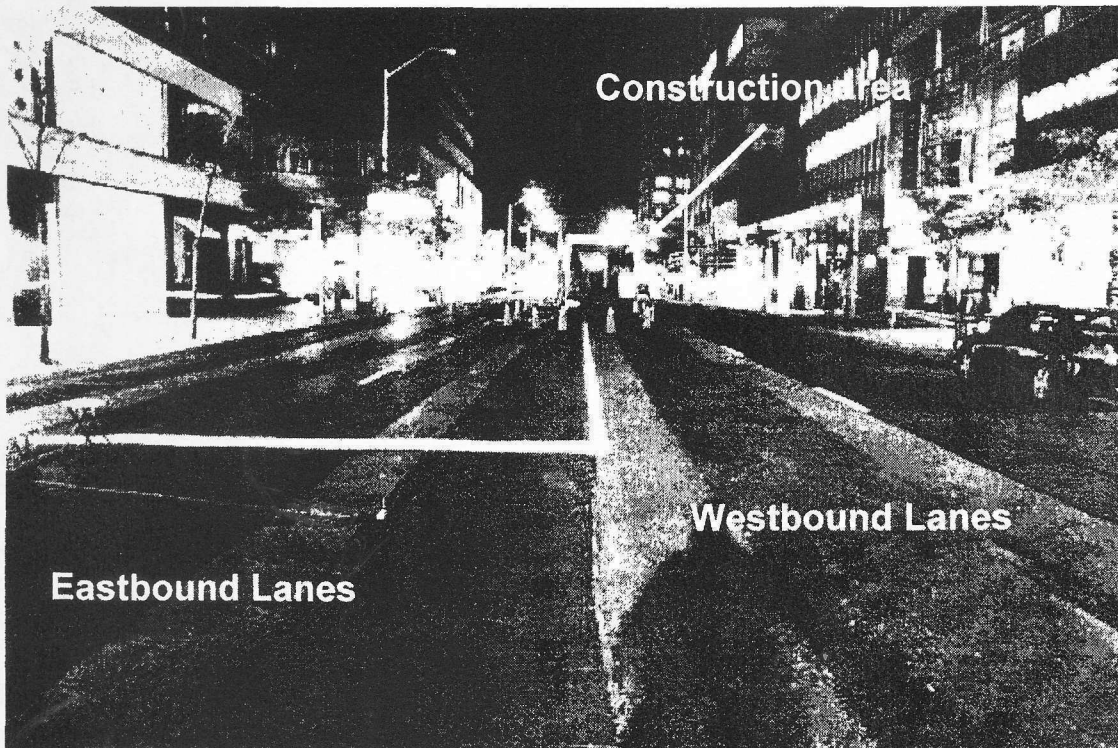
Fig 1.3 Westbound Bloor Street West approaching the construction (TSV00373.09 058)

The night of this incident a work crew had the east and westbound passing lanes closed. There were pylons and construction signs outlining the area. Only a cautionary work sign was presented for westbound traffic. The construction area was cordoned off by pylons with ample space in the curb lane for east and westbound traffic flow. Eastbound traffic had a directional arrow.

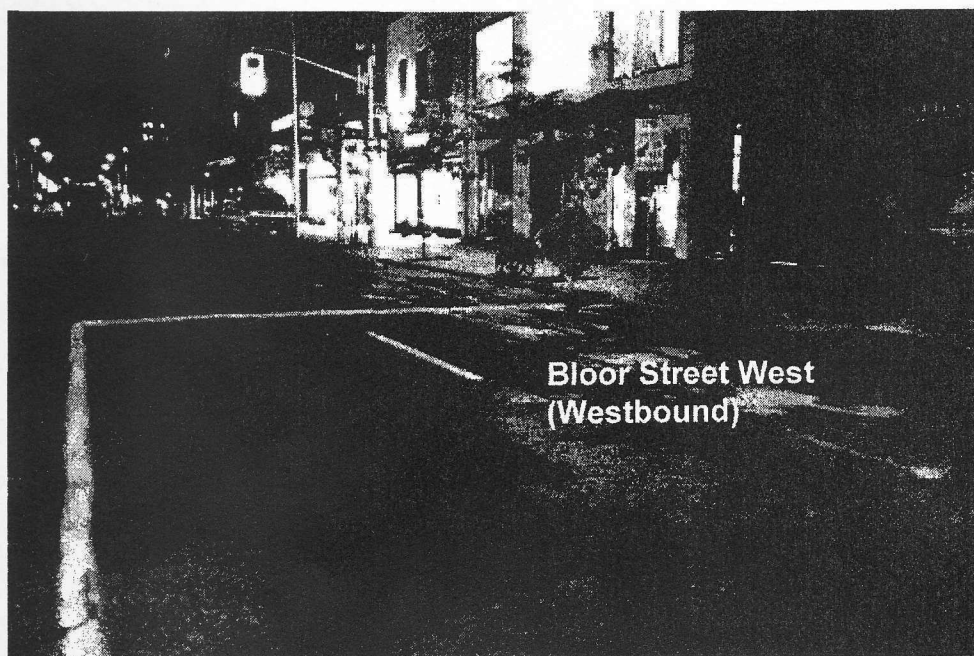
Fig 1.4 Bloor Street West east of signalized pedestrian crosswalk near #102 (TSV00373. 09057)

Collision #1 was captured on a video camera located at 102 Bloor Street West. No physical evidence was observed on the roadway from this collision.

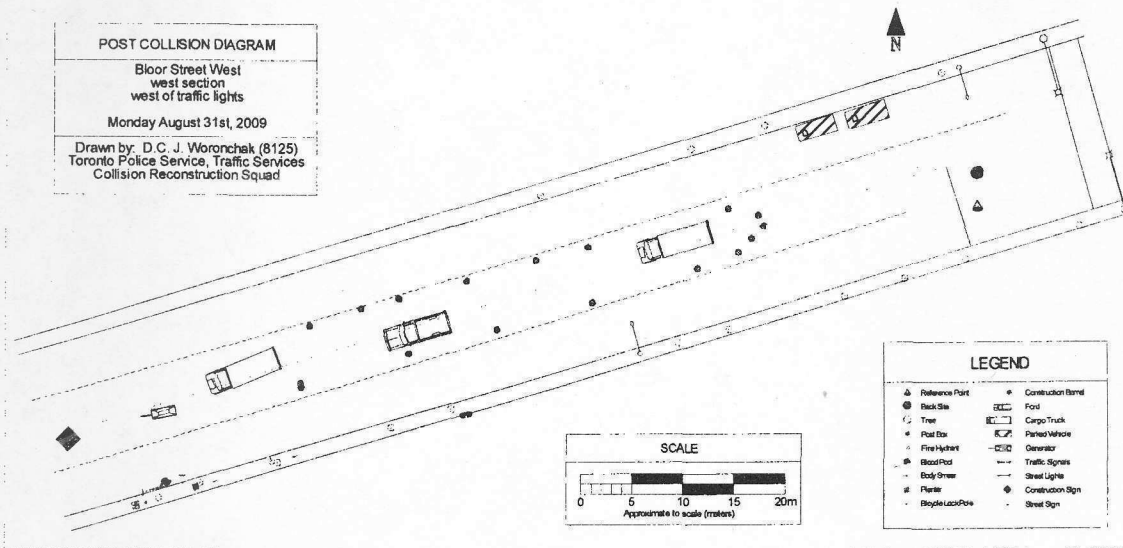
Diagram 2

Collision Scene #3 occurred near # 131 Bloor Street West on the south side of the roadway in the eastbound lanes. A tree near #131 Bloor Street West was observed to have a smear mark on it between 0.5 m and 0.43 m above the ground. A piece of bark was located on the sidewalk to the west of the tree. A fresh clean break in the tree bark was observed.

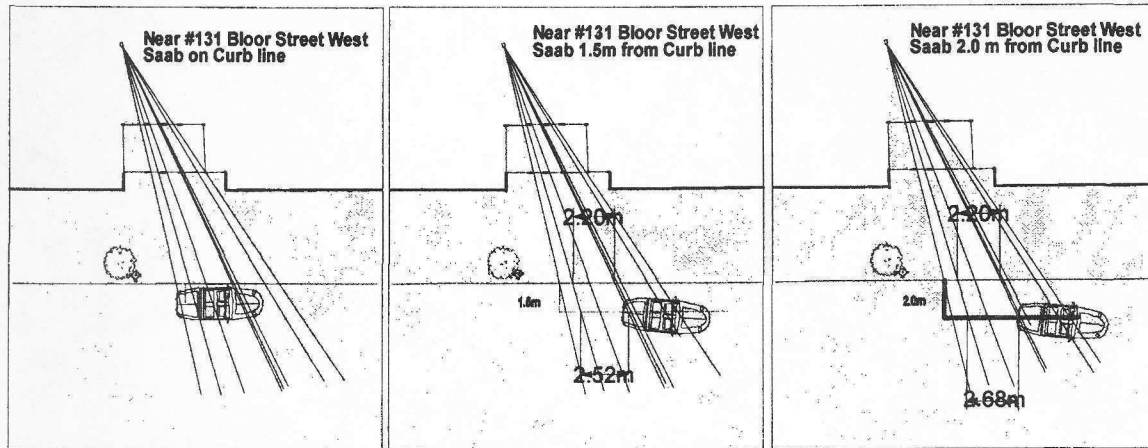
Fig 1.19 Bloor Street West near #131 varying distances of the Saab from the curb.

Measurements were taken at the scene in conjunction with sightlines with the security camera of the store. It could not be determined how far north the Saab was in relation to the curb line on the roadway. The video showed the Saab travelling across the screen and the lights moved higher in the frame. This would suggest the Saab moved in a northerly direction towards the westbound lanes of Bloor Street West.

Scenario #1 determined a speed for the Saab as it utilized the curb line as a distance measurement. This scenario was not possible as there was no physical evidence found to suggest the Saab was travelling on the curb. A distance of 2.2m was used for the Saab.

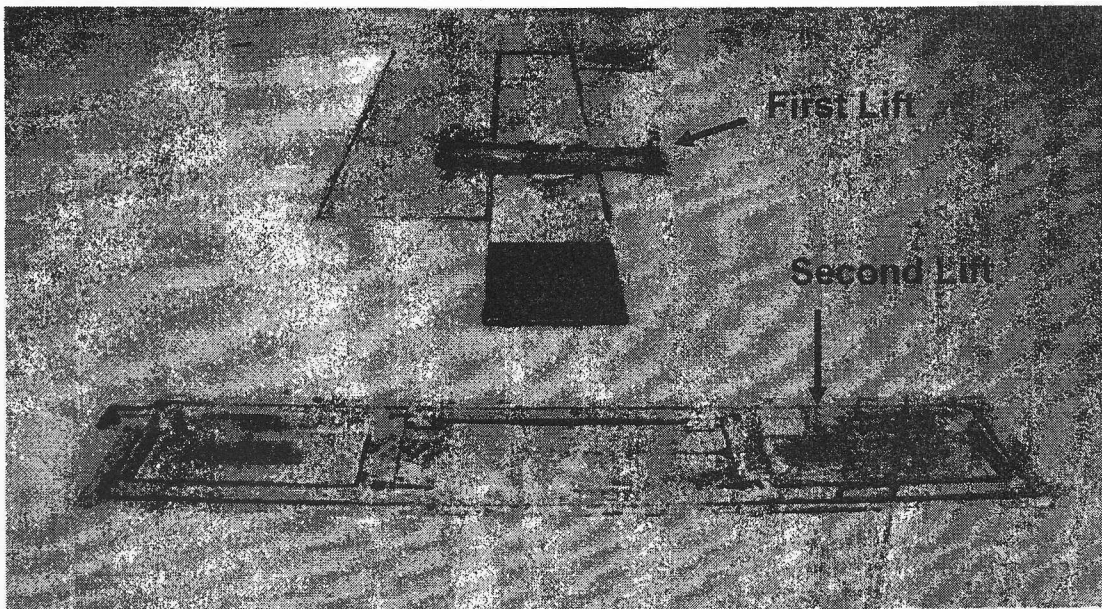
Fig 1.22 Vehicle lift at CFS. (TSV 0527.09 003)

During the mechanical examination of the Saab, the Qualified Automobile Service Technician, noted the drivers' side rear brake line was broken and there was a fluid leak.

The lift used by the CFS was comprised of two separate pieces for each axle of a vehicle.

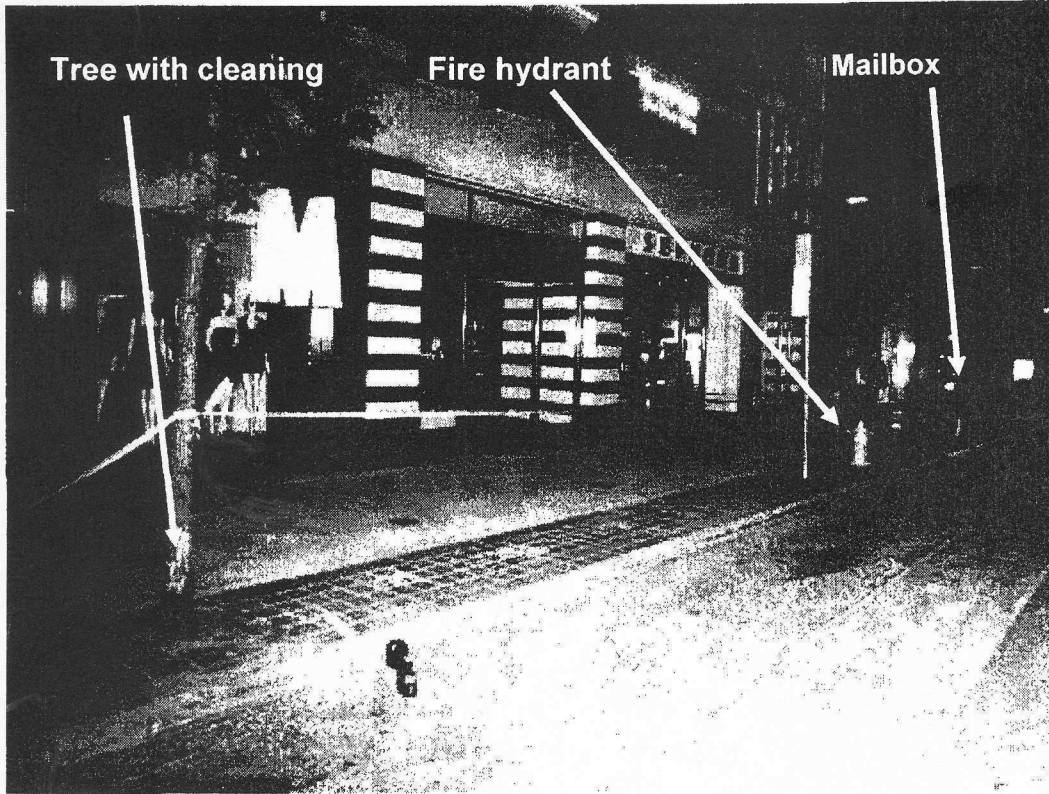
Fig 1.27 Overview, south side of Bloor Street near #131 (FIS207309 5643)

There was cleaning noted on a tree near #131 Bloor Street West with a small piece of bark located west of the tree. The tree was 0.8m south of the south curb of Bloor Street West 12.27m east of the fire hydrant near Sephora at #131.

The cyclist had an abrasion wound to his left ankle which was consistent with glancing off the tree dislodging the bark.
