# **The Tornadoes of Oklahoma City of May 3, 1999**

a report prepared by

Wind Science and Engineering Research Center  
Texas Tech University  
Lubbock, Texas

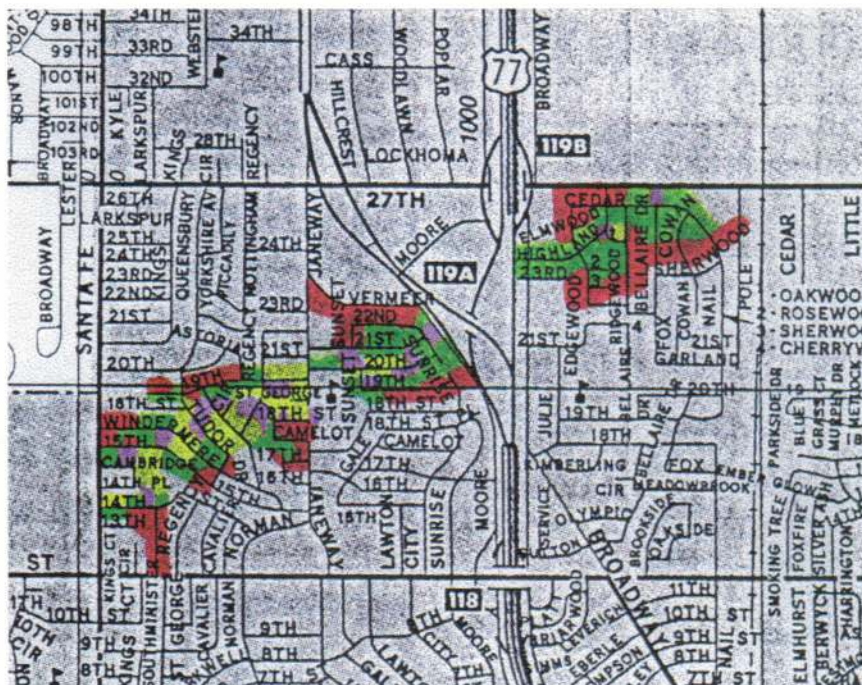
FIGURE 11. MOORE DAMAGE

Red-minor/moderate damage, Green-extensive damage, Purple-severe damage, and Yellow-destroyed damage.

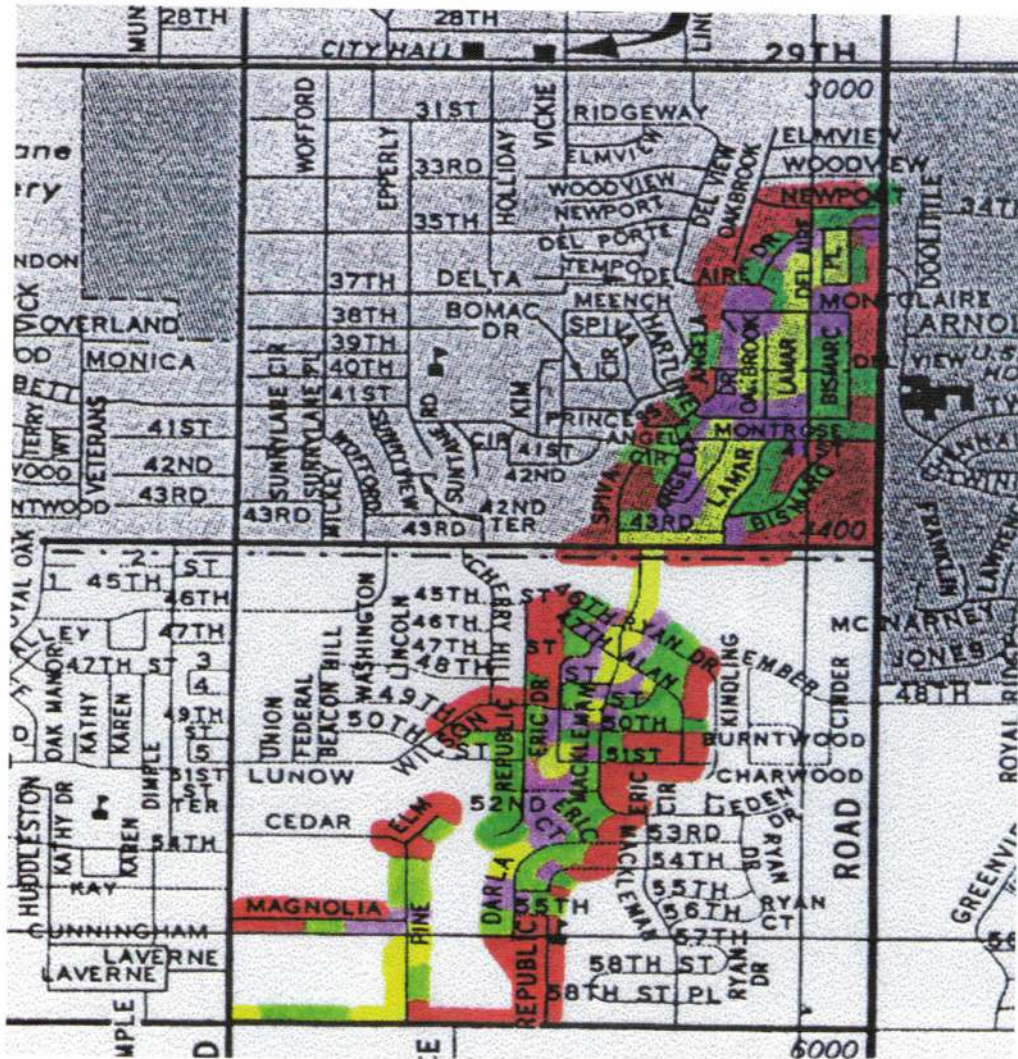
**FIGURE 12. DEL CITY DAMAGE**

*Red-minor/moderate damage, Green-extensive damage, Purple-severe damage, and Yellow-destroyed damage.*

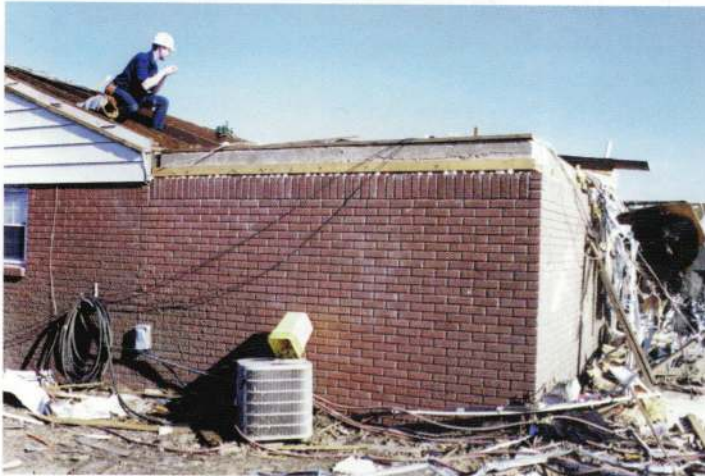
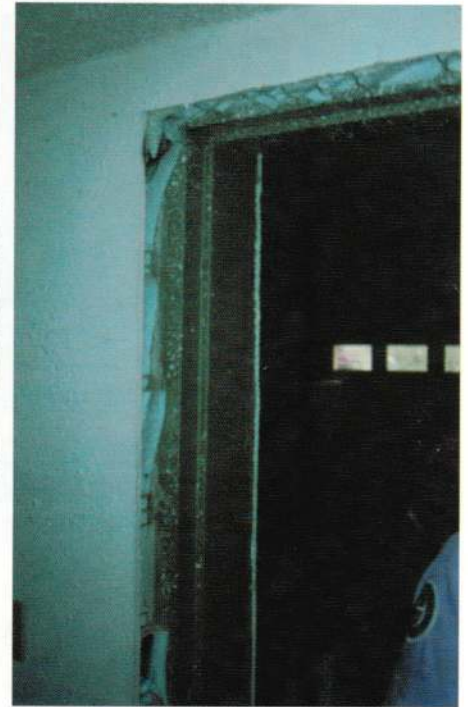
**FIGURE 13. ABOVE GROUND SHELTERS**

Both above- and below-ground shelters were found in the damage path of the tornadoes that struck Oklahoma City on May 3, 1999. Above-ground shelters included cast-in-place concrete, i.e., the Bartlett Shelter (Figure 13, left), and insulated concrete formed, i.e., the Lewis Shelter (Figure 13, right).

*Cast-in-place concrete Bartlett Shelter, Del City, OK (left); insulated-concrete formed Lewis Shelter, Bridge Creek, OK (right).*

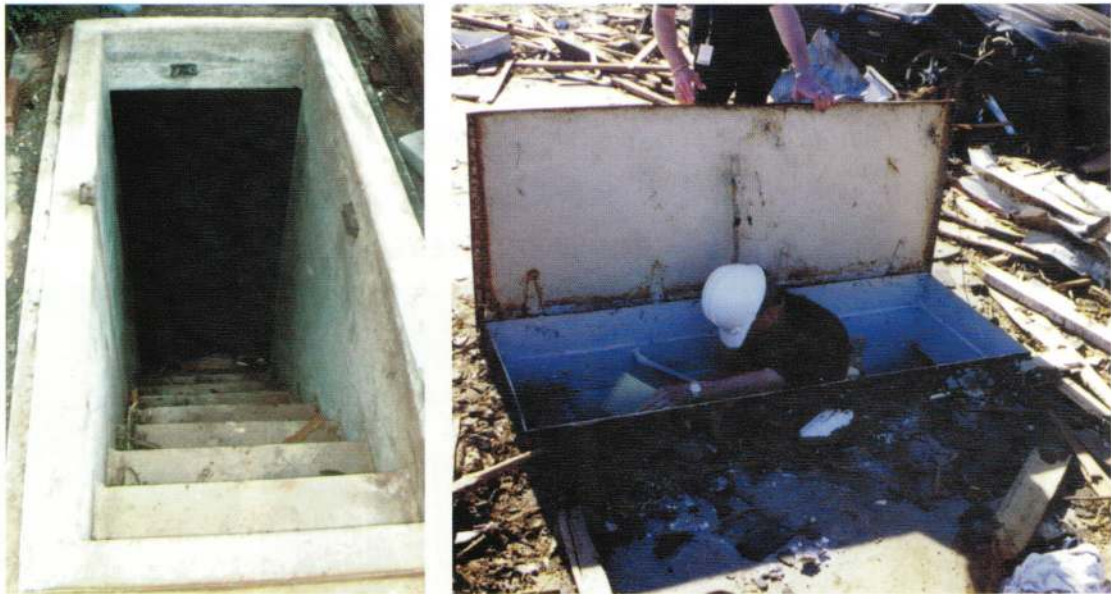
**FIGURE 14. SELF-CONTAINED BELOW-GROUND SHELTERS**

Although common in many parts of the country, residential basements are not common in Oklahoma and were not observed by the damage documentation team. However, self-contained shelters located below-ground and out of the building footprint, commonly referred to as cellars, were observed. These storm cellars were constructed of cast-in-place concrete (Figure 14, left) or prefabricated steel with a concrete cover (Figures 14, right).

*Cast-in-place concrete (left); prefabricated steel (right).*

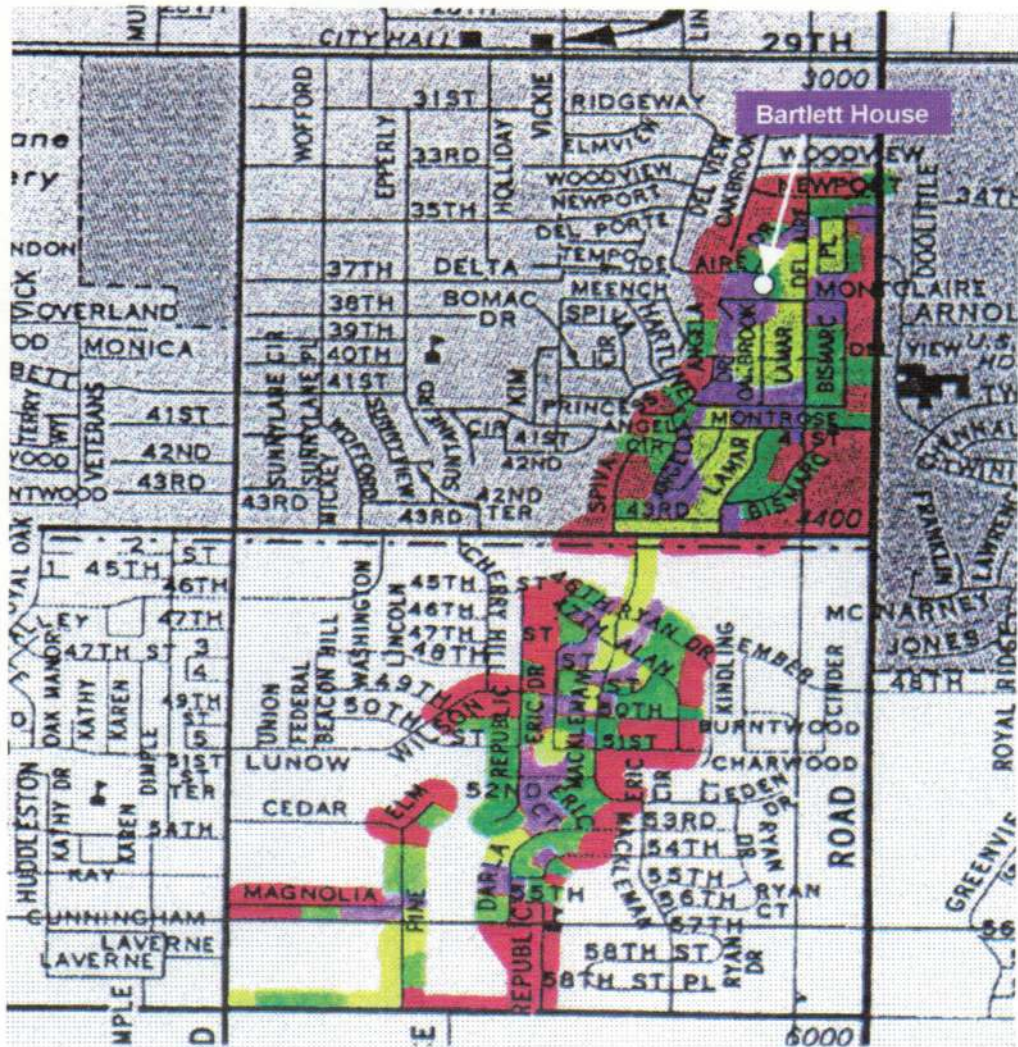
**FIGURE 15. BARTLETT NEIGHBORHOOD**

The Bartlett Shelter was located in Del City, Oklahoma. The Bartlett neighborhood experienced extensive to severe damage (Figure 15). The Lewis shelter was located in the Bridge Creek Estates in Bridge Creek, Oklahoma, an area which experienced minor/moderate damage. Both shelters survived without any damage, even though the Bartlett home was classified as having severe damage (Figure 16).

*Red-minor/moderate damage, Green-extensive damage, Purple-severe damage, and Yellow-destroyed damage.*

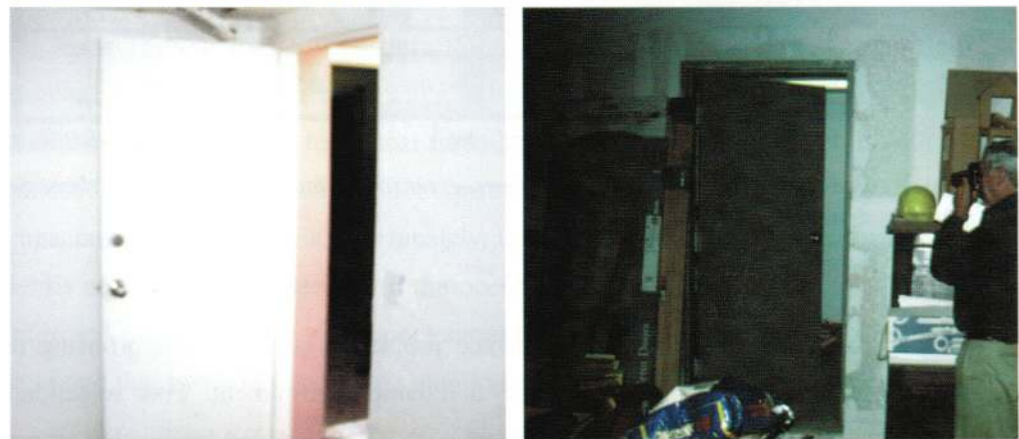
**FIGURE 17. SHELTER DOORS**

The construction of each shelter was consistent and somewhat excessive compared to the Texas Tech shelter (FEMA Safe Room, FEMA, 1998) guidelines. The Bartlett Shelter had 12 in. thick concrete walls and ceilings (FEMA, 1998). The doors on both shelters were 16 gage (or less) steel set in hollow metal frames and locked with a single deadbolt (Figures 17). This door construction setup is not sufficient to resist direct impacts from flying debris. Fortunately, the doors did not show signs of impact by debris and provided protection to the occupants. The owners of both shelters were informed that the lighter gage doors should be armor plated with a layer of 14 gage steel and that two additional locks should be added to meet shelter guidelines.

*Bartlett Shelter, Del City, OK (left); Lewis Shelter, Bridge Creek, OK (right).*

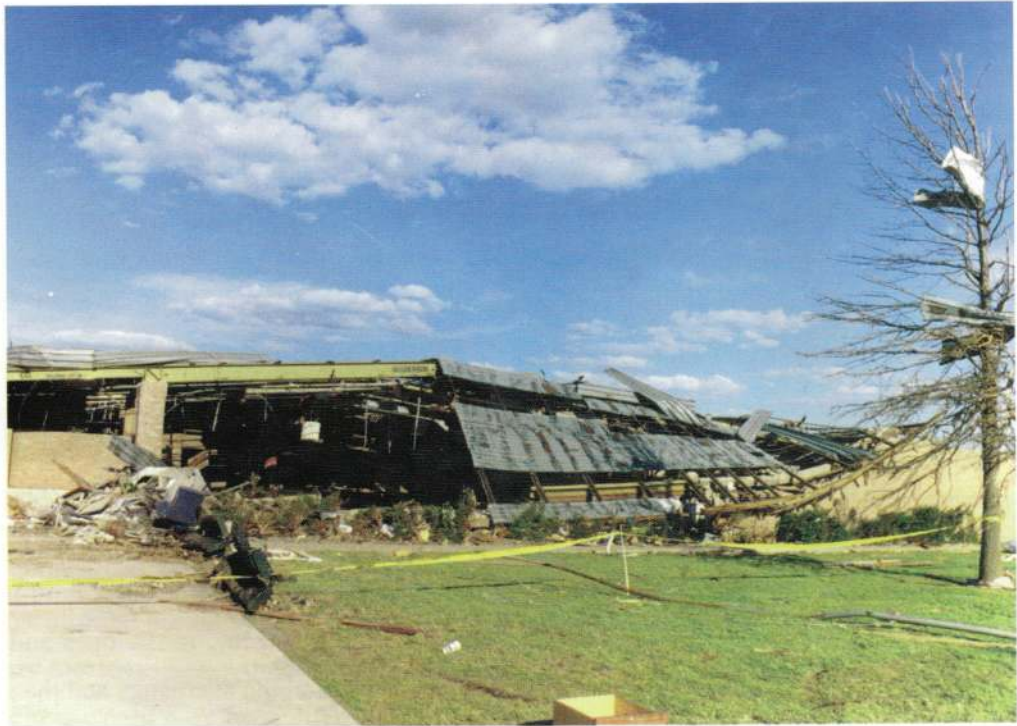
**FIGURE 21. KELLY ELEMENTARY SCHOOL, MOORE, OK**

Kelly Elementary (Figure 21) had a load-bearing concrete masonry wall construction with light steel columns and beams with bar joists supporting a built-up roof over metal roof deck. The 1960's vintage building had low roof slopes and large overhangs. The strong wind forces produced uplift on the overhangs and the storm debris compromised the building envelope allowing internal wind forces coupled with the external wind forces, to remove the roof decking. Initial structural failure occurred at the roof deck to joist connections. The sequential failure of the decking probably produced eccentric loading on the structural steel frame causing racking of the frame (Figure 22) and eventual failure of the beam blocks in the bearing wall (Figure 23). It is of interest to note that the planned areas of emergency refuge within the building were the corridors, each of which was filled with toppled masonry walls and twisted building elements.

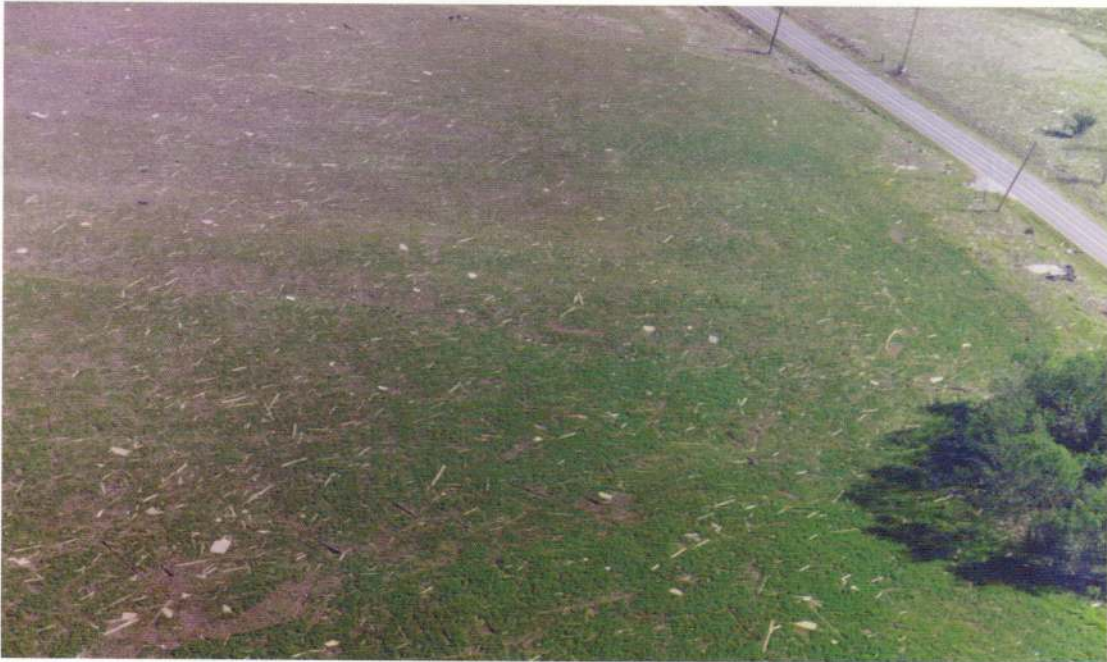
**Figure 31. Debris Field**

Debris of different materials, shapes and weights may or may not become windborne. Some building parts may become windborne and disintegrate into several components. Documentation of debris would include original and final locations of debris pieces and the size and shape of debris pieces. The documentation teams did not document general debris (Figure 31), but focused on projectiles: pieces of debris that impacted and were found penetrating walls and other surfaces and objects. Note that projectiles are a small subset of debris. Since the sample size is relatively small, no attempt is made to perform statistical analysis of debris or projectiles.

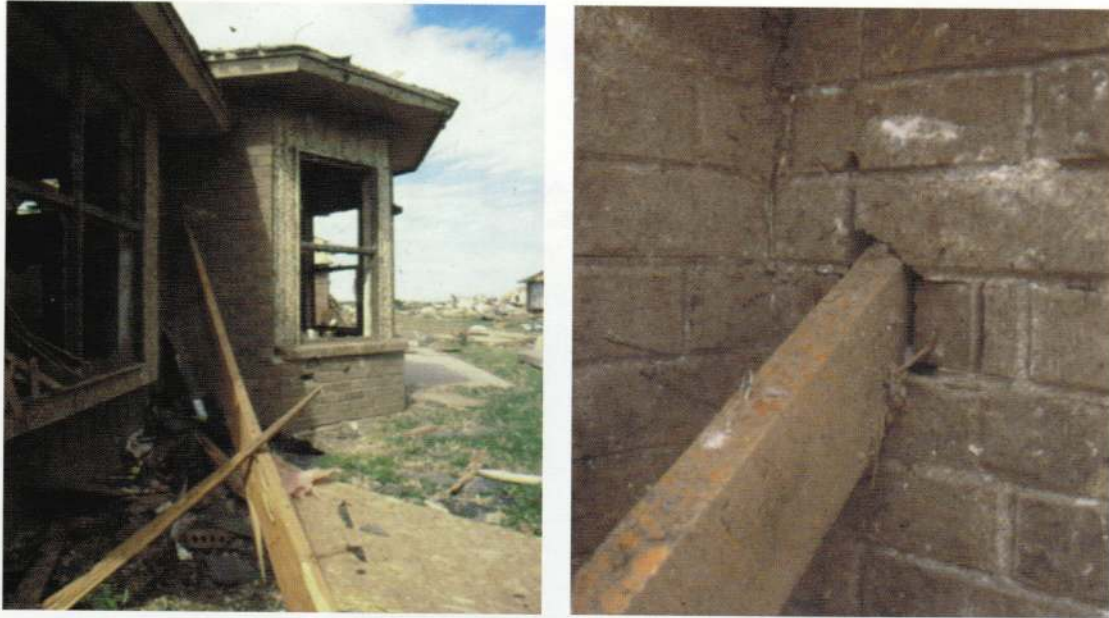
**Figure 32. Large 2x6 Wood Projectile**

The majority of buildings surveyed were residential buildings of wood-frame construction, thus most of the debris and projectiles observed were broken wood boards. **Wood board projectiles** consisted of a wide variety of shapes, from small 3 cm x 3 cm (1 in x 1 in) pieces to a 4 m (14 ft) long 5 cm x 15 cm (2 in x 6 in) member. Out of the 27 wood projectiles documented, there were two 3 cm x 15 cm (1 in x 6 in), nine 5 cm x 10 cm (2 in x 4 in), and sixteen 5 cm x 15 cm (2 in x 6 in) members. The average weights of documented 5 cm x 10 cm (2 in x 4 in) and 5 cm x 15 cm (2 in x 6 in) projectiles were 13 and 44 N (3 and 10 lbs), respectively. An unusually large 5 cm x 15 cm (2 in x 6 in) projectile (4 m, 14<sup>+</sup>ft long) with an estimated weight of 151 N (34 lb) was observed (Figure 32). Wood projectiles penetrating brick veneer were typically 5 cm x 15 cm (2 in x 6 in) wood boards (Figure 33). Wood projectiles penetrating wood roof decks (Figure 34) and automobiles included 3 cm x 15 cm (1 in x 6 in), 5 cm x 10 cm (2 in x 4 in) and 5 cm x 15 cm (2 in x 6 in) wood boards (Figure 35). The weights of documented wood projectiles ranged from 9 to 151 N (2 to 34 lbs), with lengths from 25 cm (10 in) to 4 m (14 ft).

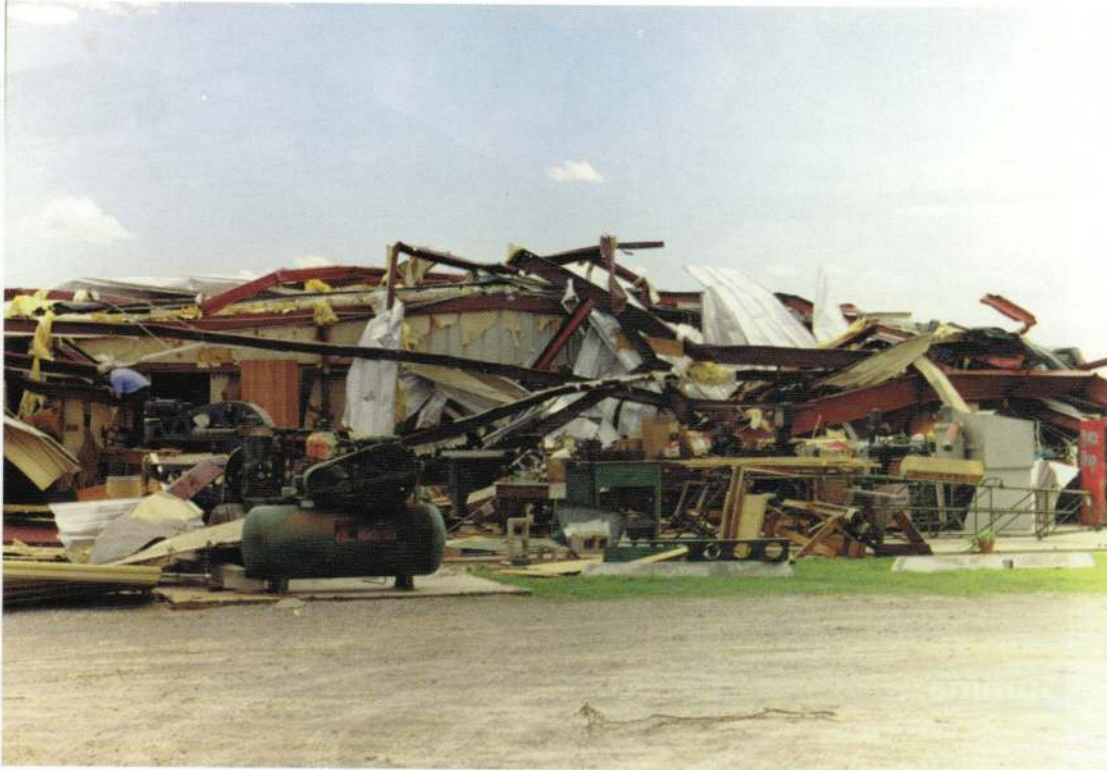
**Figure 36. Steel Building Failure**

Steel projectiles were rare since steel components were not widely used in residential construction. Failed steel buildings were normally found in agricultural areas, and their components typically did not completely separate from each other. Steel members were often found twisted and tangled in a mound (Figure 36). A short, lightweight **C-section steel** piece, 64 cm (25 in) long and 8 cm (3 in) wide, was found stuck in grass-covered ground (Figure 37). A **steel gas pipe** segment, about 1.5 m (5 ft) long, was found penetrating a wood roof deck (Figure 38).
