Formal Observation Report

Tornado: Moore, Oklahoma, May 20, 2013

Safe Room Performance, Observations, and Conclusions

FEMA P-1020 / August 2014

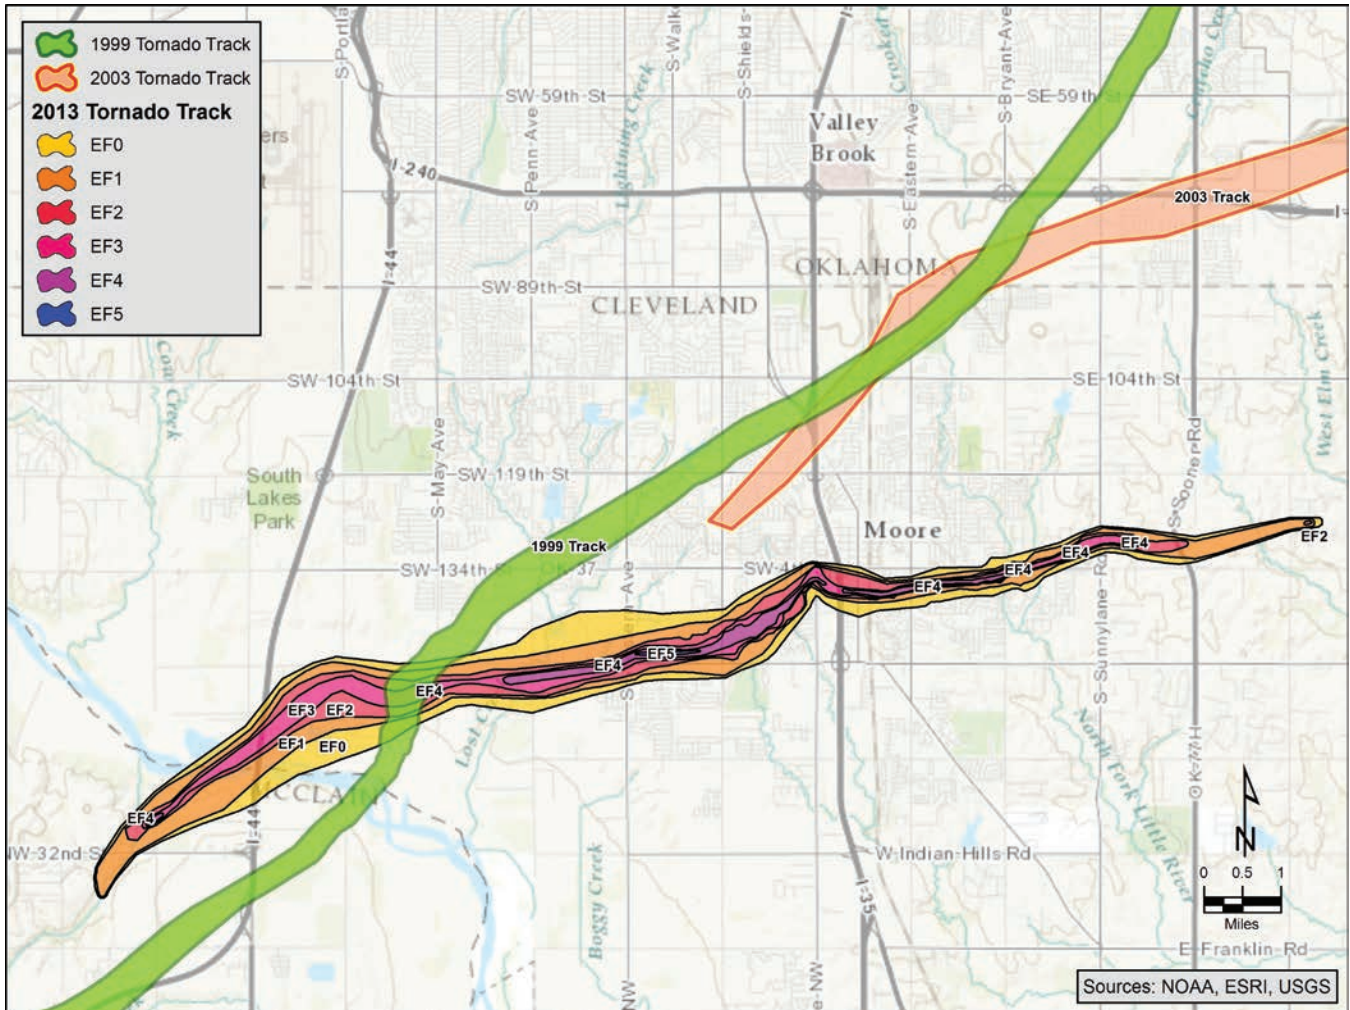
The City of Moore and surrounding areas have experienced three tornadoes with an intensity of EF-4 or greater, including the 2013 event, in the past fifteen years. An F-5 tornado occurred May 3, 1999 and an F-4 tornado on May 8, 2003, both of which destroyed large sections of Moore. Figure 1 shows the tracks of the three tornadoes, the 2013 tornado track (multi-colored outline) crossed through the western end of the 1999 tornado track (green outline), but the majority of the 1999 tornado track and the entire 2003 track (red outline) were just north of the 2013 track.

Figure 1: Approximate tornado tracks for the 2013 event (multi-colored outline), 2003 event (red outline), and 1999 event (green outline)

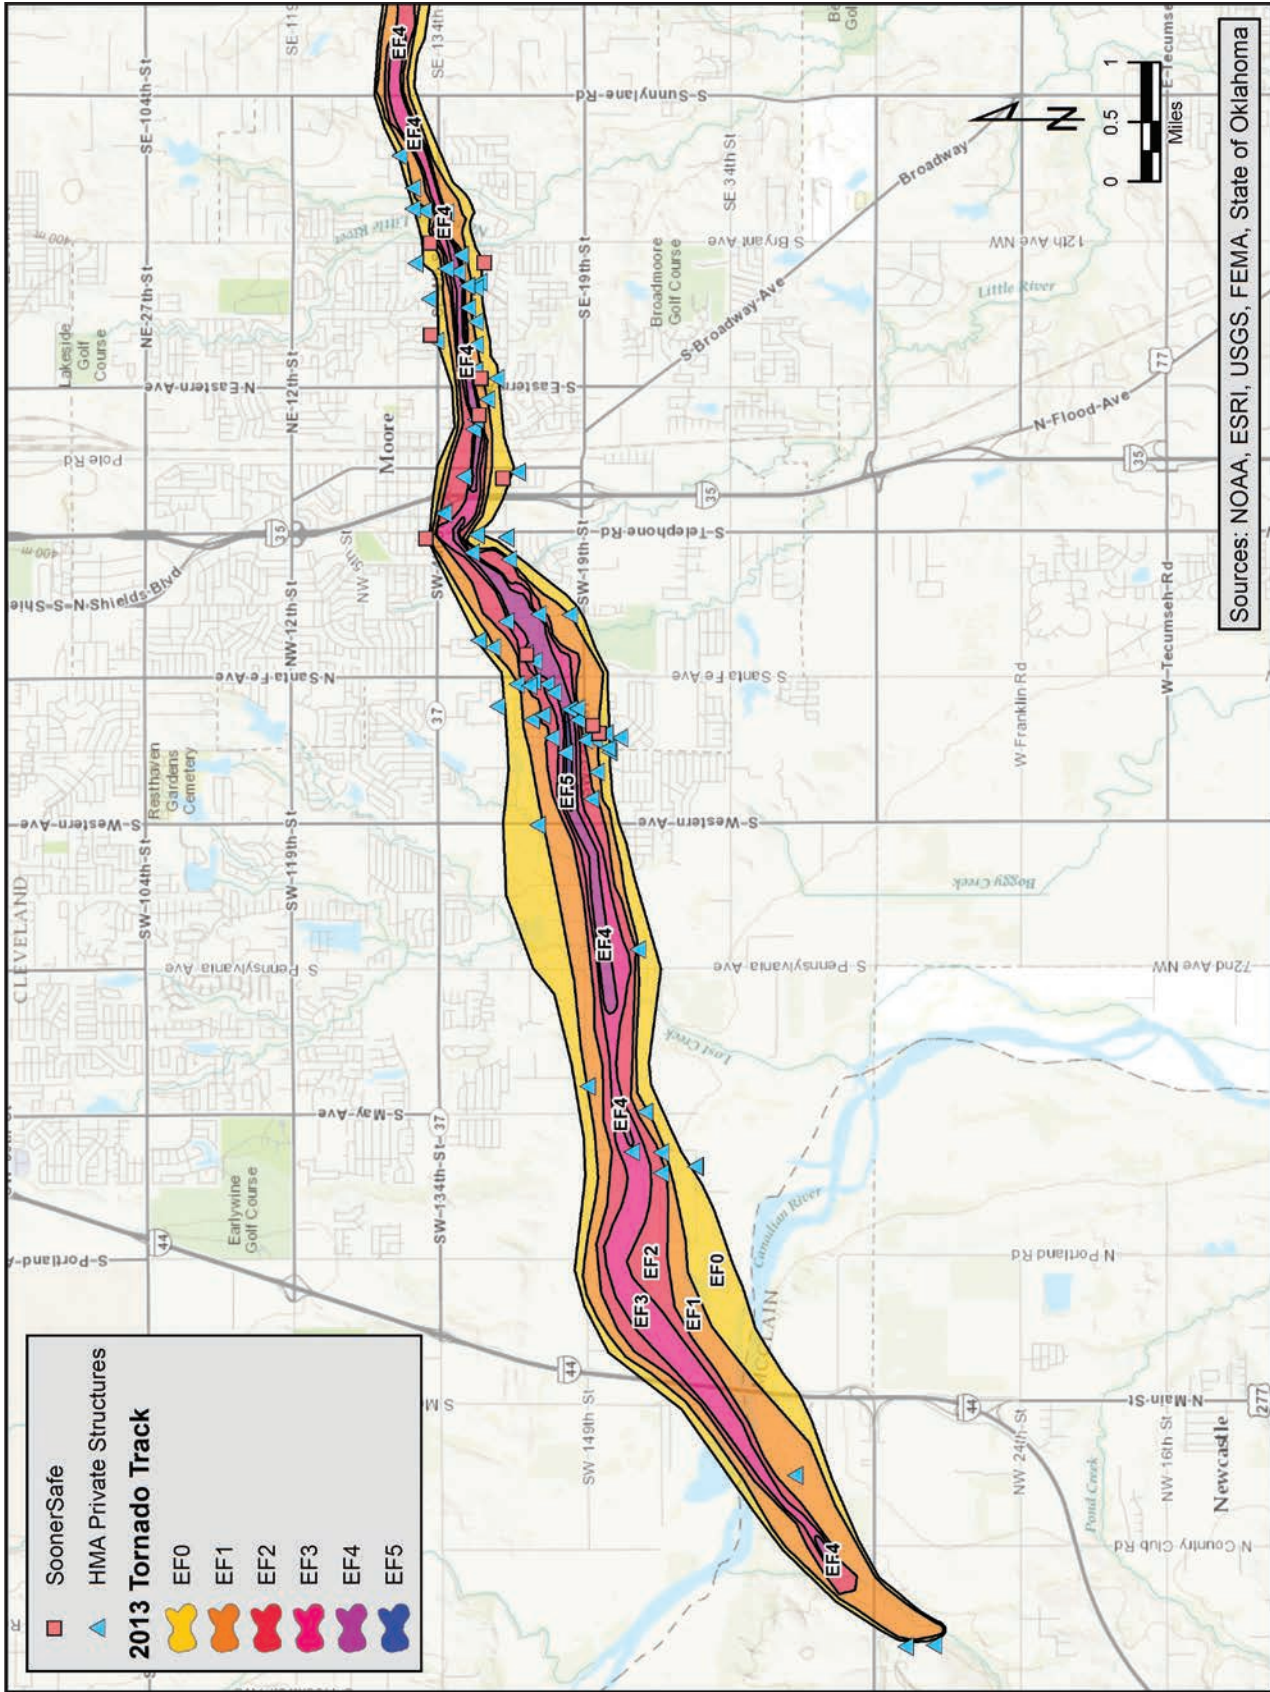
Figure A-1. Map showing the known locations of residential safe rooms and shelters in relationship to the 2013 tornado track.

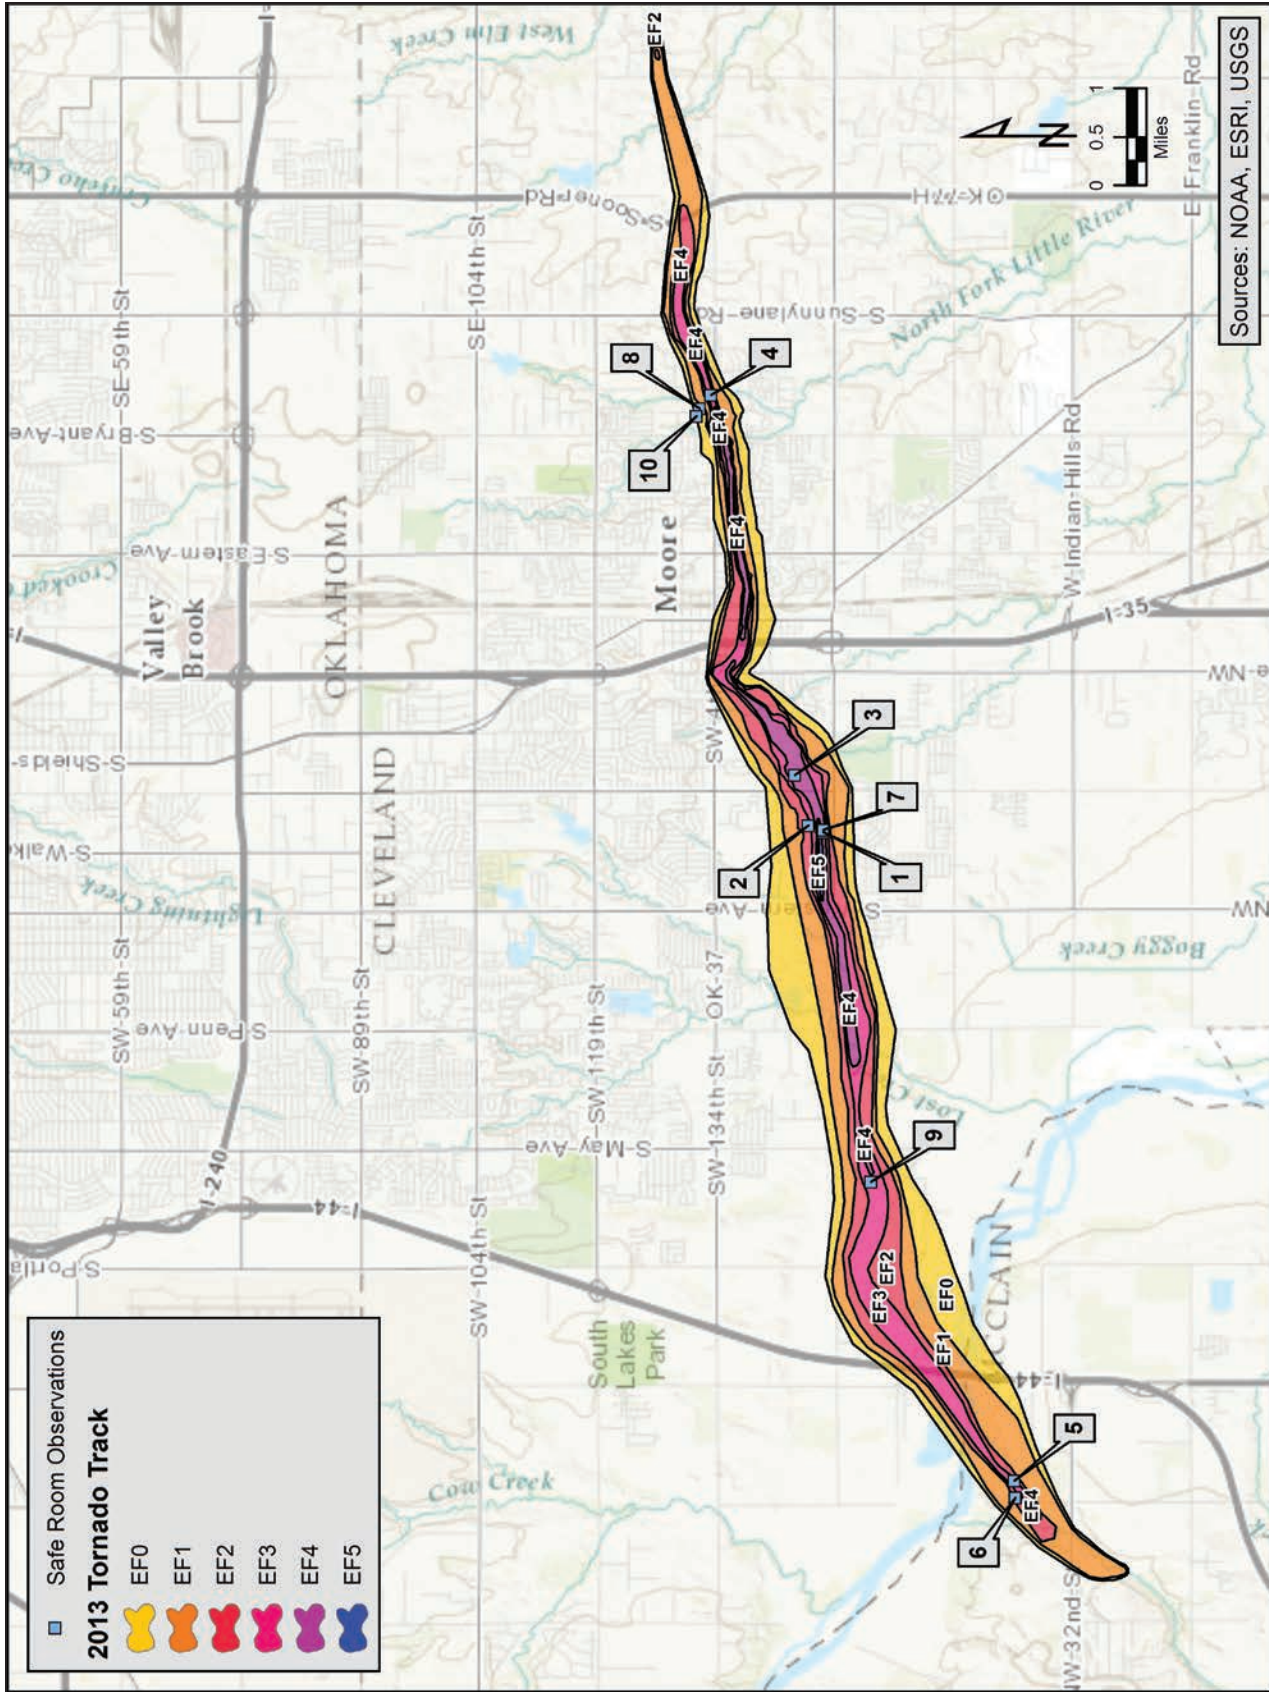
Figure A-2. Map showing observation locations with respect to the 2013 tornado track.
