AIRCRAFT ACCIDENT REPORT 2/96

Air Accidents Investigation Branch

**Report on the accident to
EMB-110 Bandeirante, G-OEAA
at Dunkeswick, North Yorkshire
on 24 May 1995**

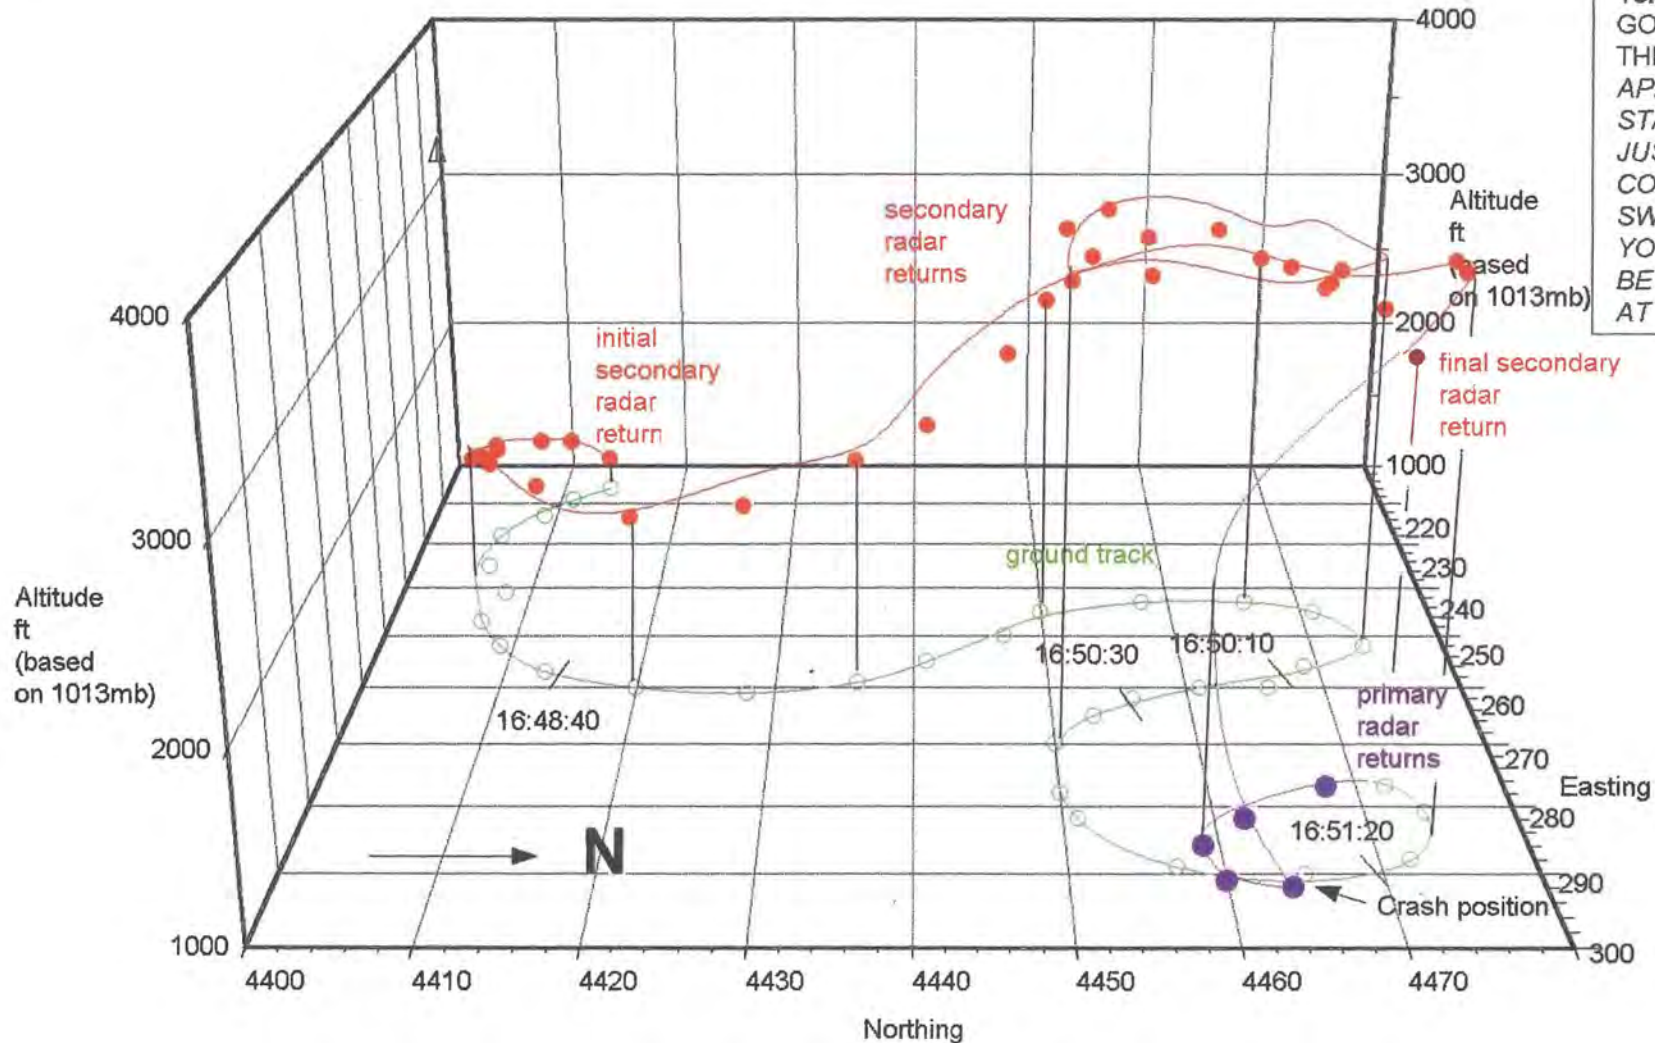
TRACK PLOT G-OEAA

16:50:10 APP CON - I SEE YOU CARRYING OUT AN ORBIT
ER JUST TELL ME WHAT I CAN DO TO HELP
816 - ARE WE GOING STRAIGHT AT THE MOMENT SIR
16:50:30 APP CON - YOU'RE IN A RIGHTHAND TURN AT
THE MOMENT ER LET ME SEE ER JUST WAIT FOR
ANOTHER SWEEPES YOU'RE GOING STRAIGHT AT
THE MOMENT AND YOU'RE HEADING SOUTHEAST

16:51:20 816 - ARE WE
GOING STRAIGHT AT
THE MOMENT SIR
APP CON - JUST
STANDBY ER
JUST WAIT FOR A
COUPLE OF
SWEEPES YEAH
YOU LOOK TO
BE GOING STRAIGHT
AT THE MOMENT

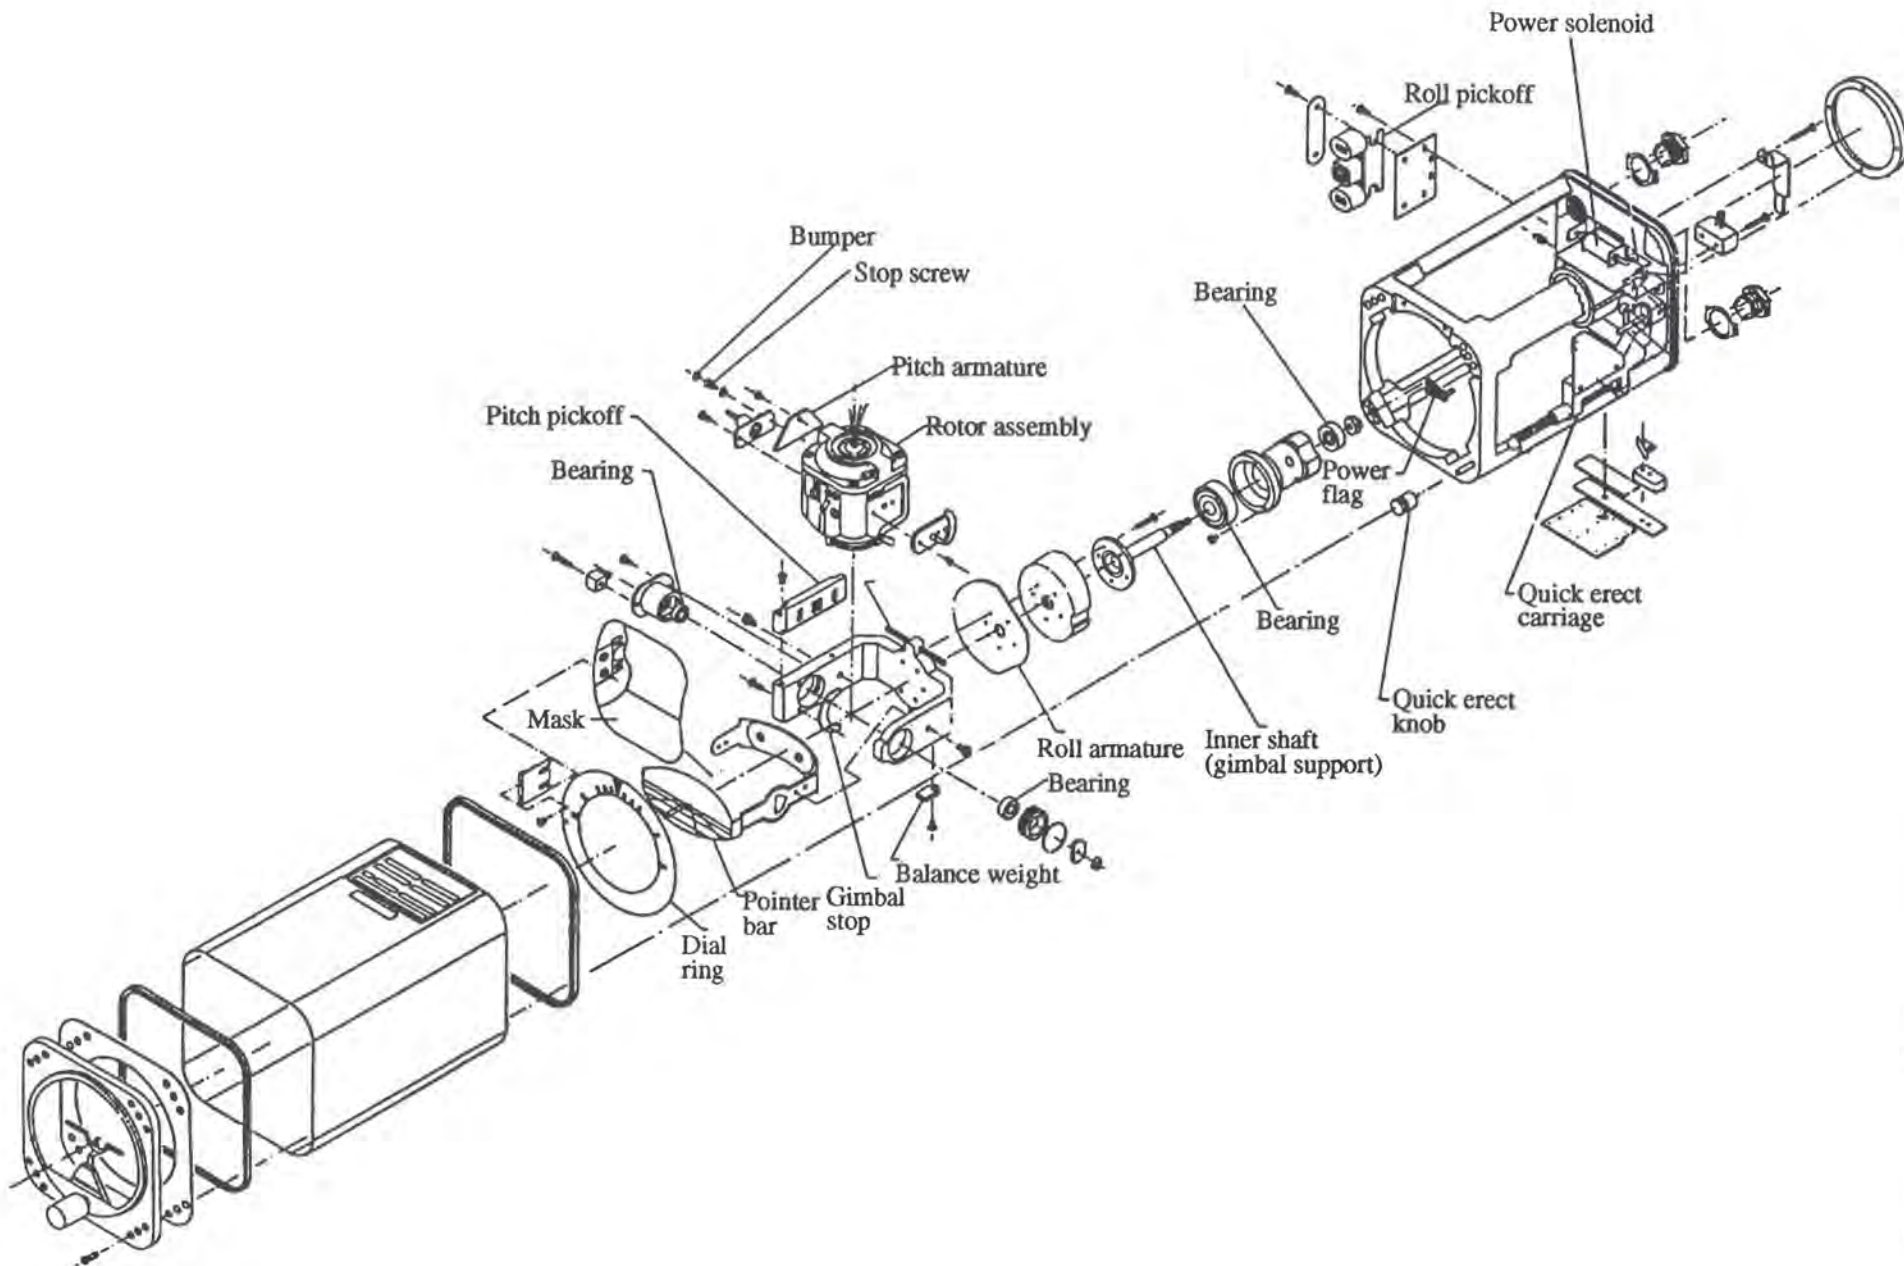
TYPICAL ARTIFICIAL HORIZON
(AIM 500 SERIES)

Both artificial horizons had been severely damaged in the final impact with the ground but the majority of the component parts were identified as follows:
