Safety & Loss Prevention Briefings Compendium 2023

Compiled by IIMS

A COLLECTION OF WORLDWIDE MARINE INCIDENT AND
ACCIDENT REPORTS, LOSS PREVENTION BRIEFINGS
AND CASE STUDIES PUBLISHED IN 2023

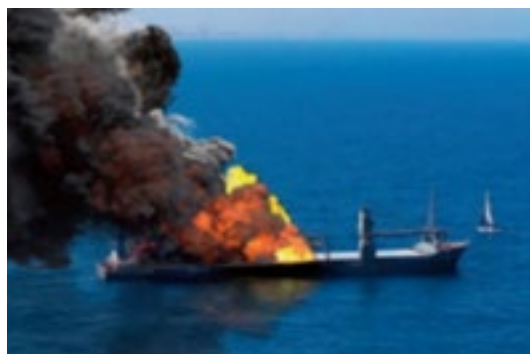
Two days into the voyage the crew noticed smoke coming from cargo hold 2. Hot spots were discovered in hold 2 on the transverse hatch coaming, both forward and aft on the portside, and an additional hot spot was also discovered on hold 3 on the transverse hatch coaming, on the portside aft. All hot spots were located adjacent to recesses in the coamings for the cargo holds' floodlights. The crew isolated the electrical power to the floodlights. Because of the increased temperature of the hot spots in hold 2, the Master released CO2 into the hold.

The CO2 did not extinguish the fire but reduced its severity for a while. When the vessel arrived at the discharge port the cargo hatches were opened, and flames broke out from hold 2. At the same time a plume of smoke escaped from hold 3. The top layer of cargo in hold 2 had been burned.

- The fire was caused because a number of cargo lights were operating while cargo covered them, so the lights ignited the cargo. There was a lack of information on board about how the light circuits were connected and how the light system should be operated. There was also a lack of records concerning use of the lights.

- Cargo lights in holds need to be properly isolated before cargo is loaded. This is best done by removing fuses or other physical links in the electrical circuits so that the lights cannot be switched on by mistake. In container ships the lights need to be properly placed so that they do not overheat cargo or other combustibles and thus cause damage or fire. Lights in car carriers and ferries are usually fluorescent, which are unlikely to cause ignition. Nonetheless it makes sense to leave lights switched off when they are not needed, particularly in cargo areas where combustibles are present.

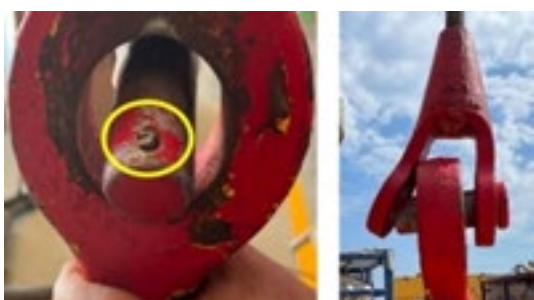
The incident investigation found that the cotter pin at the end of the hook pin had sheared, which allowed the washer to fall and the pin to back out. Following the backing out of the pin, it caused the ear on the connection to distort, resulting in the hook failing.

The BSEE investigation found there was an inadequate pin configuration design. The pin installed on the hook assembly had a smooth composition. The operator determined that a threaded bolt with nuts and keepers was the proper pin design for ensuring the stinger remains secure throughout lifting operations. Following this event, the operator inspected their other facilities and found the same improper arrangement on additional cranes.

- Be sure to inspect all cranes on the facility and verify that the hook assembly has a threaded pin with nuts and keepers.
- Retro-fit any stingers equipped with an improper stinger hook pin configuration.
- Verify all crane components are in alignment with current manufacturer recommendations.
- Add assessment of the pin condition into the pre-use inspection checklist, which should be completed before conducting lifting operations.

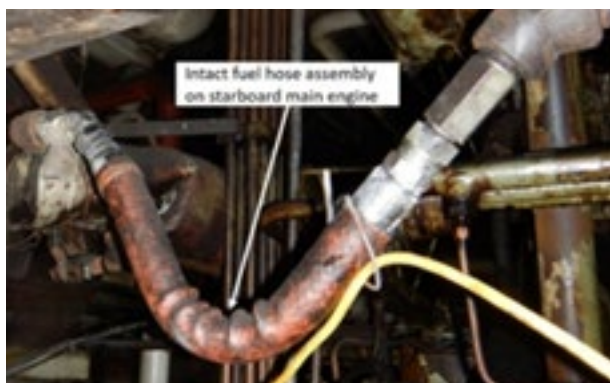
Flexible fuel hose assembly on the inboard side of the starboard main engine (Photo credit: TSB)

The investigation determined that the fire on board the Tecumseh originated on the port main engine after a flexible fuel hose assembly supplying fuel to the main engine failed. The analysis examined engine room maintenance, the effectiveness of the vessel's structural fire protection and emergency equipment, and the decision to re-enter the engine room after the fire had been initially suppressed by the carbon dioxide (CO₂) fixed fire suppression system.

- A fuel hose assembly of unknown origin and integrity failed on the port main engine, which allowed fuel oil to spray on to local sources of ignition, leading to the fire.

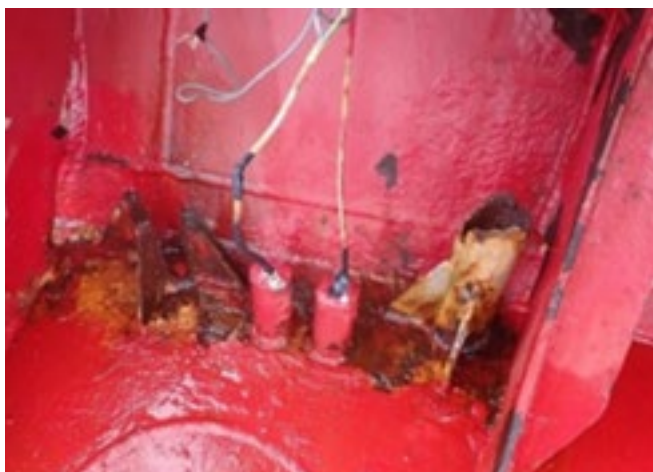
As there was no electrician onboard, the vessel's third engineer was sent to investigate why the vessel's forward anchor light was out. He found the wiring in extremely poor condition. The insulation was missing in some areas and heavily cracked in others. The wire itself was shorted out against the side of the deck penetration. He made repairs using some wire he had in his tool belt and a lot of electrical tape. He then reported that the problem was fixed.

Two days later, with the vessel still at anchor, a Port State Control inspector observed the poor wiring and detained the vessel for an ISM deficiency. In the course of investigating the cause of the detention, the Chief Engineer and Master were upset that the third engineer's repair had been so poor. However, they were more upset that the third engineer had not recognized or reported the need for more permanent repairs consistent with the vessel's safety management system.

A poor repair could have caused the forward anchor light to fail again. That would have increased the risk of a collision and increased the potential confusion for other vessels manoeuvring into and out of the anchorage. Additionally, the poor electrical repair created an electrical shock hazard.

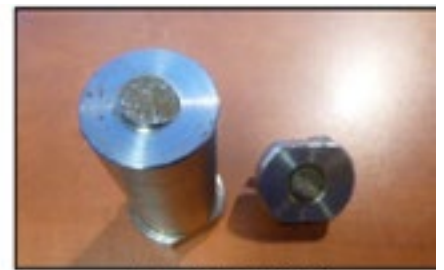
Image 3 - Failed Shaft (vessel 2)

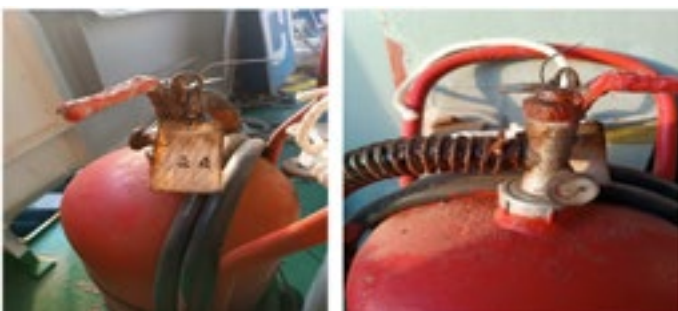
Fire-fighting equipment in poor condition

Several 50kg wheeled dry powder fire extinguishers on board a vessel were found to have low pressure and heavy signs of corrosion. This was discovered during an audit walk-around by shore-based personnel.

Fire extinguishers being absolutely crucial safety equipment on a vessel, they should be maintained to the very highest standards in full readiness for use in an emergency. Regular thorough inspection of fire-fighting equipment to verify that this is so, is a regulatory requirement in some countries including the UK.

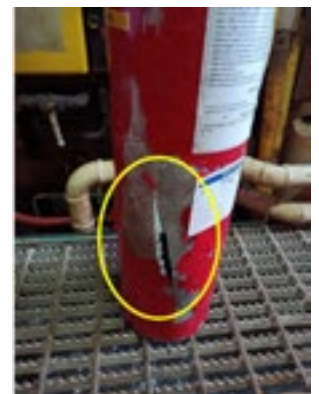
Fire extinguisher failed during pressure testing

An IMCA member reported an incident involving the failure of a 5kg CO2 fire extinguisher during hydrostatic pressure testing. The extinguisher, rated to 200bar, was being tested to a pressure of 300bar. The incident occurred when the test pressure reached 196 bar. The extinguisher was 13 years old. No-one was harmed.

General Wear and Tear: Over time, fire extinguishers are subjected to various environmental factors and conditions that can lead to wear and tear. This wear and tear may include corrosion, stress, or weakening of materials due to exposure to temperature fluctuations and external elements. It is essential to regularly inspect and maintain fire extinguishers to ensure their integrity.

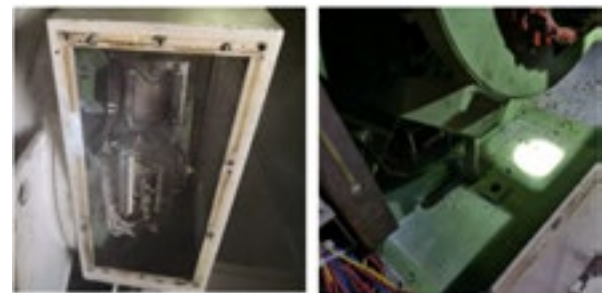
Fire in diesel generator following tests

There was a small fire in the engine room on a vessel in port. The incident occurred when a diesel generator was being maintained by a third-party maintenance team. On completion of a change of alternator bearings, the generator was tested at idling speed, and no problem was found. But when the generator was tested at operational speed, after a few minutes fire came out of the non drive end exciter. The alarm was raised; the diesel generator was brought to an emergency stop and the fire was put out with an extinguisher.

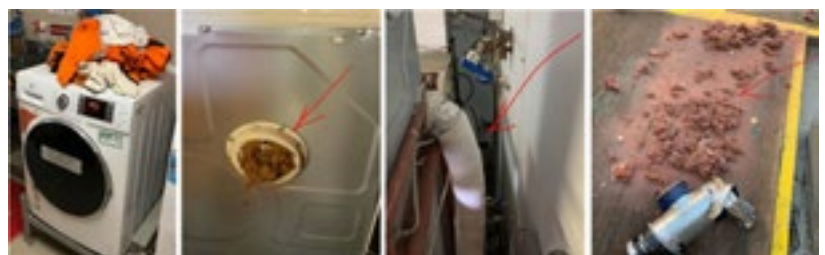
Clogged tumble-dryer exhaust fan – potential for fire

During a weekly inspection of the laundry room on a vessel, rags and lint twisted together were found in the exhaust fan of one of the dryers. Further investigation revealed more accumulated lint in the dryers' outlet exhaust pipe. When the end of the outlet pipe was removed to check the inside, it was found to be almost completely blocked with lint. It would only have taken a small spark, short circuit or static electricity inside the drying machine for there to have been a fire.

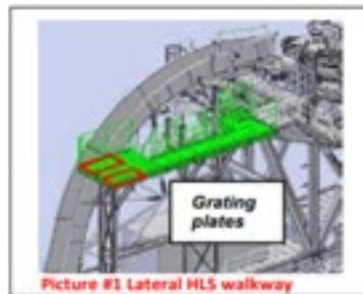
Picture #1 Lateral MLS walkway

Two workers removed grating panels at height on a horizontal lay system, in order to gain access to lift points for further removal of a lateral walkway section. The removed grating created an open hole with the likelihood that someone could have fallen through it. None of the team involved were wearing the required PPE for working at height and no tool lanyards were used. The area around the horizontal lay system had not been barricaded. The activity was immediately stopped. No-one was injured; no dropped object resulted.

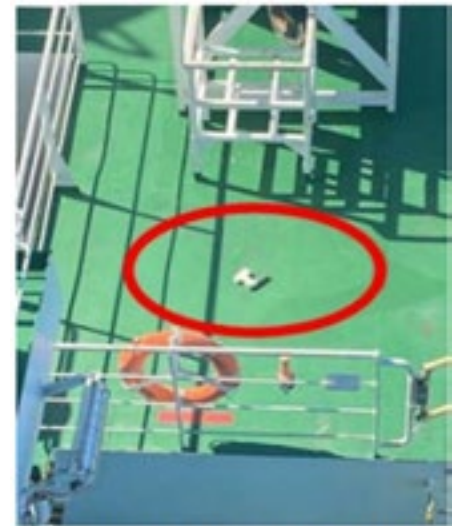
During a vessel transit during which the crane was unused in its boom rest, a crew member observed a piece of metal debris lying under the crane boom tip. It was discovered that one of the three Crane Whip Line Block Catcher Limit Switches (3.6kg) had fallen off and tumbled 6.5m to the deck. There were no injuries.

Location of the limit switch at the time when it was noticed

- Inadequate design verification – the cross-sectional area of the broken plate was not sufficient to bear the stress applied to the limit switch;
- The bolt spring was acting as a strong point and was creating unbalanced forces on the limit switch plate;
- There was insufficient preventive maintenance or inspection of this area;
- The equipment was not being used as it was originally designed;
- The maintenance schedule recommended by the crane manufacturer, was not adequate.

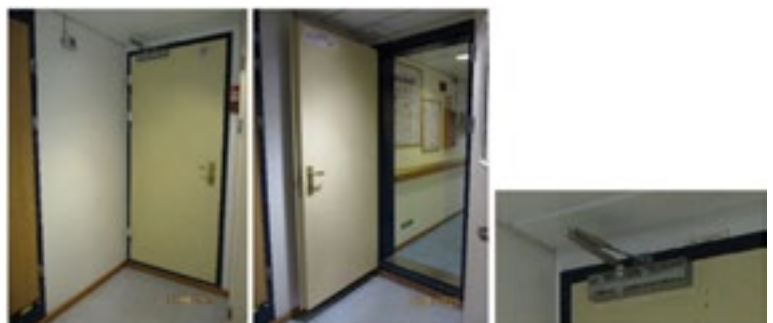
Fire Doors and Closing Mechanism

It was noted that in recent months there have been repeated internal and external audit findings related to inadequate maintenance, unapproved modification and the incorrect functioning of fire doors onboard their vessels. This has included Port State Control Inspection deficiencies that have raised safety concerns and been communicated to the Flag State Authorities.

Inadequate maintenance and unapproved modifications reduce the effectiveness of fire and smoke boundaries significantly, with potentially serious consequences during a fire and increased risk to crews and assets.

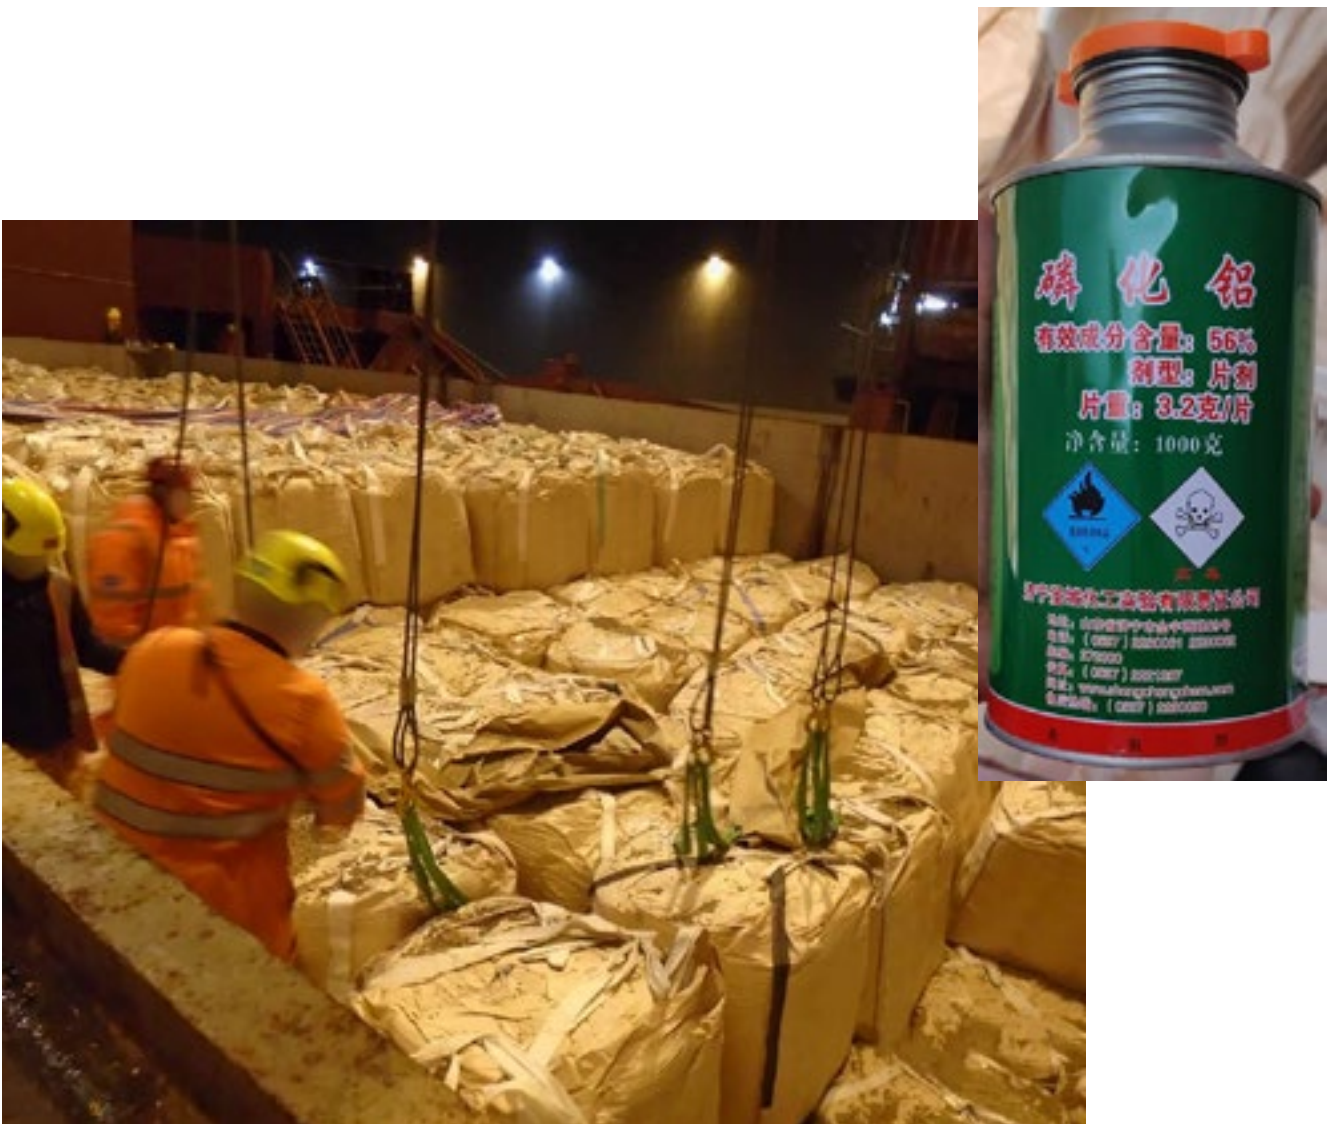
The untrained crew incorrectly deployed the fumigant, which did not fully volatilise or disperse during the 5-month voyage to the cargo's discharge port and so presented both a fire hazard and poisoning risk. The crew did not record the use of fumigant on board and the discharge port was unaware of its presence among the cargo. The ship's cargo holds were tested for oxygen levels, carbon dioxide, carbon monoxide, hydrogen sulphide and lower

explosive limit before the stevedores discharged the cargo. When the stevedores started working in the holds they soon began to find the cans of fumigant among the bags of sweet potato pellets (see figure). The cans were marked with hazard symbols and the stevedores showed them to their supervisor; however, the cargo work was not suspended for several hours, by which time some of the stevedores had been in contact with the aluminium phosphide. The next morning one of the stevedores became unwell and required hospital treatment for sickness, disorientation and nerve damage to his hand.

Figure: Stevedores unloading the bags of sweet potato pellets and (inset) a can of fumigant

1. **Qualified** → Fumigation of a ship's cargo is a specialised operation that should not be undertaken by untrained crew or stevedores.
2. **Risk** → Before unloading operations start, fumigated cargo holds must be tested by qualified fumigators and any residual fumigant removed. Port operators are reminded to be vigilant for potentially risky cargoes and to check with ship operators whether fumigants have been used on board.
3. **Hazard** → Cargo holds can be a hazardous environment; stop work if you find something unusual and check if it is safe to proceed.

4. **Equipment** → Appropriate personal protective equipment (PPE), including coveralls, gloves, face masks and respirators, must be worn when handling fumigants.
5. **Procedure** → Masters, owners and charterers are reminded of the contents of IMO Circular MSC.1/ Circular.1264 – *Recommendations on the Safe Use of Pesticides in Ships Applicable to the Fumigation of Cargo Holds*, which details the safe use of fumigants, measurement of fumigant levels on board ships and the responsibility to notify port authorities of the potential presence of fumigants on board.

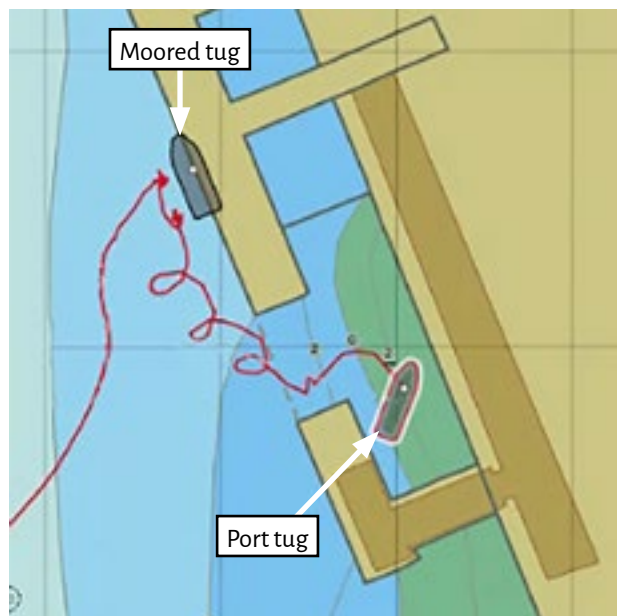
After accepting propulsion control from the engineer in the engine room, the master struggled to break clear due to the strong tidal stream. To prevent a collision with the other tug, full astern was being used on both engines when the port propulsion unit alarm sounded and the tug began to spin clockwise to starboard, narrowly missing both the moored tug and the floating pontoon (Figure 1).

Figure 1: Uncontrolled track and final position of the port tug

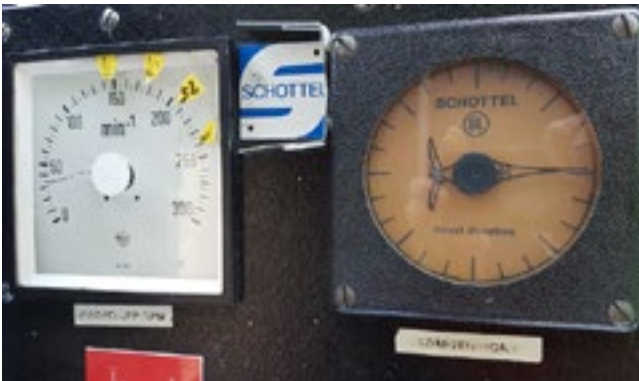
The tug continued its spin to starboard while the master tried to respond to the problem. The darkened bridge meant that it was difficult to see the azimuth direction indicators (Figure 2) as he attempted to arrest the spin. The port

Figure 2: The azimuth direction indicators

3. **Risk** → The azimuth directional indicators were hard to read due to the glass covers becoming less transparent with age. The port shaft indicator had failed a day earlier after an attempt to replace the internal lamps resulted in a broken indicator needle. A temporary needle repair was unsuccessful and the master, unable to adjust the brightness of the new lamps, resorted to covering the indicator with a piece of paper. A defect report submitted on the same day stated: *(Still) able to operate equipment and requires repair asap*. As a result, the master relied on the starboard shaft indicator for both shafts. Risk assessments are essential to identify the potential hazards arising from inoperative or ineffective propulsion controls and indicators and when to keep the vessel in operation or withdraw it from service for repairs.

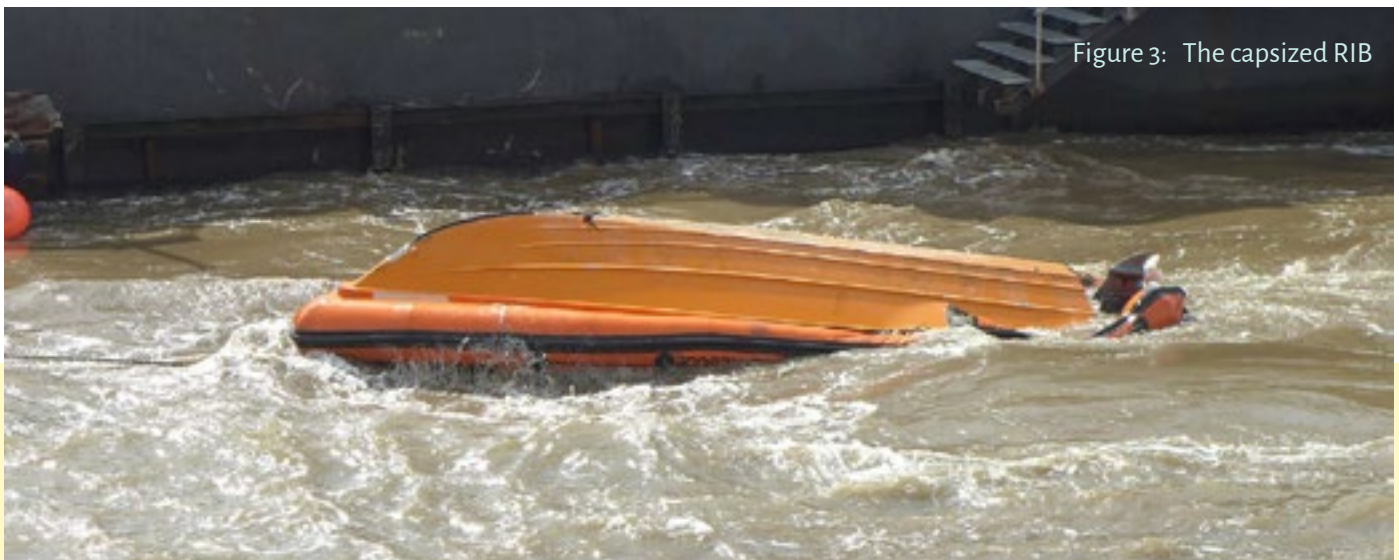
The tug's bow made hard contact with an adjacent floating pontoon's handrails and pontoon air tank. Its port quarter then made heavy contact with a moored rigid inflatable boat (RIB), the impact of which caused the RIB to capsize and its landing stage to sink (Figure 3). The tug's stern and starboard side then rotated close to the shore before full propulsion control was regained and the master manoeuvred the tug out into the river.

Figure 3: The capsized RIB

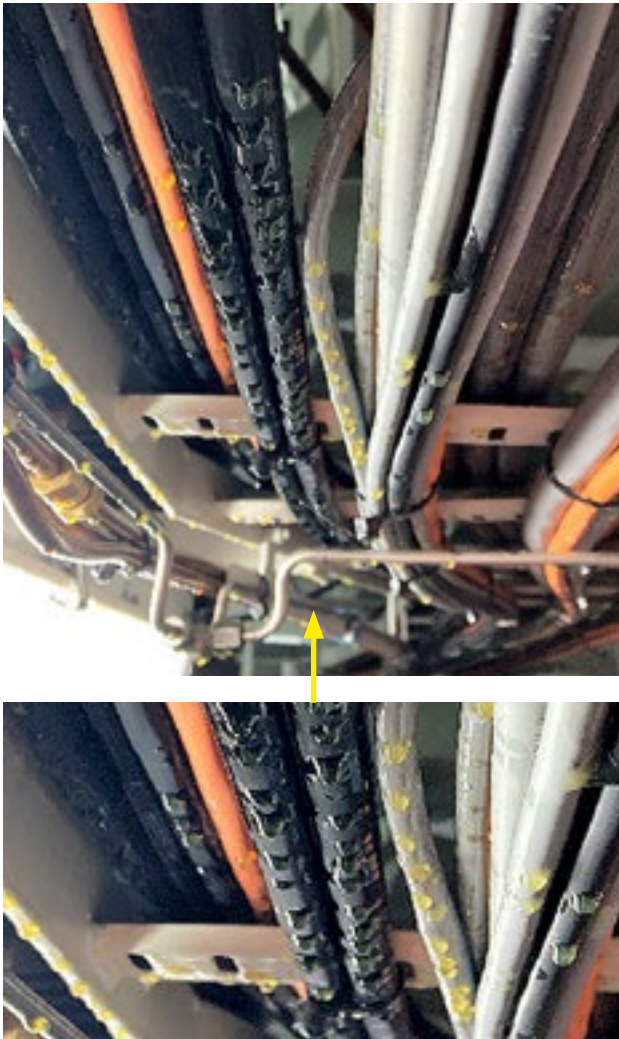
Figure 1: Oil dripping from engine room cables

The vessel was able to make its way to port, where an investigation was started that involved the shipbuilder and gearbox manufacturer. Before the vessel could leave port, the contaminated lagging was replaced, electrical cable trays and affected electrical connections were cleaned and checked, various electrical motors were overhauled and the engine room was washed down.

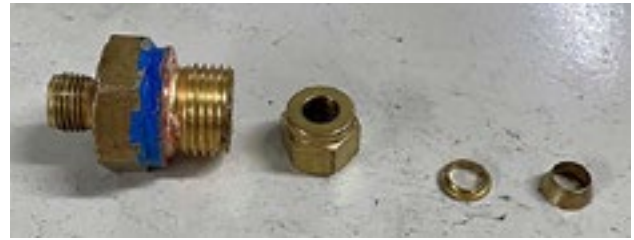
Figure 2: The original temperature probe fitting

- Equipment** → Although it was a marine gearbox, the design of the probe fitting was insubstantial in terms of the operating environment and the consequences of it coming loose. Poorly designed equipment increases the risk of injury to the crew and can force them into undesirable workarounds. In this case, the manufacturer produced a redesigned fitting and probe housing that would prevent reoccurrence and allow the probe to be changed while the propulsion system was working (Figure 3).

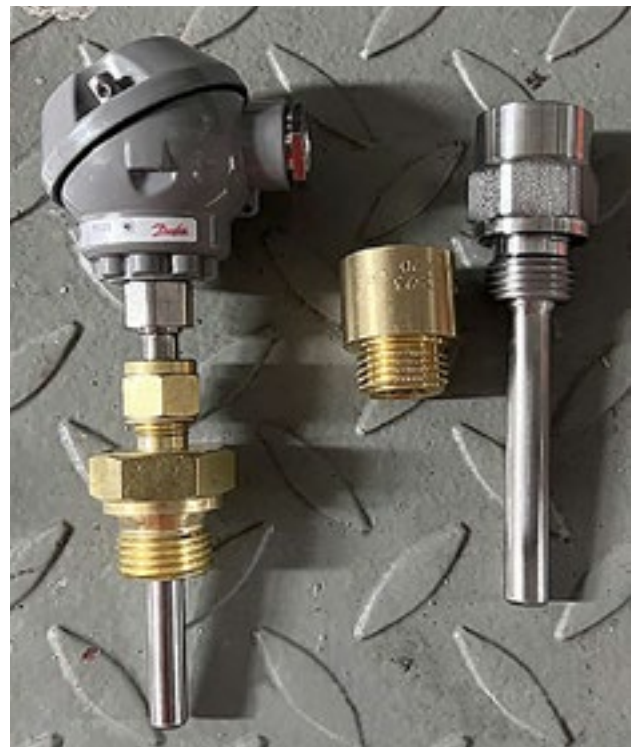
Figure 3: The new temperature probe fitting

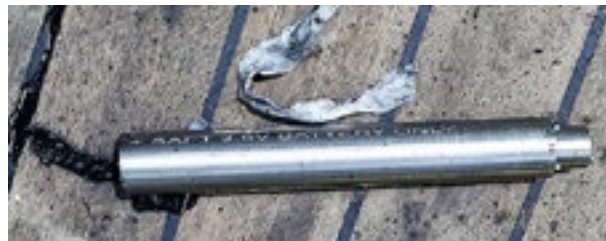
Seven hours later, the vessel's bridge team heard a loud bang followed by a fire detection system warning for the deepwater equipment storage area. The attending crew members discovered a scorched and damaged metal battery tube lying on the deck (Figure 1).

Figure 1: Damaged battery tube

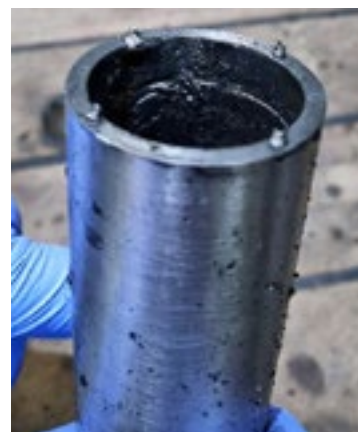
Examination of the battery tube indicated that sea water had leaked into the battery compartment (Figure 2) and contaminated the Li-ion battery, which caused pressurised gasses to build up and self-combust and resulted in a brief explosion. The remaining battery tubes were removed to a secure storage area for further checks.

Figure 2: Water ingress and damage

- Maintain** → A Li-ion battery that is found to be damaged or affected by water should not be used or charged. Remove the battery to a secure place where it can be monitored and potential spontaneous combustion can occur safely. In the event of a fire, use an ABC¹ or BC² powder fire extinguisher to put it out. Other methods include misting the fire with chemically exfoliated vermiculite or dousing it with large quantities of fresh water.

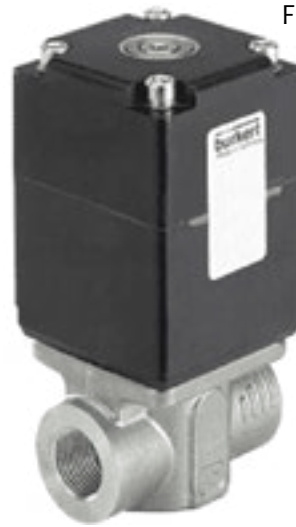
inlet fuel valve actuator (Figure 2). The actuator had become detached from the valve body and the whole assembly was severely damaged by fire and heat (Figure 3). Separation of the actuator and valve actuator spindle from the valve body allowed the fuel, operating at 2 bar pressure, to escape and spray over nearby heating and electrical equipment. On closer examination, the screws that secured the two parts of the actuator to the valve body were found to be slack.

Figure 2: Example of a fuel valve actuator

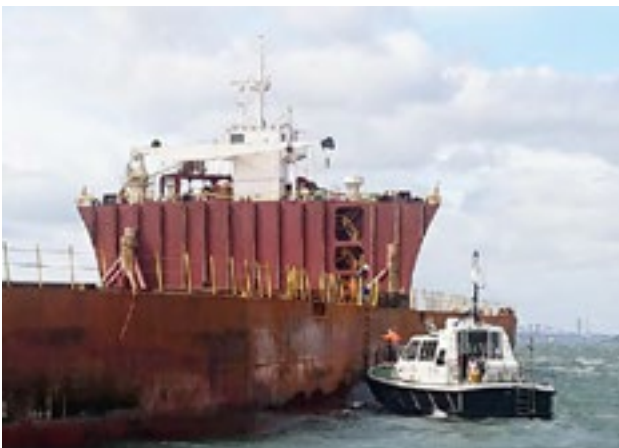
A crew transfer vessel in a northern European port had come alongside a cargo ship (Figure 1) to transfer two passengers and their luggage. The first passenger successfully climbed the pilot ladder (Figure 2) and boarded the cargo ship. The second passenger had started to ascend the ladder while the transfer vessel moved clear of it; as he continued to climb, first one foot and then the other slipped from the rung. Unable to either regain his footing or support himself, he fell from a height of 2m into the water between the two vessels.

Figure 1: The transfer vessel alongside the cargo ship

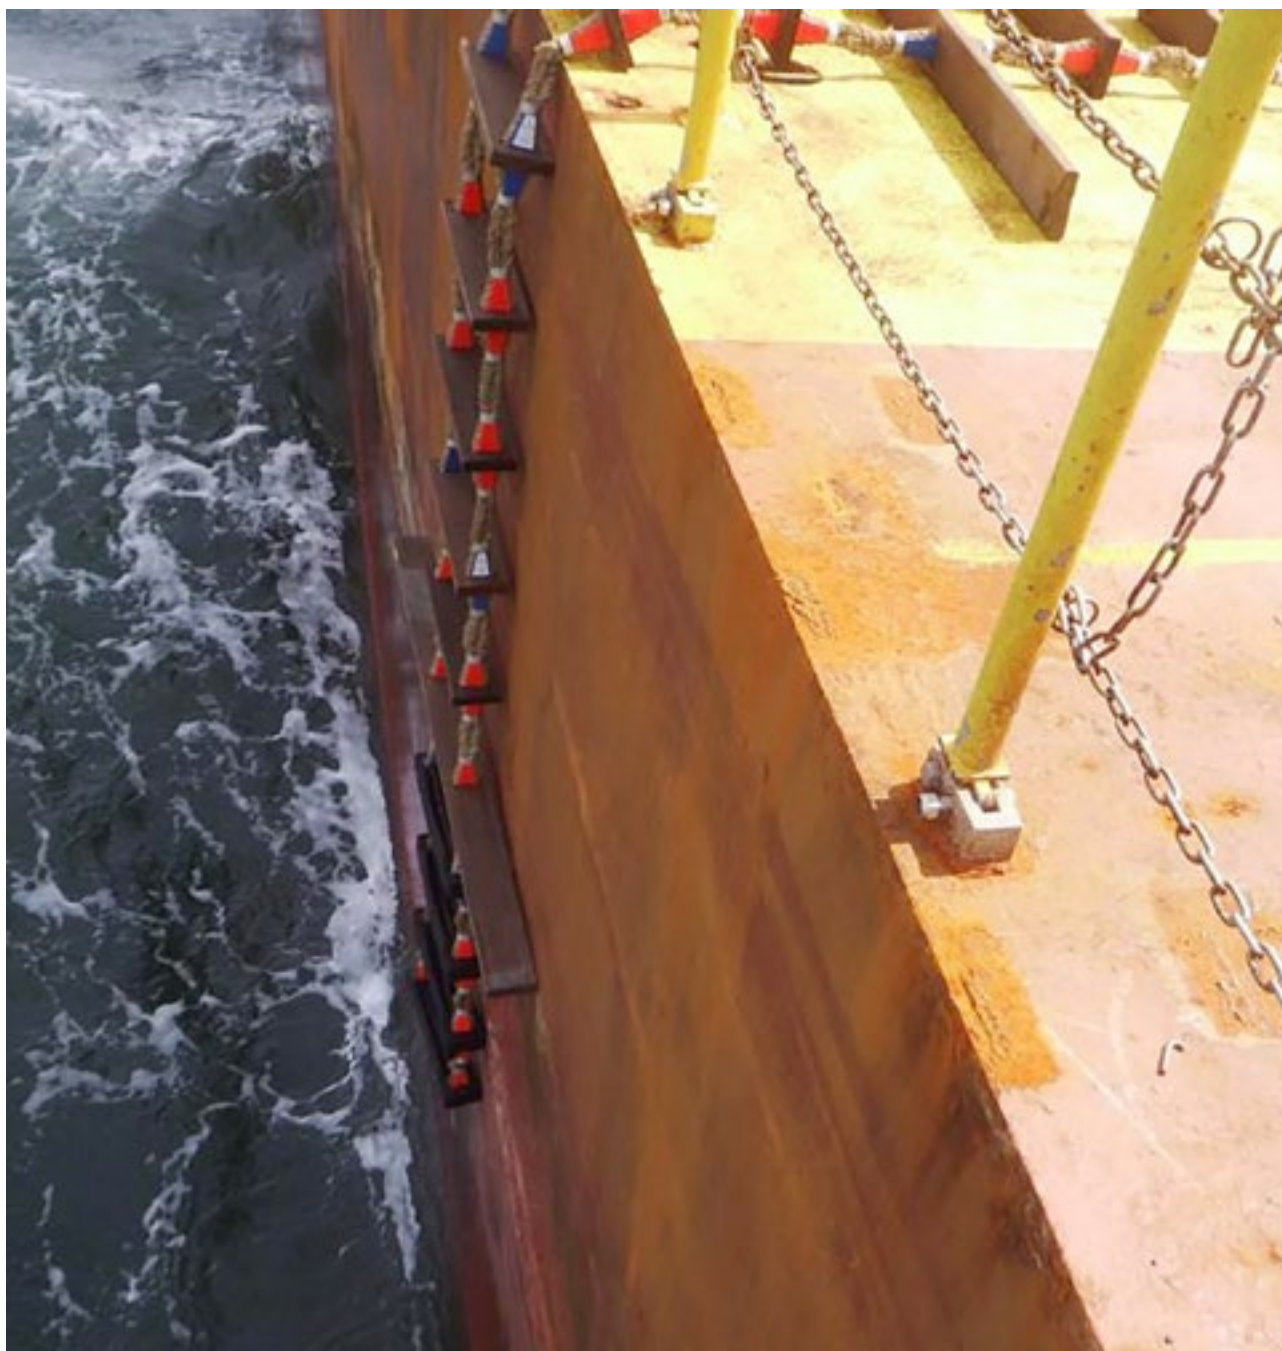
Figure 2: The cargo ship pilot ladder

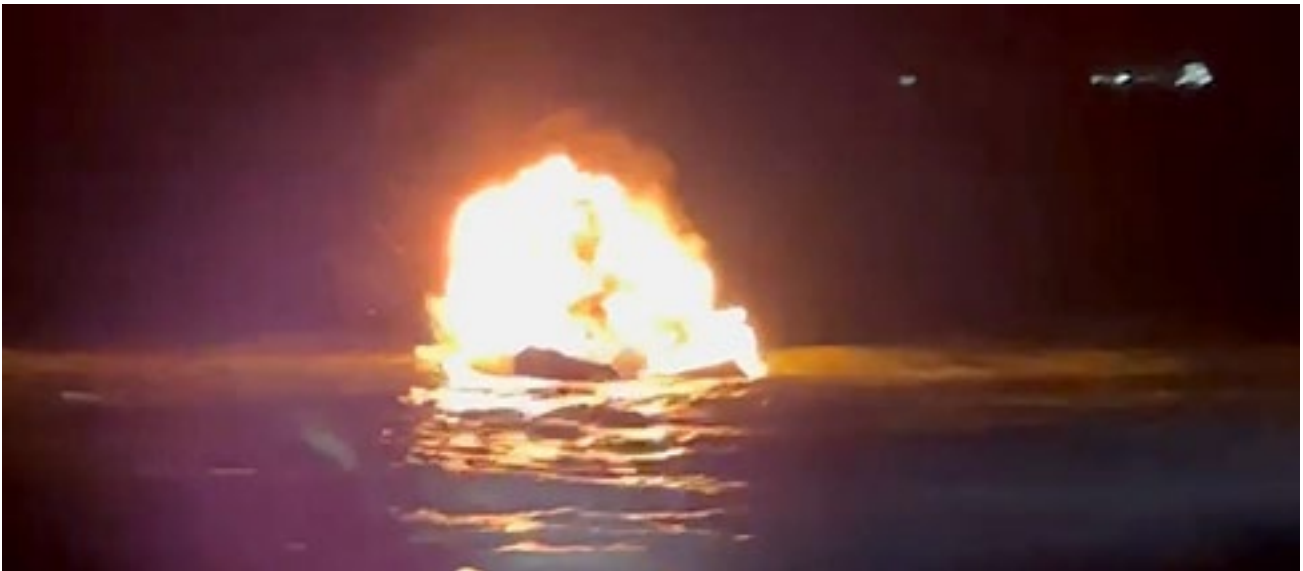
Figure 1: RNLi video still, showing cabin engulfed in flames

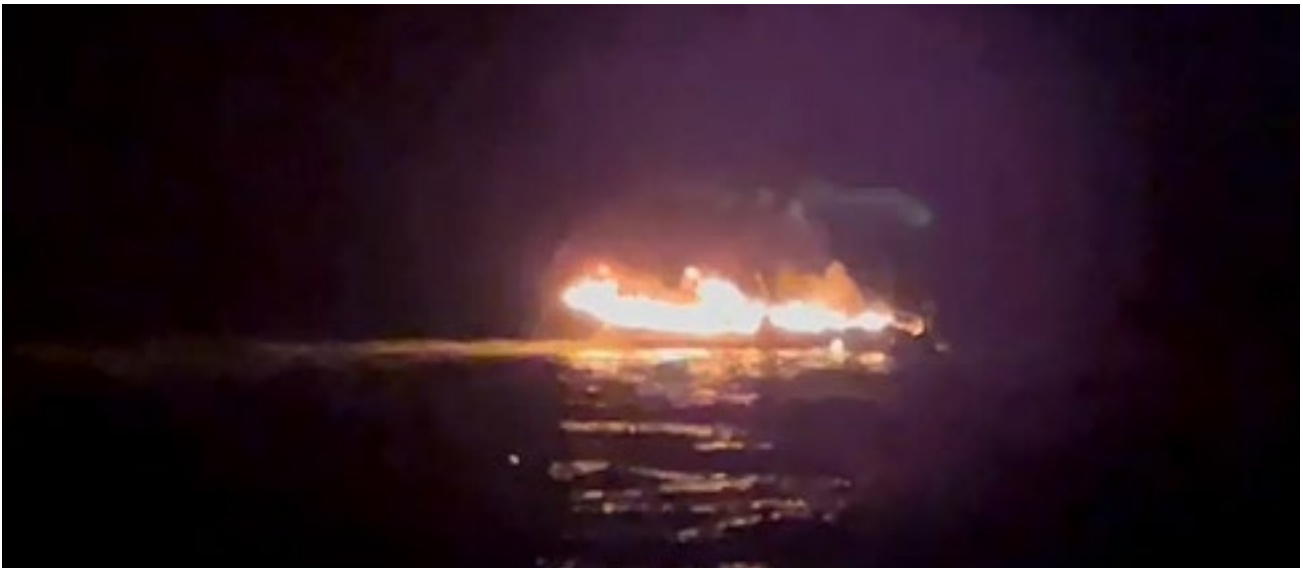
Figure 2: RNLi video still, showing whole cabin destroyed by flames with only the hull remaining intact

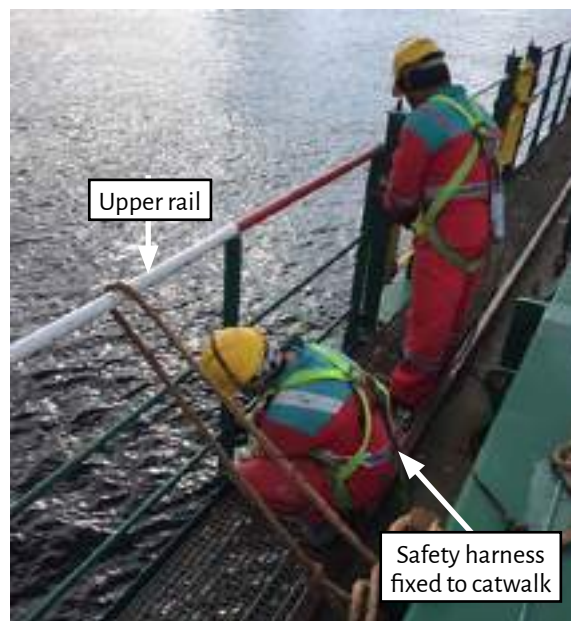
A bulk carrier was alongside in port late one afternoon. The cargo discharge had been completed and the second officer (2/O) and able seaman (AB) were standing on the midship port side catwalk, preparing for the loading of the next cargo by lowering the upper rails around the hold hatches (Figure 1). Once the rail was released, the rail would hang vertically downwards and allow the cargo to be loaded without interference from the rail.

Figure 1: Bolts being removed from a section of upper rail

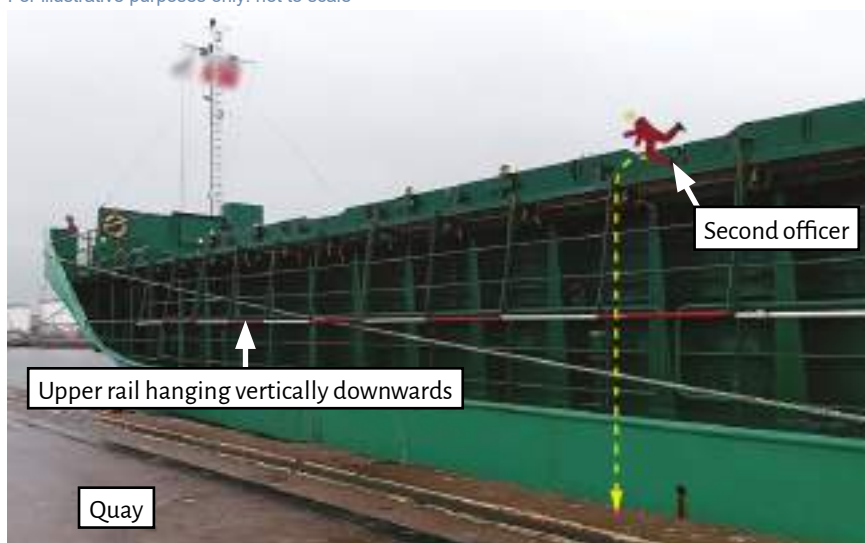
The 2/O was leaning towards the unsecured rail when it suddenly started to fall outboard. The 2/O, who was not wearing a safety harness fixed to the catwalk, lost their balance (Figure 2) and fell about 3.5m to the concrete quay below. The 2/O was in hospital for more than 10 days, having broken both legs in an attempt to land on their feet.

Figure 2: Illustration of the second officer falling to the concrete quay

1. **Procedure** → The shipboard risk assessment for this task required anyone working aloft or over the ship's side to wear a fall arrester. Following safety procedures increases the opportunity to identify hazards and determine what equipment or control measures are needed to mitigate them and keep people safe.
2. **Equipment** → A safety harness and appropriate restraint tether would have prevented the fall. Personal protective equipment (PPE) may be deemed uncomfortable to wear and will likely require adjusting to allow you to work effectively, but it is essential when carrying out high-risk tasks such as working at height.

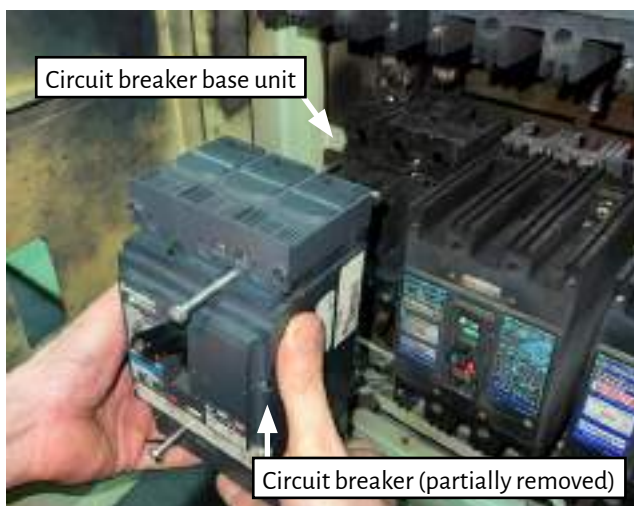
The circuit breaker was designed to be removed without the need to isolate the base unit (Figure 1); however, the electrician was unfamiliar with this arrangement and had loosened one of the live connections on the input to the base unit (Figure 2). The electrician used rubber gloves to insulate themselves from the live 440 volt (V) alternating current terminals when working on the connections.

Figure 1: The circuit breaker arrangement

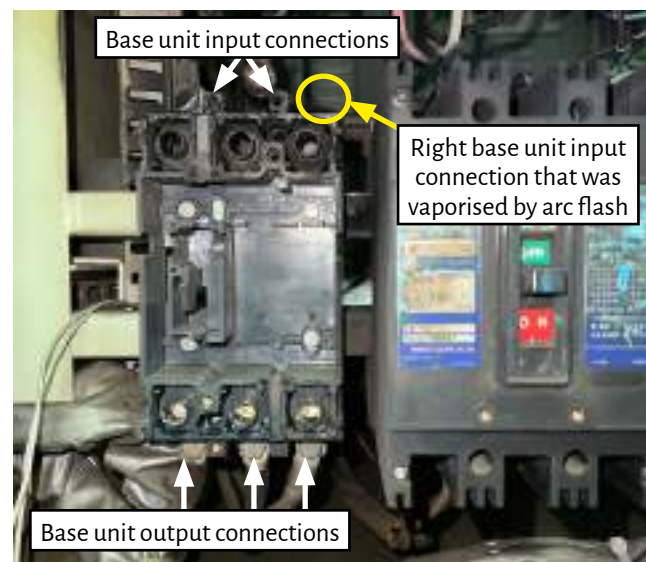
Figure 2: The base unit connections

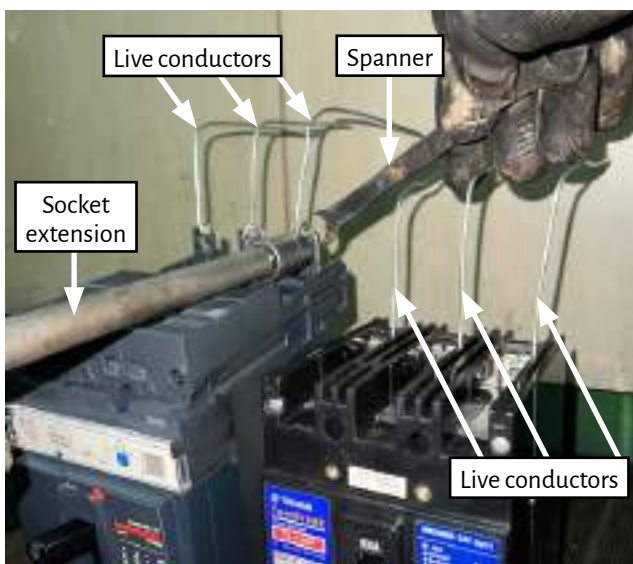
After the C/E left the engine room, the electrician tried to reconnect the cables to the base unit using a socket extension on the head of the bolt and a spanner to hold the nut in position at the rear of the connections. As the electrician tightened the bolt on the live input connection, the nut rotated and the steel spanner touched an uninsulated copper conductor on the adjacent circuit breaker base unit. This caused a short-circuit between two phases of the switchboard (Figure 3).

The short-circuit caused a high current to flow, vaporising the copper conductor and part of the spanner in an arc flash creating extreme

Figure 3: Reconstruction of the accident

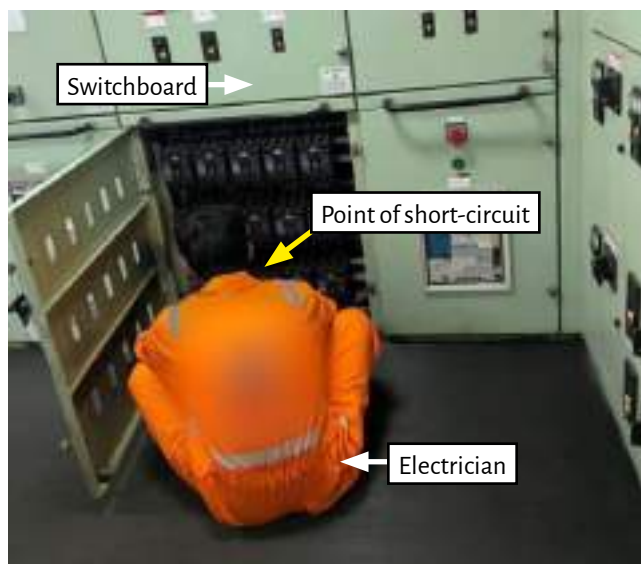
heat and blinding light. A burst of hot gas and molten metal exploded from the panel onto the electrician's face and chest (Figure 4).

Figure 4: Position of the electrician

- Observe** → This accident was avoidable because there were opportunities to stop the work and reassess the risks. Everyone has a responsibility to be alert to what is happening around them and should feel empowered to intervene and stop any work that raises safety concerns.
- Equipment** → Working near live electrical equipment requires specific tools and PPE. The use of uninsulated tools while working in a live switchboard invited a short-circuit and the electrician, who was not wearing face protection, was lucky not to lose their eyesight in the accident.

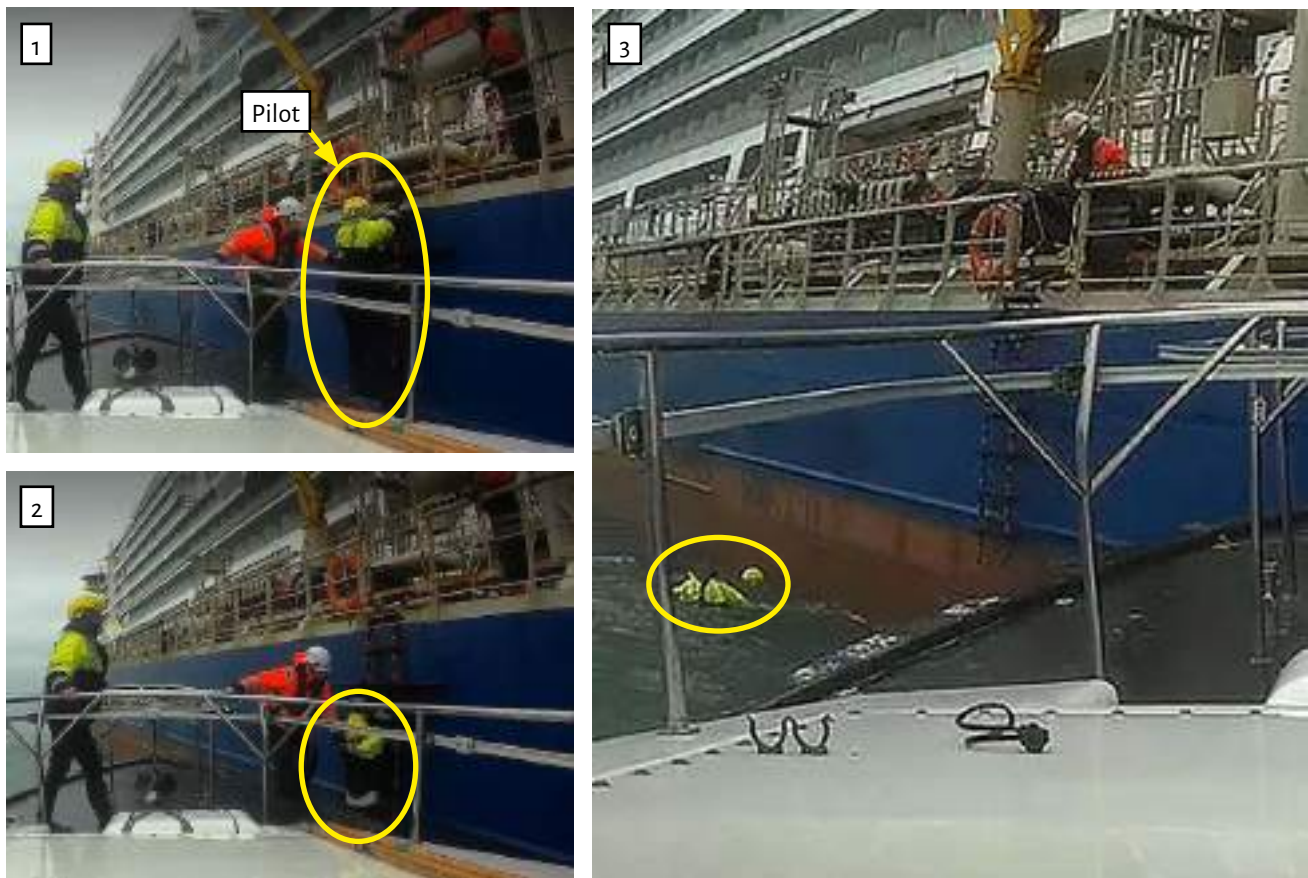
A pilot was embarking a moored bunker tanker via its pilot ladder in calm conditions. Once alongside the tanker, the pilot tested the ladder and then stepped onto it. As the pilot began to climb, the ladder suddenly dropped by over a metre and the pilot fell from it into the water (Figure 1).

Figure 1: The fall sequence

- Check** → A responsible officer must check that the pilot ladder is correctly rigged and ready for use before the pilot boards. In this case a rung of the pilot ladder had become caught on a deck fitting and when the pilot put their weight on the ladder it unexpectedly dropped, causing them to lose their handhold and fall into the water.
- Equipment** → A post-accident inspection of the tanker's pilot boarding arrangements found that the tanker's guard rail handholds were more than 80cm apart and its boarding arrangements were therefore assessed as noncompliant with SOLAS¹ regulations. Figure 2 shows the arrangements at the time of the accident and after the owner's modifications to provide compliant handholds.

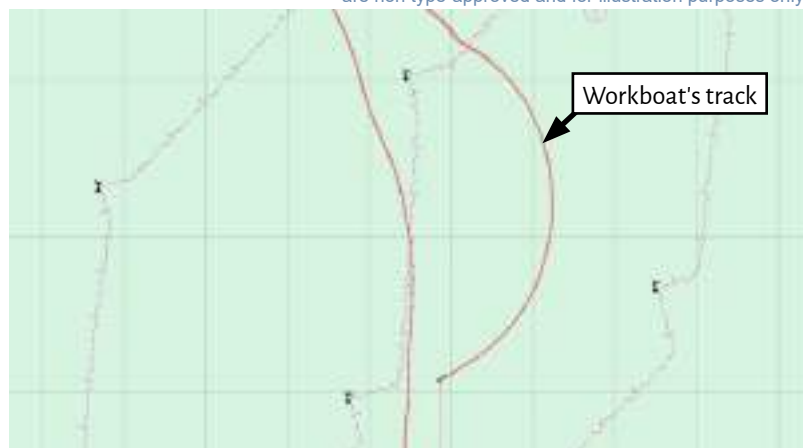
Figure 1: The navigational track of the workboat, showing its slow turn to starboard

1. **Procedure** → It is important to keep administrative tasks up-to-date, but crew and vessel safety remains the priority. Where paperwork must be completed, for example updating the bridge logbook while on watch, ask someone else to keep watch or post a lookout to maintain proper and effective visual navigation.
2. **Monitor** → The slow turn to starboard may not have been evident from the bridge windows alone and watchkeepers should monitor all available sensors and equipment to establish an accurate navigational overview. Regular checks of data from an Electronic Chart Display and Information System (ECDIS), rate of turn indicator, and directional gyro, etc. allows the watchkeeper to identify hazards and take preventative action to avoid an accident.

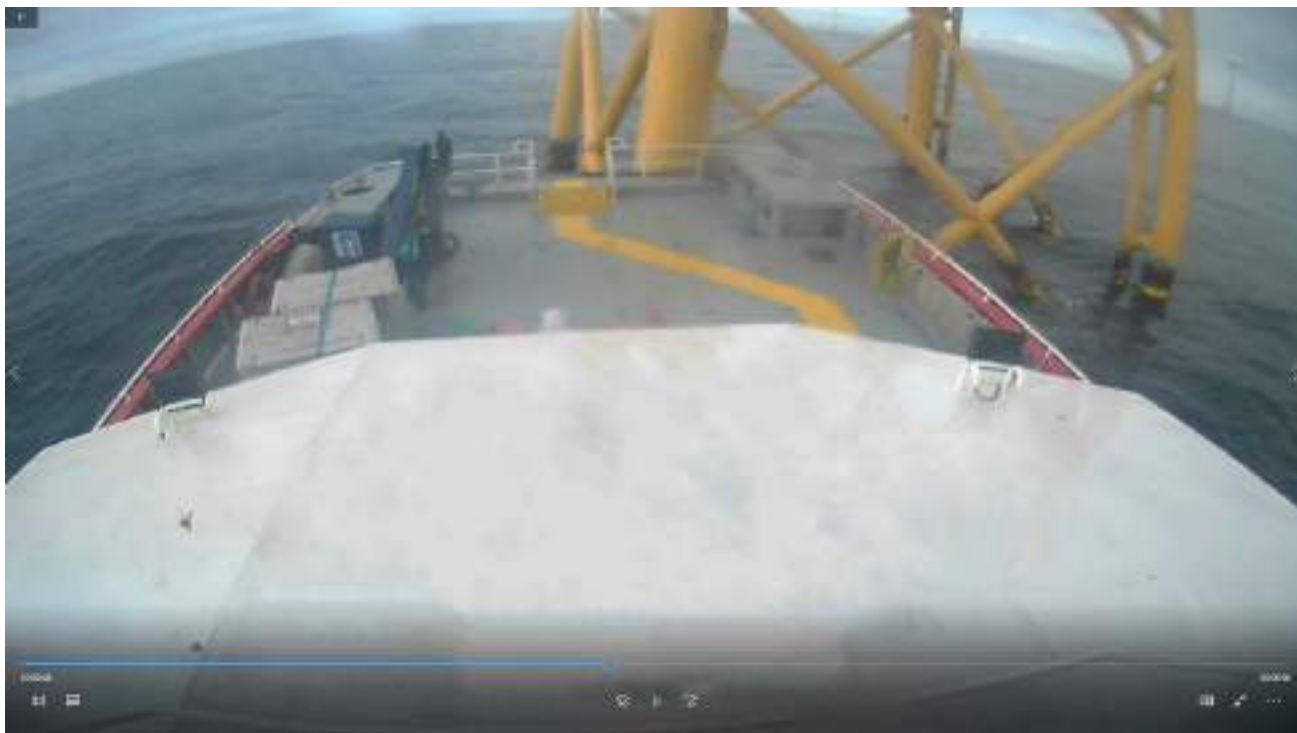
Figure 2: The moment the workboat bow collided with the wind turbine tower platform

The workboat took the brunt of the impact on its off-centre protected bow section (Figure 2) and unsecured items were thrown forward across the deck as the vessel came to a jolting standstill. The crewman was thrown against a shelf and sustained two broken ribs. The master assessed the crewman's injury and the damage to the

workboat and returned to harbour to evacuate the crewman for treatment at the local hospital. Fortunately, there was little damage to the workboat other than small dents and abrasions. The master was left with a much larger paperwork mountain to climb.

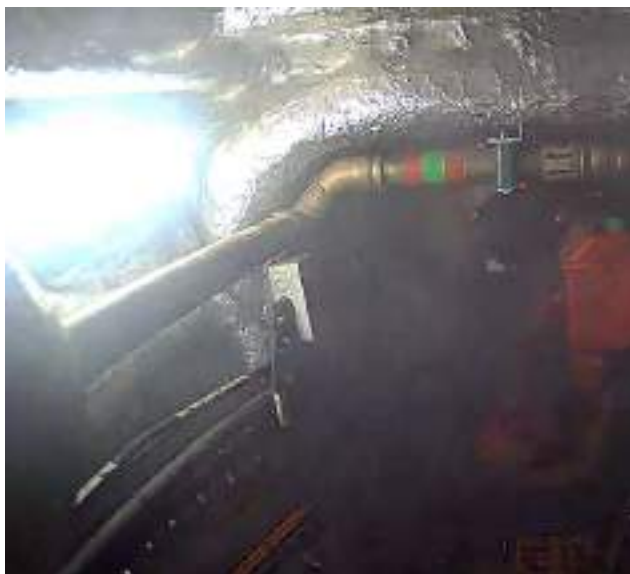
Later, the master observed smoke and flames in the starboard engine space on the CCTV and immediately shut the starboard engine down and instructed crew to close the ventilation flaps for the area (Figure 1). The master then activated

Figure 1: CCTV still showing smoke in engine space
