Safety & Loss Prevention Briefings Compendium 2023

Compiled by IIMS

A COLLECTION OF WORLDWIDE MARINE INCIDENT AND
ACCIDENT REPORTS, LOSS PREVENTION BRIEFINGS
AND CASE STUDIES PUBLISHED IN 2023

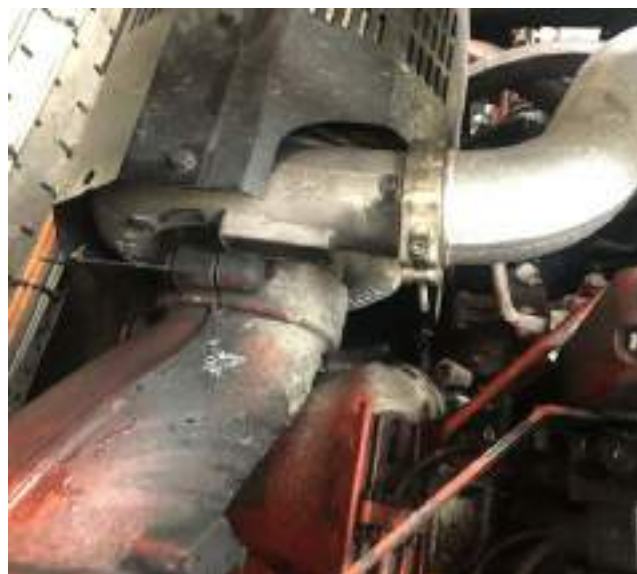
The ferry's engineers found scorched lagging around the main engine turbocharger, along with signs that paint and oily debris had ignited on the engine (Figure 2). This happened because the exhaust inlet casing to the turbocharger had fractured, allowing hot exhaust gases to encroach the lagging and the engine.

Figure 2: The seat of the fire (glowing orange)

2. **Maintain** → A thorough inspection of an engine during routine maintenance is essential for its safe operation. Check fittings are secure and fit for purpose, replace missing components and report, repair or replace fractured engine supports or brackets before further damage occurs (Figures 3 and 4).
3. **Action** → The swift and measured response by the master prevented the fire escalating and causing serious damage to the starboard engine space. The risk of the fire being reignited was also removed by the master's prompt actions to activate the fixed firefighting system after closing the ventilation flaps and keep the space secured until the fire had been extinguished and the boundary temperature reduced to a safe level.

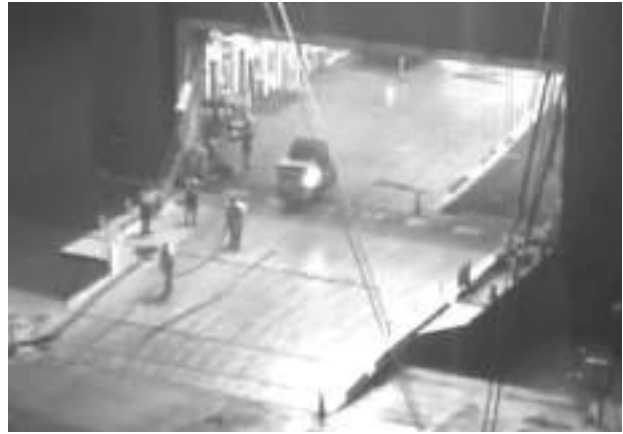
The ferry's staff were responsible for simultaneously supervising the offloading of cars and palletised cargo, which was undertaken using forklift trucks driven by stevedores. After the cars had been offloaded the crew prepared to back load excavators onto the ro-ro's deck, a process that required the positioning of lengths of heavy rope on the stern ramp. At the same time as two stevedores lifted the first length of rope and were moving it across the centre of the stern ramp, a forklift truck with a pallet of slate was being driven off the ferry (see figure).

The forklift truck driver did not see the stevedores on the stern ramp and the stevedore nearest to the approaching forklift truck was standing with their back to the ferry and did not see the oncoming forklift truck. The forklift truck driver was wearing ear defenders and did not hear a

Figure: Forklift truck and stevedores on ramp

1. **Hazard** → The accident happened because the stevedores moving the ropes were standing on the stern ramp at the same time as vehicles were being driven across the ramp. The forklift truck driver did not see the stevedores as the direct line of vision ahead was obscured by the palletised slate loaded onto the forklift truck and the driver expected that pedestrians would keep clear of moving vehicles. The stevedores were oblivious to the approaching forklift truck as they had become accustomed to working near moving vehicles. The strategy of *see and be seen*, with the onus on pedestrians to keep out of the way, was flawed as it did not account for a driver's restricted visibility or stevedores becoming distracted by the task. Industry codes of practice require that pedestrians and vehicles remain segregated by appropriate means.

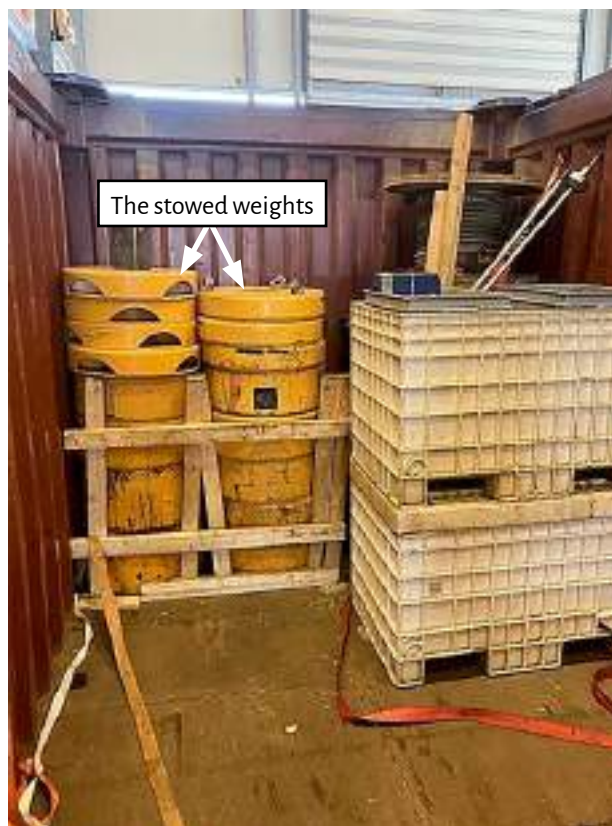
Nearly 8 tonnes (t) of weights had been stacked in the back corner of the container when the equipment was originally loaded into the container (Figure 1).

Figure 1: Weights loaded in container

1. **Plan** → The distribution of load is as important as the total weight when preparing a lift and its effect on the lifting operation should be carefully considered in the total lifting plan. In this case, neither the crew on board nor the crane driver were prepared for the swing that the unbalanced load caused when the container was lifted.

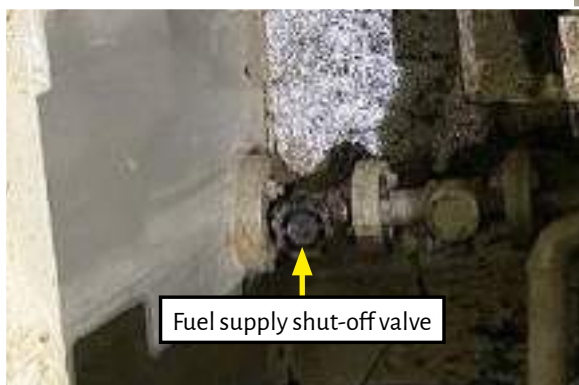
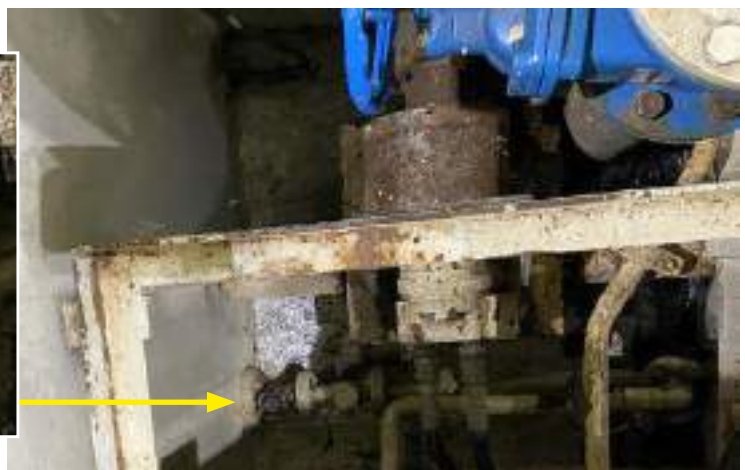
A fishing vessel was on a routine day trip when the peace was shattered by the sounding of the engine room smoke alarm. The crew went to investigate and found smoke emanating from a new alternator they had recently fitted to the engine. Despite their attempts to tackle it with portable extinguishers, the fire raged on and the crew were unable to reach the fuel supply shut-off valve (see figure) to stop the engine.

Figure: Fuel supply shut-off valve

- Equipment** → In an attempt to save money the owner had fitted a poor-quality alternator, which was replaced with a genuine spare part following the accident. Never be tempted to cut corners when repairing a vessel; the consequences can be expensive and could prove to be fatal.

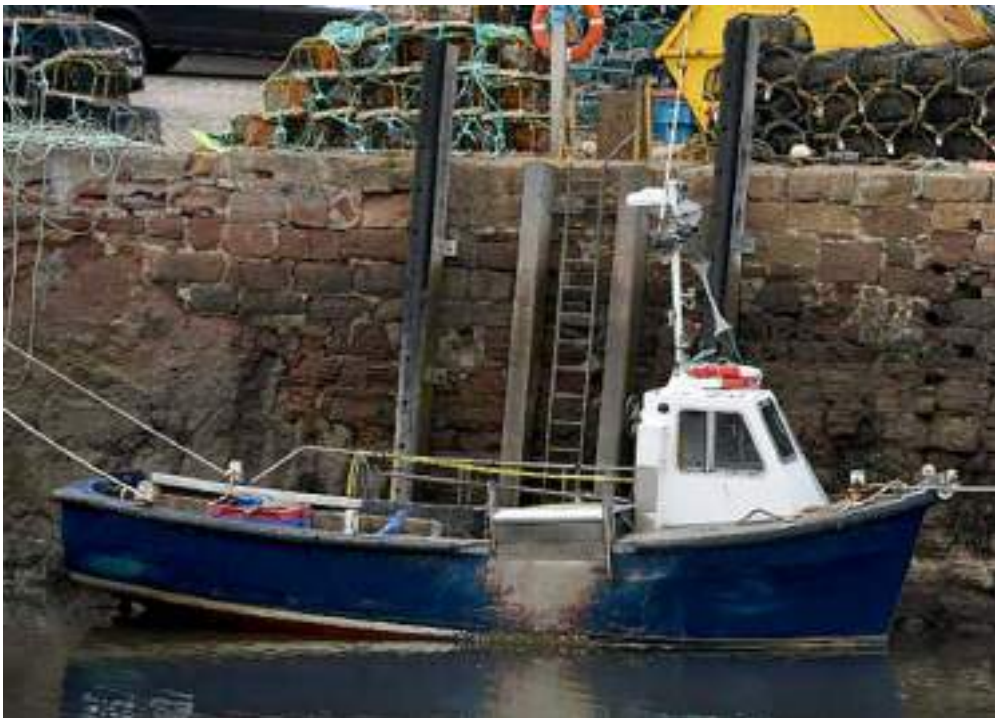
Figure 1: The single-handed creel vessel

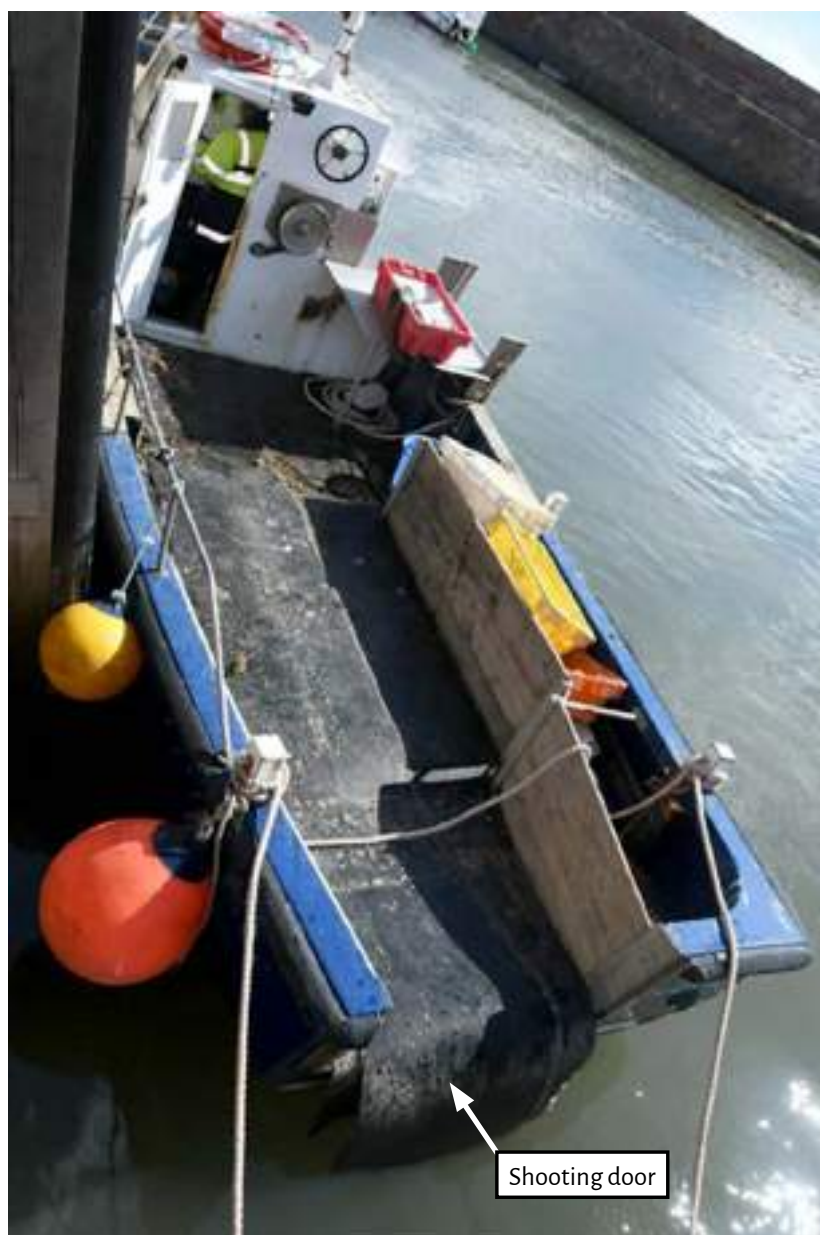
shooting door (Figure 2). The skipper's personal flotation device (PFD) automatically inflated on contact with the water, keeping them afloat and their face clear of the water. However, the skipper did not have an easy means by which to reboard their vessel and no method to raise the alarm while in the water and they succumbed to cold water immersion.

Figure 2: The shooting door (drop-in closing board removed)

1. **Procedure** → Fishers are advised to follow industry guidelines to minimise the likelihood of being pulled or falling overboard; a barrier between the fisher and the fishing gear during every phase of the fishing process and the wearing of a tethered safety harness offers the best protection against unexpected events.
2. **Plan** → It is important to consider what methods of reboarding the vessel from the water are available. Emergency measures, such as rigging a man overboard ladder or having an overside tyre arrangement in place, can improve the chances of survival.

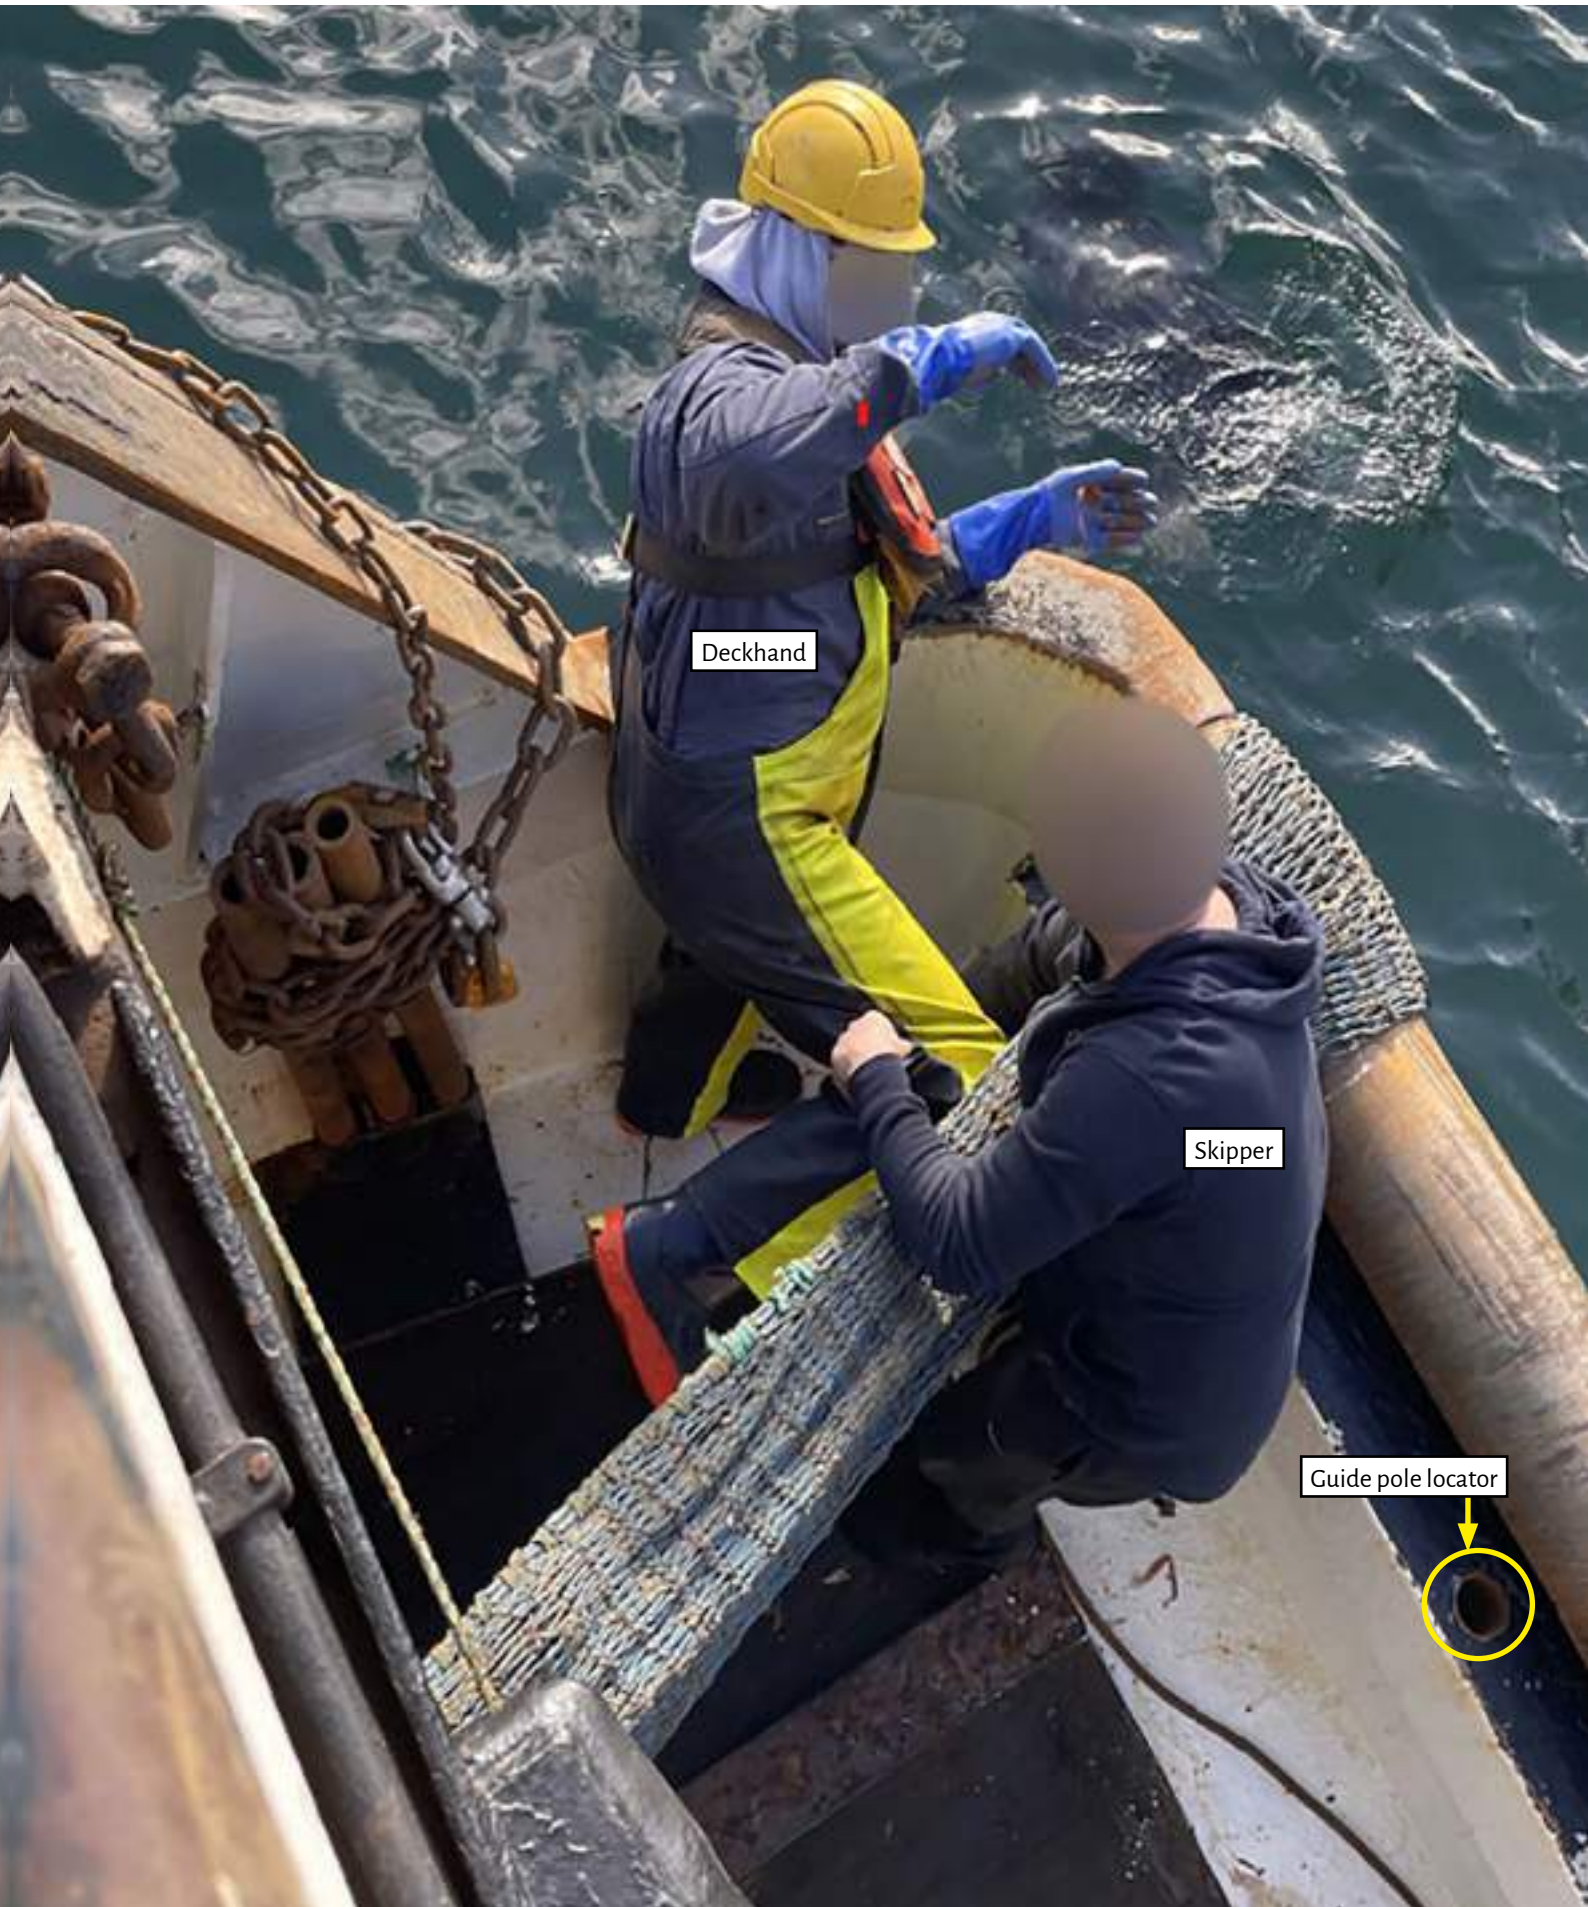
Figure: Reconstruction, showing the deckhand standing in working position between the bulwark and net

3. **Hazard** → An unconstrained net during hauling is a significant hazard in anything other than the most benign conditions. The operation requires careful monitoring to prevent shortcuts being taken or complacency creeping in. Reminding crew of the hazards before they start working the net is advised.

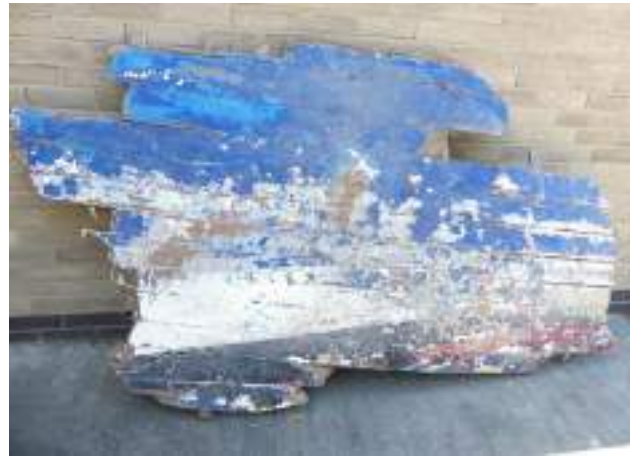
Figure: Recovered hull section

1. **Check** → The wooden motor cruiser had an unknown heritage and maintenance record. Further, the day of the accident was the first time that the owner had taken the boat out to the open sea. A post-accident examination of part of the boat’s hull established that it was in poor condition (see figure). While surveys are not mandatory when buying a pleasure boat, they can inform a new owner of the vessel’s condition and any repairs required to ensure its seaworthiness.

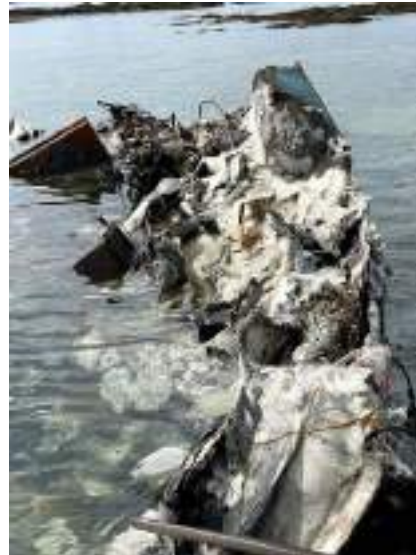
Figure: The remains of the vessel

The skipper used the VHF radio to transmit a “Mayday” call and was picked up by another sailing vessel and taken ashore. Fortunately, they had not sustained serious injuries and were treated for smoke inhalation and emotional shock; however, the sailing vessel burned down to the bilges and sank, eventually coming to rest on a sandbank (see figure).

- Hazard** → Lithium-ion (Li-ion) batteries present a fire hazard and should be used with this in mind, particularly when they are being recharged. Ensure that associated equipment such as charging cables and plugs are both compatible with Li-ion devices and undamaged before use. Never attempt to charge potentially damaged batteries. Items containing Li-ion batteries should be stored in a non-combustible area maintained at a temperature of 4°C to 26°C. Consider the consequences of activities that pose a combustion risk on board sailing vessels, which are often constructed of wood, plastic and fibreglass, and take steps to mitigate this by installing appropriate equipment such as fire extinguishers and fire blankets. The London Fire Brigade provides useful fire safety guidance on Li-ion chargers and batteries: <https://www.london-fire.gov.uk/safety/the-home/electrical-items/batteries-and-chargers/>

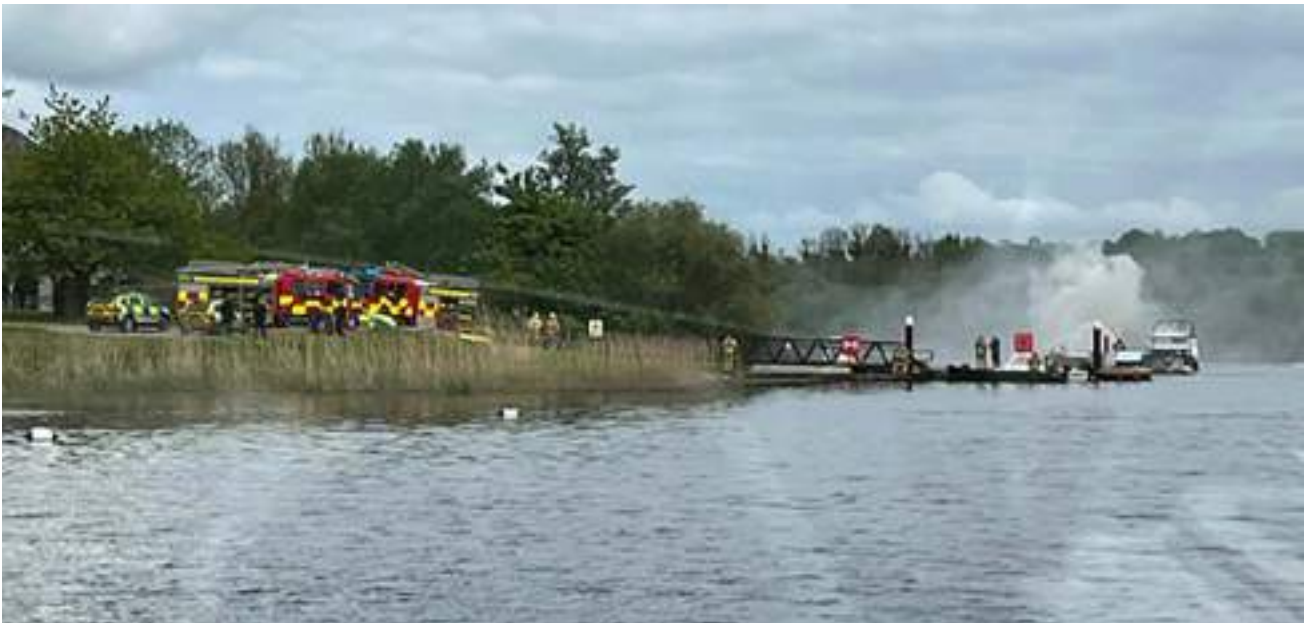
Figure 1: Emergency services attending the scene

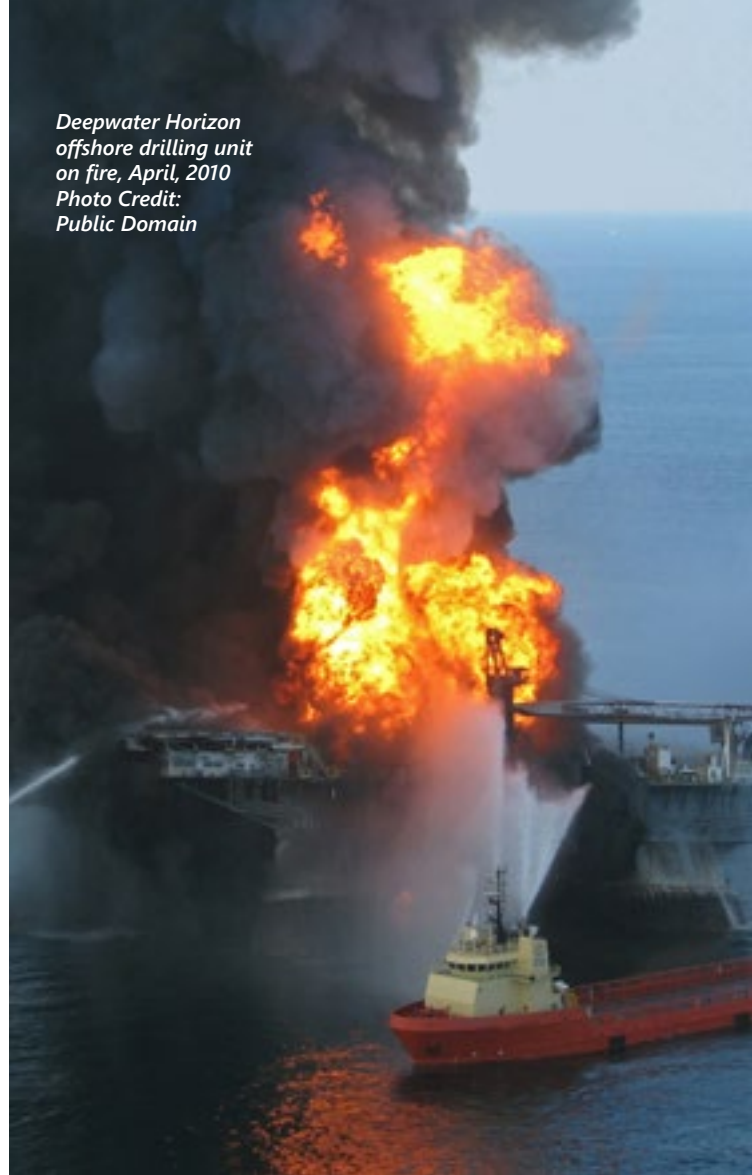
Deepwater Horizon offshore drilling unit on fire, April, 2010
Photo Credit: Public Domain

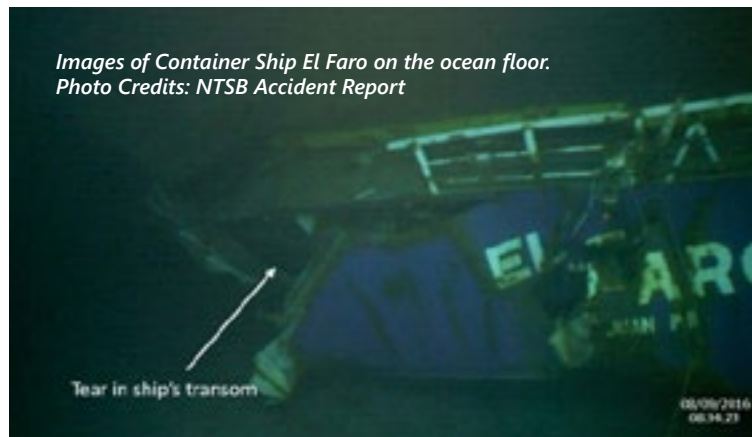
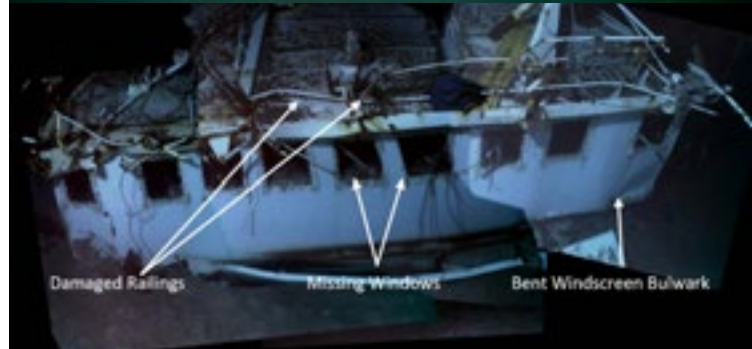
Images of Container Ship El Faro on the ocean floor.
Photo Credits: NTSB Accident Report

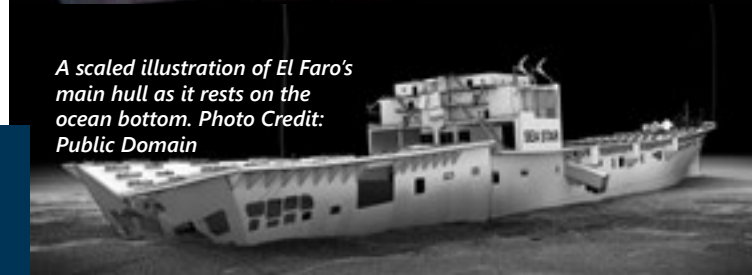
A scaled illustration of El Faro's main hull as it rests on the ocean bottom. Photo Credit: Public Domain

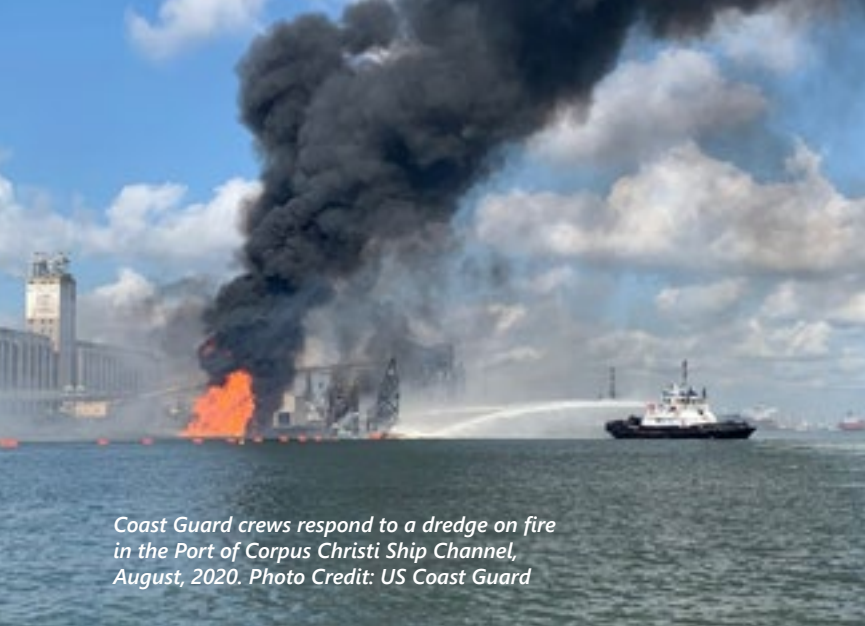
Coast Guard crews respond to a dredge on fire in the Port of Corpus Christi Ship Channel, August, 2020. Photo Credit: US Coast Guard

On August 21, 2020, the dredging vessel Waymon L. Boyd caught fire and exploded in the Port of Corpus Christi, Texas, after striking a submerged pipeline. The incident claimed five lives and caused several injuries, along with significant environmental damage due to the release of oil and other pollutants.

The NTSB identified that the primary cause of the accident was shortcomings in Orion Marine Group's planning and risk assessment procedures. These lapses led them to overlook how close their dredging activities were to the hazardous liquids pipeline, resulting in the dredge's rotating cutterhead hitting it. Compounding the problem, Schneider Engineering and Consulting provided flawed dredging plans. These inaccuracies further caused Orion to convey incomplete details to pipeline owner Enterprise Products during the coordination.

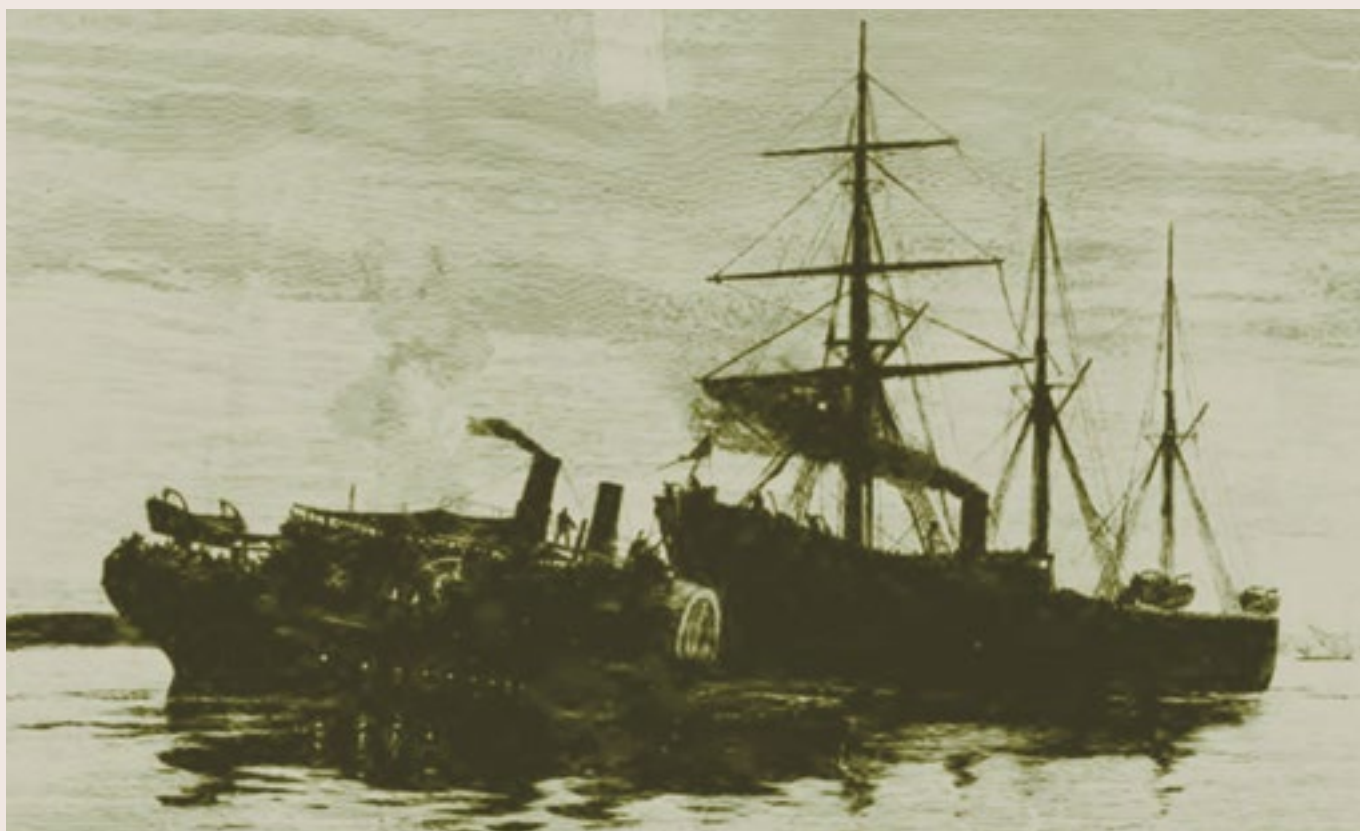
The Princess Alice and the Bywell Castle collide | The Graphic | 14 September 1878

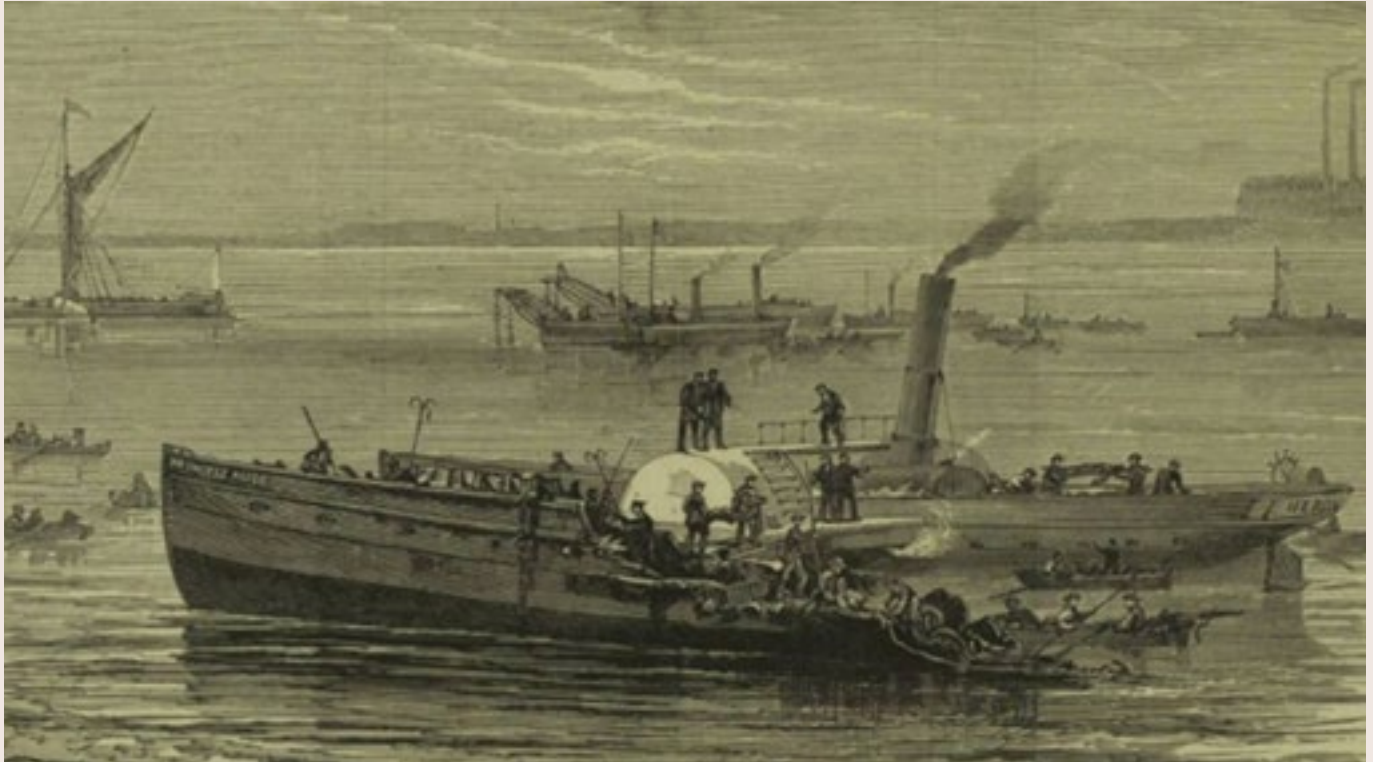
Bodies are recovered from the wrecked front end of the Princess Alice | Illustrated London News | 14 September 1878
