three mile island

**A REPORT TO THE
COMMISSIONERS
AND TO THE
PUBLIC**

**NUCLEAR REGULATORY COMMISSION
SPECIAL INQUIRY GROUP**

VOLUME II Part 2

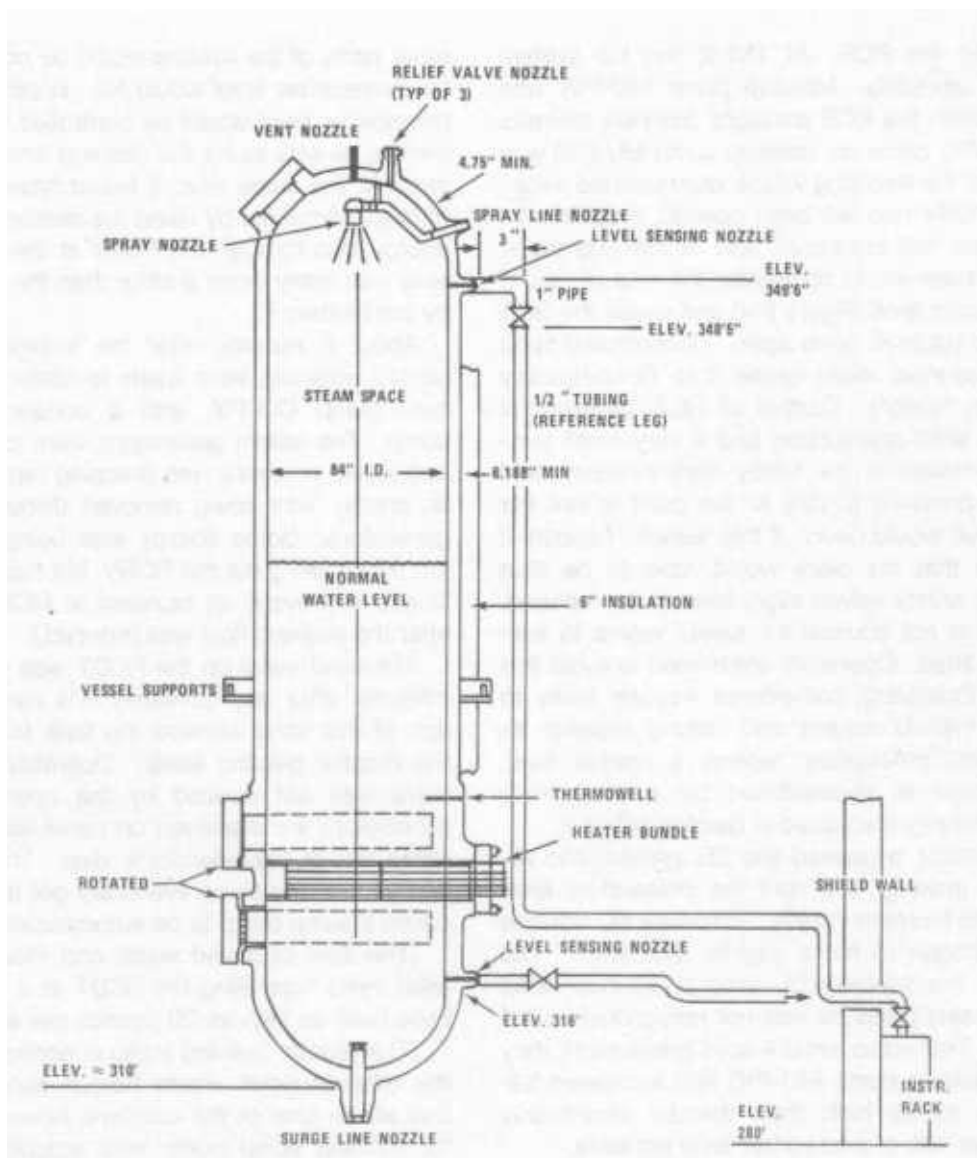
FIGURE 11-4. The Pressurizer

[If the PORV had not been opened, it could now be expected that increased flow of makeup water into the system would accelerate the rate of rise of the pressurizer level (Figure 11-4) and cause the RCS pressure to begin to climb again. Uncontrolled filling of the pressurizer might cause it to fill completely (pressurizer "solid"). Control of RCS pressure is lost with a solid pressurizer, and a very small temperature increase in the totally filled system could cause the pressure to rise to the point where the safety valves would open. If this were to happen, it is possible that the plant would have to be shut down. The safety valves might have to be repaired, because it is not unusual for safety valves to leak after being lifted. Operators are trained to avoid this situation. Operating procedures require them to switch to manual control and reduce makeup as soon as the pressurizer regains a normal level. (This practice is necessitated by a preexisting design deficiency discussed in Section II.C.1.c.)]

The safety and relief valves and the vent valve are at the top of the pressurizer. One of these is the pilot-operated relief valve, which stuck open in the accident at TMI-2. The purpose of the safety and relief valves is to allow escape of steam if the pressure gets too high. The vent valve is used to bleed off air and other gases when the plant is being started up.

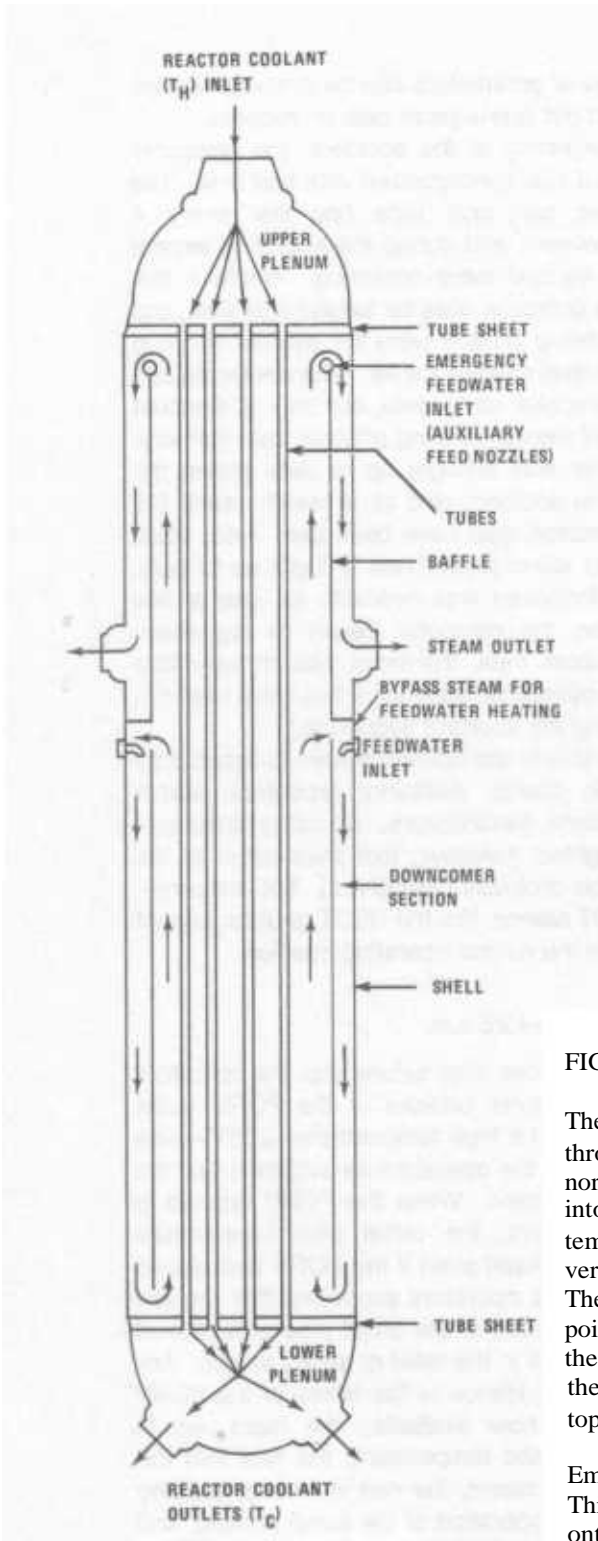
FIGURE II-5. The Once-Through Steam Generator

At 8 minutes after turbine trip, the operator discovered that the emergency feedwater block valves were closed and opened them. Opening these valves caused a rapid increase in steam pressure, which had previously dropped when the steam generators boiled dry, and a drop in RCS temperature. Steam generator level, however, did not recover noticeably for another 14 minutes. [The reason for the lag in recovery of the steam generator level is that emergency feedwater is sprayed directly onto the hot tubes and evaporates immediately (Figure 11-5). Evaporation raises steam pressure, but

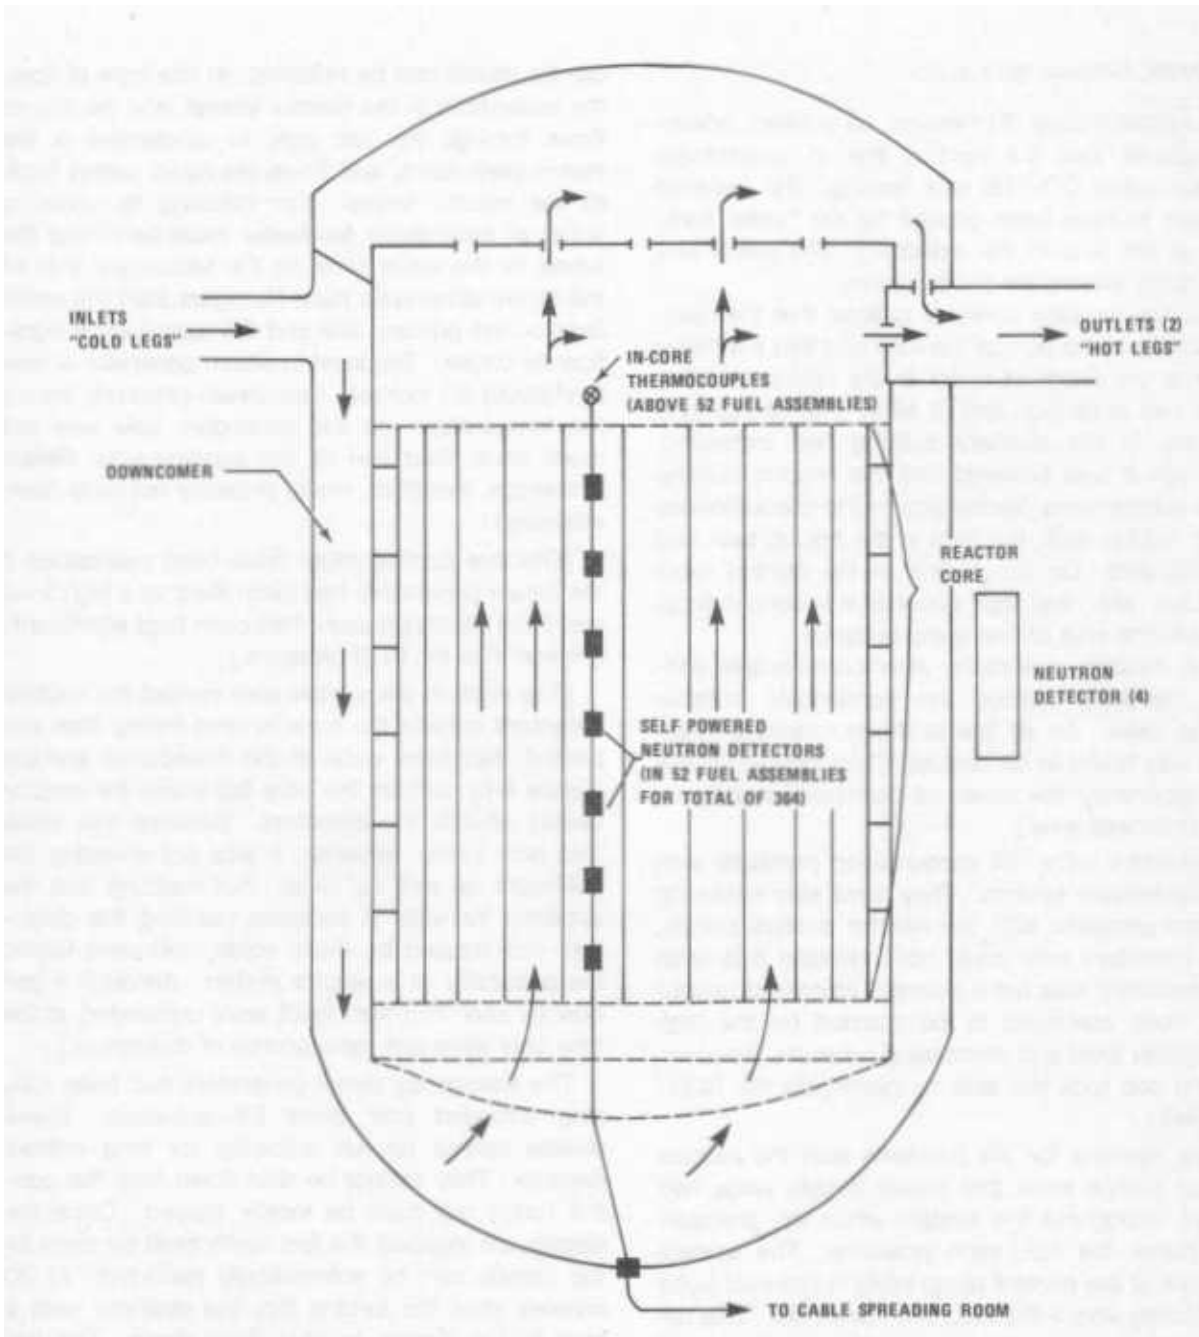
FIGURE 11-6. The Reactor and Reactor Pressure Vessel

[The voids in the system also caused the neutron detectors outside the core to read higher than expected. Normally, water in the downcomer annulus (Figure 11-6), outside the core but inside the reactor vessel, shields the detectors. Because this water was now frothy, however, it was not shielding the detectors as well as usual. Not realizing that the apparent increase in neutrons reaching the detectors was caused by these voids, operators feared the possibility of a reactor restart. Although it can now be seen that their fears were unfounded, at the time they were one more source of distraction.]

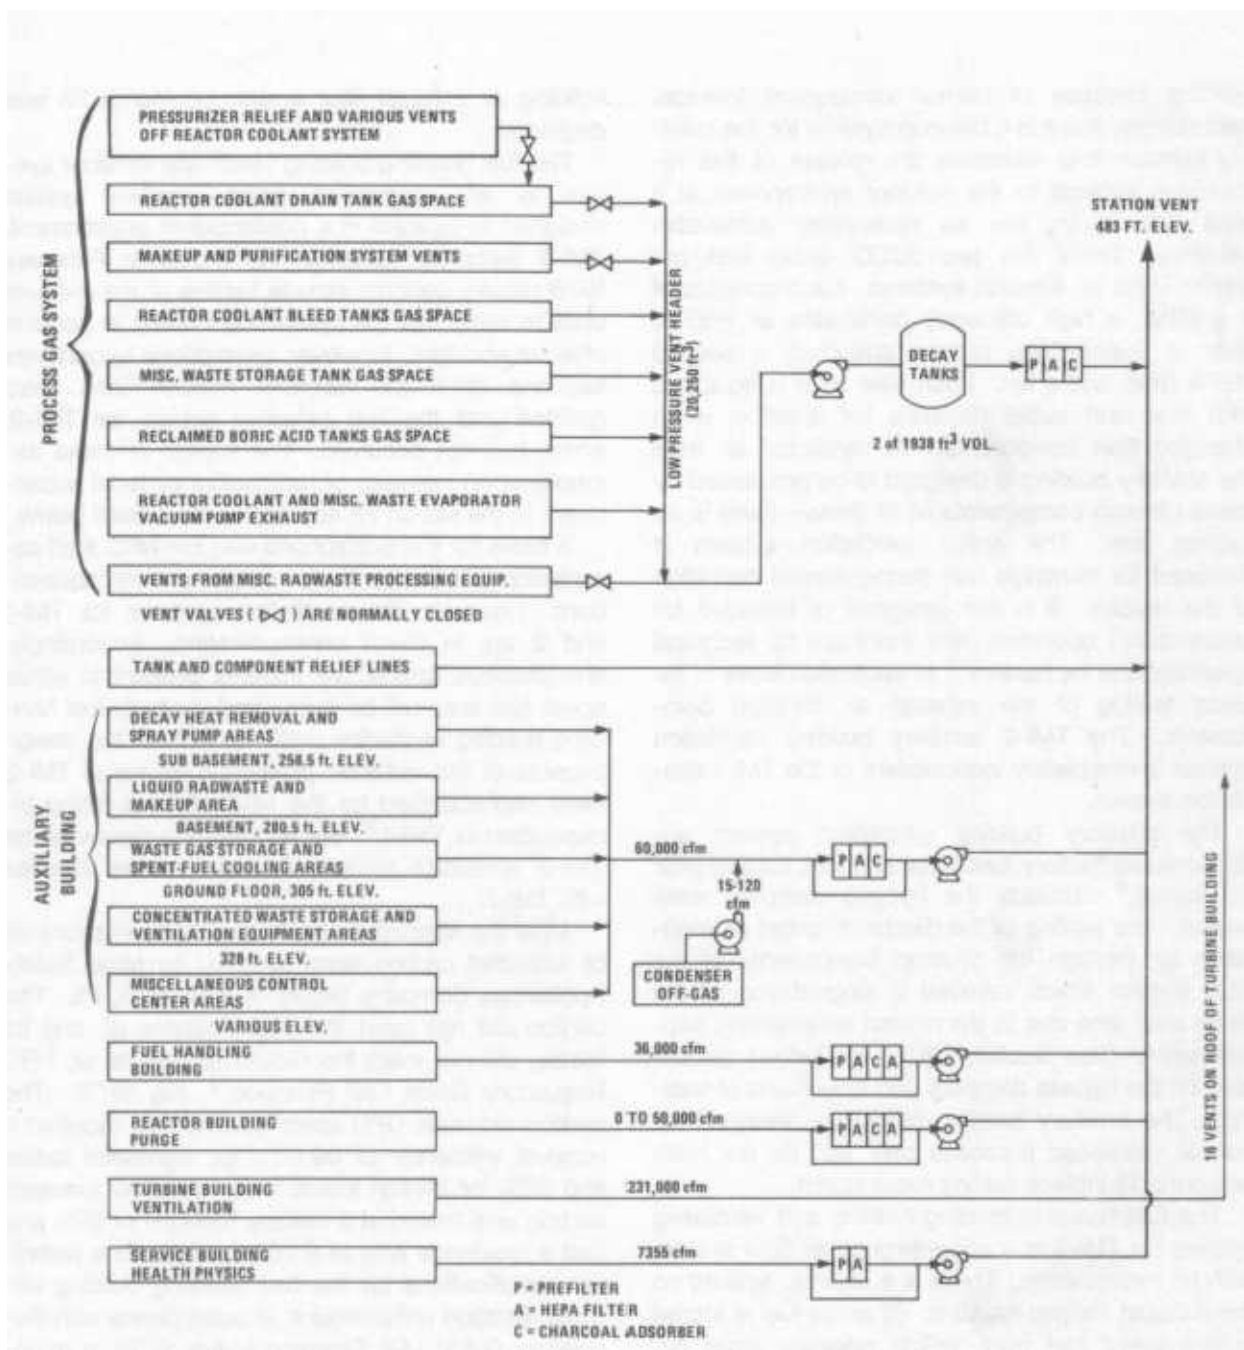
FIGURE 11-9. Ventilation and Waste Gas System Release Pathways

Gaseous Radwaste System - The gaseous radwaste system for TMI-2 processes gaseous wastes based on their origin and expected radioactivity levels. Figure 11-9 shows the gaseous radwaste and ventilation systems. Filtration sys-

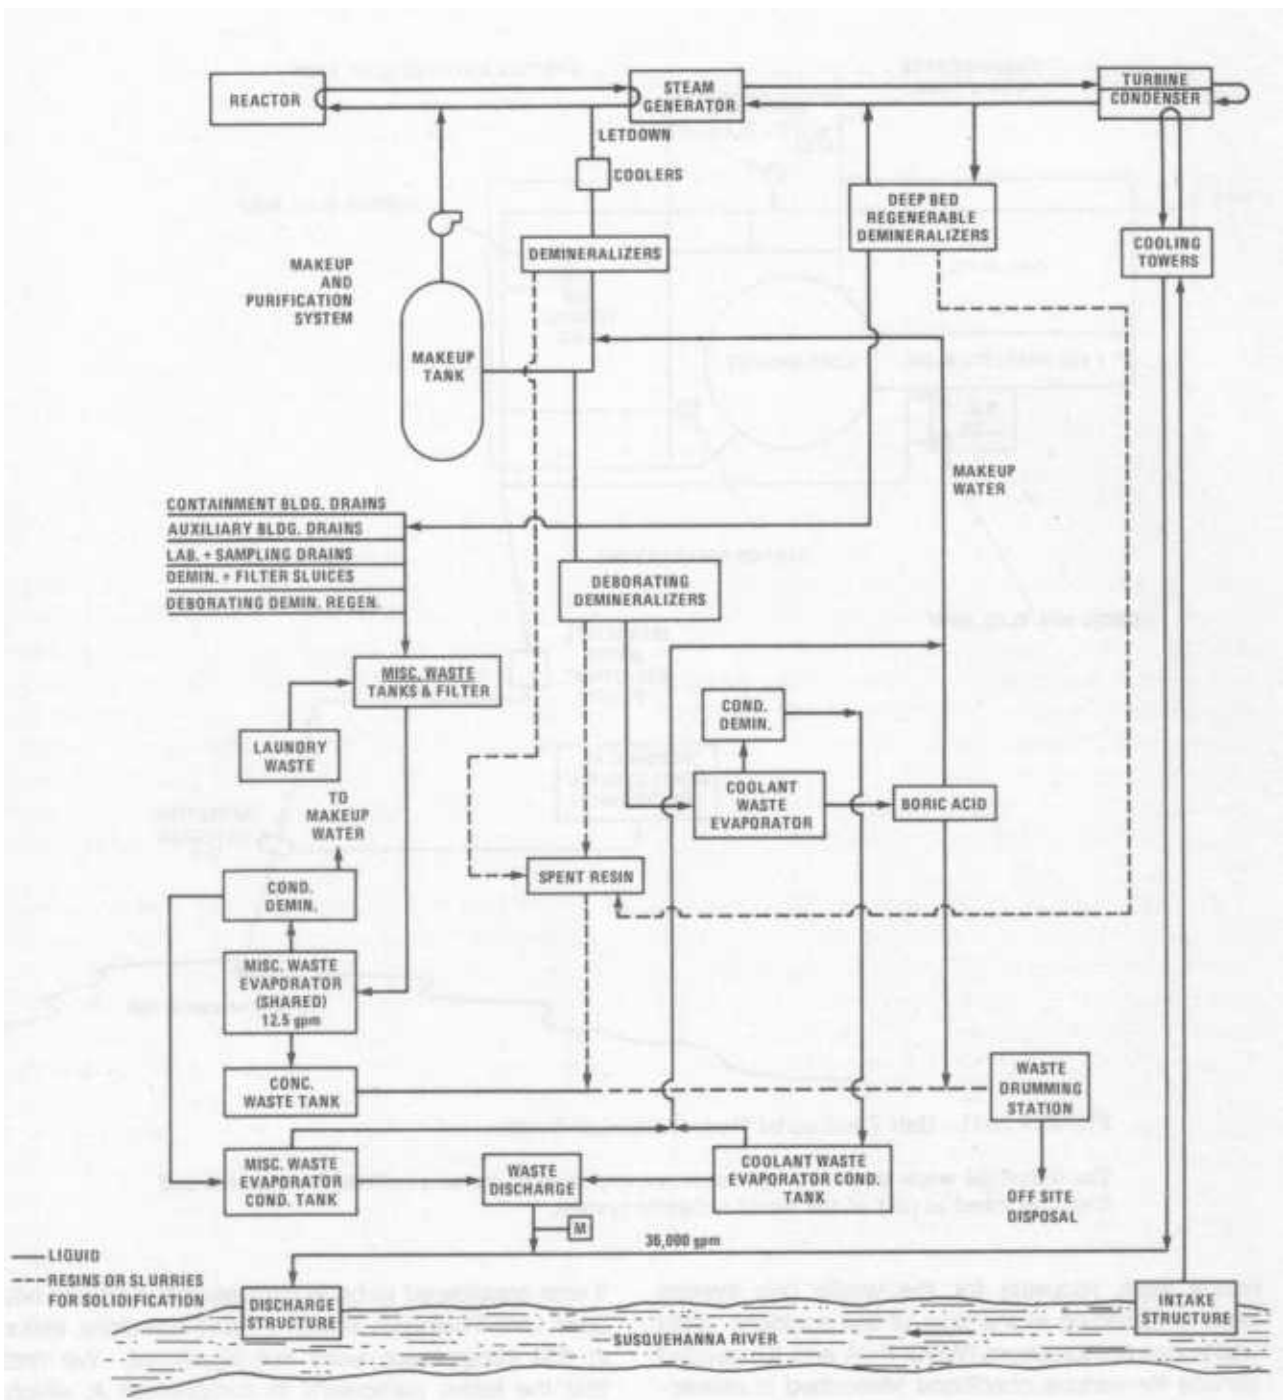
FIGURE II-10. Liquid Radioactive Waste Treatment System

Immediately prior to the accident, approximately 60% of the station's available liquid radwaste storage capacity (300 000 gallons per unit) was filled. Of particular importance, the auxiliary building sump was approximately 63% full, the auxiliary building sump tank (WDL-T-5) was approximately 76% full, the two contaminated-drains tanks (WDL-T-11A and 11B) were 77% and 24% full, respectively, and the three reactor coolant bleed holdup tanks,

capacity for the site. Accordingly, we find that for normal operations the liquid radwaste storage and treatment system was marginal at best.

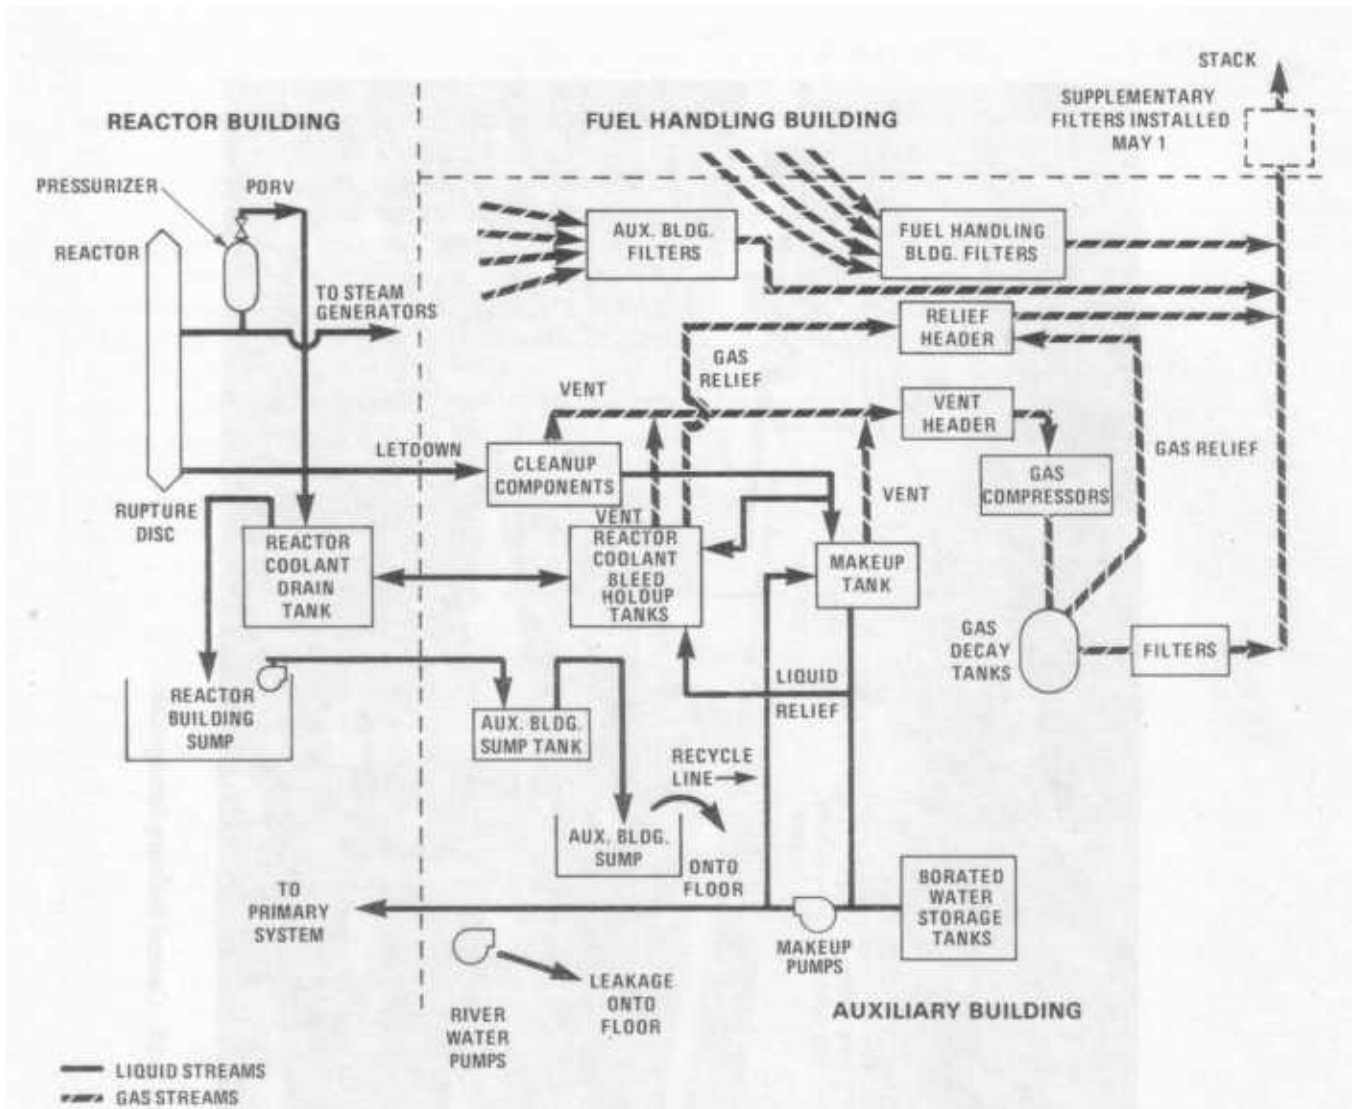
FIGURE 11-12. Release Pathways

The TMI-2 stack was the main release point for gaseous effluents. Numerous pathways to the stack existed for the release of radioactive gaseous effluents. The release pathways from the reactor to the auxiliary and fuel handling buildings are shown in Figure 11-12. Figure 11-13 shows the general arrangement of buildings at the site, and the TMI-2 stack.

The vent line from the reactor coolant drain tank to the vent header was open on March 28, as indicated by the open status of valves WDL-V-126 and V-127.²⁴ The high pressures in the reactor coolant drain tank forced liquid (primary coolant) through the vent line to the vent header. The vent header relief valve (WDG-R-3) is set at 150 psig, so water under pressure caused leaks in the water drains. This water also damaged some of the 10 check valves located between the vent header and connected tanks (such as WDG-V-113 to the reactor coolant bleed holdup tanks, or WDG-V-153 to the reactor coolant evaporator). These check valves are designed to permit flow only from the component to the vent header and not in the opposite direction, but are known to operate inefficiently and fail easily.²⁵ Therefore, a significant pathway existed from the vent header to a number of tanks. The relief valves on these tanks, which were set at relatively low pressures (reactor coolant bleed holdup tank at 20 psig, reactor coolant evaporator at 10 psig), opened. Lifting of these relief valves resulted in untreated releases directly to the stack via the relief valve vent header (shown in Figure 11-12). We find that the gaseous radwaste system design included "relief to atmosphere," which provided a path to the environment for untreated gas. We find, also, that the high reactor coolant drain tank pressures between 4:00 and 4:30 a.m. on March 28 damaged portions of the vent gas system and resulted in a gaseous release pathway to the vent header, through failed check valves to components with low-pressure relief valves. Once established, this release path was available whenever the vent header was used, such as in the venting of the makeup tank.

Problems with the waste gas system compressor have already been discussed. A postaccident examination of compressor B found a hole approximately the size of a quarter. The operation of the compressor at any pressure would be considered a significant release path.²³ However, compressor B was off line from March 28 until March 29.²⁶ In addition, the design of the waste gas system includes a pressure regulator (WDG-V-59) that limits the inlet pressure to the compressors to approximately 1 inch of water gauge. This prevented any high pressures in the vent header from reaching the

Continued operation of the letdown transferred primary coolant from the reactor to components in the auxiliary building. Pressure buildup in components due to degassing of the hydrogen and noble gases in the letdown system caused gaseous leakage to the auxiliary building and operation of relief and vent valves to release gaseous radioactivity to the auxiliary and fuel handling buildings and to the environment.

Each time the makeup tank was vented, the radiation levels inside and outside the plant increased. The pathway for the gaseous activity from the makeup tank venting process and for other component vents is shown in Figure 11-12. Cleanup components in the letdown and the makeup tank have manually operated vents that discharge to the vent header. During normal operation, vented gases are held up and filtered prior to release.

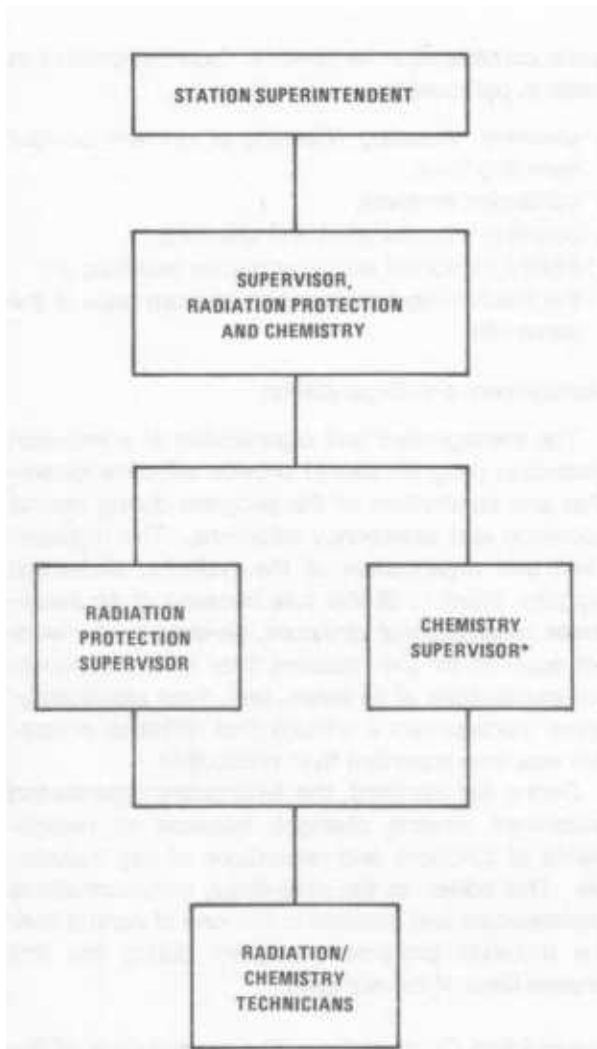
FIGURE 11-16. Organization of the Radiation Protection and Chemistry Staff as Indicated in Technical Specifications, Figure 6.2-1.

Preaccident Organization- The organization of the radiation protection staff was approved by the NRC staff and is shown in Figure 11-16. This organization has the Supervisor of Radiation Protection and Chemistry, Richard Dubiel, reporting directly to the station superintendent, the senior plant official. However, a different organization (Figure 11-17) was prescribed by Met Ed at the time of the accident, which added another level of management between Dubiel and the senior plant official. Moreover, Dubiel actually reported to the unit superintendents. ²²⁴ Dubiel's theoretical and actual reporting responsibilities were inconsistent with the technical specifications. ²²⁵

Under the Met Ed organization as approved by the NRC, the radiation protection-chemistry technicians (R-CTs) performed the dual functions of radiation protection and chemistry and reported along two different chains of command. The dual function of technicians is common in the nuclear power industry. ²²⁶ The inefficiencies of this system detracted from the implementation of an effective radiation protection program. One R-CT characterized this as "the biggest, most devastating hindrance to our

* REMAINED UNFILLED SINCE ISSUANCE OF THE TECHNICAL SPECIFICATIONS. THE DUTIES AND RESPONSIBILITIES OF THIS POSITION WERE BEING FULFILLED BY THE SUPERVISOR, RADIATION PROTECTION AND CHEMISTRY AND THE CHEMISTRY FOREMEN.

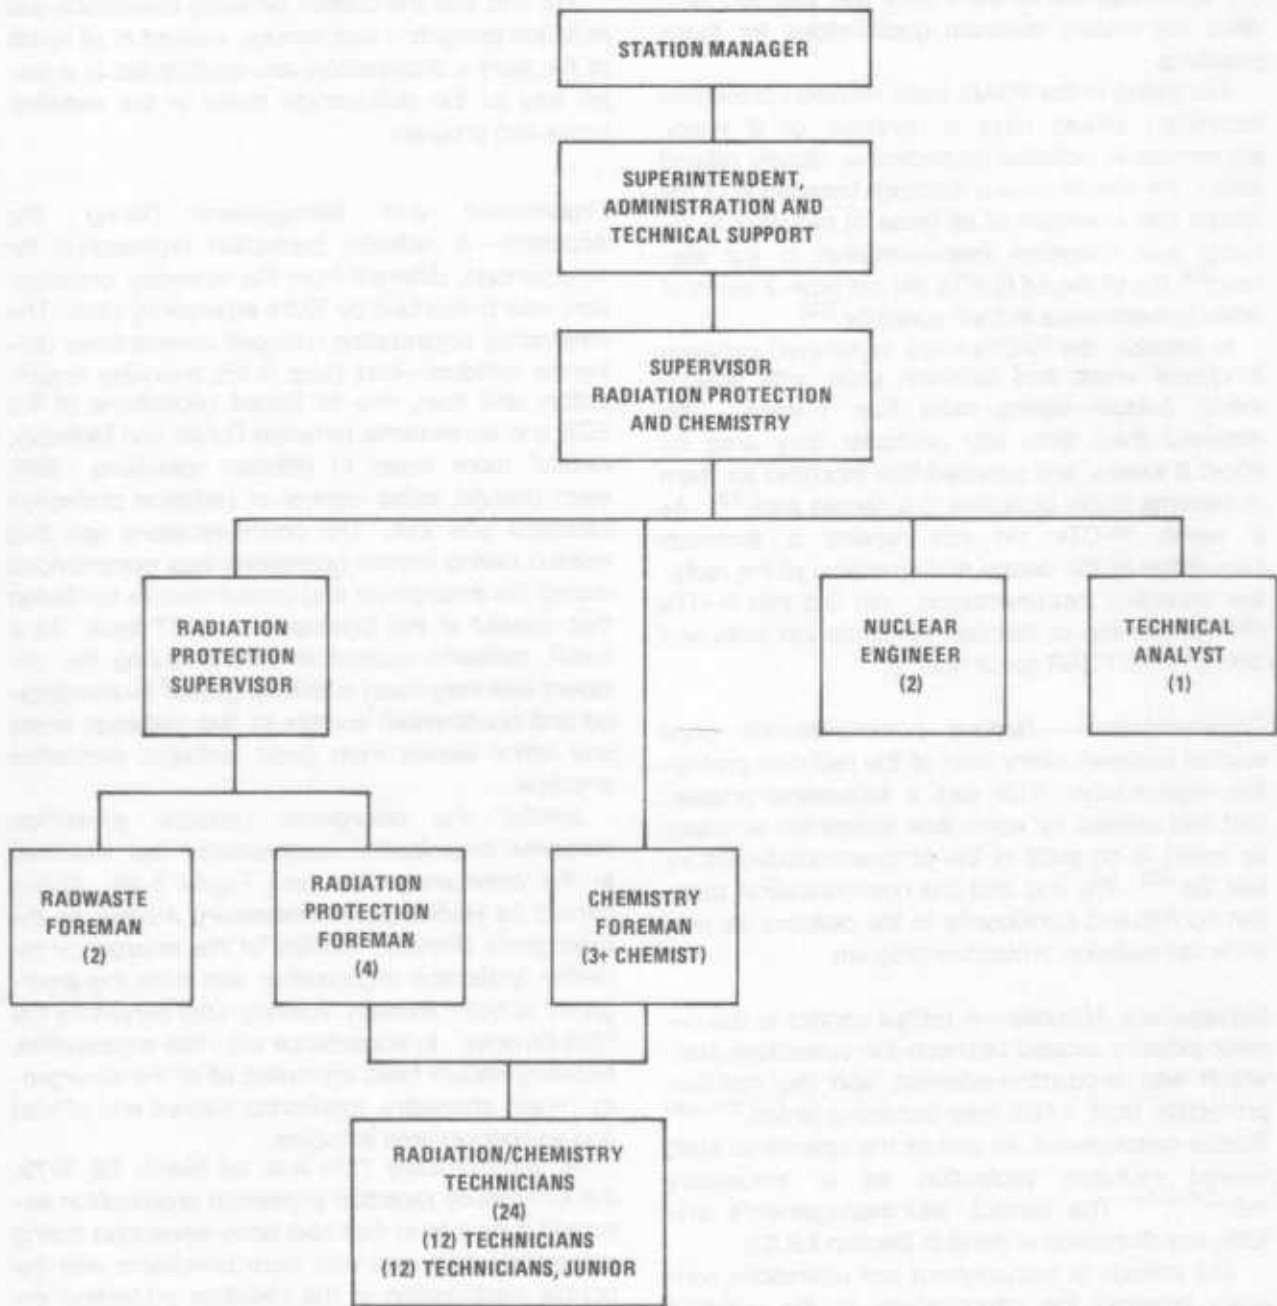
FIGURE 11-17. Actual Organization of TMINS Radiation Protection and Chemistry Staff Before March 28, 1979 (NUREG-0600, P.II-1-2)

Dubiel's time and attention were spread much too thinly because: (1) he was acting (in conjunction with the chemistry foremen) as chemistry supervisor, (2) he had the additional burden and responsibilities of running the radiation protection program for a two-unit station, and (3) he had too many people reporting to him.²²³ As a result, we find that Dubiel did not function as the RPM as defined in

Regulatory Guide 1.8, and that the role fell, by default, to Mulleavy, who was not qualified for this position.

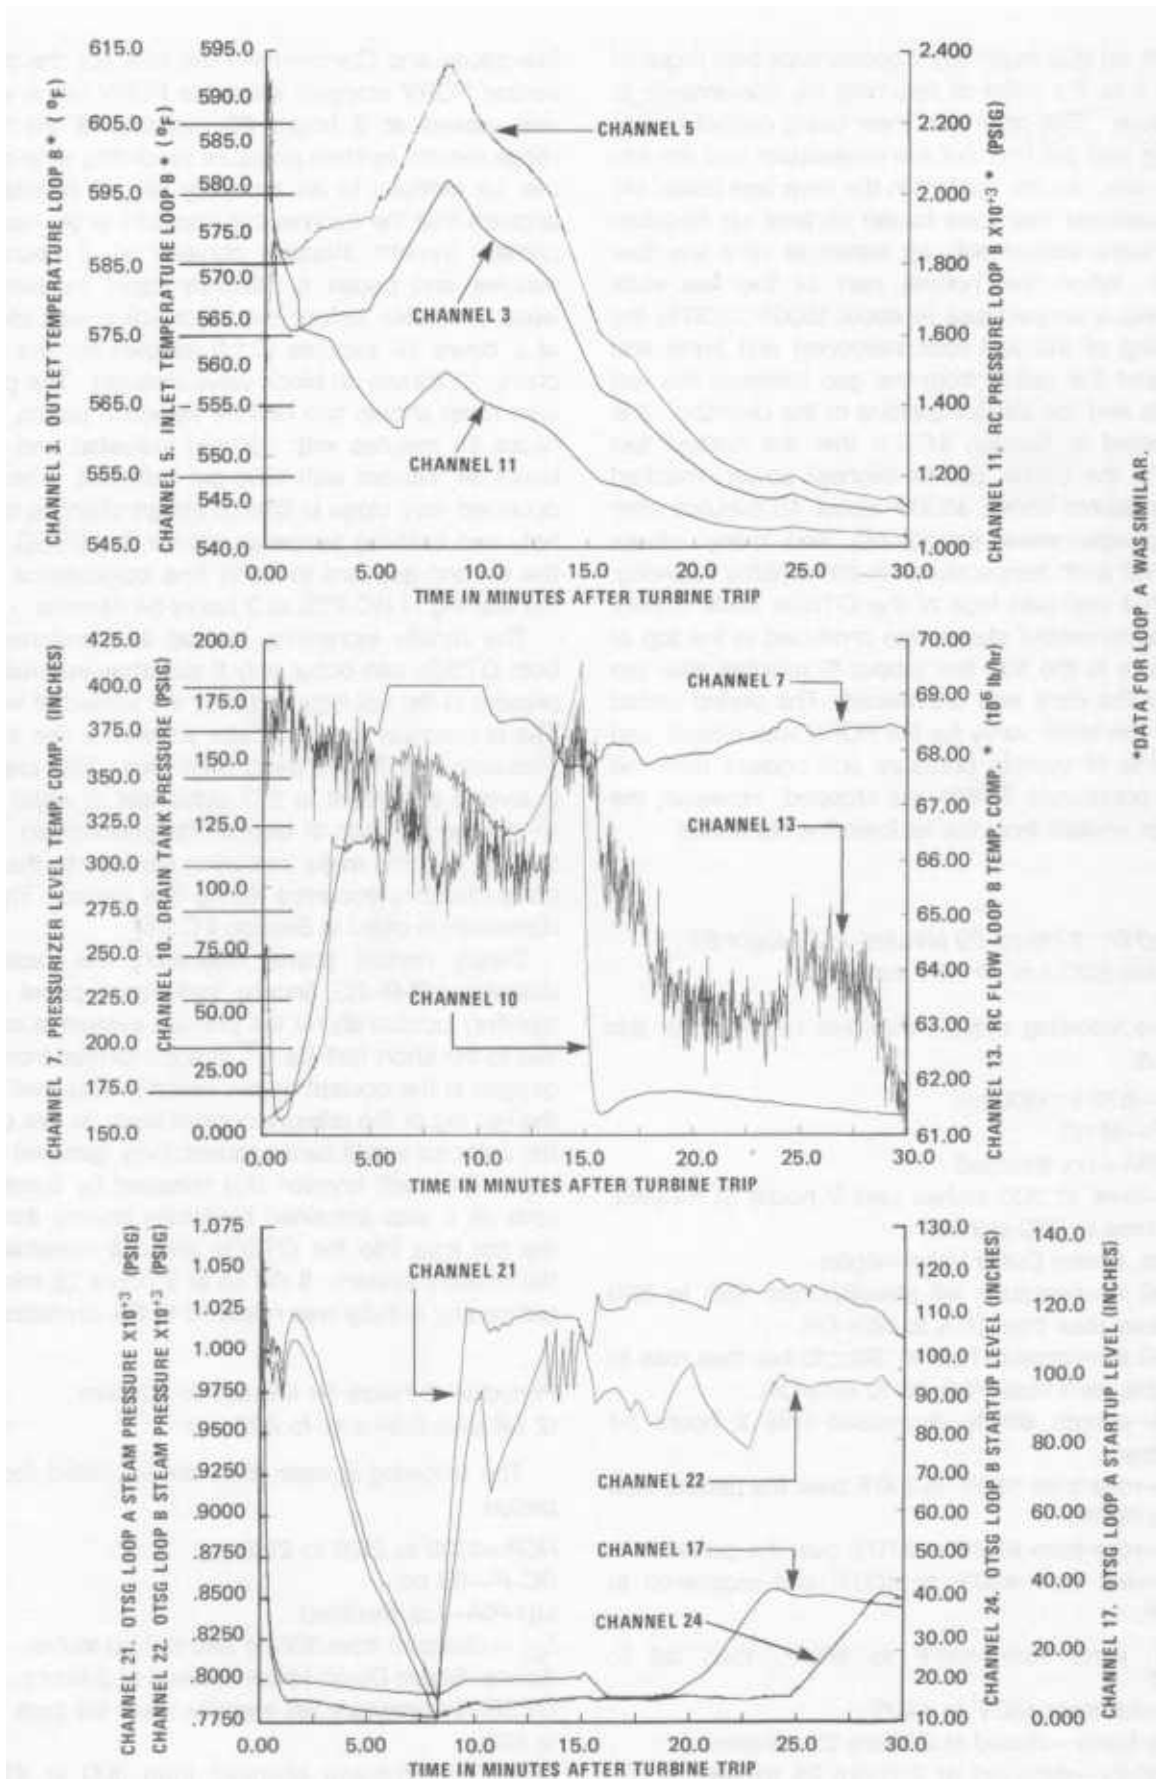
FIGURE 11-26. System Parameters for the First Thirty Minutes of the TMI-2 Accident

range. (This may be a minimum reading for the instrumentation, rather than a "zero" on the scale used.) System parameters for the first 30 minutes are shown in Figure 11-26.

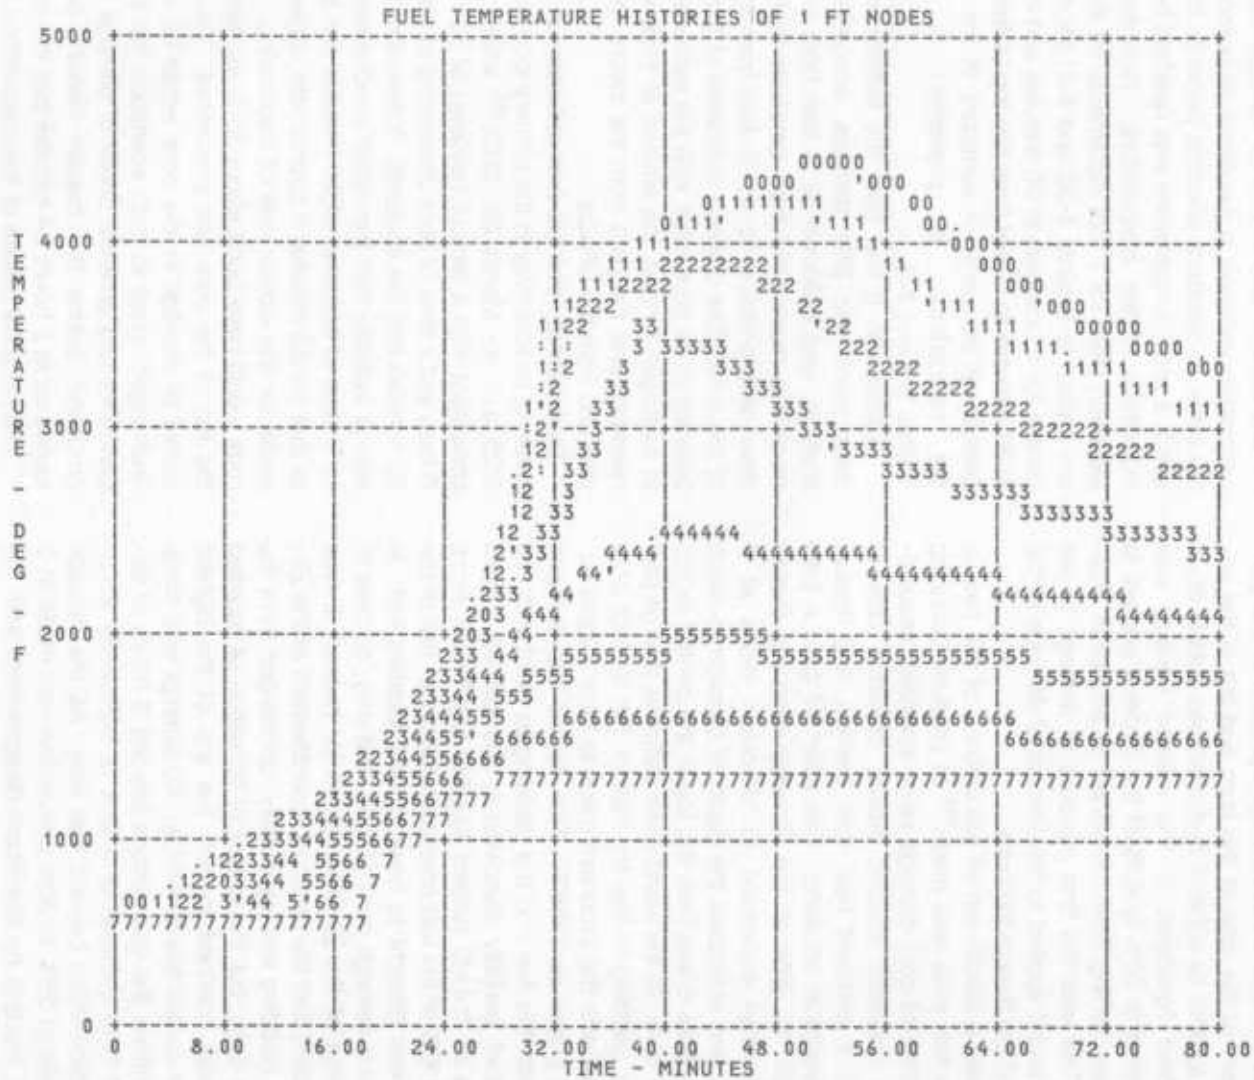
FIGURE 11-30. Fuel Temperature Histories

The principal results of the calculations show that the ranges of time and location of rod burst ($1500 \pm 100^\circ\text{F}$) are from about 13 to 25 inches and 20 to about 40 minutes from center to periphery for all ranges of boildown and time to boildown depth.

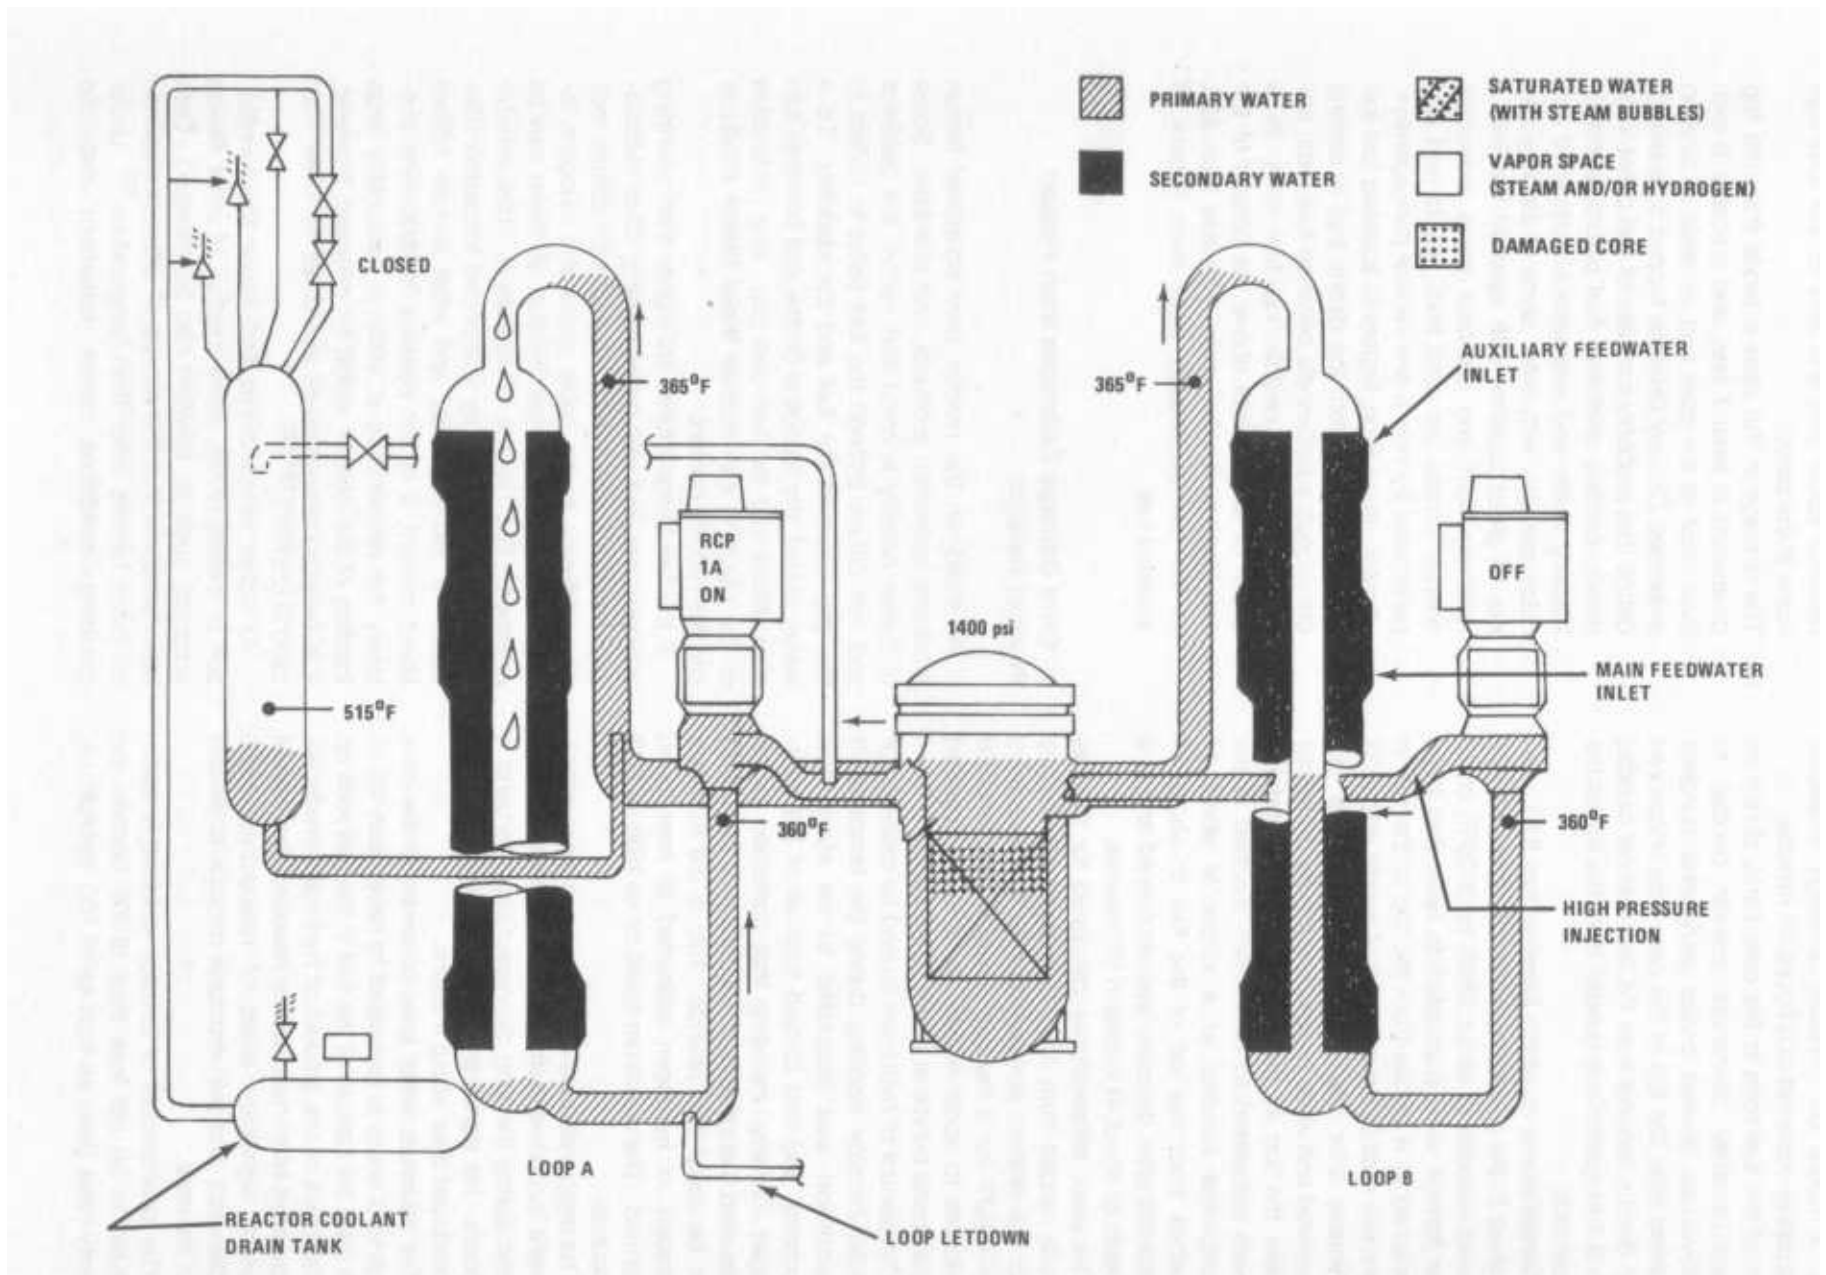
FIGURE 11-32. Reactor Primary System at 16 Hours

The distribution of the water and gas inventory of the primary system at 16 hours is shown in Figure 11-32. At that time there were four gas bubbles in the system, one in the top of each OTSG, one in the top of the pressure vessel, and one in the pressurizer. Coolant water was being pumped through the hot leg of OTSG A, flowed over the top of the candy cane, and dropped through the gas bubble to fill the lower part of the OTSG and be recirculated by the pump. The reactor pressure vessel was filled above the hot-and cold-leg nozzles, and hydrogen was trapped in the pressure vessel head.

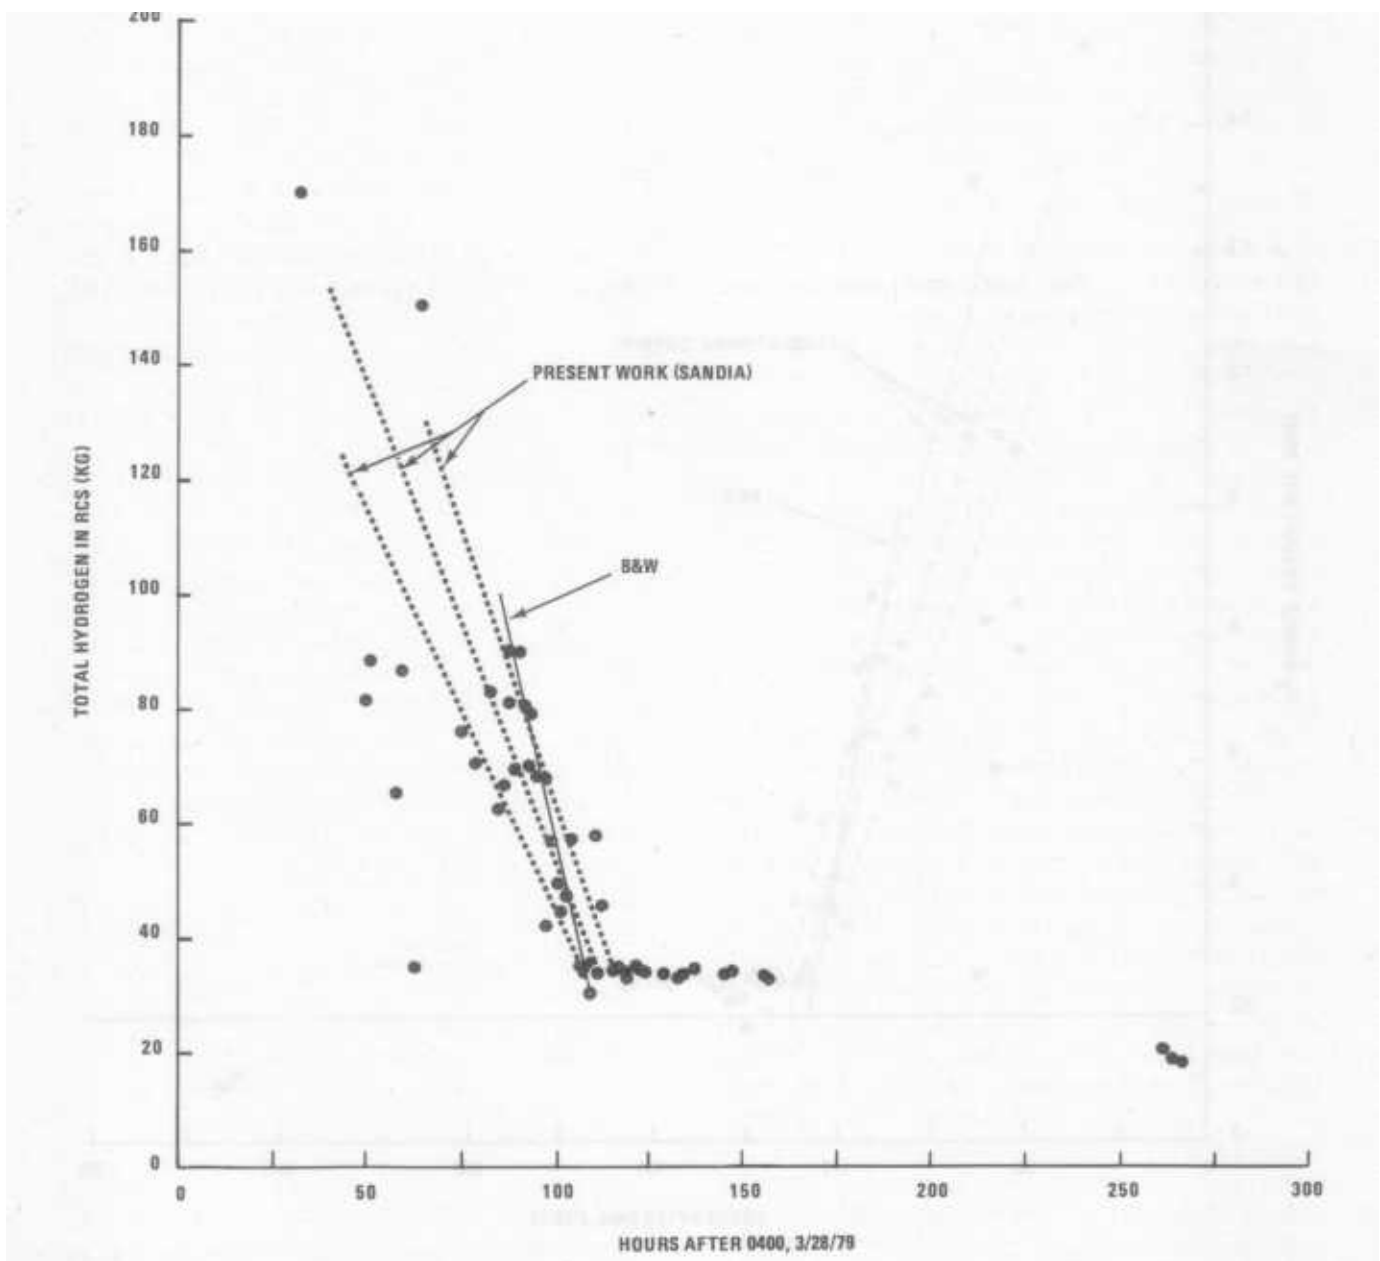
FIGURE 11-33. Total Hydrogen in RCS

principle—the compliance of a liquid containing a gas bubble—was used by each organization. After the accident, Sandia carried out an independent investigation²⁰⁷ at the request of the TMI Special Inquiry Group. The results of the latter study, as given in Figures 11-33 and 11-34, show that the bubble was about 1470 ft³ at 2:00 p.m. on March 28 and was completely gone by 6:00 p.m. on April 1.

Except for changes in dissolved hydrogen due to changes in RCS pressure and temperatures, degassing at a constant rate of letdown would give a constant rate of bubble shrinkage. Figure 11-33 shows the results of bubble calculation with the Sandia formula, along with a least squares fit for removal rate. Also shown in Figure 11-33 is a removal rate calculated by B&W and a one standard deviation error band about the Sandia fit. Figure 11-34 shows the same data, except that the ordinate is total hydrogen in the RCS—in the bubble and dissolved in the coolant. The time of removal can be

taken to be the intercept with the horizontal axis in Figure 11-33. The data show that the bubble had disappeared between 3:00 and 9:00 p.m. on April 1.
