three mile island

**A REPORT TO THE
COMMISSIONERS
AND TO THE
PUBLIC**

**NUCLEAR REGULATORY COMMISSION
SPECIAL INQUIRY GROUP**

VOLUME II Part 2

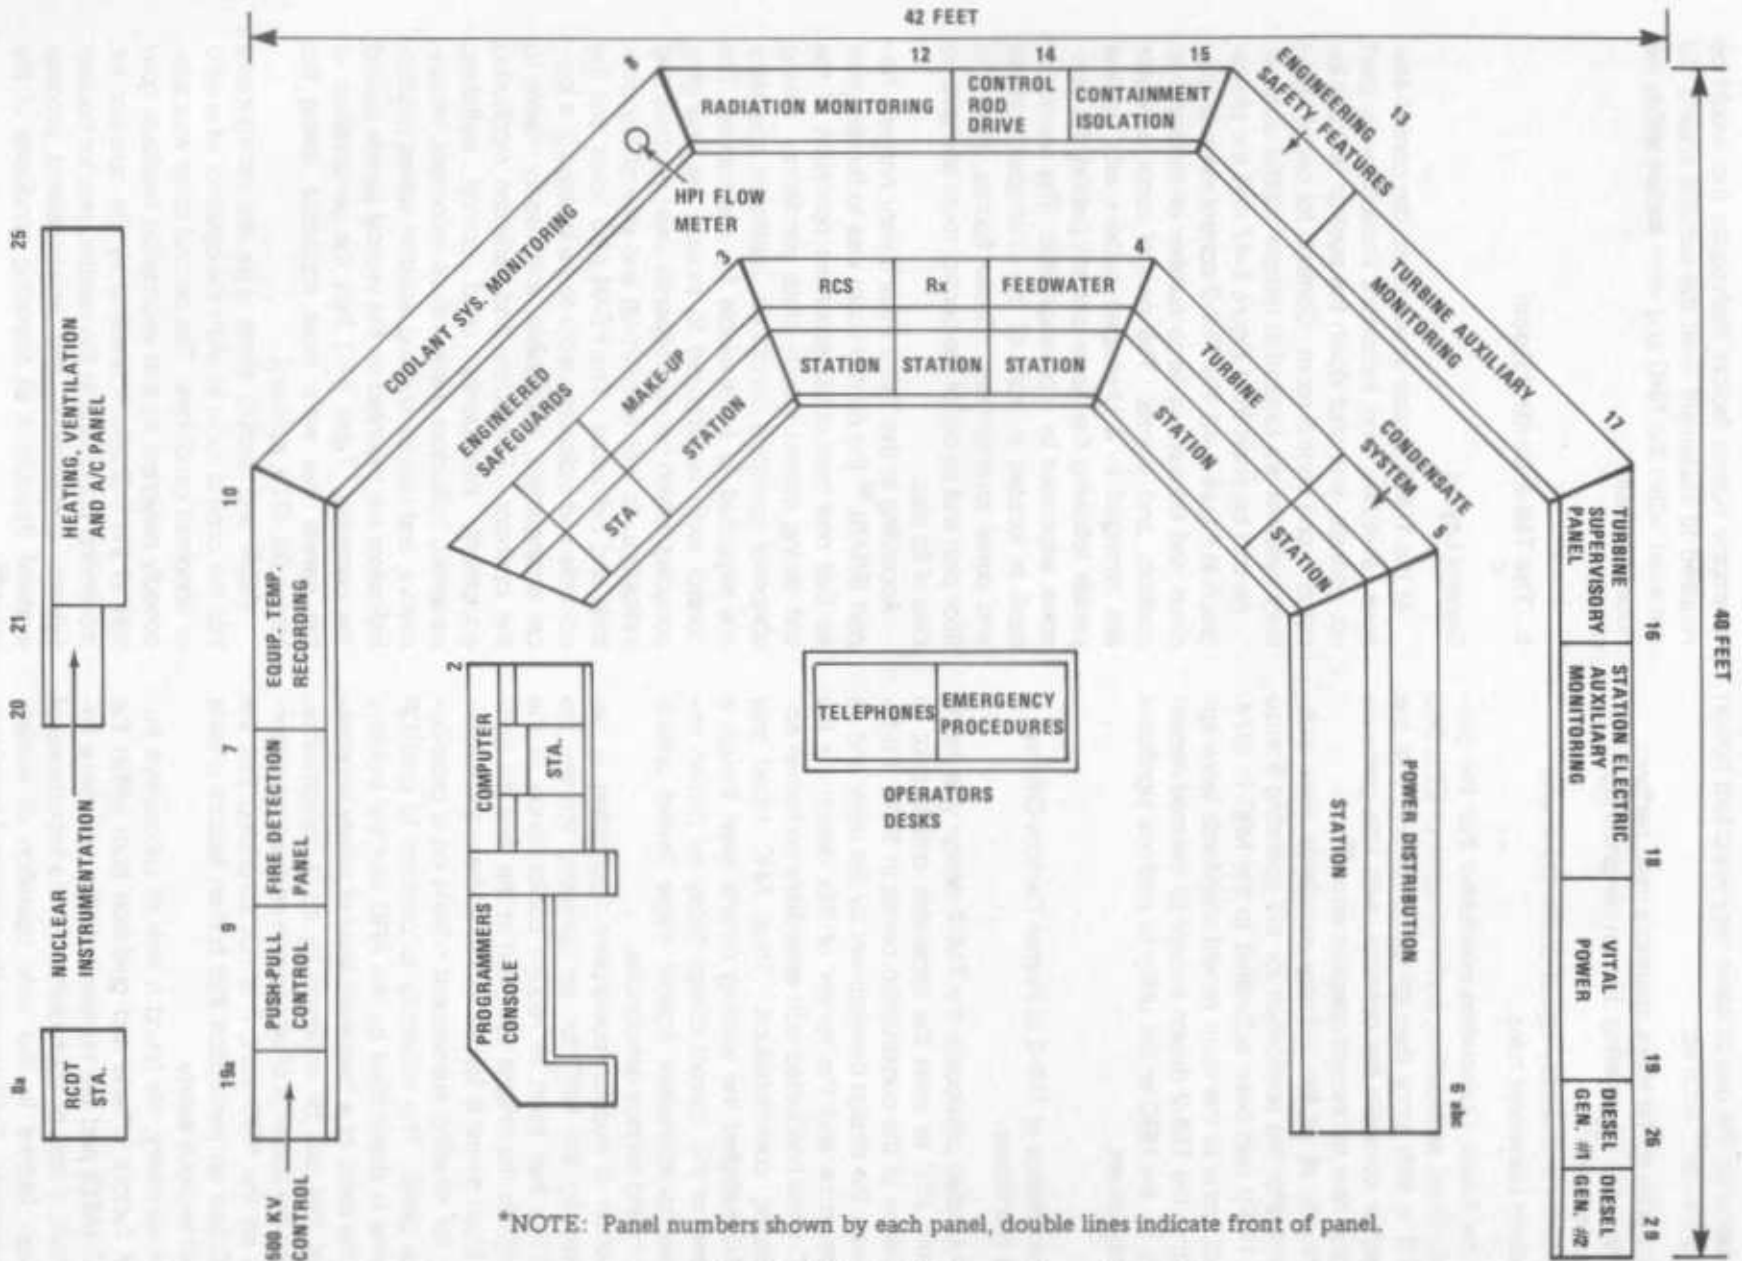
FIGURE II-47. TMI-2 Control Room Layout*

Moreover, the instrumentation for RCDT conditions and the corresponding alarms are behind the control panel and cannot be read unless the operator leaves his normal operating area in front of the control panel and walks about 50 feet (see Figure 11-47). To further compound the problem, the RCDT instrumentation on the back panel only gives instantaneous information. It does not record the parameters that indicate the previous conditions and thereby indicate trends in the RCDT temperature, level, and pressure. Consequently, when the operator went to check the RCDT status, he had difficulty telling whether the RCDT conditions were a result of an expected single opening and closing of the PORV at the beginning of the accident or whether they were a result of an unexpected longer, continuous leak from a stuck-open PORV.

- RCDT instrumentation is located on panel 8A, which is completely outside the main operating area. See Figure 11-47.

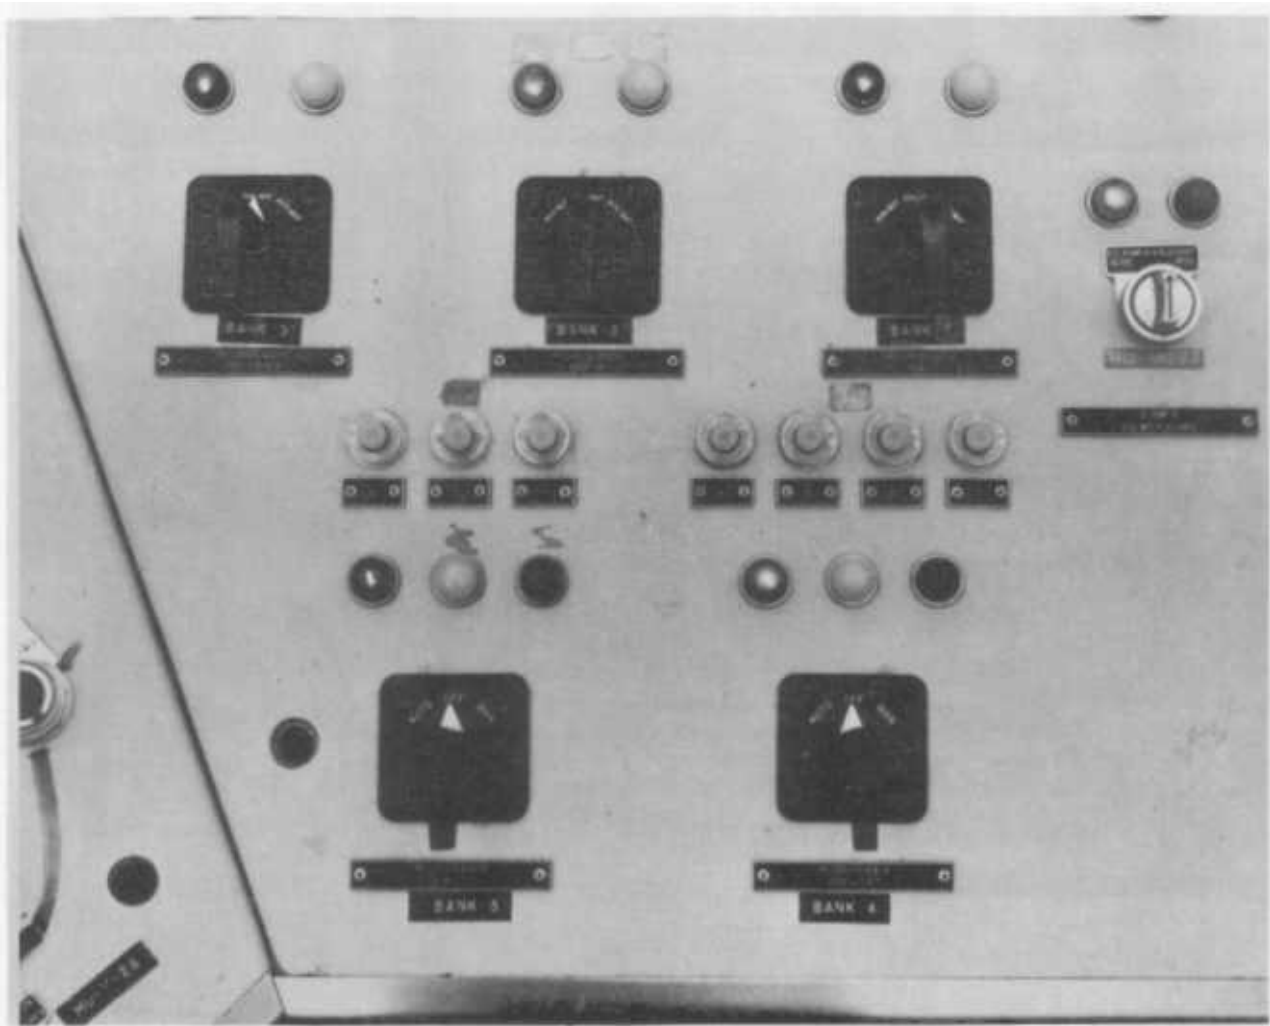
FIGURE 11-50. Pressurizer Heater Control*

- Auditory displays associated with annunciators are not prioritized to assist the operator in discriminating critical alarms.
- Controls having common operating modes (i.e., automatic and manual) are not designed so that mode selection is consistent between controls. In some cases, controls having similar functions are turned clockwise to place the system in manual, and in others, counterclockwise. See Figure 11-50.

*Note the right to left sequence and inconsistency of control movement to auto and manual.

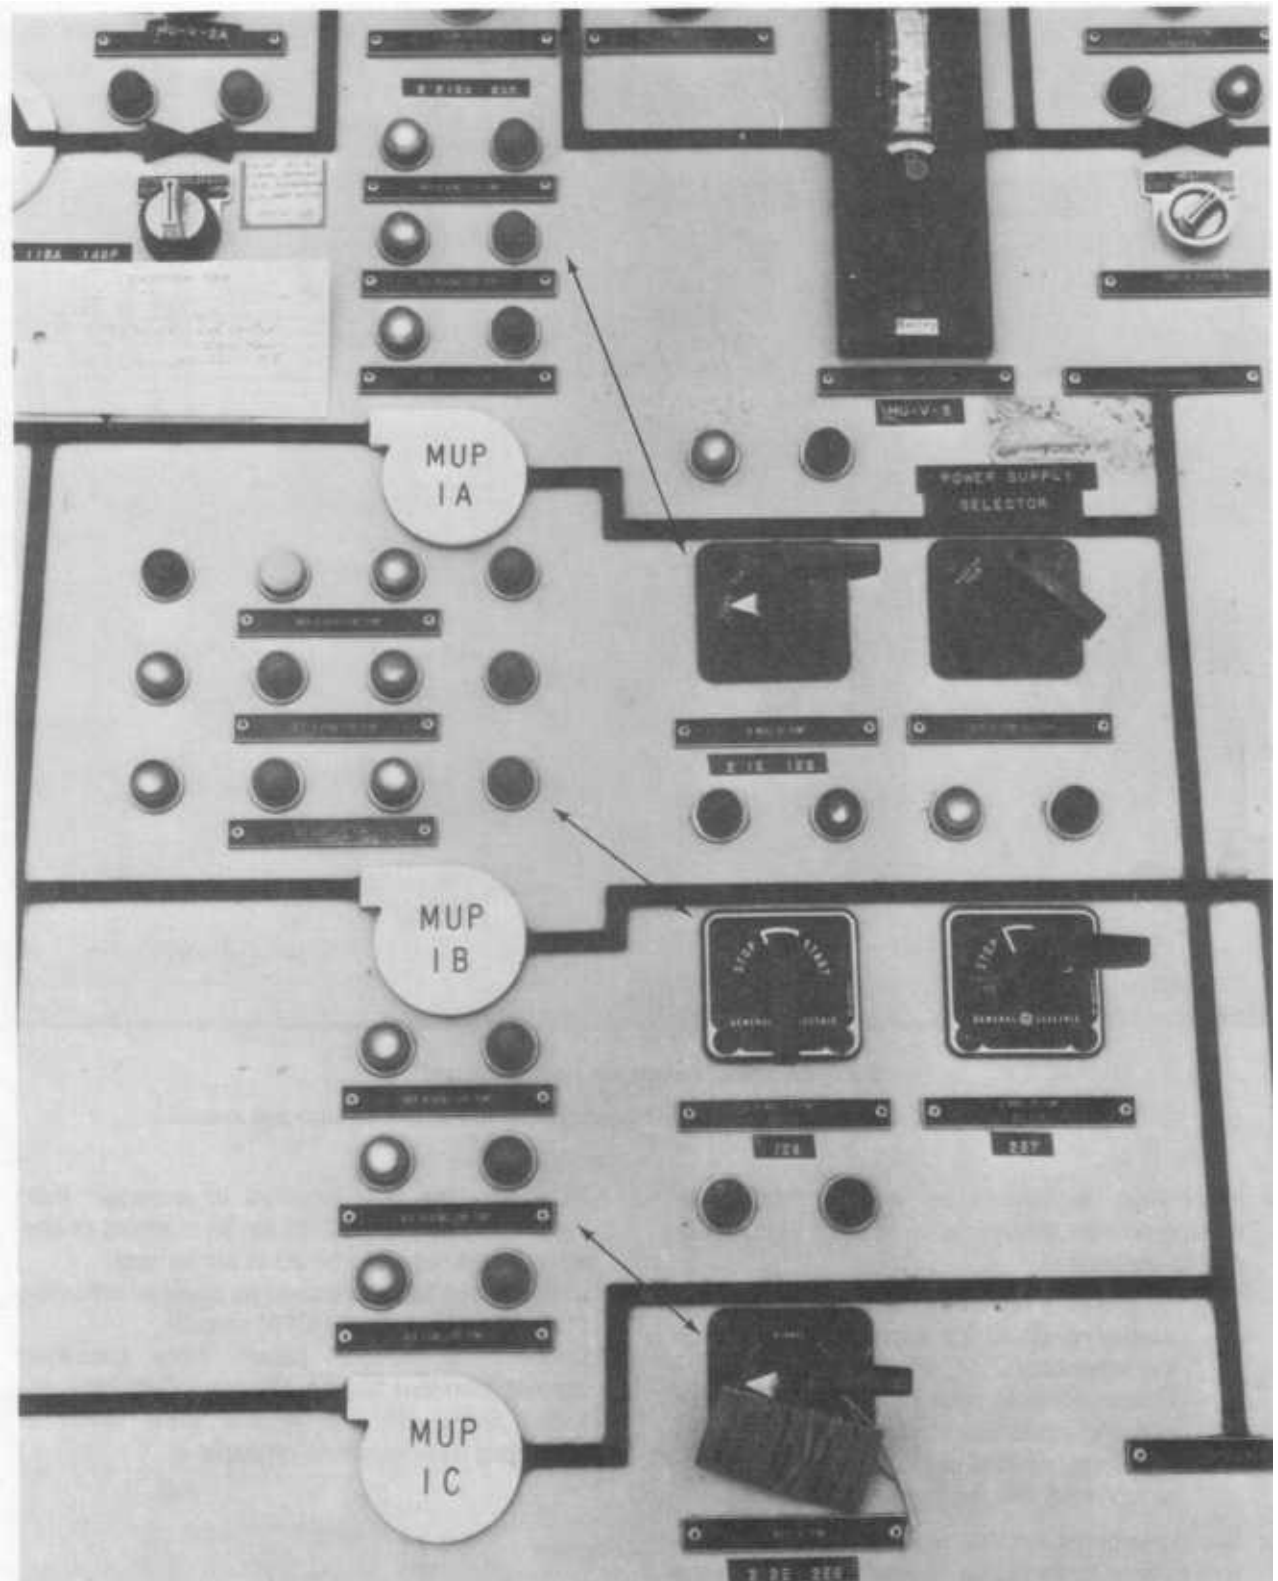
FIGURE 11-51. Relationship of Makeup Pump Controls and Indicator Lights

- In many cases, workstation design appears to maximize visual scan, reach, and walking requirements.
 - RC pump seal pressure is on panel 10, and seal temperature is on panel 8, but the pump controls are on panel 4.
 - Makeup control is on panel 3, but makeup flow indication is displayed on panel 8. See Figure 11-49.
- Controls and displays are not logically or consistently sequenced.
 - Pressurizer heater controls are sequenced from right to left rather than from left to right. See Figure 11-50.
 - Pressurizer narrow range indicators are B, A instead of A, B
- Indicator lights are inconsistently placed above, beside, or below their associated controls. See Figure 11-51.

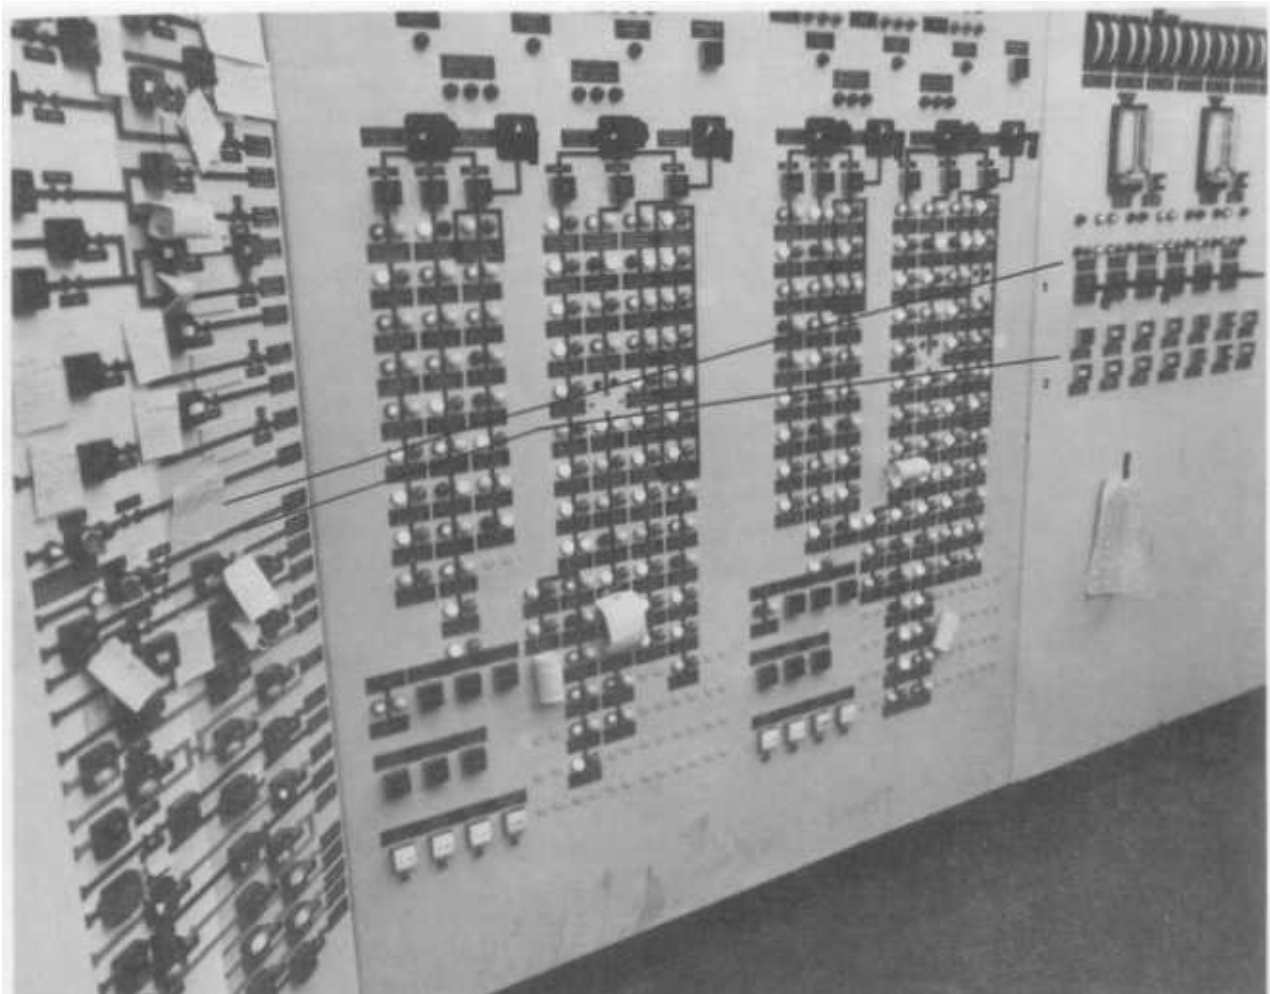
FIGURE 11-52. ESF Station Indicator Board

- ESF indicator board on panel 13 consists of 16 rows of indicator lights. Due to placement and organization of this panel, a 6-foot-tall operator can see only eight rows of lights from his normal operating position. See Figure 11-52.

1. INDICATION BELOW THIS LINE CANNOT BE SEEN BY A 6 FT. OPERATOR STANDING AT THE ESF OPERATING STATION

2. INDICATION BELOW THIS LINE CANNOT BE SEEN BY A 6 FT. OPERATOR FROM THE CLOSEST POSITION IN FRONT OF THE CONTROL CONSOLES

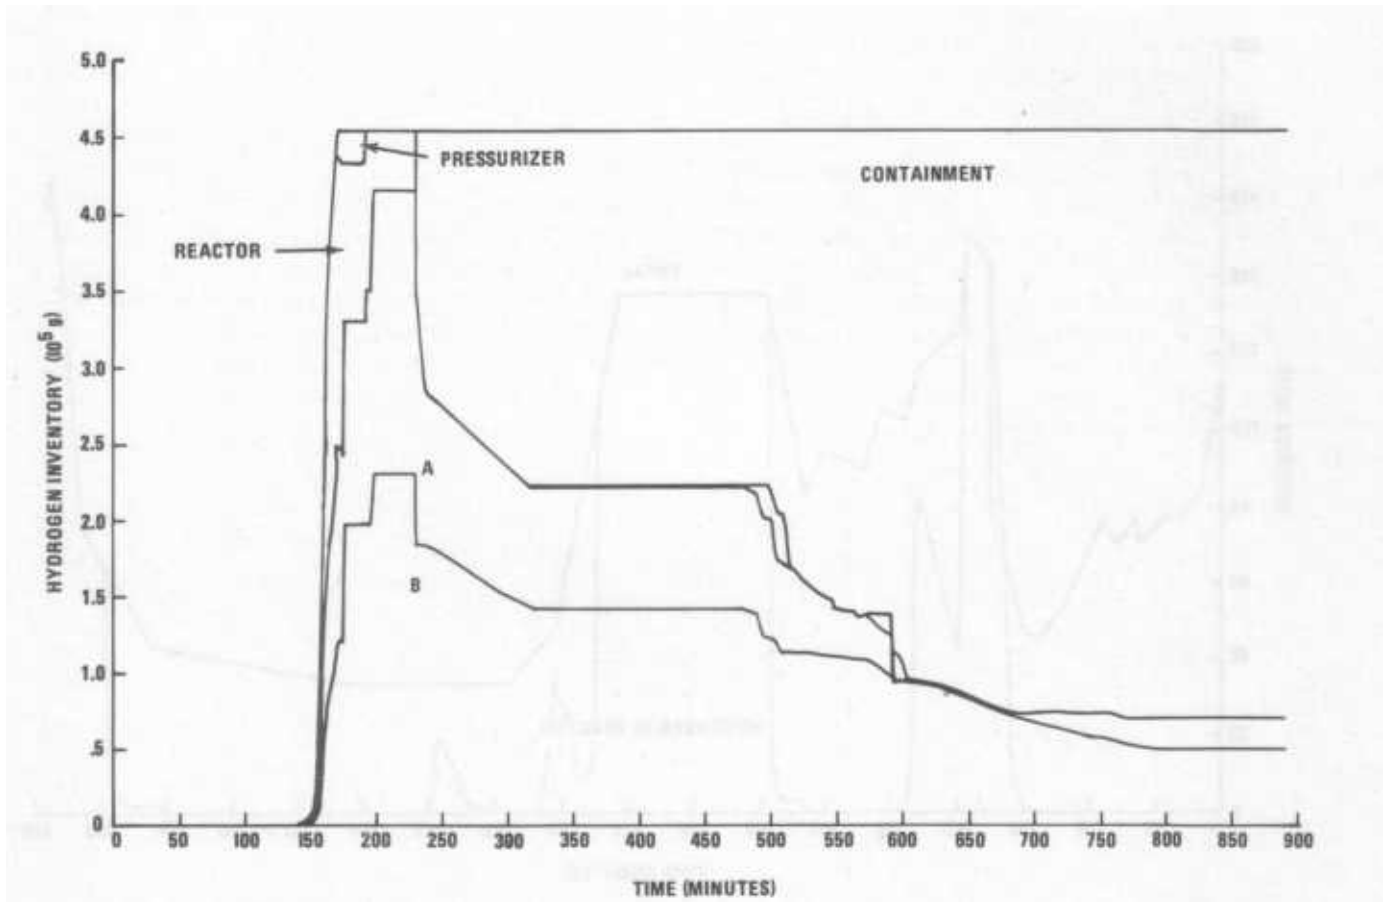
APP. FIGURE II-42. Hydrogen Inventory (Figure 1)

Hydrogen was generated over a short period of time (~ 150 - 175 minutes). The model had been "tuned" so that 4.5×10^5 g of hydrogen was produced. When the PORV was opened at ~ 220 minutes, hydrogen was rapidly vented from the reactor to containment. From ~ 220 to ~ 300 minutes the hydrogen venting continued from both A and B steam generators and hot legs. On opening of the PORV at ~ 450 minutes (system depressurization), the venting continued and resulted in a hydrogen deflagration in containment at ~ 600 minutes. About 6×10^4 g of hydrogen remained in the system after 900 minutes.

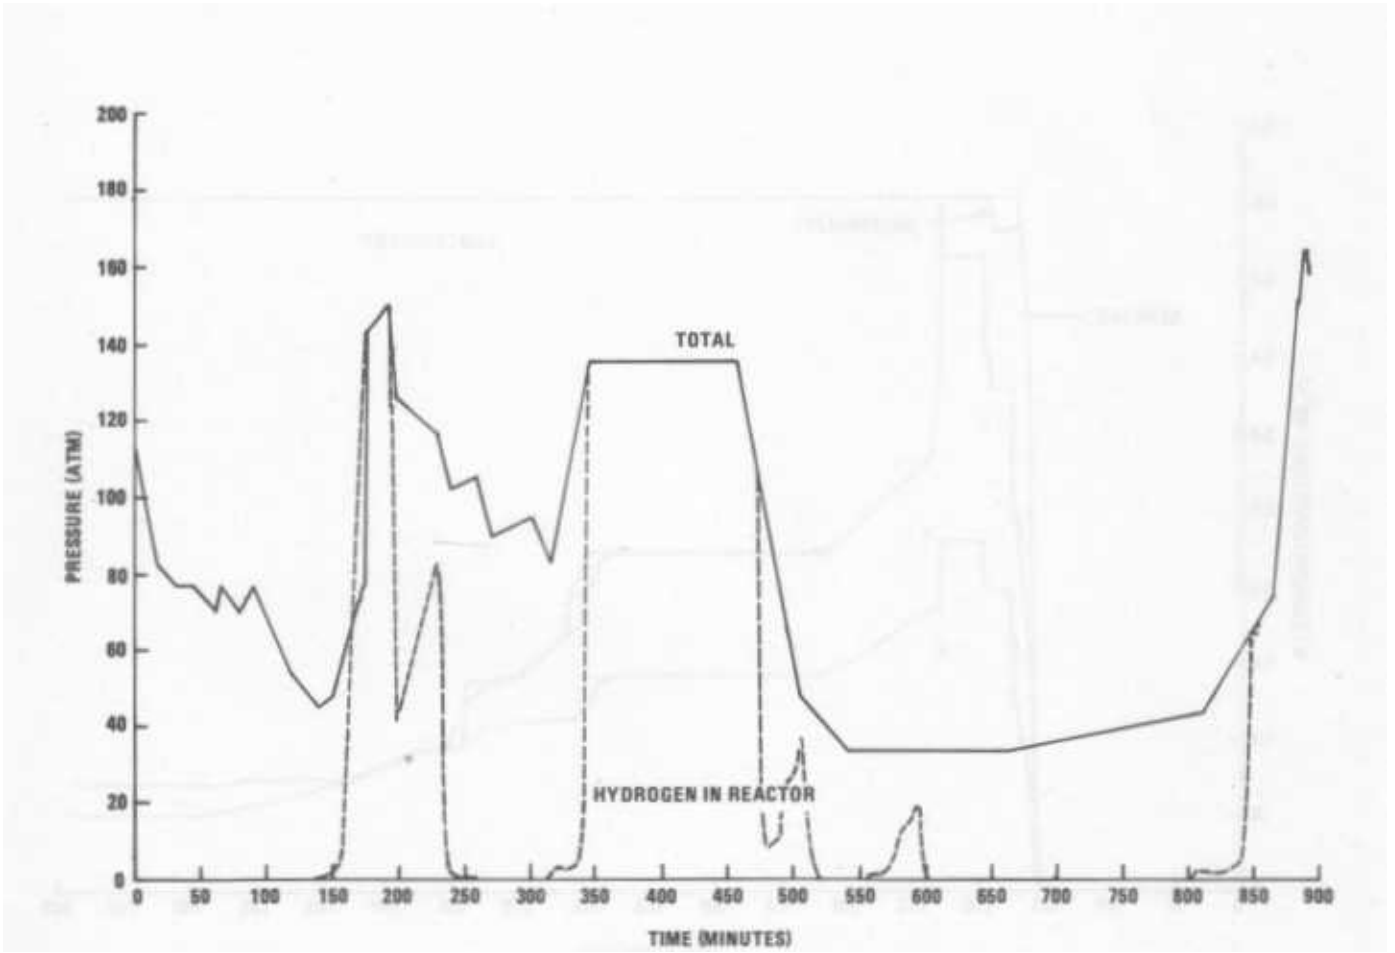
APP. FIGURE II-43. Hydrogen Pressure in Reactor Void Space (Figure 2)

From the onset of hydrogen generation (150 minutes) to 240 minutes, a substantial amount of the reactor void space was filled with hydrogen gas. Hydrogen was vented rapidly through the open PORV at 200 minutes and again at 240 minutes. At 315 minutes when the PORV was closed and the system repressurized, hydrogen again occupied a substantial amount of the reactor void space. During the depressurization starting at 450 minutes, hydrogen was again vented rapidly through the open PORV. After the repressurization at 800 minutes, hydrogen again occupied a substantial amount of the reactor void space.

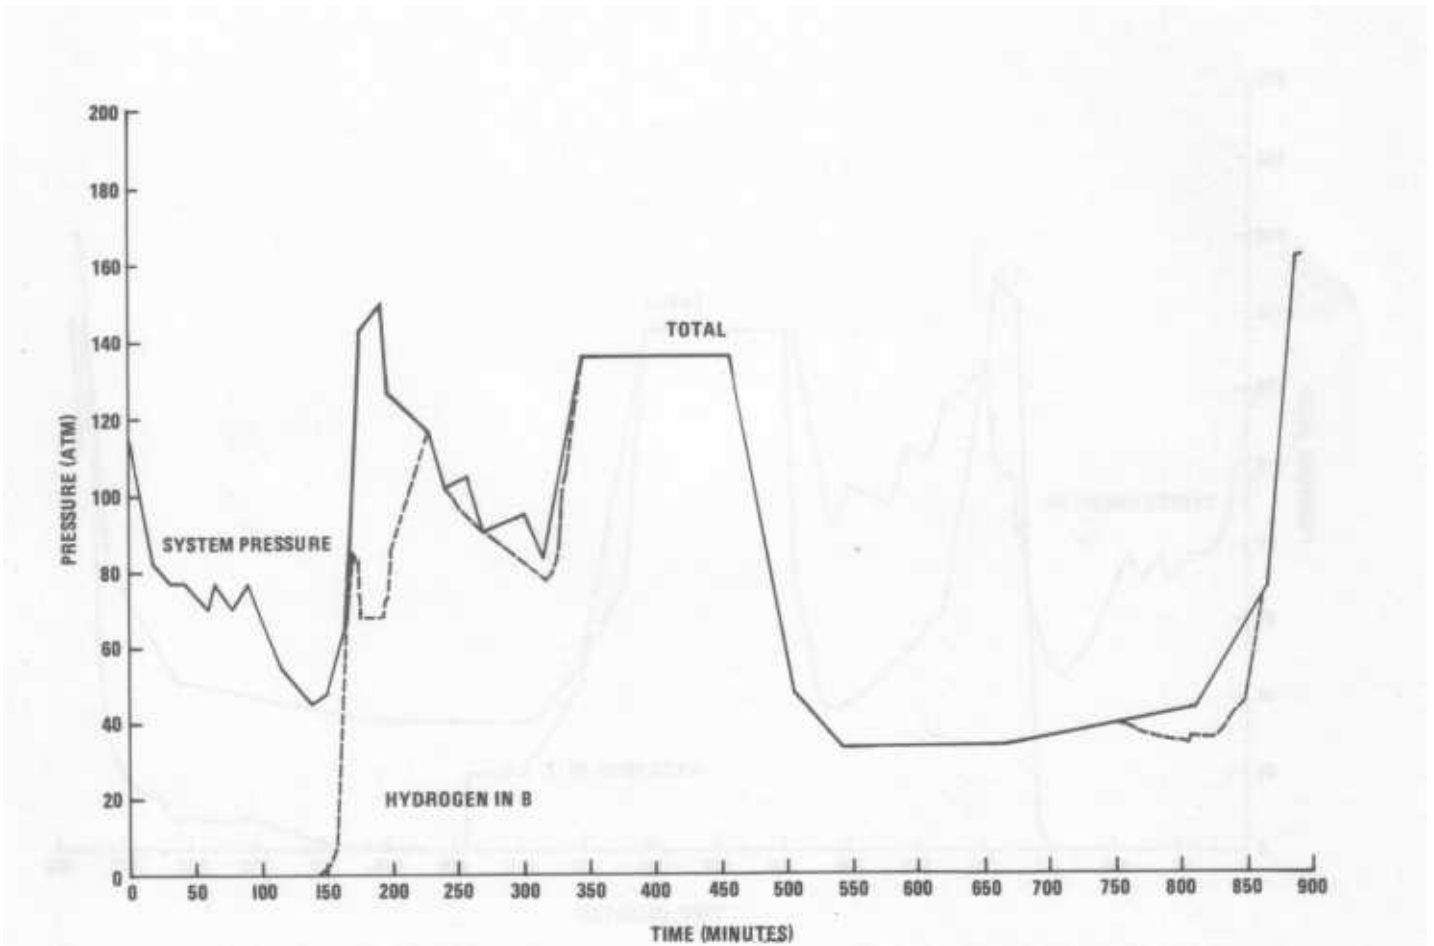
APP. FIGURE 11-44. Hydrogen Pressure in B Steam Generator and Hot Leg (Figure 3)

From the onset of hydrogen generation (-150 minutes) through -900 minutes, hydrogen occupied a substantial amount of the void space in the B steam generator **and hot leg.**

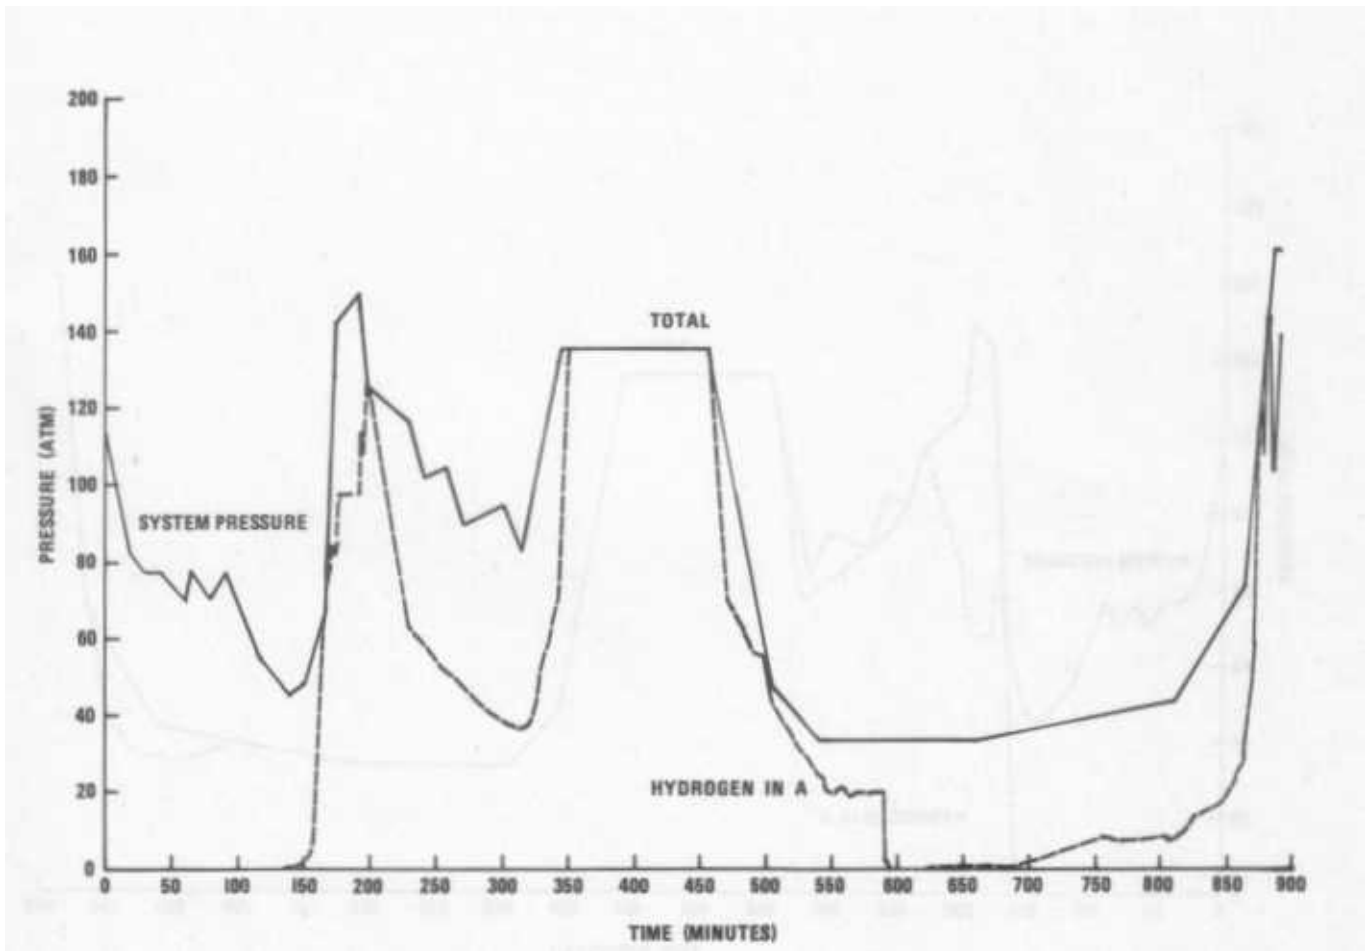
APP. FIGURE 11-45. Hydrogen Pressure in A Steam Generator and Hot Leg (Figure 4)

From the onset of hydrogen generation (\sim 150 minutes) through \sim 600 minutes, hydrogen occupied a substantial amount of the void space in the A steam generator and hot leg. From \sim 600 to \sim 800 minutes, hydrogen partial pressure in the A steam generator and hot leg was small.

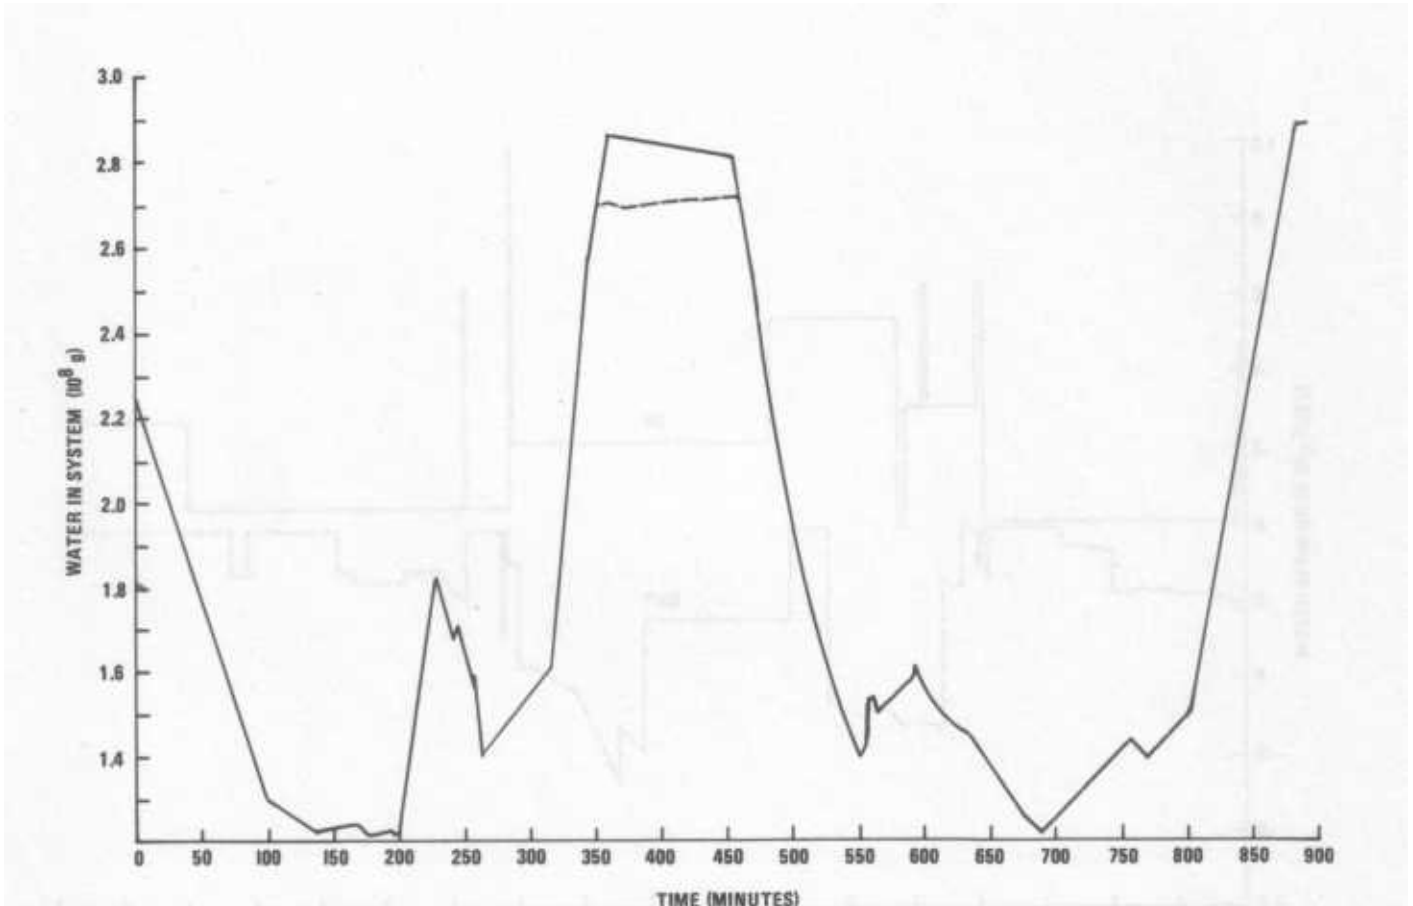
APP. FIGURE 11-46. Water Inventory in System (Figure 5)

The water inventory in the system was calculated assuming net makeup/letdown from BWST levels and flow through the PORV and vent valve. A saturated vapor model, a saturated liquid model, or a subcooled liquid model, depending on the recorded pressurizer level, temperature, and pressure was used. The system volume was large enough to contain this amount of water in addition to the calculated hydrogen (at 700^o K), except during the short period from 350 to 500 minutes. This excess water could have a number of explanations, for example, a net gain in the makeup tank, a lower average hydrogen temperature, a smaller amount of hydrogen generated, or a larger amount of hydrogen released to containment.

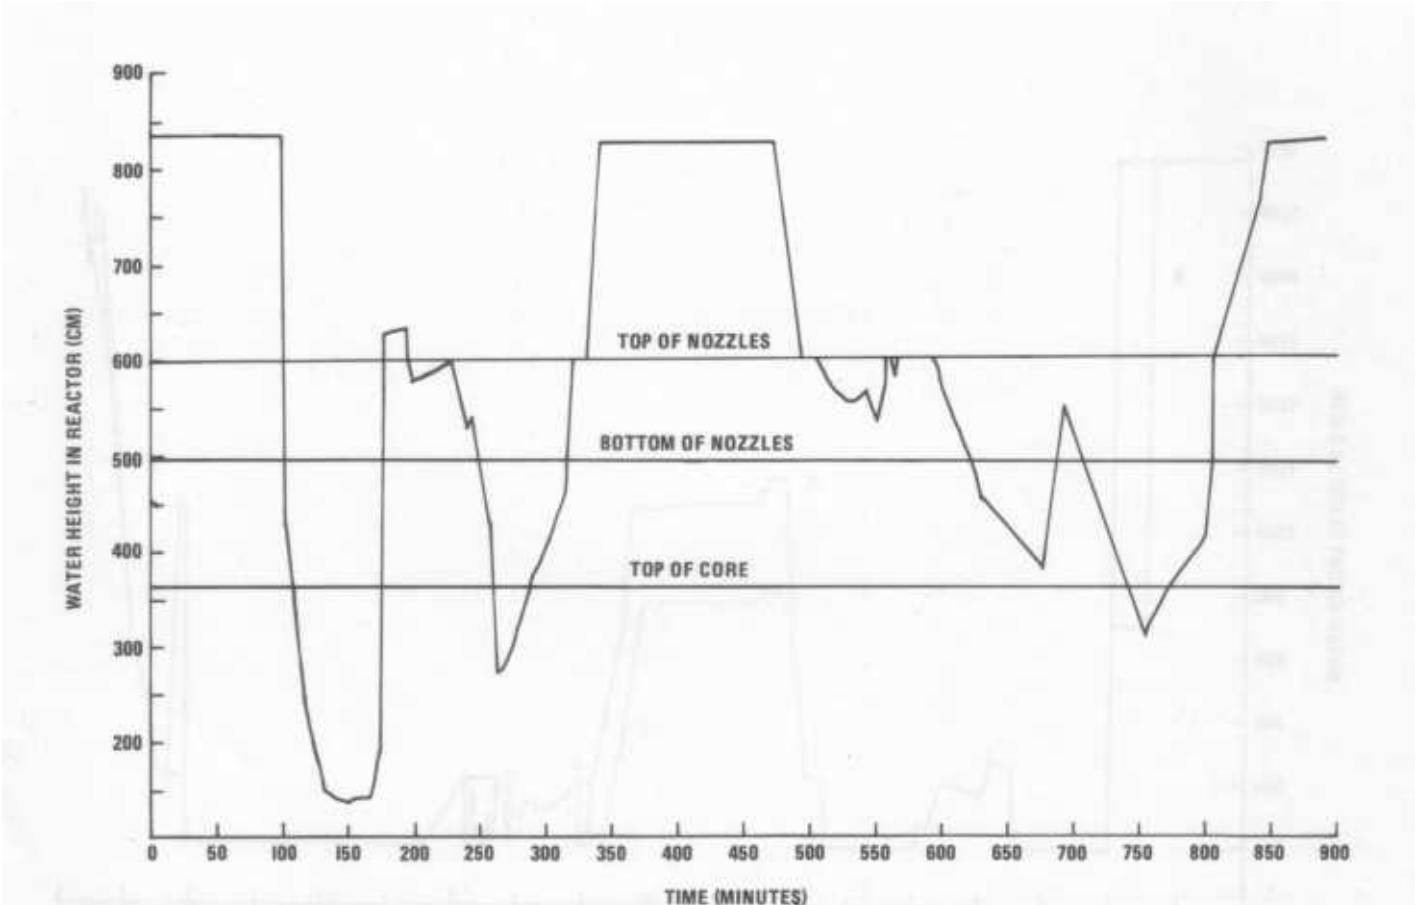
APP. FIGURE 11-48. Water Height in Reactor (Figure 7)

The water level in the reactor fell rapidly at ^100 minutes when the steam generator A RCP was turned off and the voids collapsed. Boiloff then reduced the level to ^-150 cm above the bottom of the core. The top of the core was uncovered at ^108 minutes. The starting of the steam generator B RCP and the subsequent HPI recovered the core rapidly. A slight uncover occurred at ^250 minutes; however the makeup/letdown details could easily have resulted in the core not being uncovered. The reactor was filled at -350 minutes and remained filled until -475 minutes when the system was depressurized. The level slowly rose until ^750 minutes when the core was again uncovered. As shown above, makeup/letdown details could easily have resulted in the core not being uncovered. The level rose rapidly as the system was repressurized at ^-800 minutes.

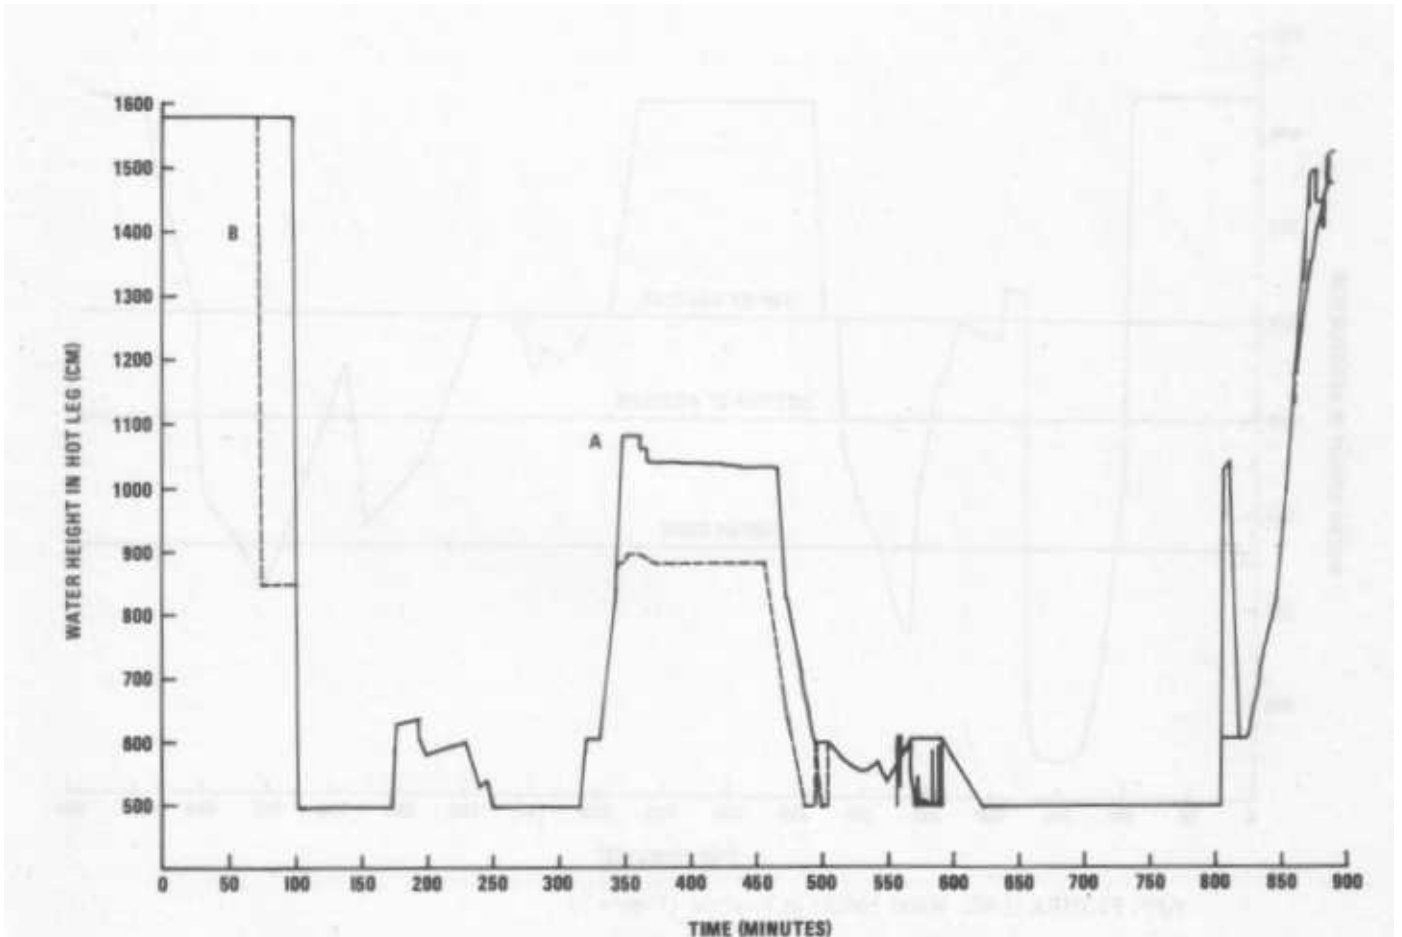
APP. FIGURE 11-49. Water Height in Hot Leg (Figure 8)

The hot legs filled with water above nozzle elevation prevented the flow of hydrogen gas for most of the accident. However, from \sim 200 to \sim 300 minutes the water level in the hot legs allowed gas flow. In addition, the depressurization at \sim 500 to \sim 800 minutes emptied the hot legs and allowed hydrogen redistribution and flow to containment.

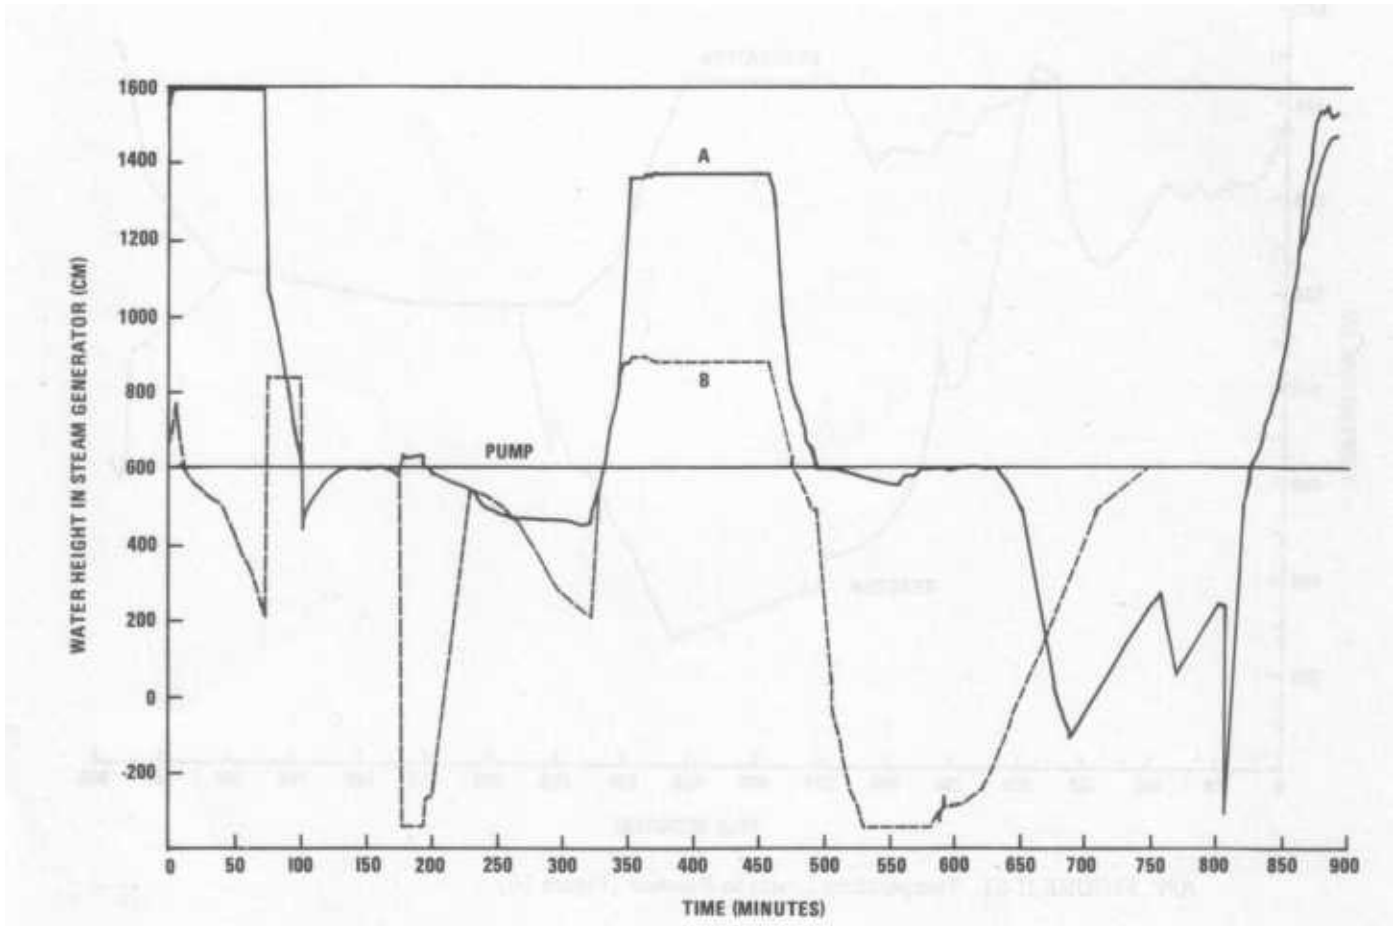
APP. FIGURE 11-50. Water Height in Steam Generator (Figure 9)

Steam generator water levels generally fluctuated about the pump elevation. An exception occurred at -175 to -200 minutes when the steam generator B RCP emptied the B steam generator. It appears that a calculational error emptied the B steam generator rather than the A steam generator during the depressurization at ^500 minutes. When the water level in the reactor was below pump elevation, the A steam generator emptied due to letdown (^-600 to -800 minutes).

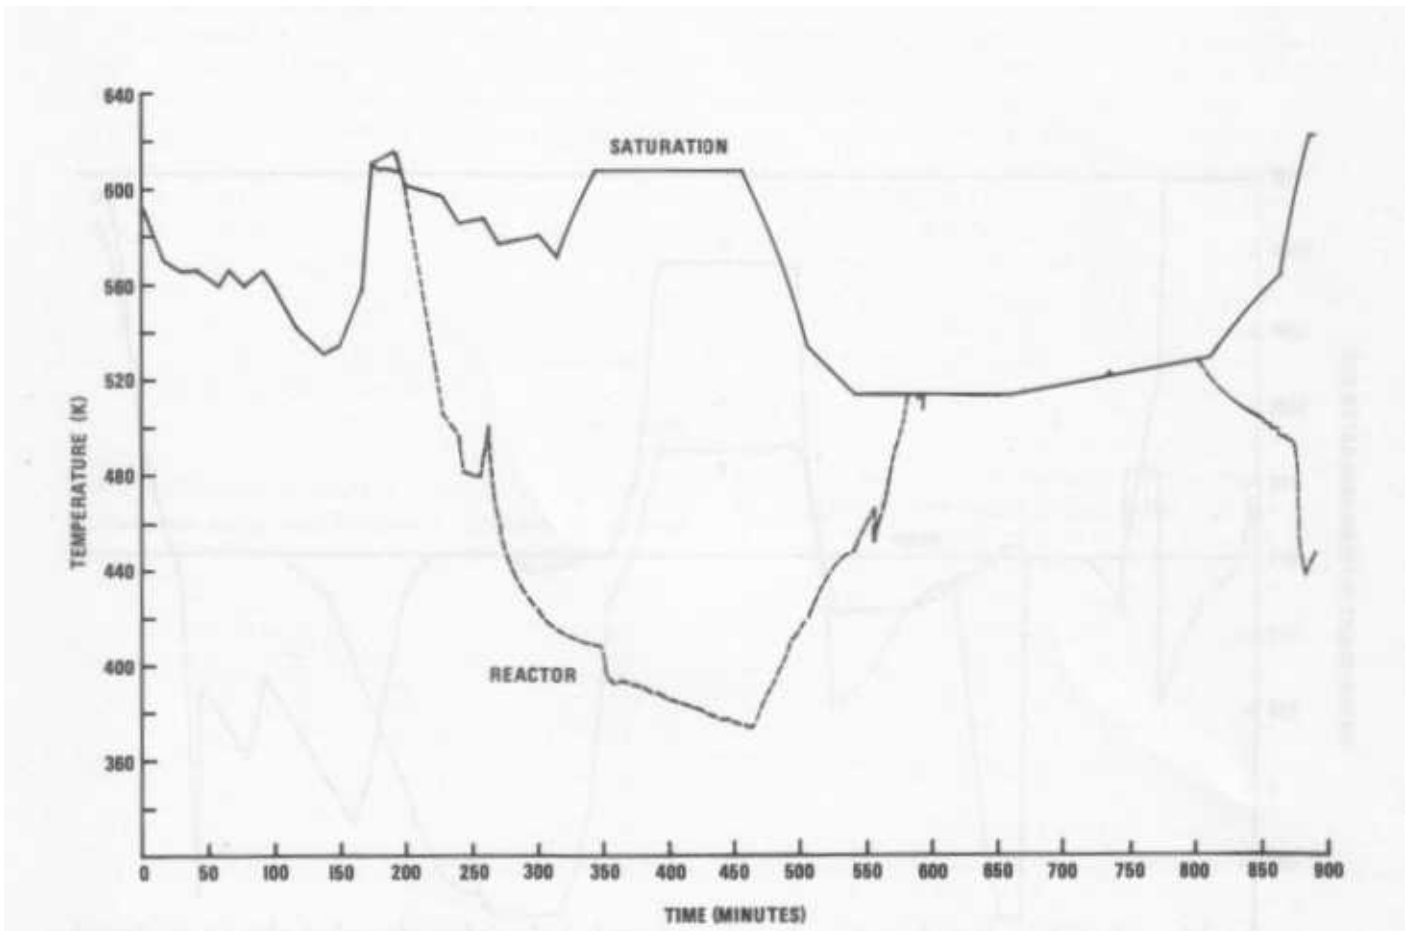
APP. FIGURE 11-51. Temperature Levels in Reactor (Figure 10)

Until -200 minutes, cold water flow into the reactor was insufficient to remove decay heat; thus the reactor remained at saturation temperatures with the excess heat being used to vaporize water. From -200 to -600 minutes, the cold water flow was sufficient to remove decay heat. This removal resulted in subcooling of the reactor. The subcooled reactor water flow through the open PORV during this period resulted in the subcooling of the pressurizer. From -600 to -800 minutes the decay heat again became greater than the cooling, and vaporization resumed. The saturated vapor flowed through the hot legs to condense in the steam generators; thus the hot leg temperature was lowered. Because flow to the B steam generator was much less than that to the A steam generator due to hydrogen blockage. A significantly larger hot leg temperature drop occurred in the A hot leg. After ^-800 minutes the reactor again became subcooled.

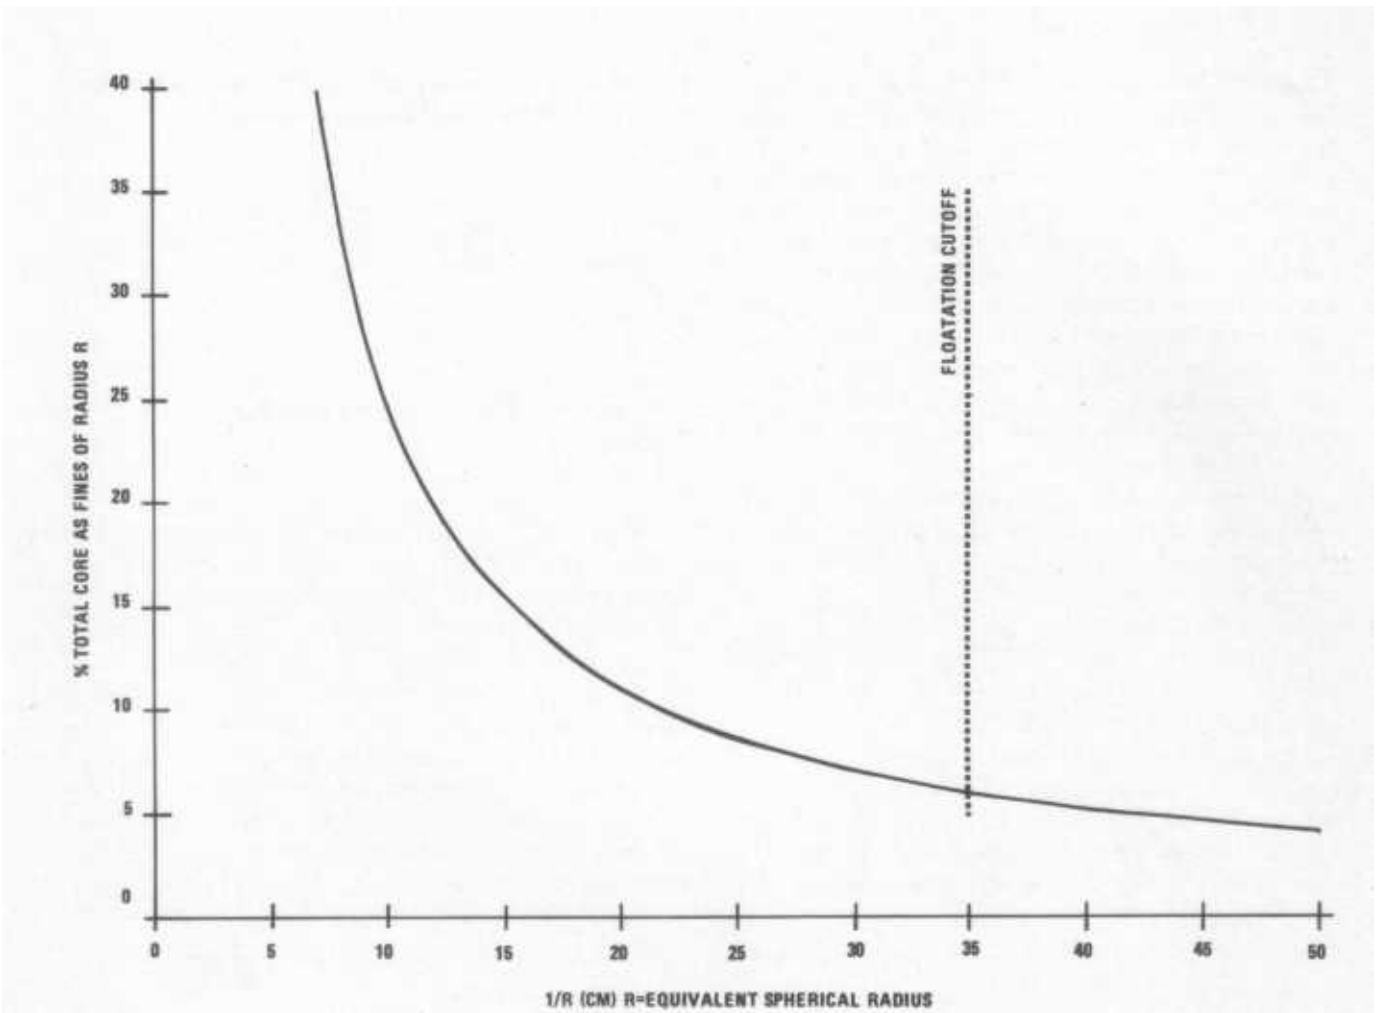
APP. FIGURE 11-53. Percent of Total Core as Fines of Radius (Figure 2)

If it is assumed that the core debris is made up of intact pellets and fuel fragments of a particular size, an estimate of the volumetric fraction of fine fragments in the core may be made. The volume fraction of the core that could have a size r is plotted versus r in Figure 2. Very fine fragments are not likely to have developed. Fine materials would be levitated by the coolant flow and would have escaped the reactor coolant system to a much greater extent than observed. Consequently, a cut-off in the possible size of the fines of about 0.03 cm is shown in Figure 2.
