The Public Inquiry into the Piper Alpha Disaster

The Hon Lord Cullen

VOLUME ONE

Presented to Parliament
by the Secretary of State for Energy
by Command of Her Majesty
November 1990

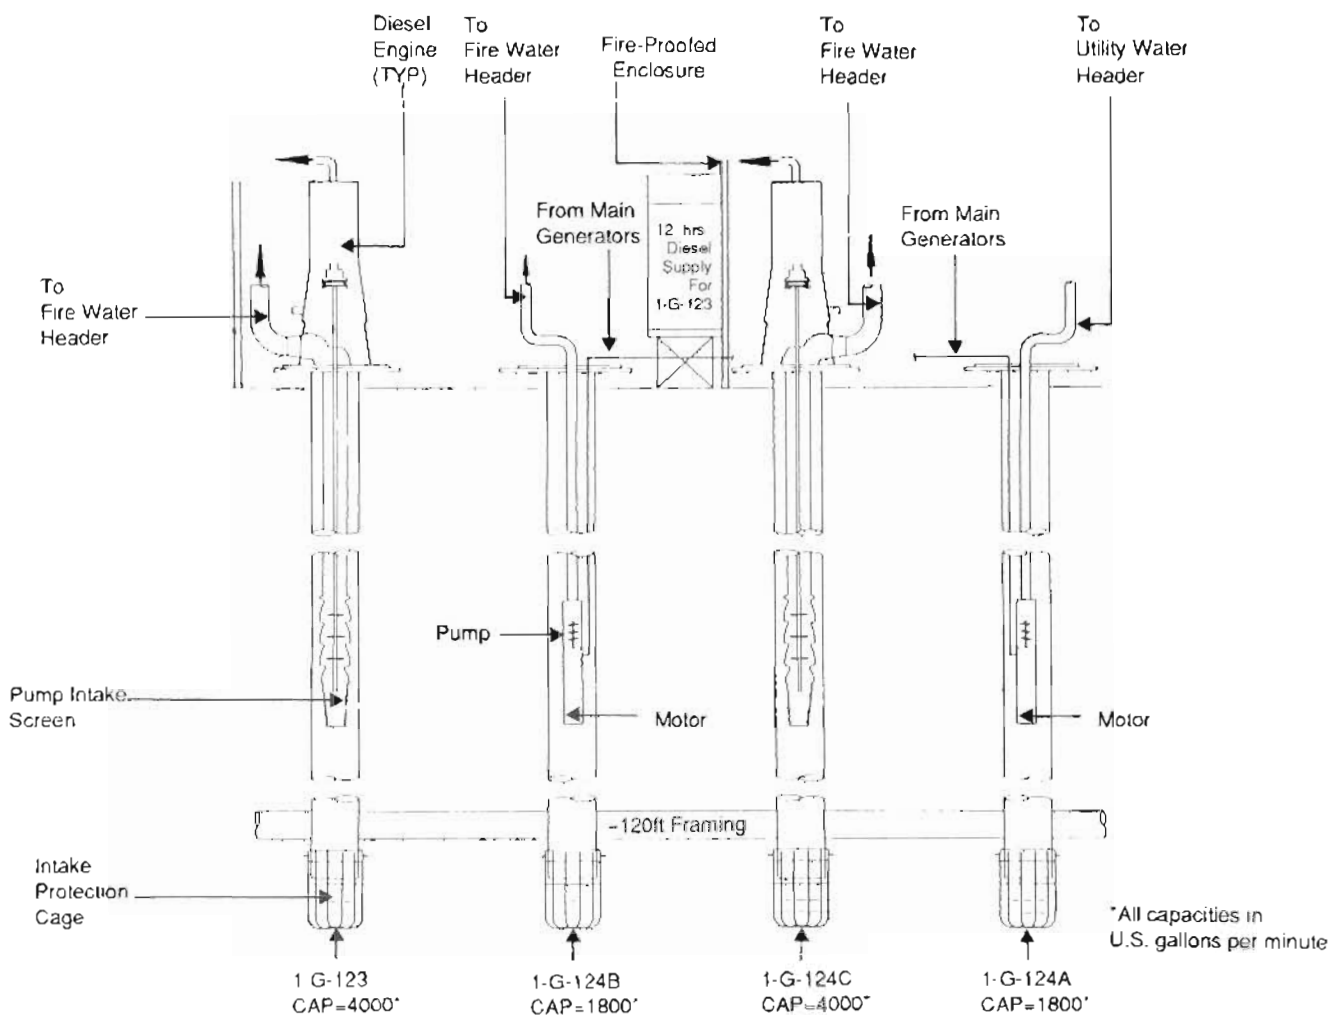
Fig. 3.6 The inlets of the fire pumps.

3.72 Stilling columns for the sea-water supply to the pumps were located on the east side of the platform near leg A4 (see Fig. 3.6). The pump intakes were at a level of about -120 ft. The intakes were some 5 ft apart and were furnished with protection cages to prevent divers from getting sucked in. The stilling columns were 2 ft diameter and the cages the same diameter and about 4 ft long. The 2 diesel-driven pumps, fire pump 1-G-123 and utility/fire pump 1-G-124C, could be put on manual start to protect divers against a sudden flow of water at the pump intakes. If these 2 pumps were on manual start, this was indicated in the Control Room by an alarm light. They could then be started only by going to the pumps themselves and starting them at the local control panel in the fireproof enclosure.

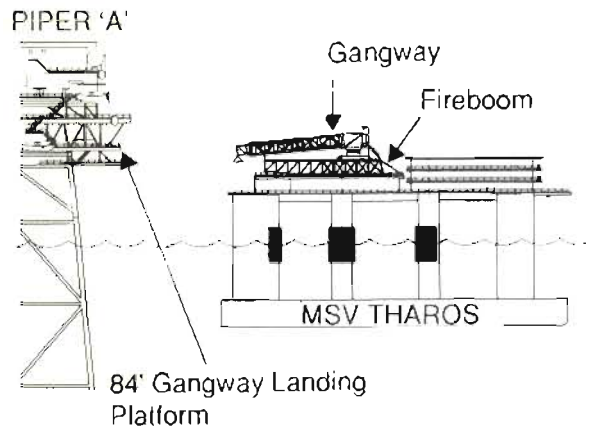
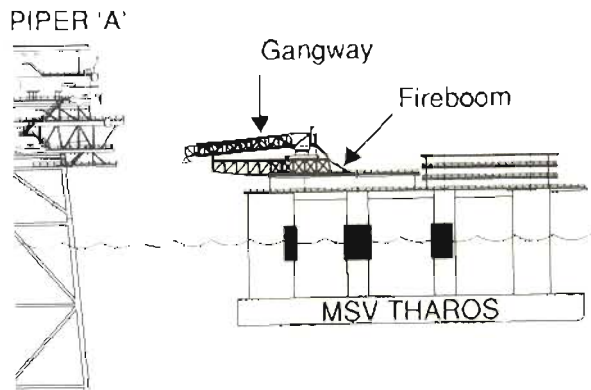
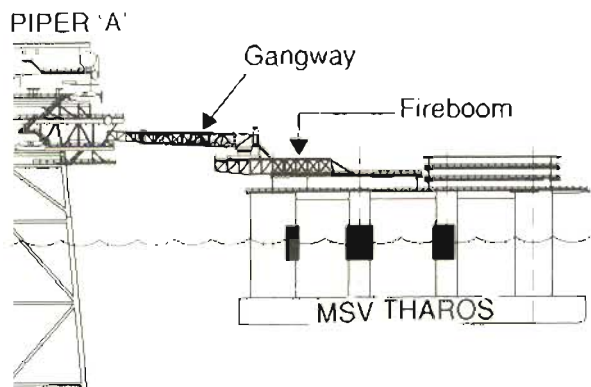
9.22 By the time of the rupture of the MCP-01 riser at 22.50 hours approximately 39 survivors had left the platform. Shortly before it occurred the FRC of the *Sandhaven* had picked up 4 men from the south-west corner of the platform and had turned back to pick up 2 additional men. All of them had probably reached that corner by descending from the drill floor. At the moment of the explosion the FRC was entangled with ropes which had been used in the escape. The explosion destroyed the FRC and killed all its occupants with the exception of the crewman Mr I Letham. The fireball associated with the explosion partially engulfed the *Tharos*, and her master gave orders
