## CHAPTER 1

# The Effects of Fouling

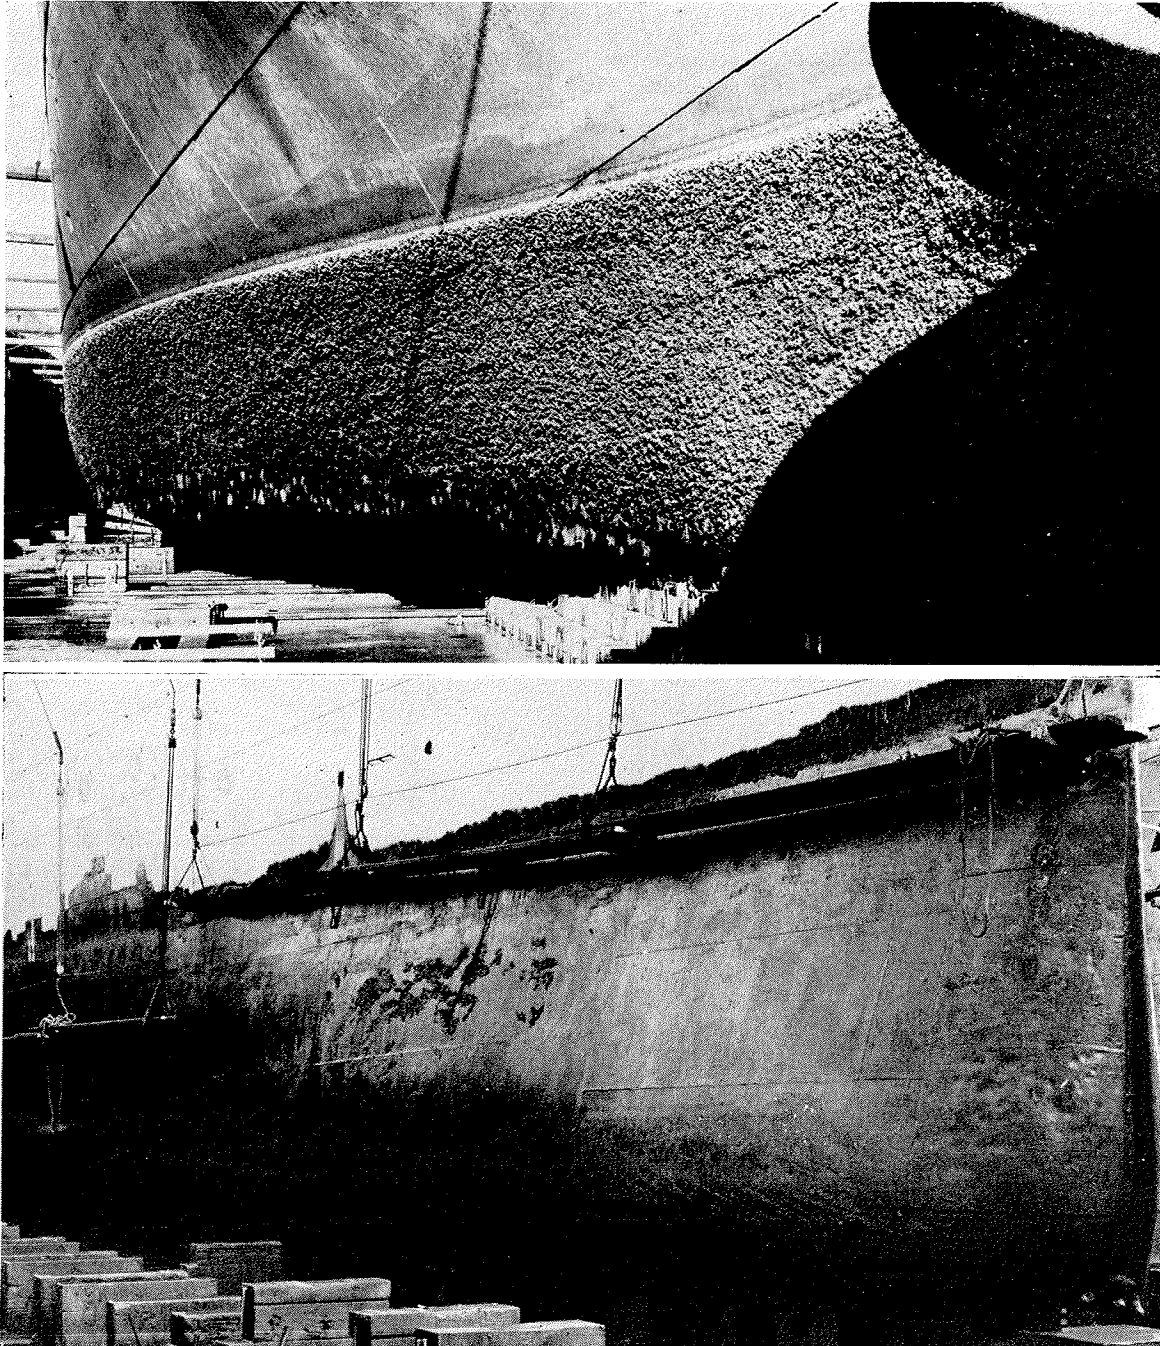
FIGURE 1. Above: U.S.S. *Tippecanoe*. Painted with Navy formula 15RC. Twelve months waterborne. (Below): U.S.S. *Augusta*. Painted with Navy

hot plastic antifouling paint. Twenty-eight months waterborne. Official U. S. Navy photographs.

The improved protection provided by modern paints is illustrated by Figures 1 and 2. Figure 1 (above) shows the heavy fouling which developed in twelve months on a ship coated with the prewar standard antifouling paint 15RC. A ship protected with the modern hot plastic coating, which remained practically clean while waterborne twenty-eight months, is shown for comparison below. Figure 2 shows the clean condition of a patch of modern hot plastic paint in comparison to the fouling developed in seventeen months on the remainder of the hull which was painted with the older formulation.

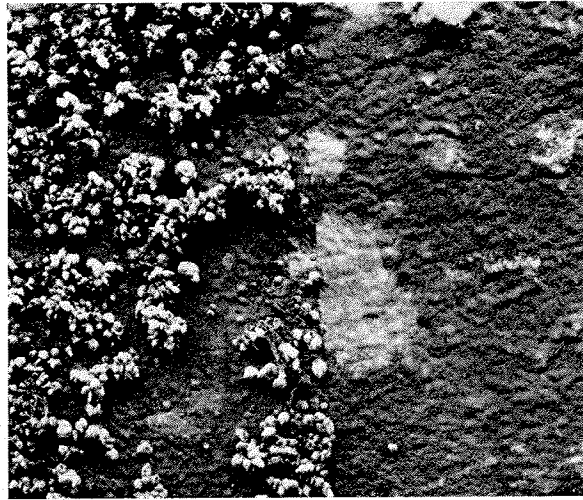
FIGURE 2. Comparison of fouling on old Navy formulation 15RC (left), and modern hot plastic antifouling paint (right), after 17 months waterborne. Official U. S. Navy photograph.

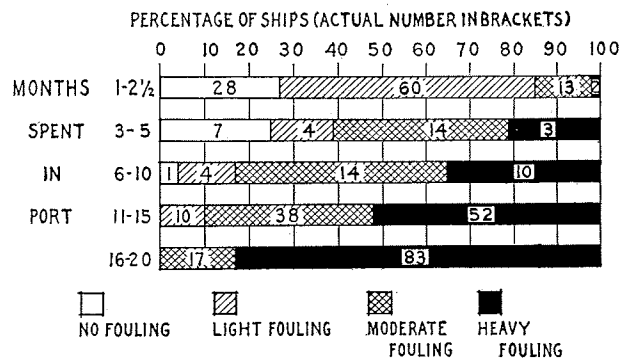
FIGURE 3. Relation between the degree of fouling and the amount of time spent in port between dry dockings. From Visscher (35).

Visscher has made an analysis of the relation of the duty of ships to fouling, based on the study of 217 vessels (35). The relation of the degree of fouling to the period spent in port is shown in Figure 3.

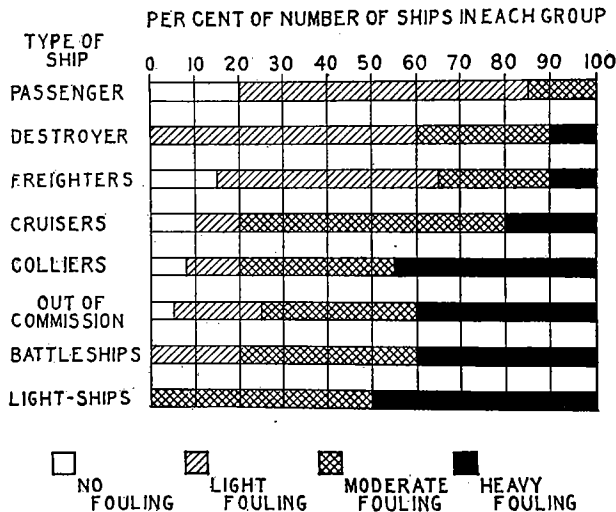
FIGURE 4. Relation between type and duty of ship and the amount of fouling, disregarding the factor of time. From Visscher (35).

ships of different types to foul is illustrated in Figure 4. Passenger vessels appear less liable to foul than freighters, as might be expected from their more active service and greater speed. Among naval vessels, destroyers and cruisers have

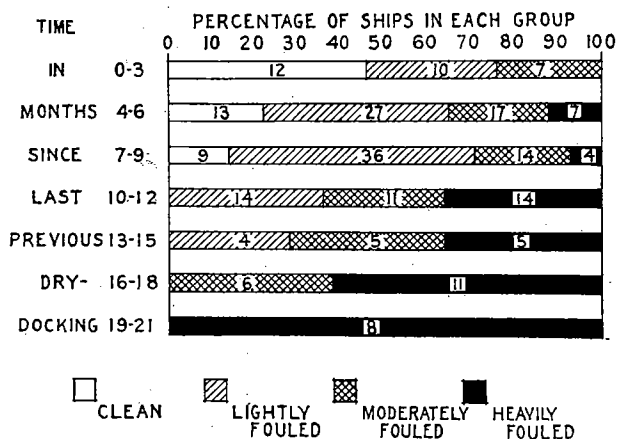
FIGURE 5. Relation between amount of fouling and amount of time between dry dockings. From Visscher (35).

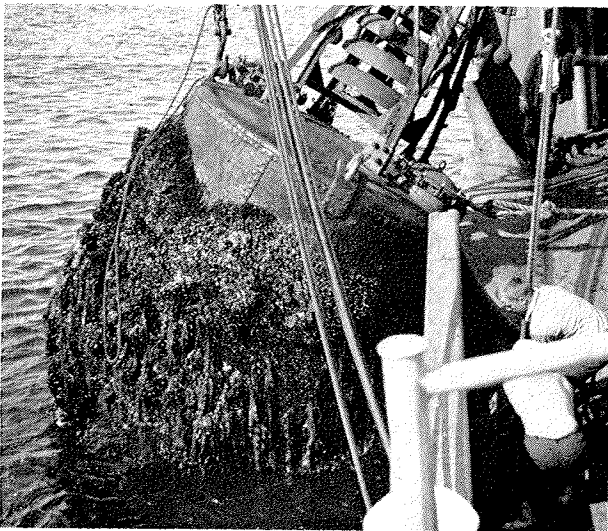
FIGURE 6. Navigation buoy heavily fouled with mussels and *Laminaria*.

Navigation buoys, even though sometimes protected by antifouling paint, usually foul heavily before servicing, which in normal times takes place at yearly intervals. (See Figure 6.) The moor-

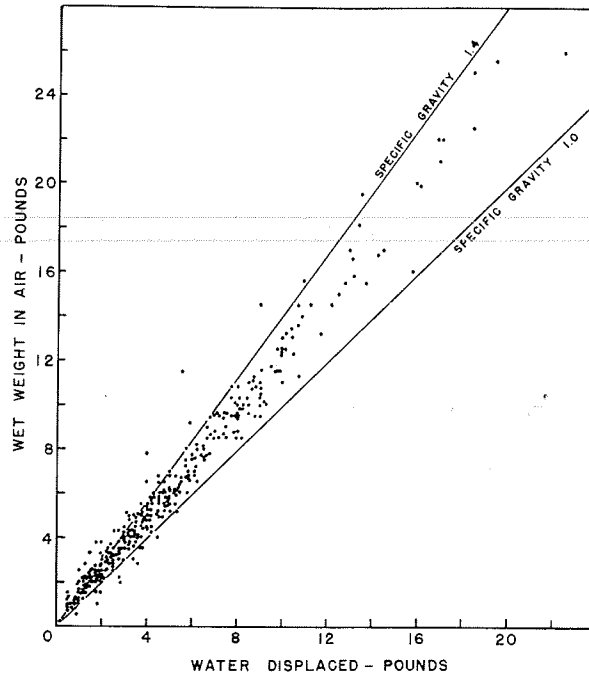
FIGURE 7. Relation of weight to displacement of fouling from navigation buoys of United States coastal waters.

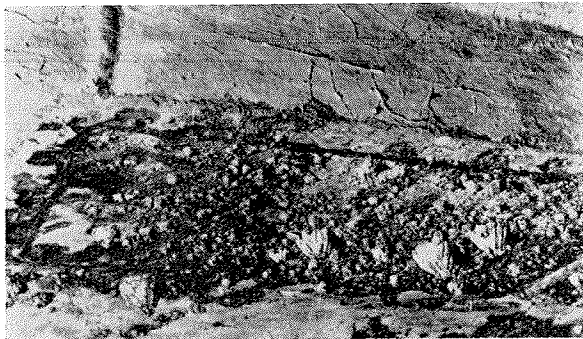
FIGURE 8. Fathometer plate, fouled with barnacles. Official U. S. Navy photograph.

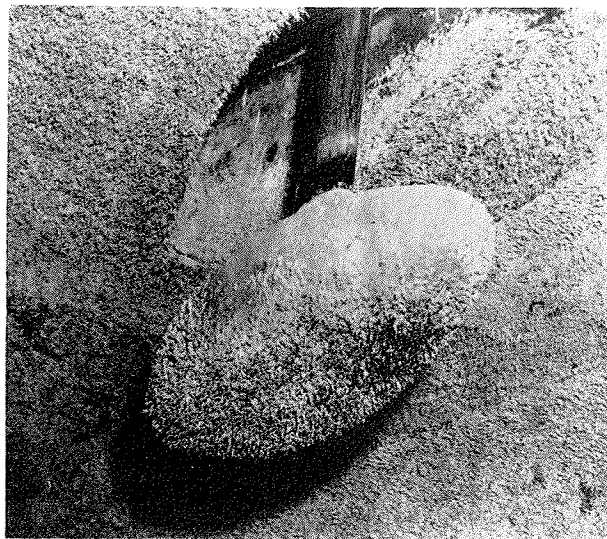
FIGURE 9. Retractable sound dome showing fouling on projector and sides of sound well. Official U. S. Navy photograph.

On the outside of sound domes, fouling is greatest on the nose and tail where the velocity of flow is least during the motion of the ship. It also occurs on the projector, retracting shaft, and sound well. (See Figure 9.) In some cases the dome can not be retracted because of the growth. In free-flooded equipment it is found on the inside of the dome where the quiet water encourages the growth of soft-bodied types of fouling as well as the hard-shelled forms. These often accumulate in the bottom of the dome to a substantial thickness. These difficulties might be eliminated by abandoning the free-flooding feature.

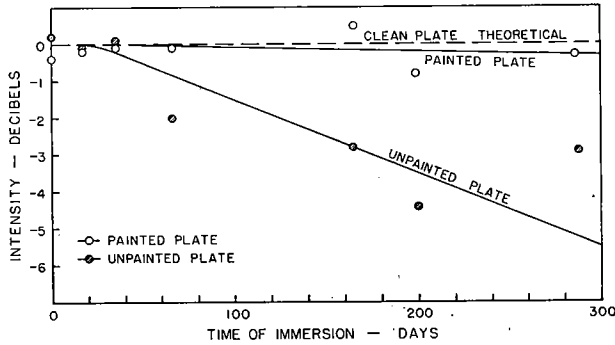
FIGURE 10. Intensity of sound transmitted by a steel panel 0.060 inch thick as affected by fouling during immersion. After Fitzgerald, Davis, and Hurdle (9).

gressed. The results are shown in Figure 10. The unprotected plate became covered with barnacles, bryozoa, tunicates, hydroids, and algae, with the soft-bodied forms predominating. At the end of 165 days it had built up a mat one inch thick. At this

time it caused an attenuation of 3 decibels; after 300 days the attenuation was  $5\frac{1}{2}$  decibels. This means that only 50 per cent and 25 per cent respectively of the incident energy was being transmitted. In contrast, at the end of 300 days, the attenuation of a plate coated with antifouling

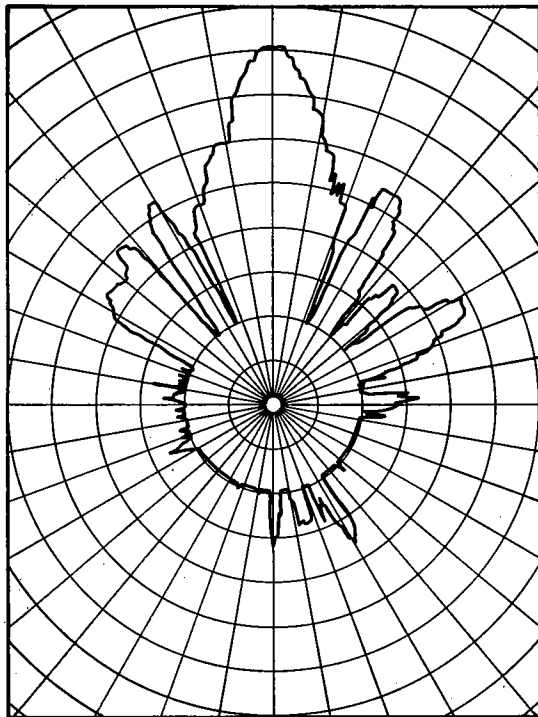
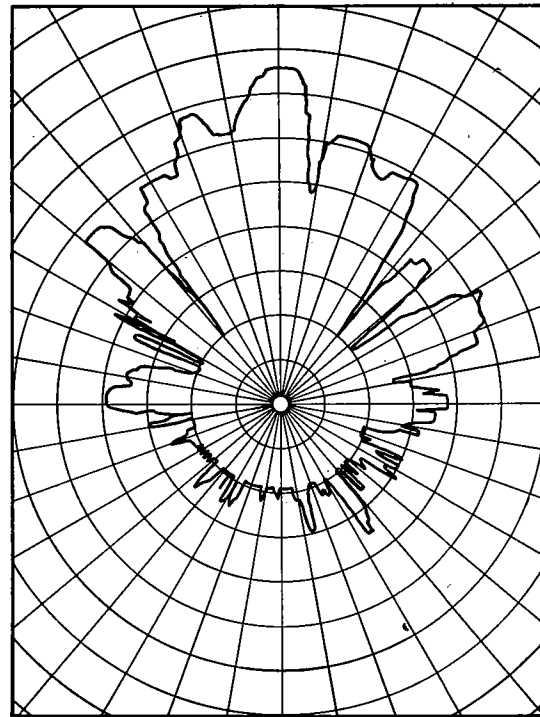
PROJECTOR BEAM PATTERNS

FIGURE 11. Beam pattern of a projector measured when clean and after the growth of fouling in which mussels predominated. After Fitzgerald, Davis, and Hurdle (9).

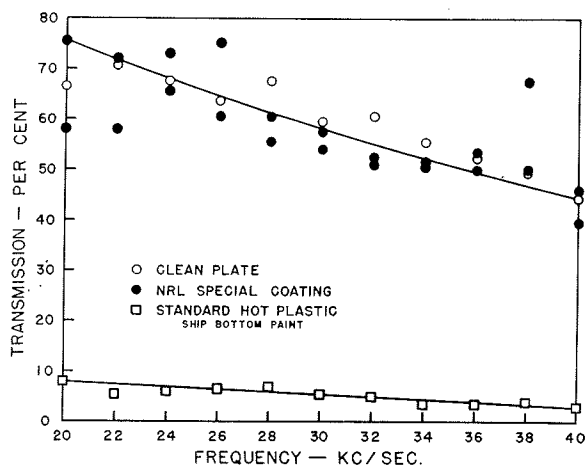
FIGURE 12. Transmission of sound of varying frequency through steel plates, uncoated, painted with a special coating (Navy Aeronautical specification M-559) and with standard hot plastic shipbottom paint. After Fitzgerald, Davis, and Hurdle (9).

The effect of coatings of antifouling paint on sound transmission have been studied, using sound varying in frequency. The result, shown in Figure 12, indicates that the use of a special coating developed at the Naval Research Laboratory for the purpose produces no essential change in the sound

transmission of a steel panel. The standard hot plastic shipbottom paint, on the other hand, reduces the sound transmission very greatly. This effect is attributed to the presence of air occluded in the coating.

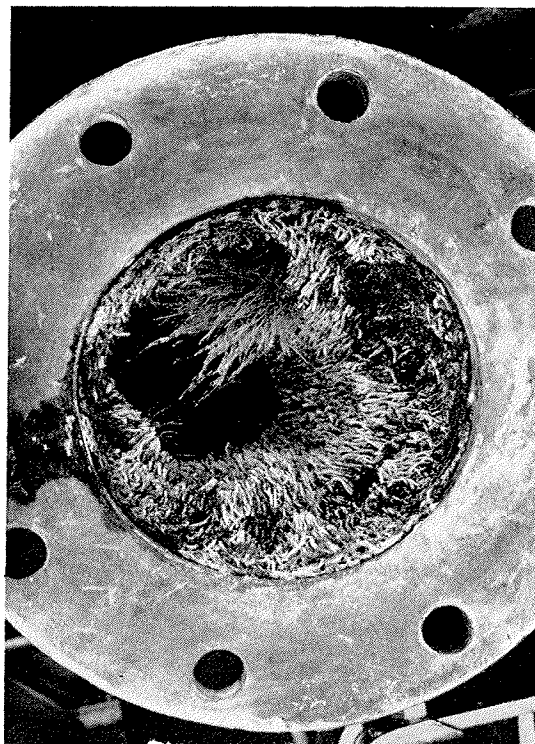
FIGURE 13. Growth of tube worms in a ship's 4-inch fire main. Official U. S. Navy photograph.

It has been found that fouling occurs most readily in fire mains and in branches leading to fire plugs on deck, ice machines, and other auxiliary machinery. A section of four-inch fire main almost completely clogged with tube worms following a period of duty of the ship in the tropical Pacific is illustrated in Figure 13. The fouling is more pronounced in the sections of five inches or more in diameter, and in the vicinity of boiler and engine rooms where the temperature is usually higher. It is reported by ship personnel that where the temperature is from 70° to 100°F, growth is prevalent, with the greatest concentration between 80° and 90°F. At higher temperatures, the amount of fouling diminishes, and it is nonexistent where the water temperature is maintained at 150°F.

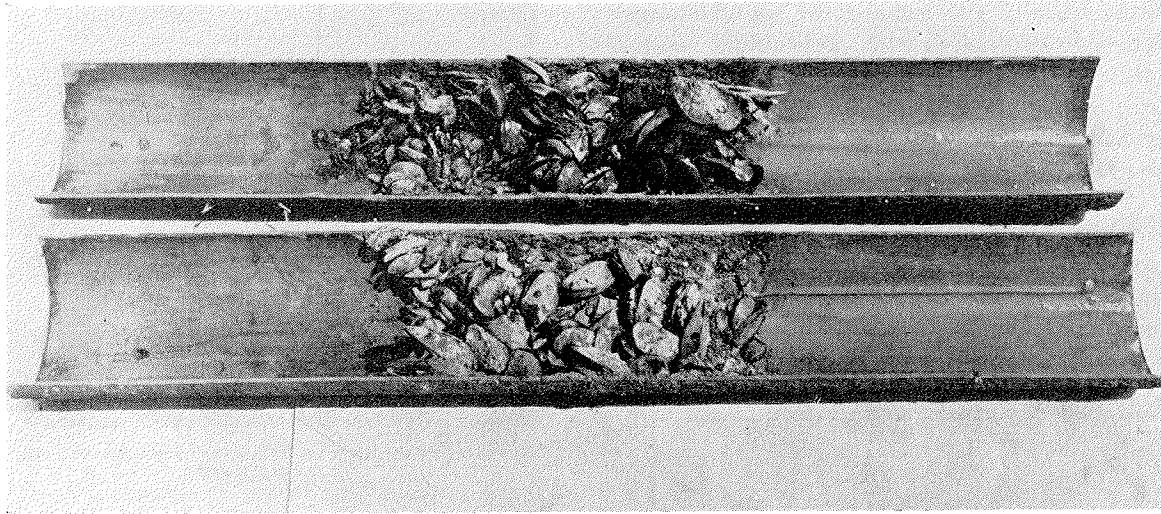
FIGURE 14. Section of pipe laid open to show a plug of mussels which developed at a point where the protective coating of antifouling paint had been damaged during welding of a joint.

that protection may be afforded in this way. It is not known as yet, however, how permanent this protection will be. Difficulties may arise from the chipping off of parts of the paint surface, which might give trouble should the chips ultimately lodge in fire sprinklers or other critical places. Localized damage of the paint coating may also cause accelerated corrosion of iron piping at the points where the metal is exposed. Figure 14 shows a length of pipe which had been protected by painting laid open. The pipe is free of fouling except at a point where the paint had been damaged in the course of welding a joint. At this point a heavy plug of mussels has developed.

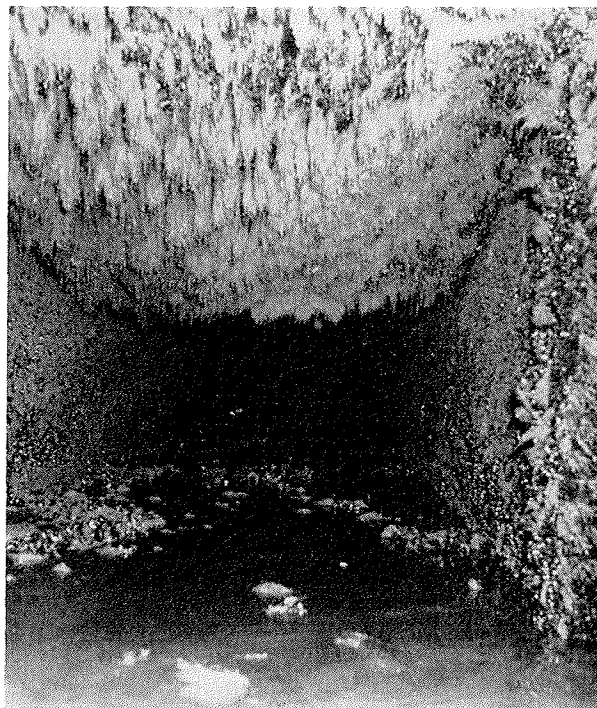
FIGURE 15. Fouling developed in less than four months in intake tunnel of the Lynn Gas and Electric Company.

The growth encrusting the walls of the intake tunnel of the Lynn Gas and Electric Company less than four months after cleaning is illustrated in Figure 15. The mussels growing on the wall of this tunnel weighed more than 10 pounds per square foot and made a mat 2 inches thick.

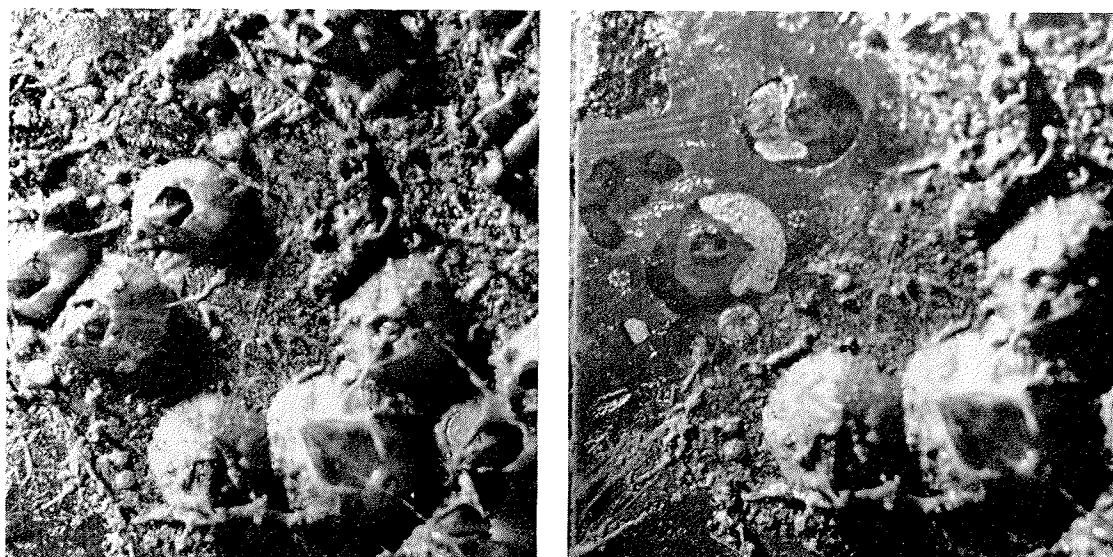
FIGURE 16. Localized corrosion of nickel beneath the bases of barnacles. (Left) Fouled condition of the panel after one month's exposure. (Right) Pits in the metal revealed by removal of three of the barnacles.

organisms become covered up and smothered by their neighbors, localized corrosion is caused. An example of this action is illustrated in Figure 16. Passive and marginally passive alloys, such as stainless steel and nickel alloys, in which the surrounding surfaces of the metal remain relatively smooth, show particularly clearly the localized corrosion which occurs under fouling organisms.

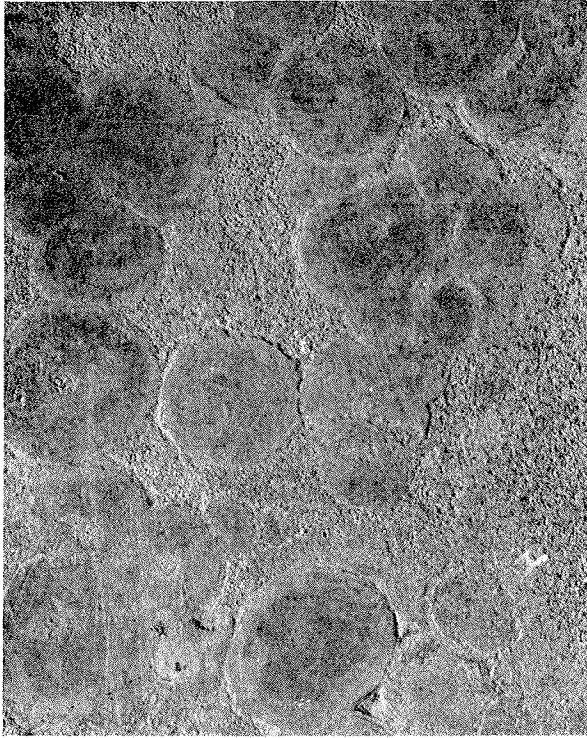
FIGURE 17. Corroded steel plate showing smooth circular areas which had been protected by the bases of barnacles.

In contrast to these observations, the corrosion of a steel surface may proceed less rapidly under firmly adhering fouling than in the bare areas between the organisms. Figure 17 shows the surface of a steel panel which had become heavily fouled with barnacles. After removing the living barnacles and the corrosion products, the steel surfaces which had been under the bases of the organisms stand out as relatively smooth plateaus surrounded by depressed and pitted areas where corrosion has taken place. This observation shows that the fouling may protect the metal locally. Whether its effect is beneficial or not is uncertain, since it is not known whether corrosion proceeded

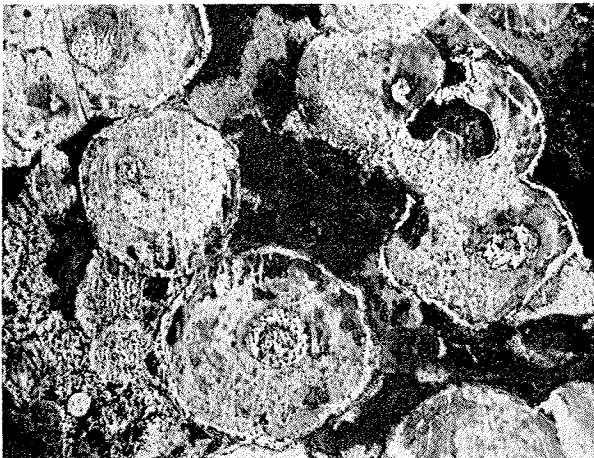
FIGURE 18. Steel panel showing black deposit which covered steel between the bases of barnacles after three months' exposure in the sea.

Sulfate-reducing bacteria are found abundantly in sea water and in the mud of harbors and on fouled or rusting surfaces which are exposed in such places. The layer of red ferric hydrate which forms on iron rusting in sea water is frequently underlaid by black deposits containing sulfides, which indicates that the primary corrosion products are being formed under anaerobic conditions (33). Figure 18 shows the black deposit which

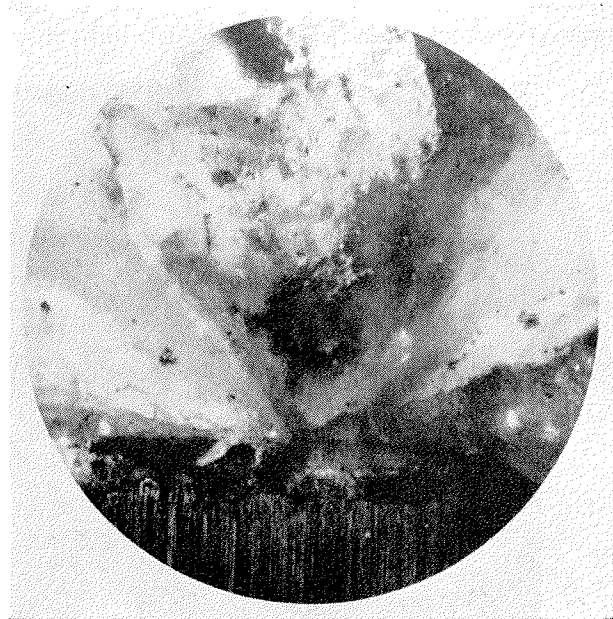
FIGURE 19. Microscopic section through a paint film showing the wedge shaped edge of barnacle shell plowing into the paint coating. The dark areas are paint; the striated zone at bottom is the steel surface.  $\times 100$ . Photograph by Dr. F. F. Lucas, Bell Telephone Laboratories.

section, as shown in Figure 19. As the base enlarges, this edge pushes outward and, if the substrate is not too hard, downward. As a result the edge of the shell tends to plow into the coating and may eventually cut down to the underlying metal. Figure 20 diagrams the process. Figure 21A shows several barnacles which have plowed into an ineffective coating of antifouling paint. The marks left by barnacles leave chips of paint adhering to the outer surface of the shell. The marks left after removing barnacles from a nontoxic paint surface are illustrated in Figure 21B. Figure 21C shows the undersurface of a barnacle which had grown on a painted glass panel. The barnacle has penetrated the paint so completely that the details of the

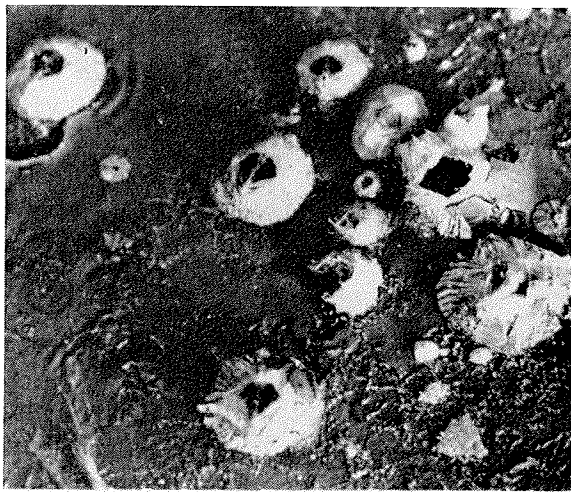
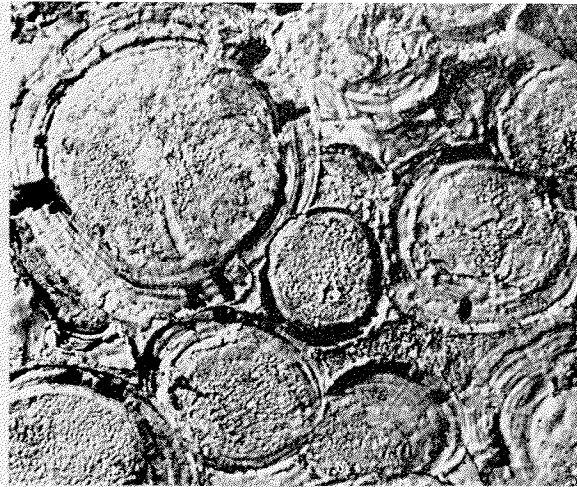
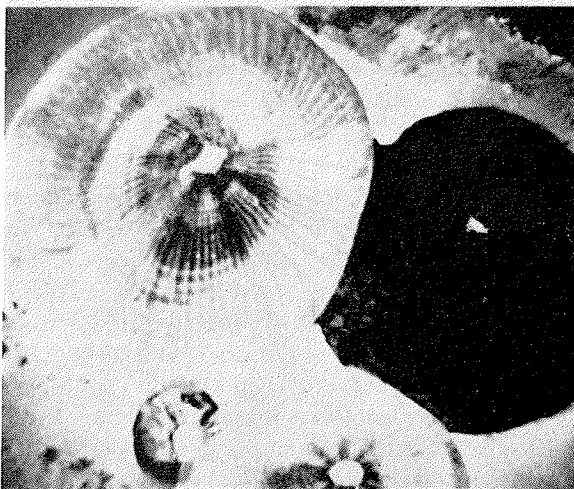
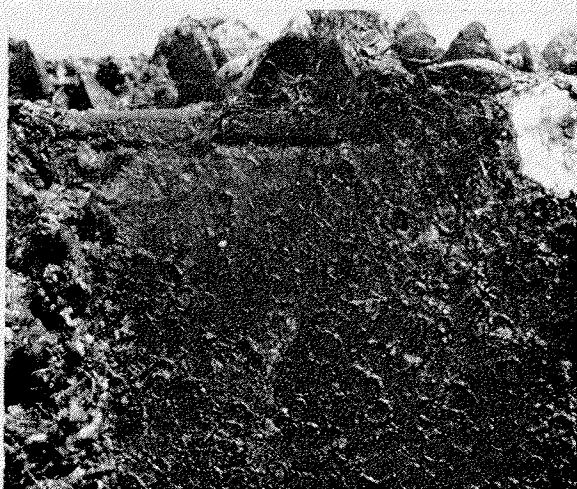
FIGURE 21. *A*—Barnacles growing on paint, showing chips of paint which have been wedged up by the shell's growth and the marks left by barnacles which have become detached. Photograph by C. M. Weiss. *B*—Marks left after removing barnacles from a nontoxic paint surface. Photograph from Nelson and Kodet (25). *C*—Undersurface of a barnacle which has penetrated the paint coating of a

Barnacles may also penetrate certain rubber-like coatings such as Thiokol, as shown in Figure 21D. Coatings of Natural Rubber, Buna S, and Neoprene have not been found to be vulnerable to such damage (15).

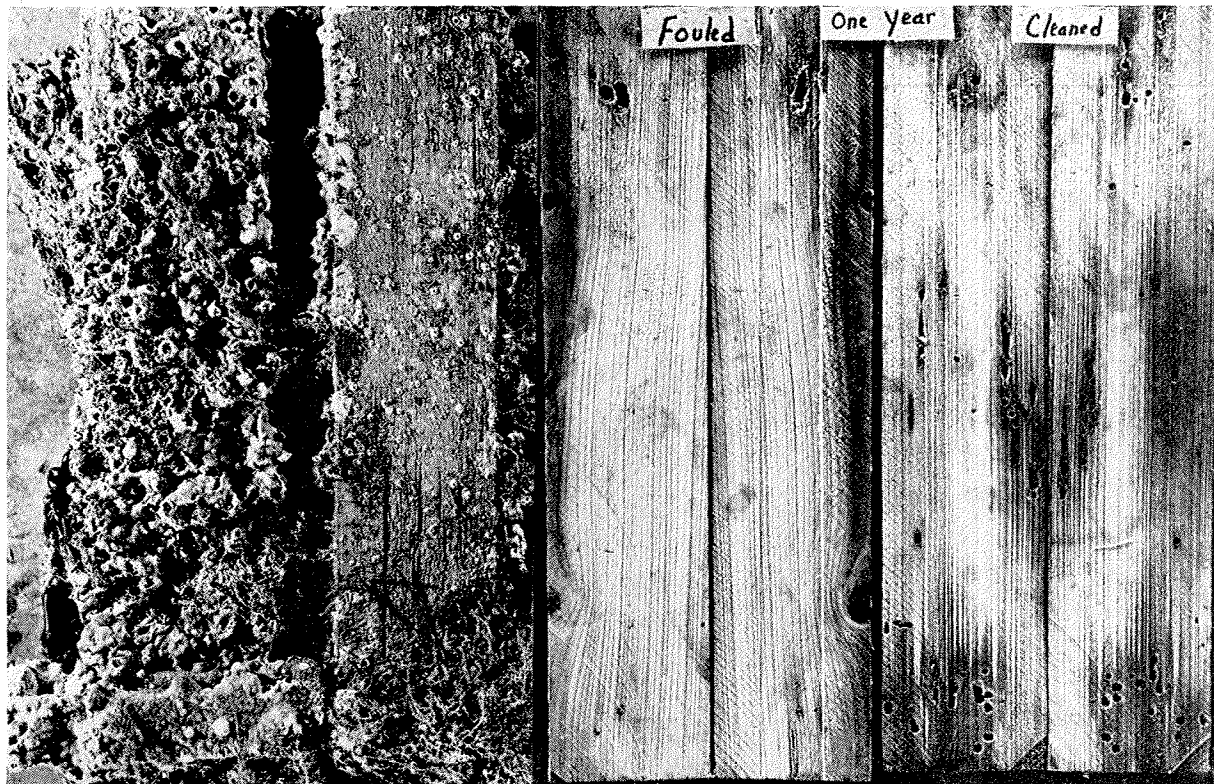
FIGURE 22. Effect of fouling on attack by wood borers. Fouling on the block at left was undisturbed during one year's immersion at Miami Beach. The block at its right was cleaned periodically to reduce fouling. The condition of the blocks when split open is shown at right.
